Important Safety Recall Notice

Airstream Interstate Motorhome

NHTSA Recall Number 12V-596

Reason for This Recall

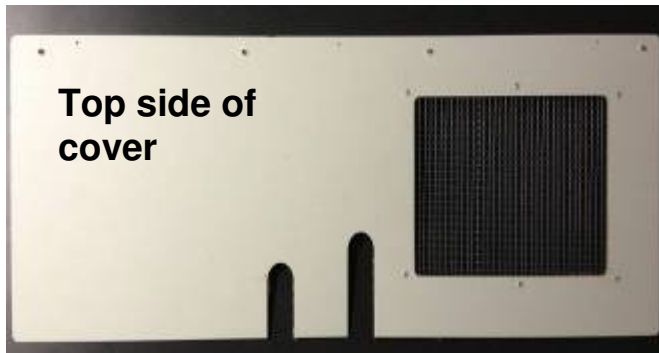
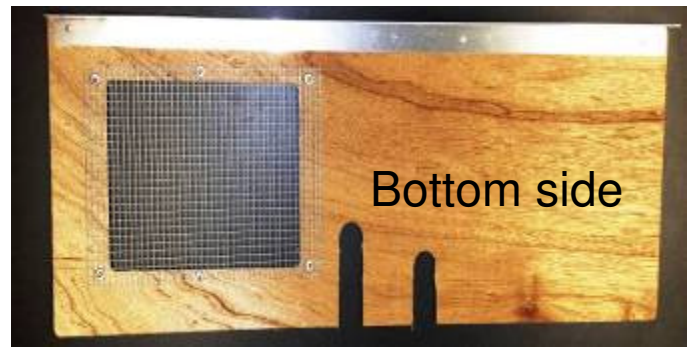
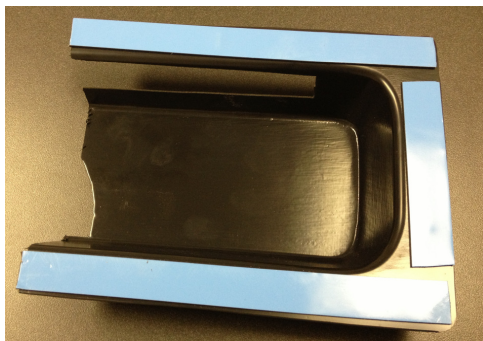
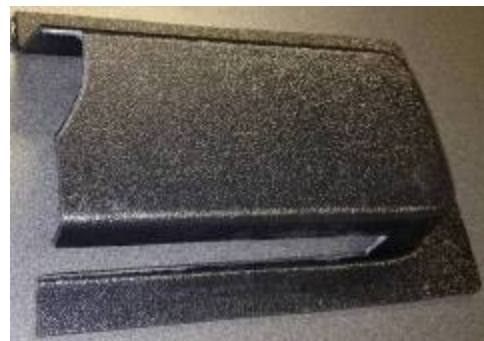
Interstate Van Wiring Closeouts

Kit # 967954-100 This will provide both Parts needed.

Service Action: The remedy is to install a cover over the electrical components located under the sofa. In addition, a protective closeout cover will be installed over the electrical connection from the battery box.

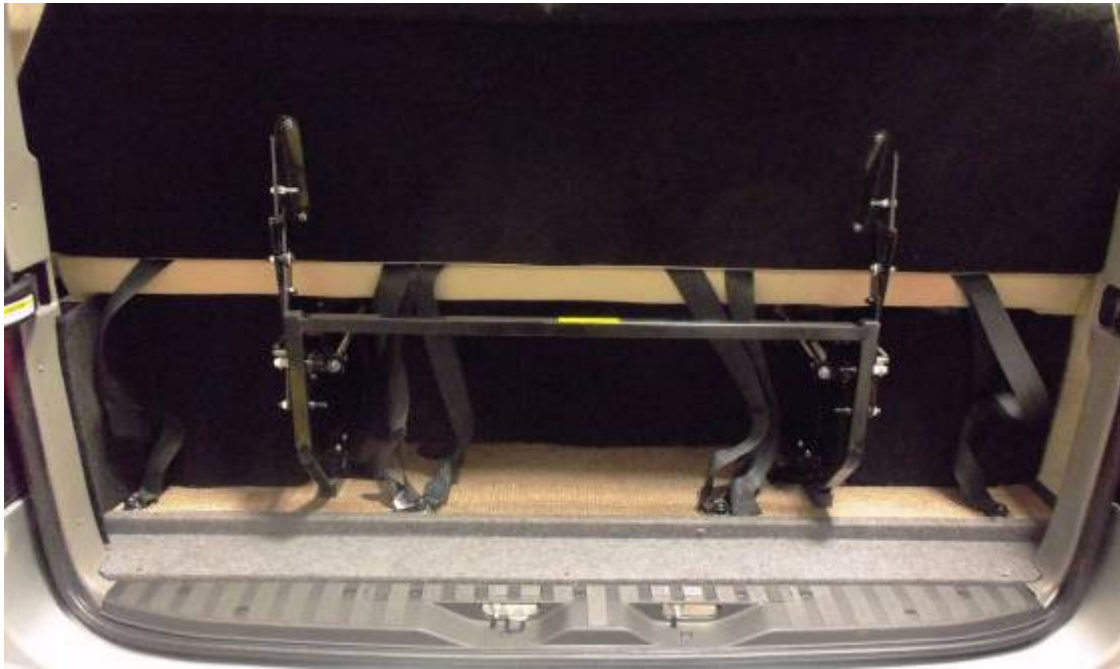
Access the panel and wiring via the rear van doors.
The compartment and battery lug are located in the area under the lounge.

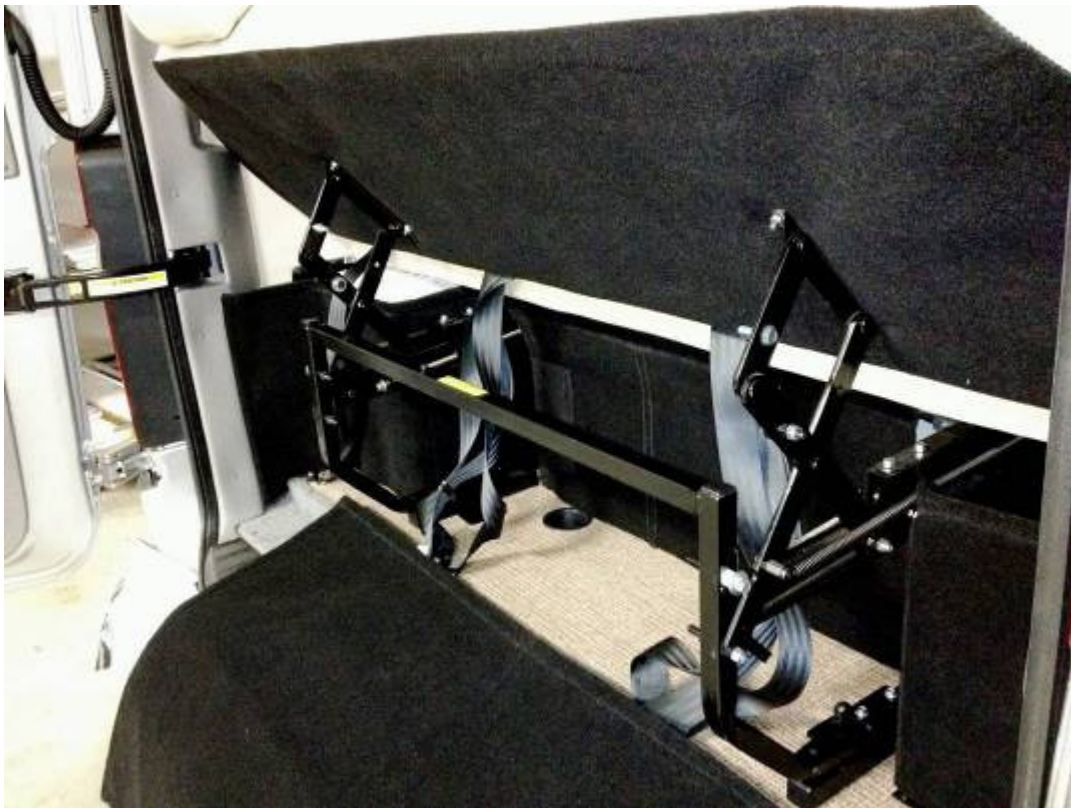
To allow additional room to work under the lounge ,lower lounge to a 45 degree angle for better access to the **compartment and wiring lug.**

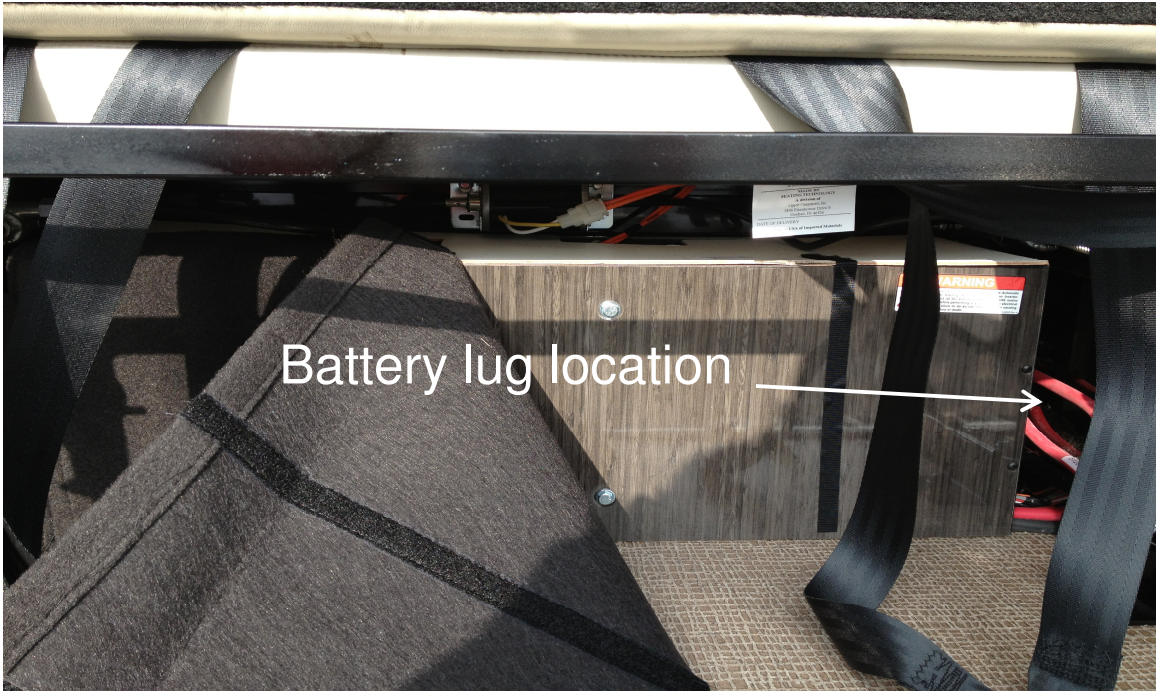
The panel and battery lug are located in the rear area of van under lounge—Remove felt covering from rear of compartment (attached with velcro).

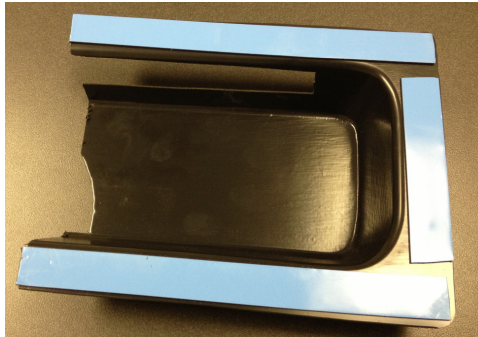
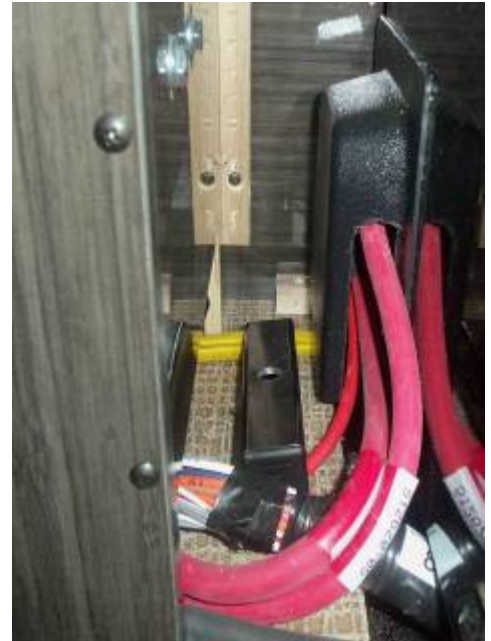
You will want to fit the plastic cover before removing the covering on the double sided tape.

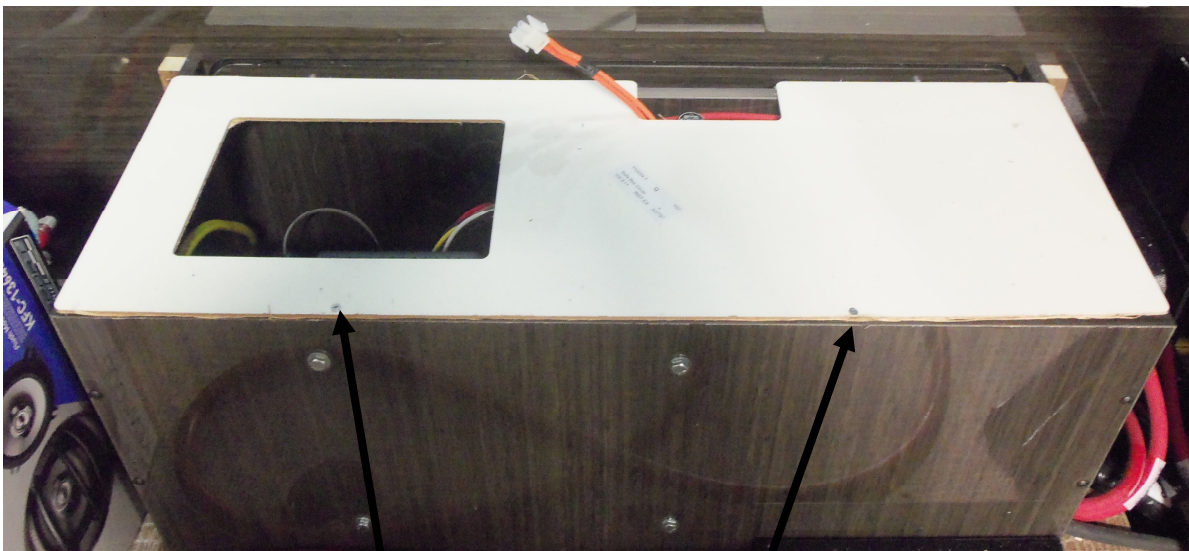
Compartment cover

If the van already has a protective cover over the compartment; remove the panel and replace (The early model vans will not have a cover and some do not have mesh over cutout).

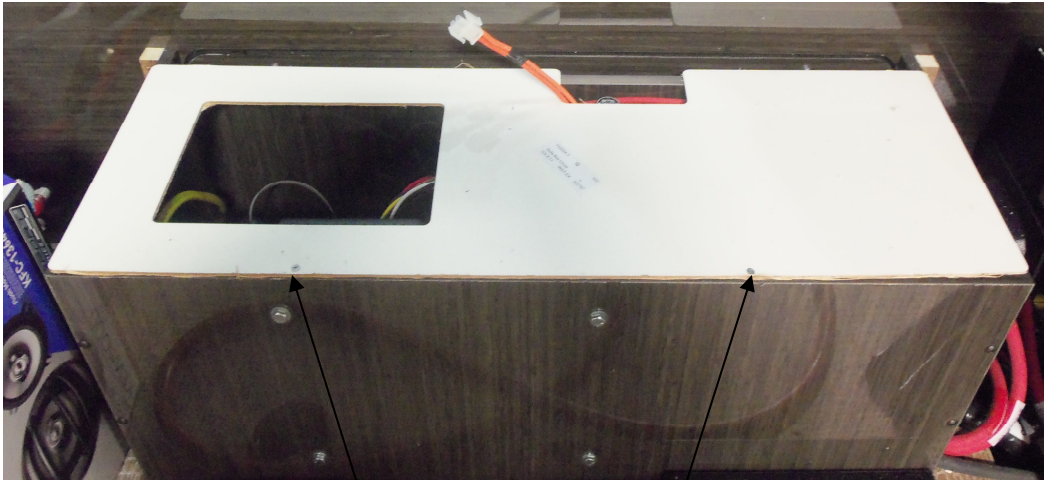
Remove screws and
remove panel

If the van already has a protective cover remove (The early model vans will not have a cover and some do not have mesh over cutout).

Example: Electrical component compartment with old style cover without mesh screen and cutouts

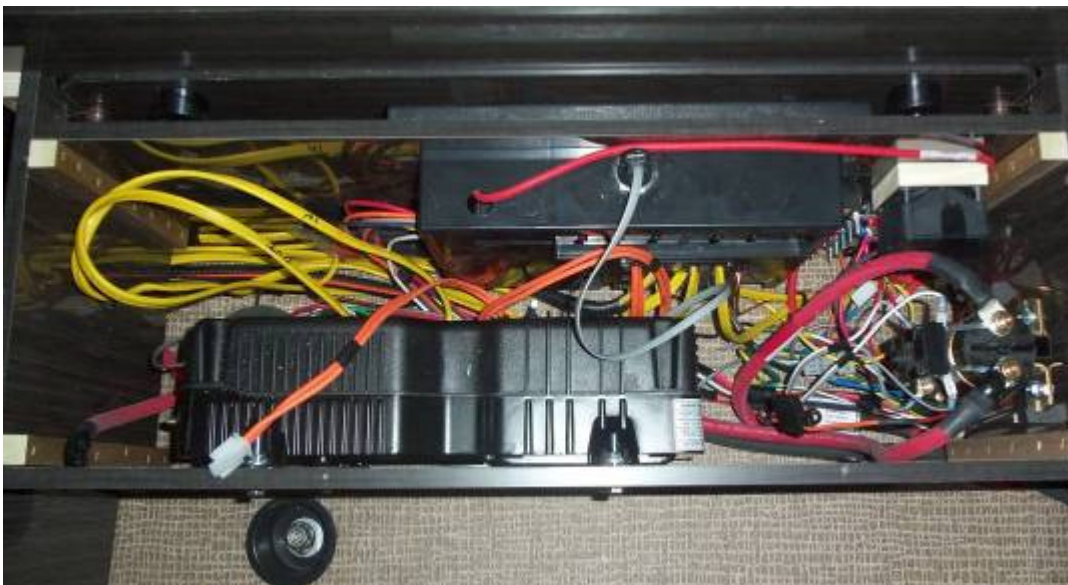
Remove screws and
remove old panel

Example: Electrical component compartment without cover

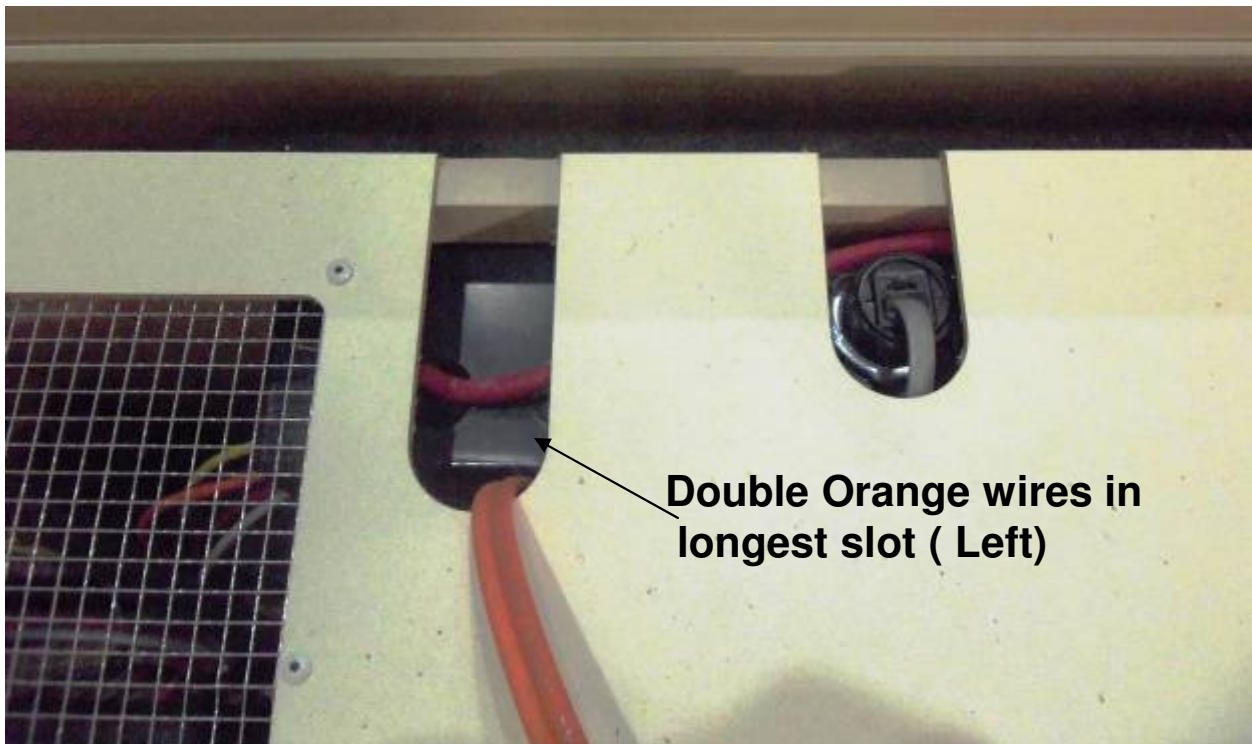
Slide panel in on top of compartment (push seatbelts to side while inserting panel). Make sure bed motor wires are in the left slot on panel.

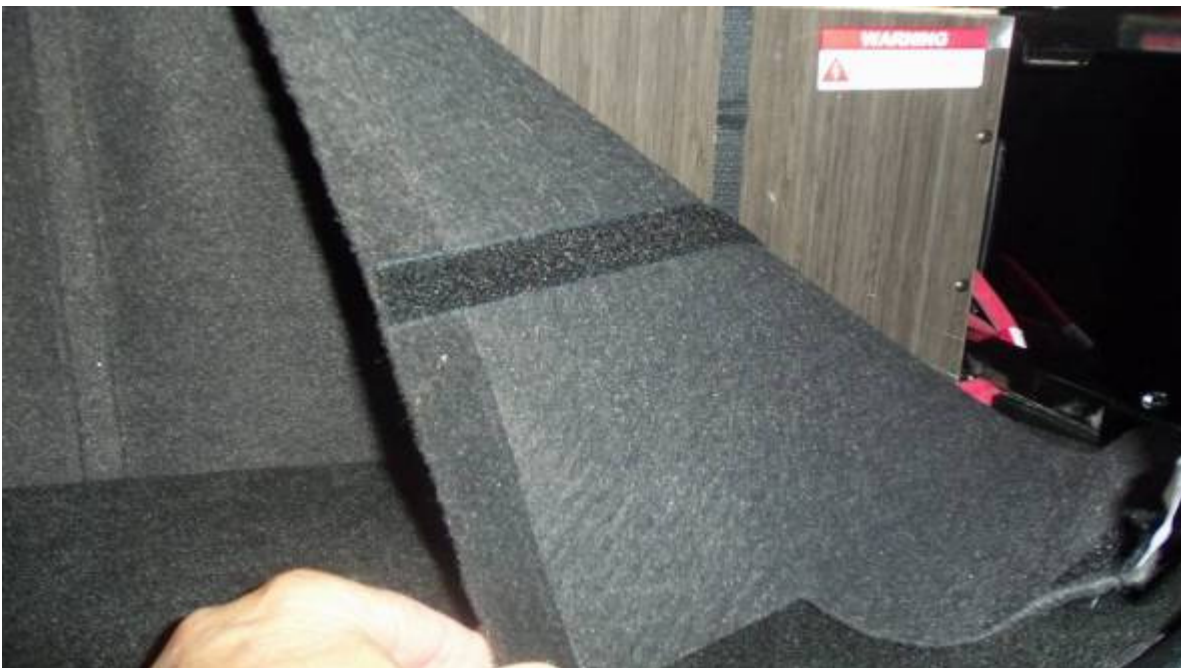
Re-install felt close out and you are finished
