SUBARU

REPAIR PROCEDURE

APPLICABILITY: 2009-2012MY Forester
 2010-2011MY Legacy and Outback
 2006-2012MY Tribeca

SUBJECT: Preliminary Inspection and Repair Procedure
 for Puddle Light Campaign WQE-41

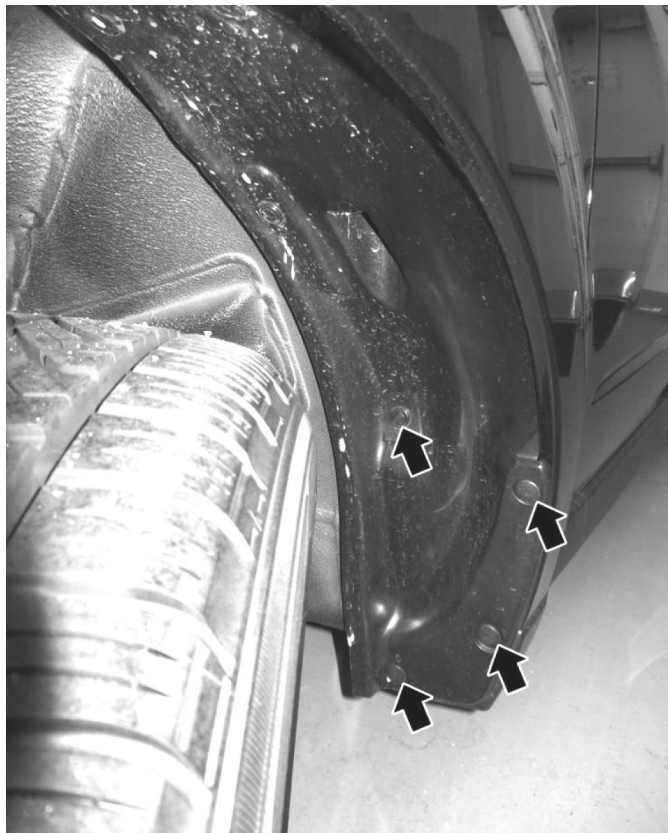
1. Raise the vehicle as necessary to access the inner fender splash shields. Wheel removal is generally not required.
2. Remove the accessory splash guard (if equipped) and the retaining clips at the rear portion of the front wheel opening. Move just enough of the splash shield to expose the puddle light wiring and body harness connectors

- A Forester is shown in the photo on pg. 4 for illustration only.
- Splash guard removal may also be required for access to the splash shield retaining clips.
- Retaining clip locations will vary by model.
- See **Appendix B** for samples of retaining clip locations by model.
- The photos below show a puddle light harness without the in-line mini-fuse on the left and the current replacement harness with the in-line mini-fuse on the right.

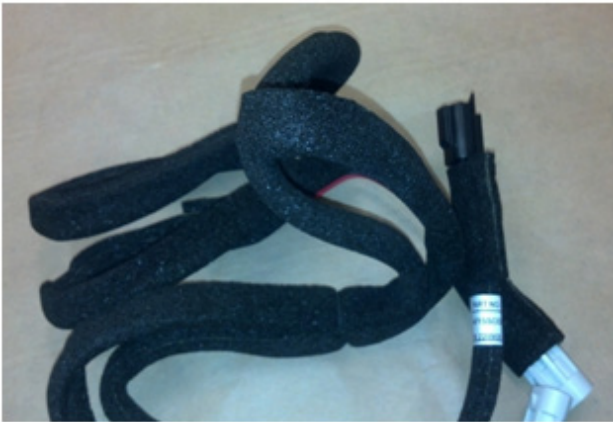
No mini-fuse installed

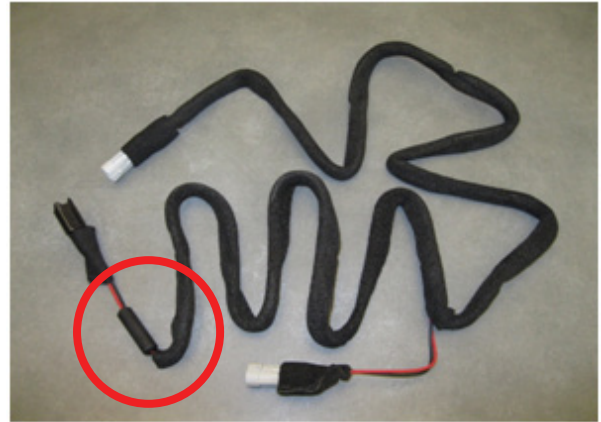
With mini-fuse installed

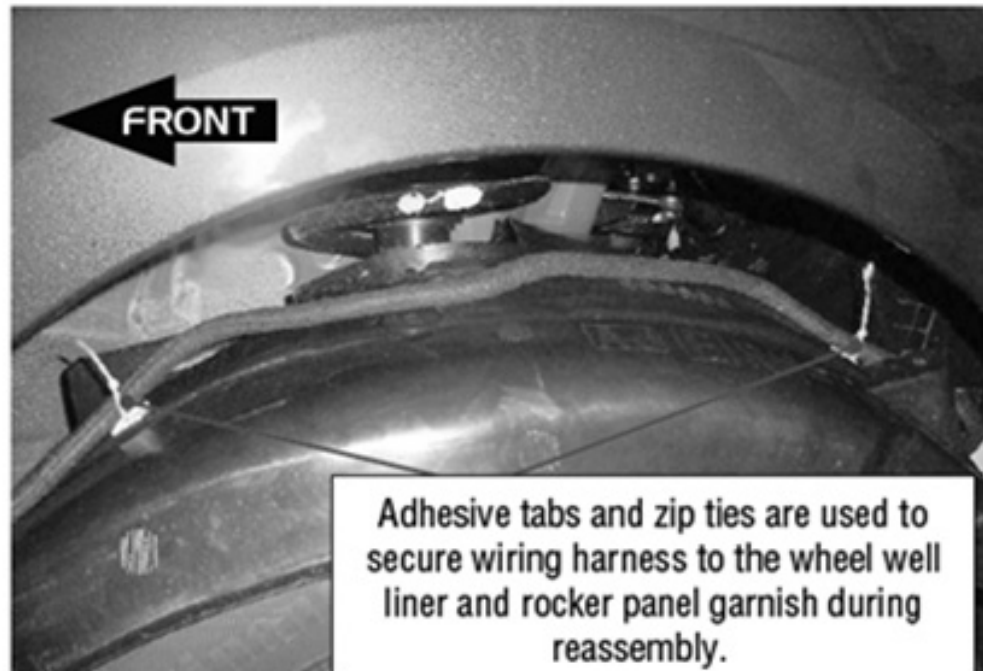
- On Legacy and Outback models, use caution when moving the splash shield as the body harness for the puddle lights is secured to it at two points as shown below. It is not required to drop the entire splash shield. Simply move enough of the shield to gain access to the connection which is located at the rear of the wheel opening. This information and photo are provided as a reference only.

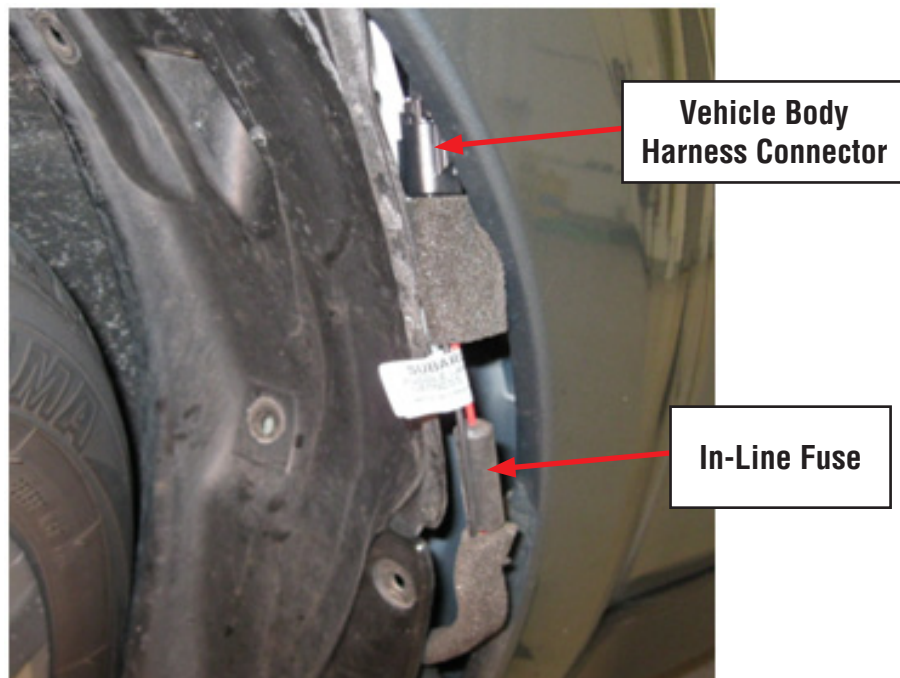
3. Once the splash shield has been moved enough for access, inspect the puddle light harnesses.
 - a. If the vehicle already has an in-line fuse in the red power wire within a few inches of the vehicle connector as shown in the photo below and both lights (all 4 LED bulbs) operate, no further action is required on that side.

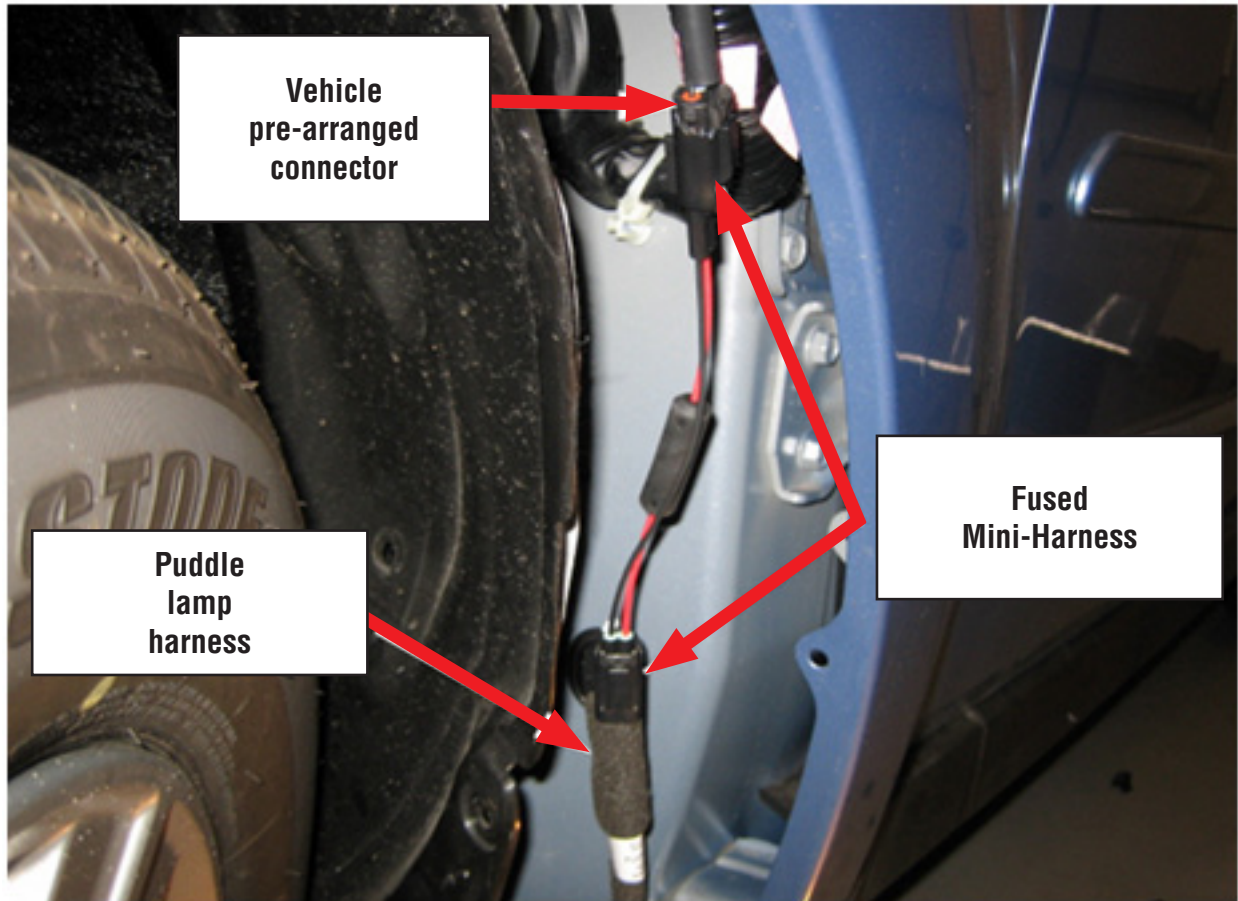
- b. Proceed to check the other side of the vehicle starting again at Step 2. Once inspection of both sides of the vehicle is complete, proceed to Step 5.
- c. If no in-line fuse or Fused Mini-Harness is present, unplug the puddle light harness connector from the vehicle body harness connector and install the Fused Mini-Harness as shown in the reference photos below.

Route the completed harness behind the splash shield. Use electrical tape to secure any excess harness out of the way avoiding any areas where it may be exposed to sharp edges or become pinched. **Do not reassemble yet.** Once both sides of the vehicle have been completed, proceed to the next step.
