SAFETY RECALL BULLETIN

SUBJECT:			No: SR-13-001REV
2012 i-MiEV VACUUM PUMP – SAFETY RECALL CAMPAIGN (REVISED)			DATE: March, 2013
			MODEL: 2012 i-MiEV
CIRCULATE TO:	<input checked="" type="checkbox"/> GENERAL MANAGER	<input checked="" type="checkbox"/> PARTS MANAGER	<input checked="" type="checkbox"/> TECHNICIAN
<input checked="" type="checkbox"/> SERVICE ADVISOR	<input checked="" type="checkbox"/> SERVICE MANAGER	<input checked="" type="checkbox"/> WARRANTY PROCESSOR	<input checked="" type="checkbox"/> SALES MANAGER

Certain brake vacuum pumps equipped on 2012 i-MiEV vehicles built between December 2, 2011 – September 7, 2012 may become inoperable due to failure of an internal component. If the vacuum pump becomes inoperable, the brake warning light will illuminate and the brake warning buzzer will alert the vehicle operator. Vacuum pump inoperability will result in reduced brake power assist, which may increase stopping distances and could lead to greater risk of crash.

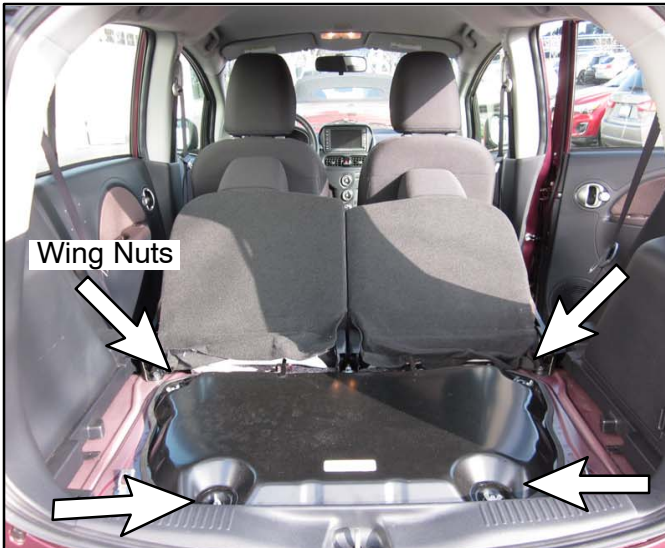
2. Open the liftgate. Adjust the rear seatbacks forward into the passenger compartment. Remove and store the rear access cover. Unscrew the four wing nuts from the power unit inspection lid and open the lid to gain access to the vacuum pump.

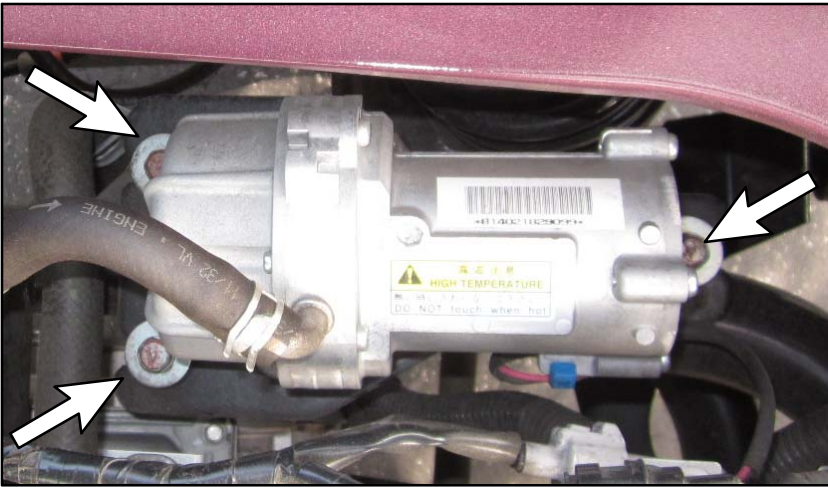
6. Unclip the vacuum pump electrical connector mount from the vehicle's body.

7. Remove three 12mm bolts to disconnect the vacuum pump assembly.

CAUTION To prevent any damage to the vacuum pump connector, ensure the connector is disconnected from the vacuum pump prior to removal.

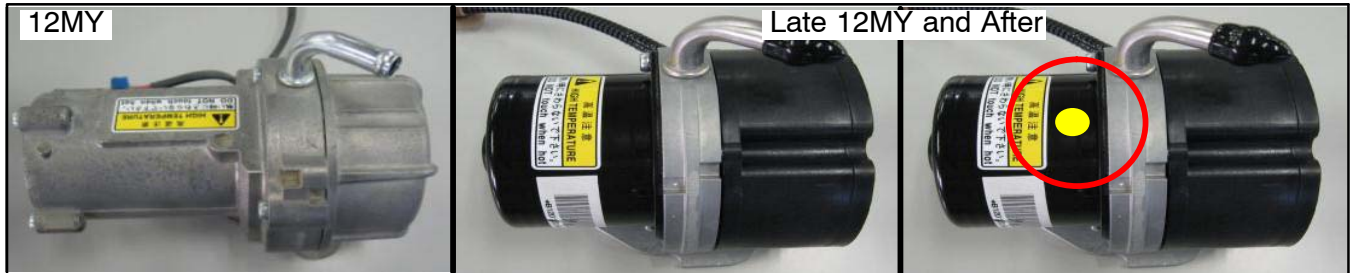
NOTE: The affected vacuum pump has either a monotone (silver) exterior or a two-tone exterior (black and silver) that may or may not have a yellow mark on the body as shown below.

9. Replace the vacuum pump with the new unit.
