**RE: Defect Information Report – Supplemental Report No. 1  
13V-127, FL-642, ICU4Me Park Brake Warning Message  
Dealer Notice**

June 2013  
FL642A  
NHTSA #13V-127  
Transport Canada #13-110

### Subject: ICU4Me Park Brake Warning Message

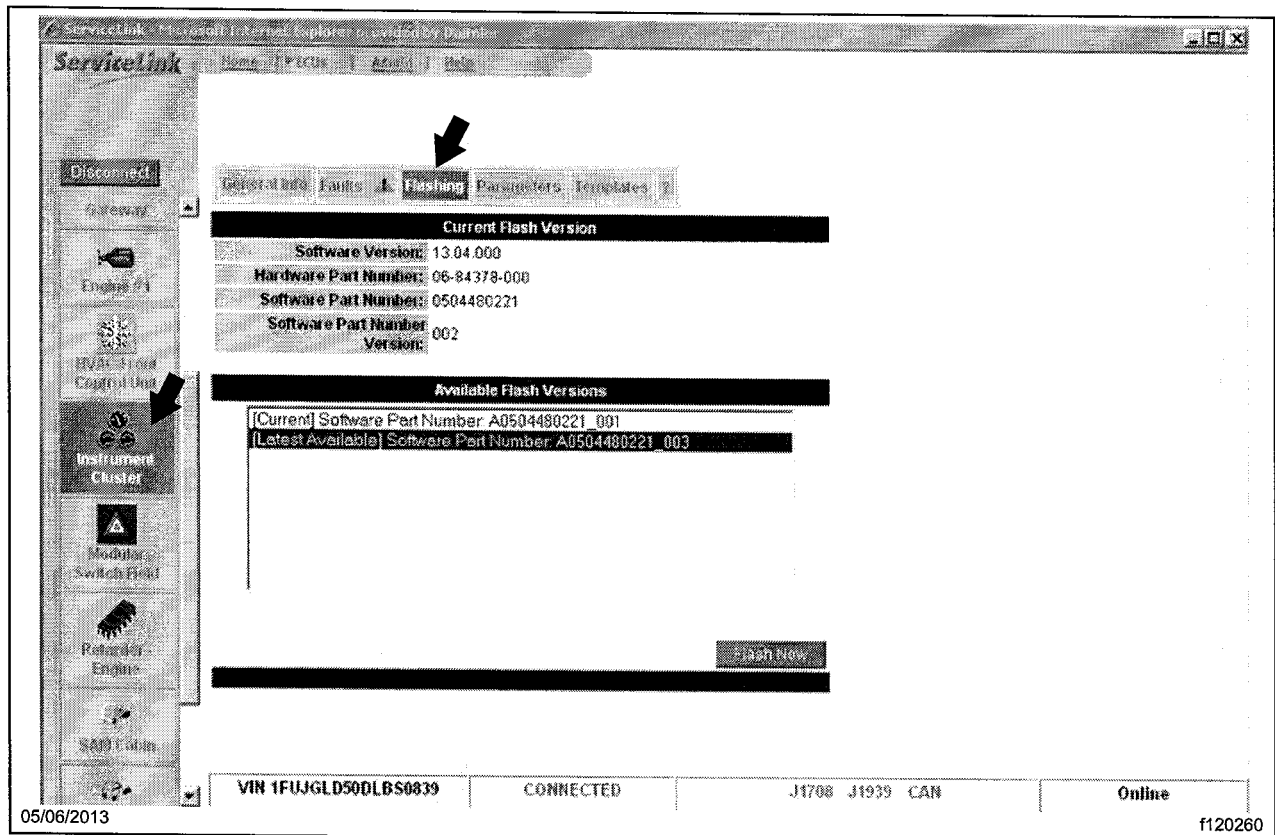
Fig. 1, Instrument Cluster Flashing Screen

1. Check the base label (Form WAR259) for a completion sticker for FL642 (Form WAR260), indicating this work has been completed. The base label is usually located on the passenger-side door, about 12 inches (30 cm) below the door latch. If a completion sticker is present, no work is needed. If a completion sticker is not present, proceed to the next step.
2. Shut down the engine and apply the parking brakes. Chock the tires.
3. Connect the vehicle to ServiceLink.
4. Select the "Instrument Cluster" icon on the far left-hand side of the screen. Then click the "Flashing" tab. See Fig. 1.

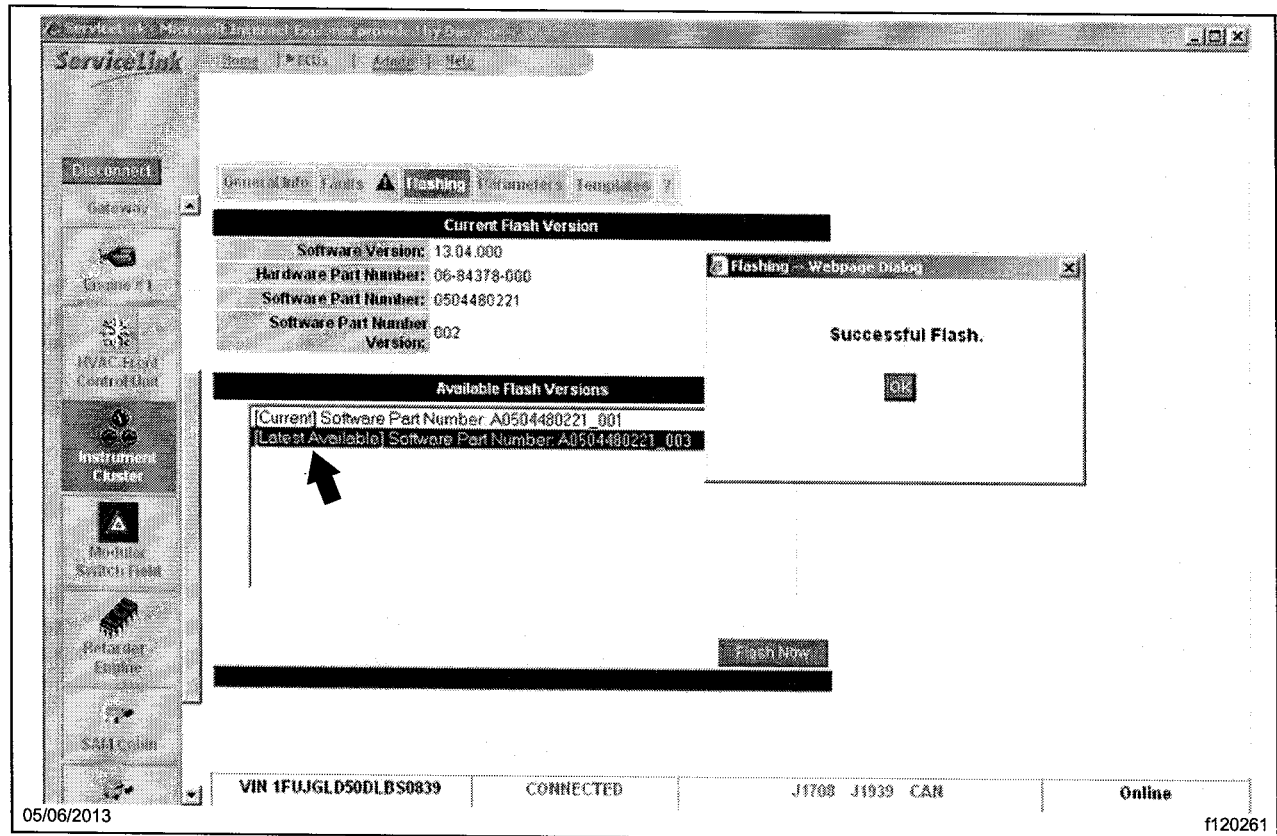
Fig. 2, Features Drop Down List

5. Select the "Latest Available" flash version. Then click the "Flash Now" button. See Fig. 2.
6. Once the flash is complete, a popup window indicating a "Successful Flash" will appear. Click "OK" on the popup window.

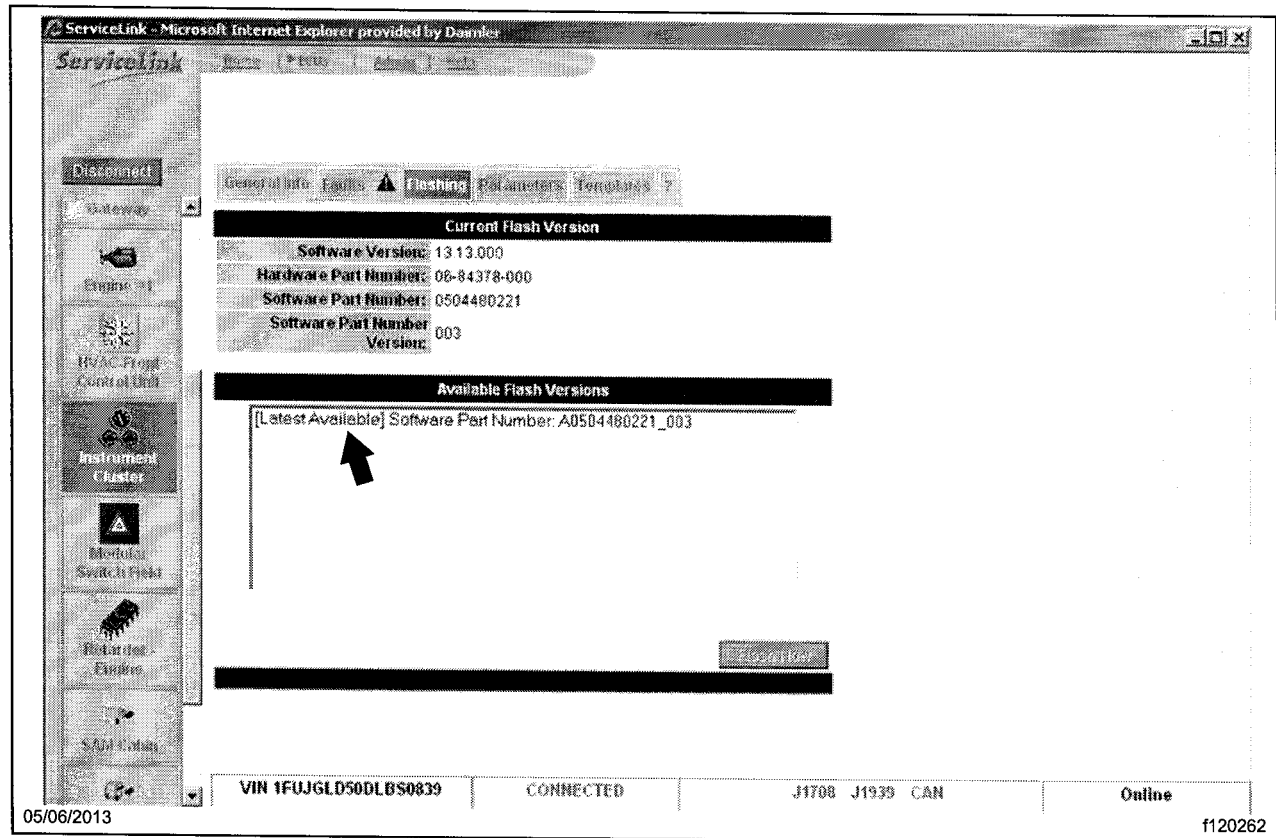
Fig. 3, Parameter Selection

7. ServiceLink will now only display the latest software version for the ICU. See Fig. 3.
