Bulletin No.: 13142A Date: August 2013

### **PRODUCT SAFETY RECALL**

**SUBJECT:** Loss of Battery Charge – Replace Generator Control Module

MODELS: 2012-2013 Buick LaCrosse, Regal

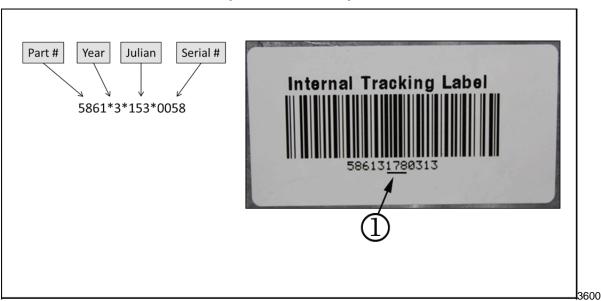
Locate the barcode label on the new GCM.

- 2. Determine the Julian date (1) as shown above.
  - If the Julian date (1) is 171 through 199, do NOT install the module. Obtain another module and perform the inspection again.
  - If the Julian date (1) is NOT 171 through 199, provide to the technician for installation in the vehicle.

Do NOT provide technicians with GCMs (p/n 24269448 or 24266403) that have a Julian date of 171 through 199. Determine the Julian date following the steps below. Return modules that fail the inspection according to Special Return Bulletin #G\_0000171850.

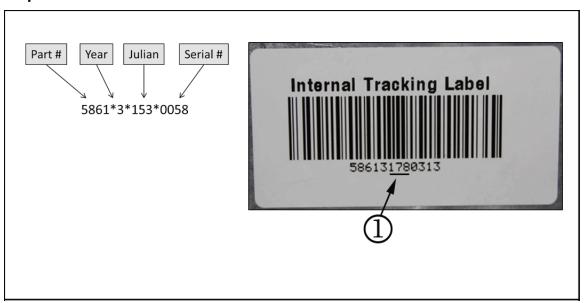
3. Locate the barcode label on the new GCM.

- 4. Determine the Julian date (1) as shown above.
  - If the Julian date (1) is 171 through 199, do NOT install the module. Obtain another module and perform the inspection again.
  - If the Julian date (1) is NOT 171 through 199, proceed to the Installation Procedure below.

**Note:** Do NOT install GCMs with a Julian date of 171 through 199. Return those modules according to Special Return Bulletin #G\_0000171850.
