**RE: Defect Information Report – Supplemental Report No. 2  
13V-364, FL-643, Auxiliary Fuel Pickup Tube  
Dealer Notice**

# Recall Campaign

FL643A

## Subject: Auxiliary Fuel Pickup Tube Labels

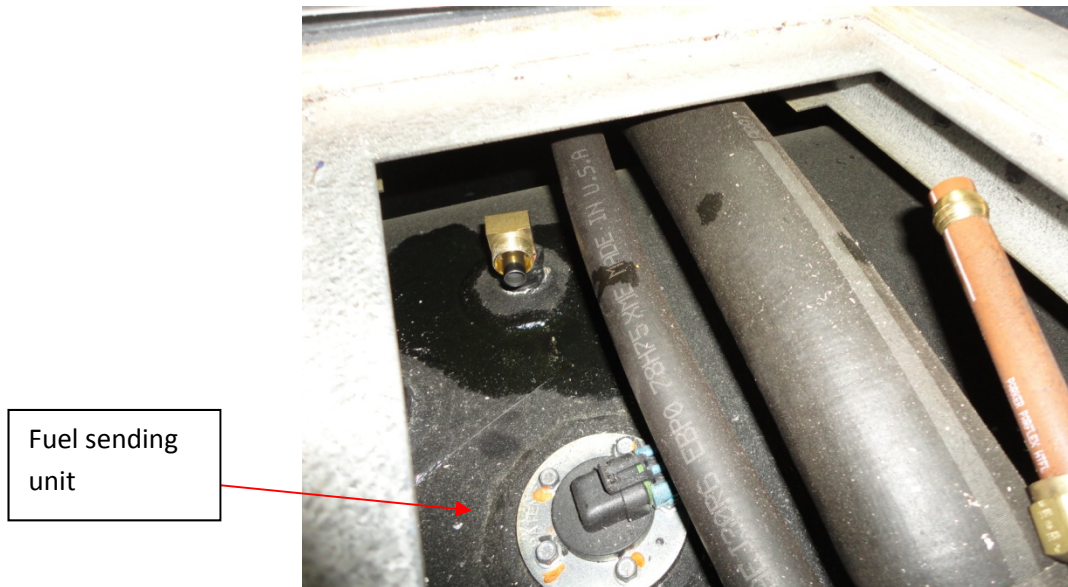
- 4) Remove the hose by loosening the compression fitting using a 15/16" wrench.
- 5) Next, push the hose out of way so that the fuel tube mounting can be reached as in Figure 2

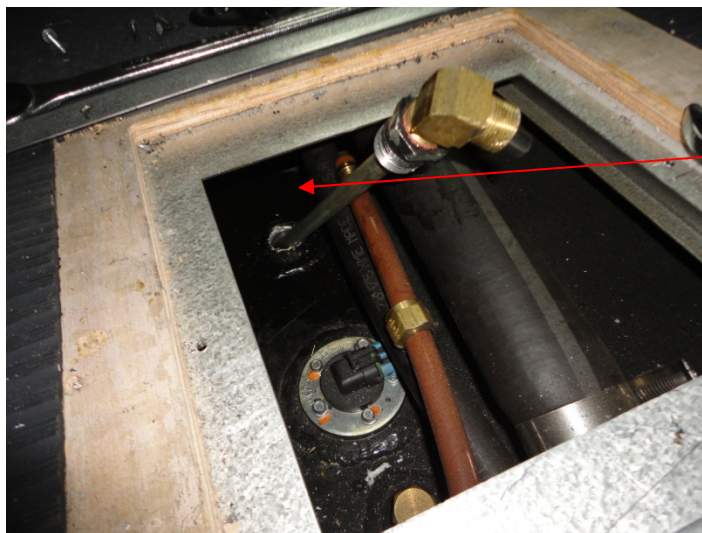
Figure 4

- 10) Reinstall the tube and hose then proceed to next step.
- 11) Remove the main pick-up tube. Loosen the pickup tube in the tank using a pair of pliers or a 15/16" wrench on the head of elbow. Next, turn the tube at an angle to remove as shown in Figure 4.

Main Fuel  
pick-up
