**RE: Defect Information Report – Supplemental Report No. 2  
13V-401, FL-645, Western Star Seat Belt Anchor Mountings  
Dealer Notice**

## Subject: Western Star Seat Belt Anchor Mountings

**Models Affected:** Specific Western Star 4900 vehicles with Stratosphere sleeper cabs manufactured May 27, 2008, through March 28, 2013.

## Work Instructions

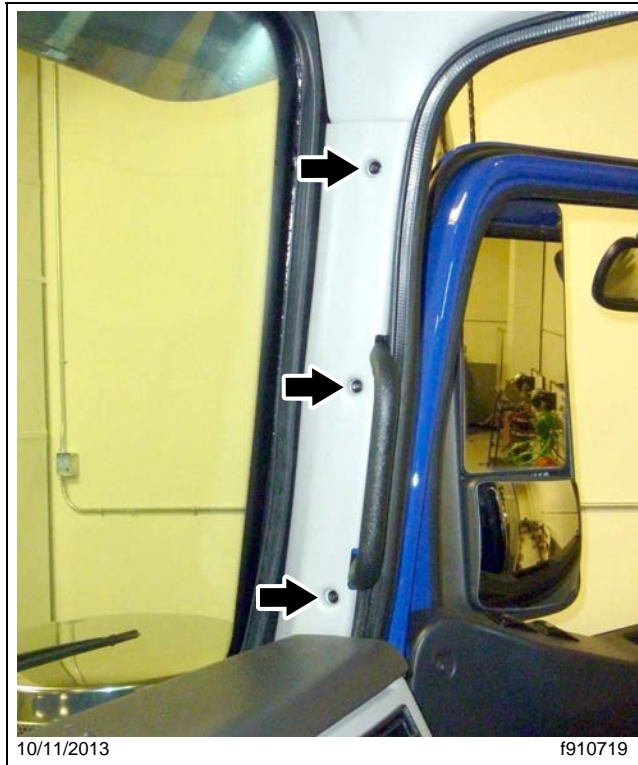
**Fig. 3, A-Pillar Cover Screws**

5. Remove the A-pillar cover. See **Fig. 3**.
6. Remove the screw that helps secure the overhead console, next to the windshield and the cantrail (upper trim panel). See **Fig. 4**.
7. Remove the screws that attach the cantrail to the cab structure. Remove the cantrail and disconnect the speaker. See **Fig. 5**.

18. Connect the speaker. Pull the sun visor wiring out through the hole in the cantrail (upper trim panel). Install the cantrail. Ensure the two tabs hook behind the roof trim panel. See **Fig. 11**.
19. Install the overhead console screw. See **Fig. 4** on page 7.
20. Install the A-pillar cover. See **Fig. 3**.
21. Connect the sun visor wiring and push the plug and wiring behind the cantrail. Install the sun visor. See **Fig. 2**.
