Safety Recall

Code: 20U6

Subject: 2013-2014 MY Audi S6 and S7
Fuel Line

Due to manufacturing tolerance issues, a fuel line in affected vehicles can become damaged over time. If this happens, it could result in a fuel leak. Leaking fuel, in the presence of an ignition source, can lead to a fire.

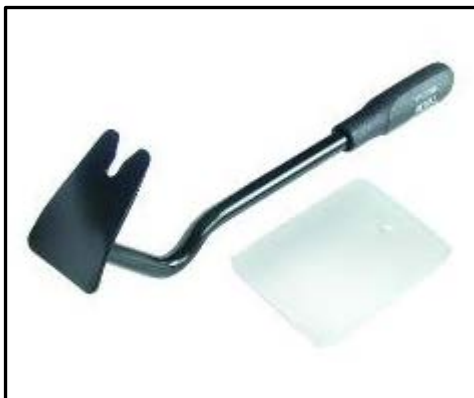
- Trim Release Lever, T10039

- Heavy-Duty Wheel Lug Torque Wrench, CNT97354 or Equivalent

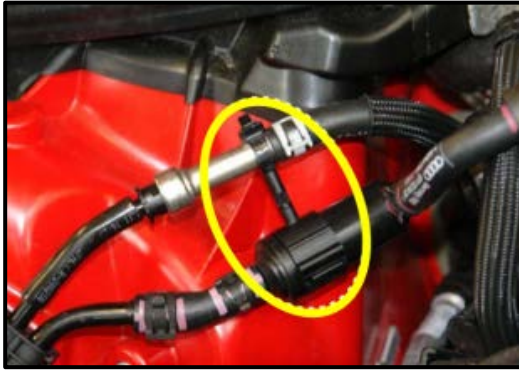
⇐ Inspect for the new clamp

- If the clamp is not present **continue to Section C**
- If the clamp is present no further work is required. **All work complete, continue to Section D**

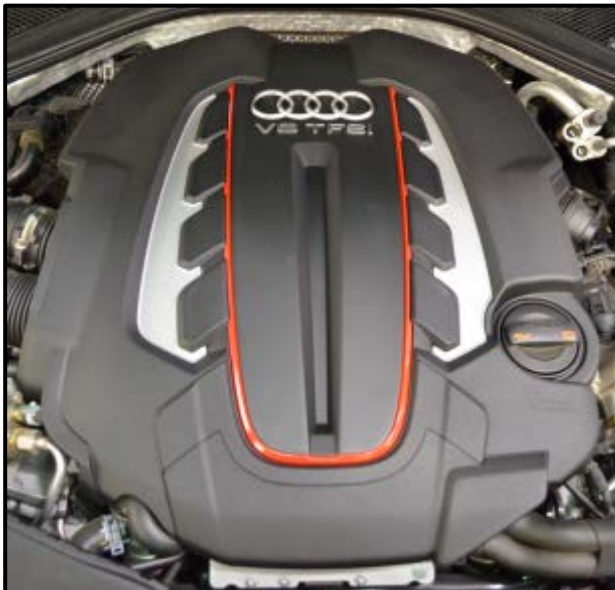
- Open the hood.
- ⇐ Remove the engine cover <left>.

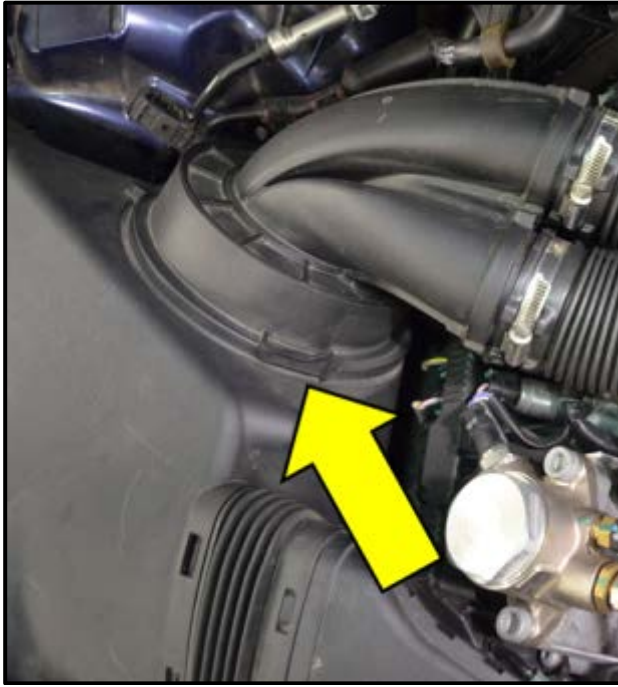
⇐ Disengage the intake tube from the air filter housing <arrow>.

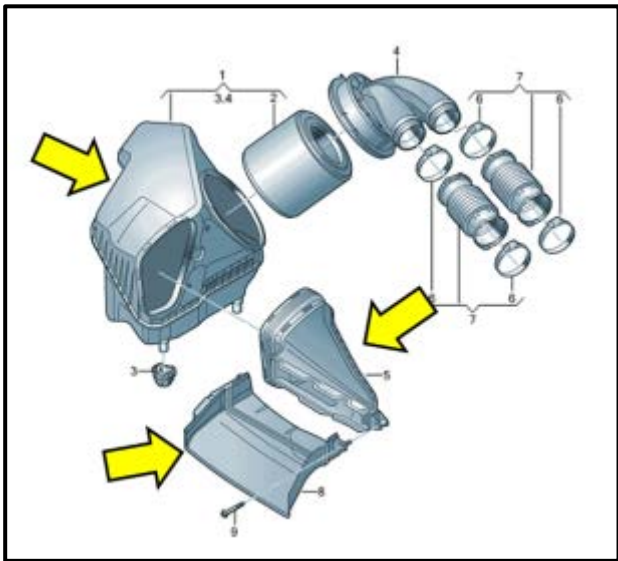
⇐ Remove the air filter housing and inlet ducts <arrows>.

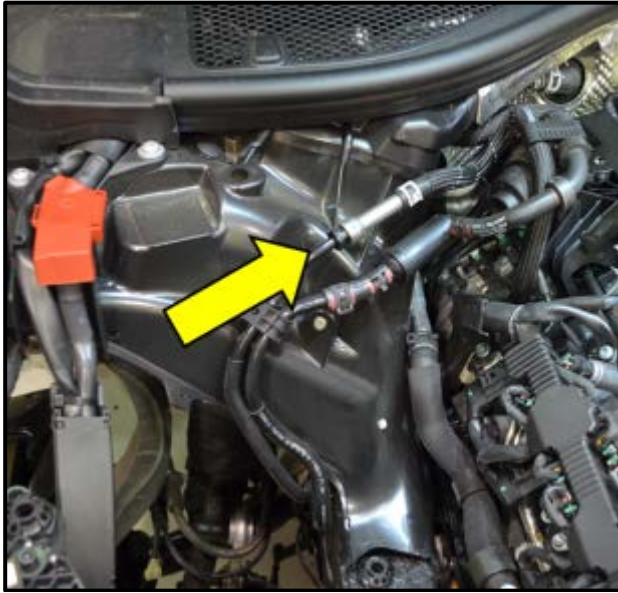
⇐ Disconnect the fuel supply line near the right front strut tower <arrow>.

TIP: Wrap a rag around the quick release connection on the fuel supply line to catch any residual fuel when the line is disconnected.

TIP: The fuel supply line is a smaller diameter than the evaporative emissions line.

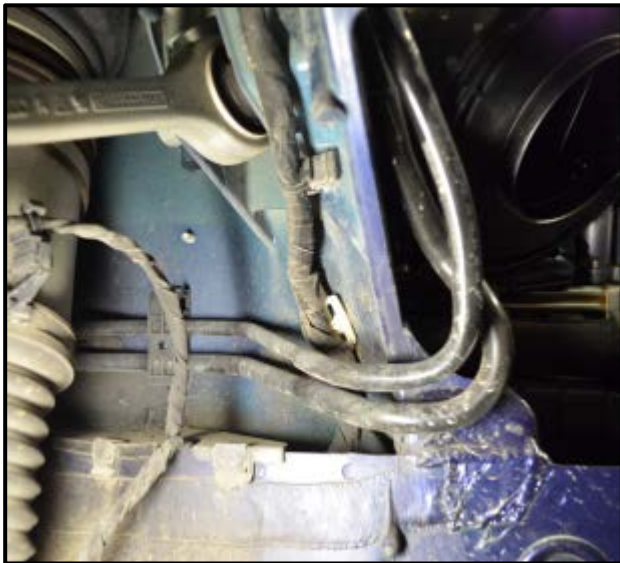
TIP: At this point in the repair process, note the routing of the fuel supply line and evaporative emissions line behind the front strut. Take photos if necessary. When the fuel line is reinstalled it must be routed in exactly the same location and orientation in order to fit properly.

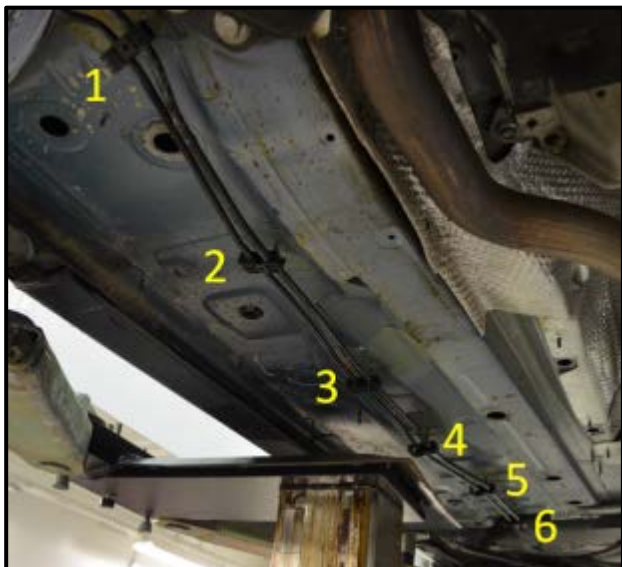
- Install the new mounting clips, 4G0 201 190, onto the evaporative emissions line and the fuel supply line.
 - Use the markings previously applied to the evaporative emissions line as a guide for clip placement.
- ⇐ Install each mounting clip onto the appropriate stud in the order shown <left>.

TIP: Once all the plastic clips are reinstalled inspect the fuel supply line and evaporative emission line routing. Verify both lines are secured to the body properly and that the lines are not able to rub against any components.

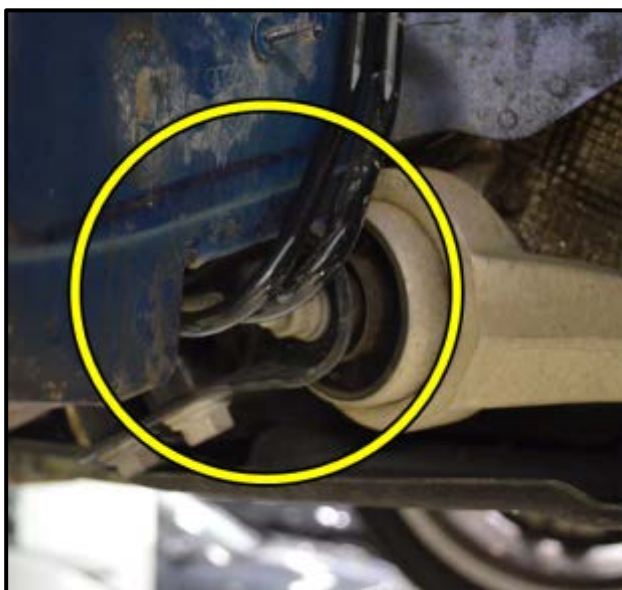
- ⇐ Inspect the fuel supply line and evaporative emissions line clearance where shown <circle>. Verify these lines do not contact the vehicle body.
- Reconnect the vehicle battery.
 - Start the engine
 - Verify the replacement fuel line is properly sealed and does not leak.

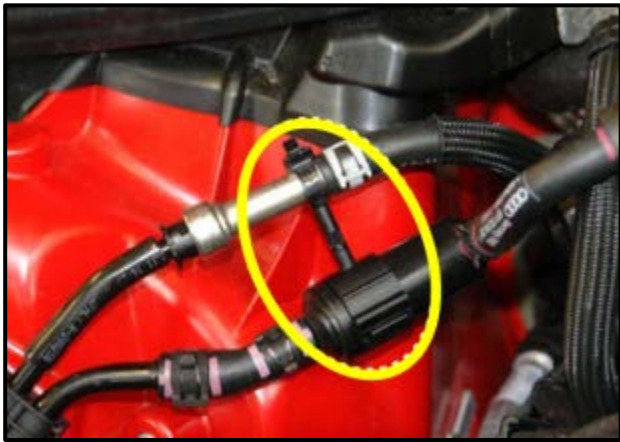
⇐ Install new double clip, 4G0 201 449 AG, <circle>
