Re: Toyota Safety Recall 13V-557 – Preliminary and Remedy Dealer Notification

**Safety Recall D0U – Remedy Available**  
**Certain 2013-2014 Model Year Tacoma Vehicles Equipped with a 4-Cylinder Engine (2TR-FE)**  
**Valve Spring Replacement**

Subject: Safety Recall D0U – **Remedy Available**  
Certain 2013-2014 Model Year Tacoma Vehicles Equipped with a 4-Cylinder Engine (2TR-FE)  
Valve Spring Replacement

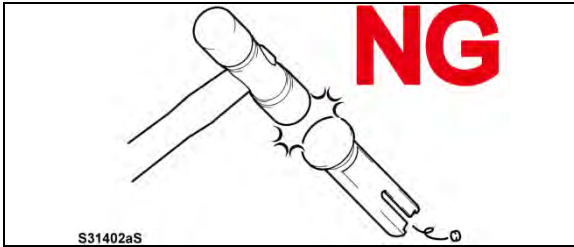
#### 1. DO NOT STRIKE REMOVER OR REPLACER

- a) **DO NOT** strike the valve retainer remover/replacer with a hammer or other tools, this could cause magnets to fall out of tools.

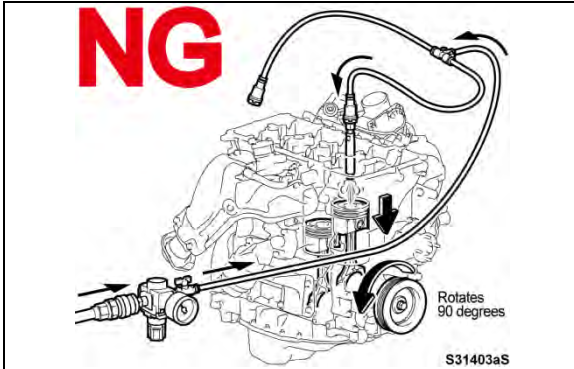
#### 2. CHECK AIR HOSE ASSEMBLY FOR LEAKAGE AND APPLY AIR PRESSURE PROPERLY

**NOTE:** If compressed air is applied to only 1 cylinder the engine will rotate abruptly.

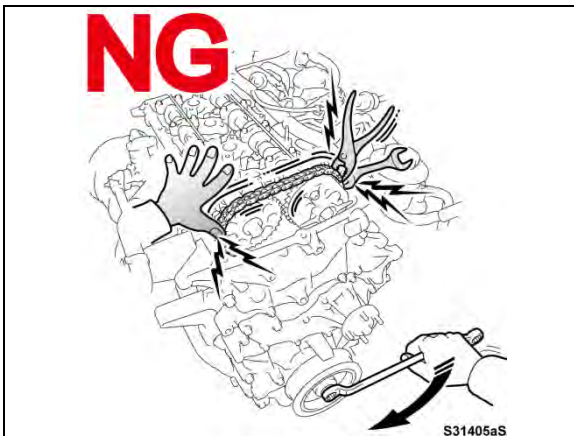
#### 3. CAREFULLY TURN CRANKSHAFT WHEN INSTRUCTED

- a) Be careful not get your hands or tool caught by the timing gears, chain or cams when turning the crankshaft.

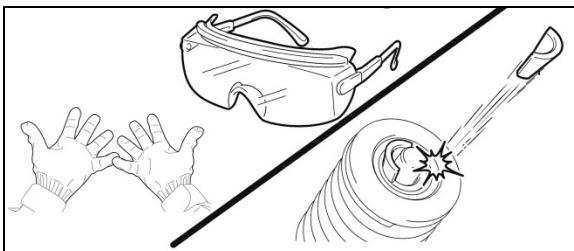
#### 4. WEAR PROTECTIVE EQUIPMENT

- a) When removing and installing the valve spring keepers always wear eye protection because the keepers may fly out if not engaged properly.
- b) Wear protective gloves when removing or installing valve spring retainers because sharp edges of cylinder head could lead to injury.

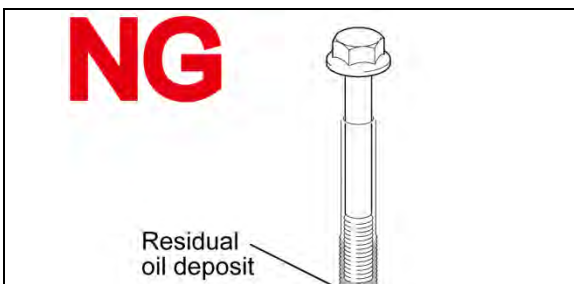
#### 5. DO NOT TIGHTEN BOLTS

- a) **DO NOT** tighten bolts if there is oil residue on the threads or bolt holes.
- b) Clean bolt threads and holes to avoid bolts from coming loose or damaging components from over torquing.

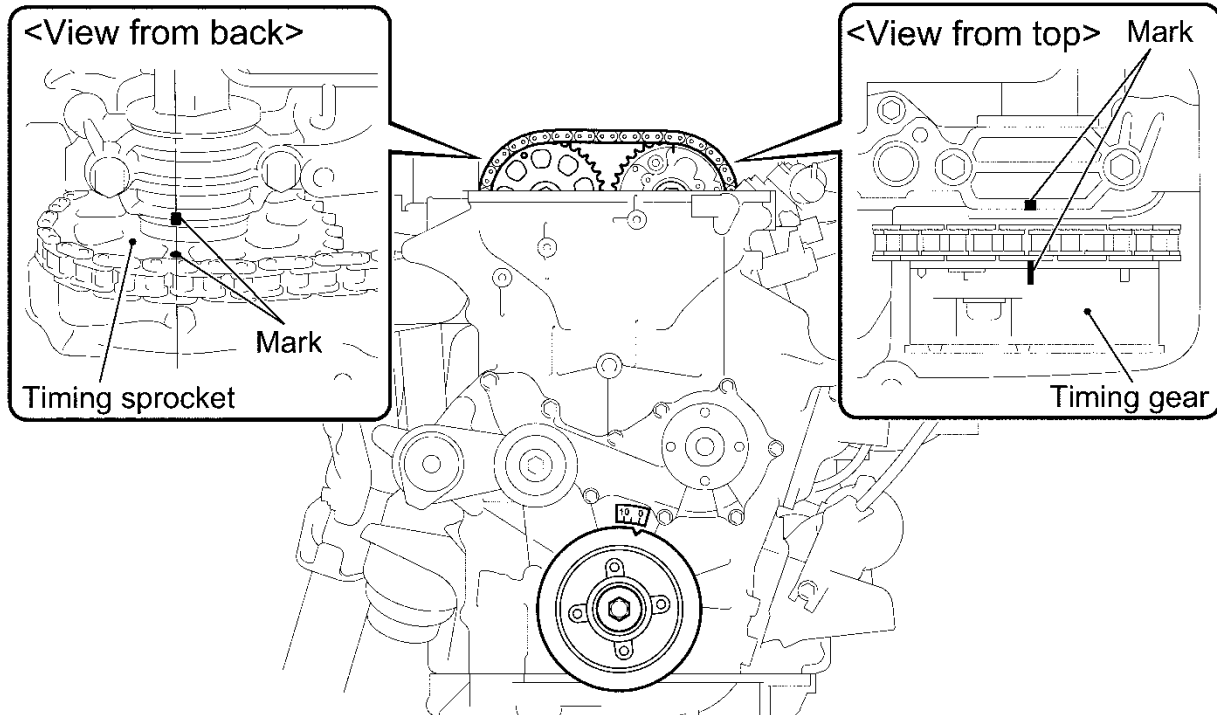
## TDC for cylinder #1

- Turn the crankshaft clockwise and align the timing mark on the crankshaft pulley with the zero degree point on the timing chain cover.
- Check the timing marks on the camshaft timing gears and ensure that they are aligned with the timing marks on the No.1 camshaft bearing cap as shown below.
- If they are not aligned turn the engine clockwise 360 degrees and recheck.

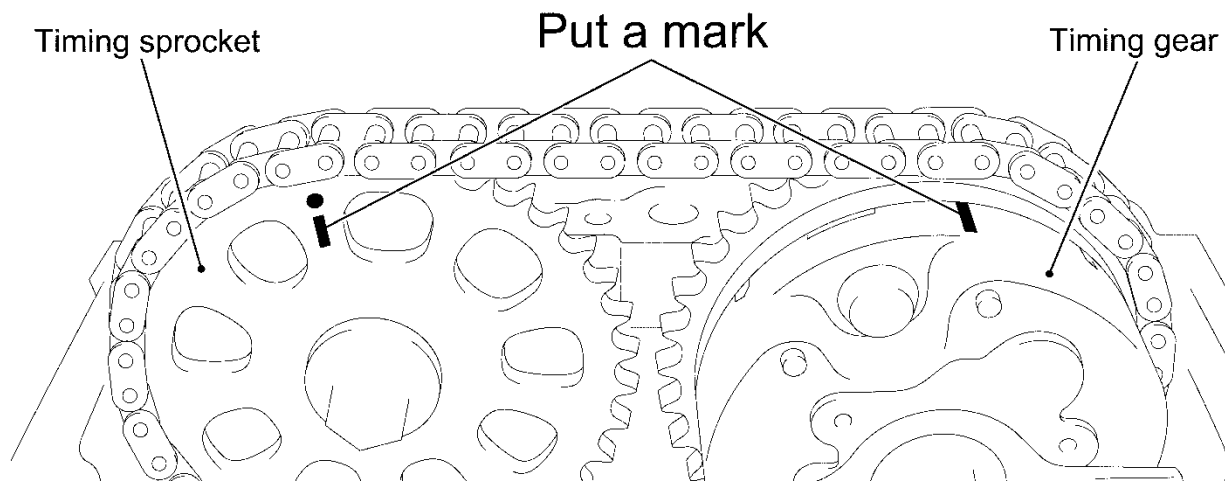
The camshaft timing gear (intake side) has several similar marks to the timing mark, and the camshaft timing sprocket (exhaust side) has to be reinstalled in the original orientation. Putting match marks onto each of them is critical, to avoid incorrect reinstallation.

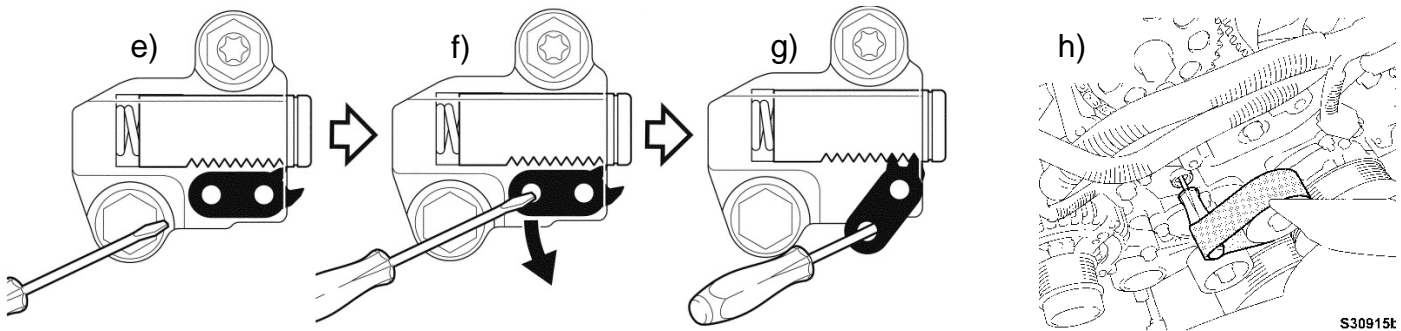
- e) Release the tensioner stopper held by the screw driver.
- f) Using the screw driver, move the tensioner stopper down as shown.
- g) Insert the screw driver through the tensioner stopper hole and placing the screw driver tip below the body of the tensioner. This will lock the tensioner in the compressed position.
- h) Secure the screw driver with tape to prevent it from coming out during the repair procedure.

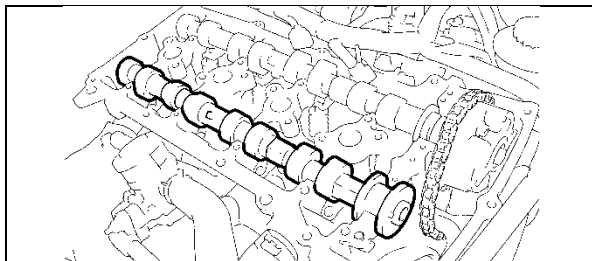
- b) Using the sequence shown loosen the 12 bolts in several passes and remove the bearing caps.

**NOTE:** 4 bolts have already been removed during the oil delivery pipe removal process.

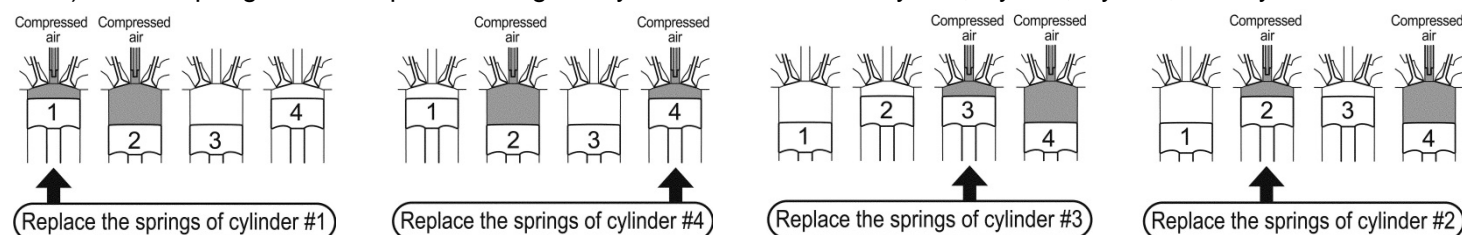
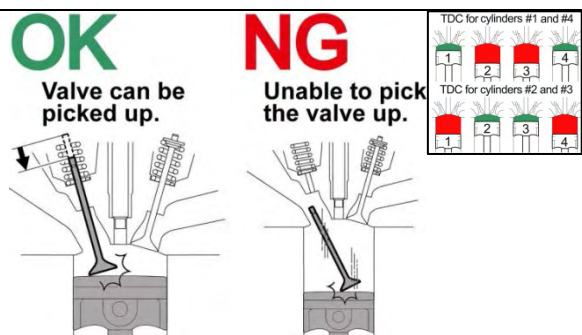
- Valve springs will be replaced using the cylinder order shown: Cyl. #1, Cyl. #4, Cyl. #3, and Cyl. #2.

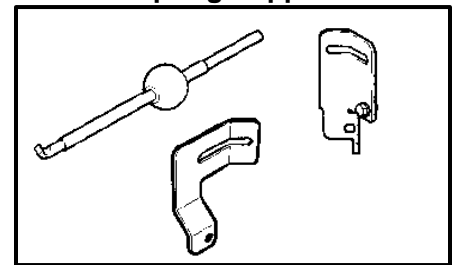
### \*Valve Spring Support Tools

**\*NOTE: If the valve springs are hard to compress by hand, utilize the support tools which will give you extra leverage to compress the springs. Instructions for these tools are located in Section XI at the end of the TI.**

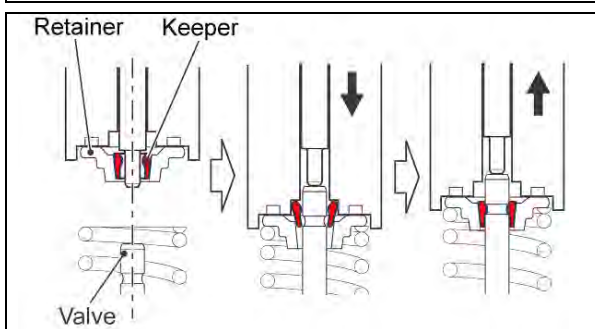
- g) Place the spring retainer facing up in your hand.  
 h) Install the keepers into the retainer.  
 i) Place the replacer tool over the valve retainer and keepers.  
 j) Confirm all parts are secured by the magnets and aligned for proper installation.  
 k) **Confirm the guide shaft is fully extended or the keepers and retainer will fall off.**  
 l) Hold your hand under the tool to ensure the retainer and keepers do not fall.

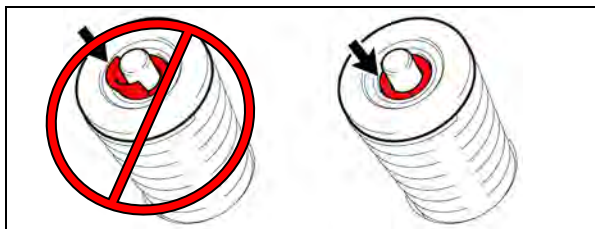
- m) Using the replacer tool, compress and reinstall the valve retainer and keepers.

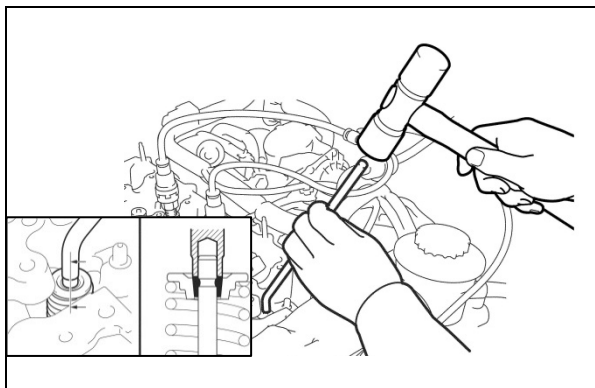
- n) Check the keepers to ensure they have engaged securely.

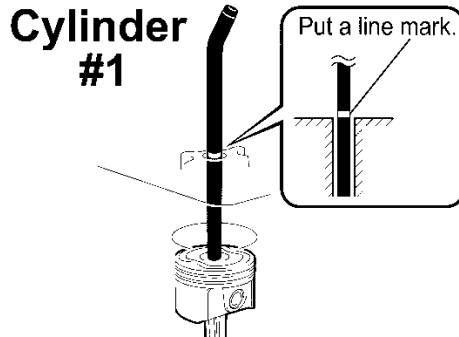
**STEP 1:** Gently place the keeper check tool into cyl. #1 and place a match mark on the tool as shown.

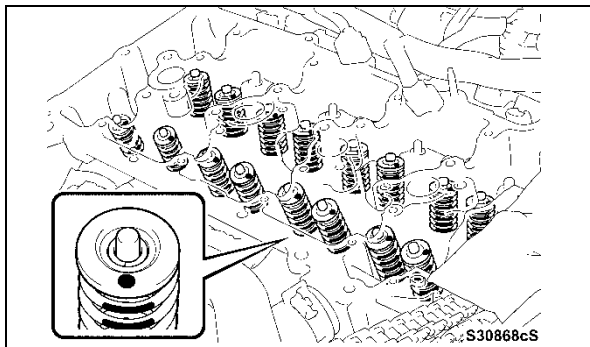
- d) Use the same procedure to replace the valve springs on cylinders # 2.

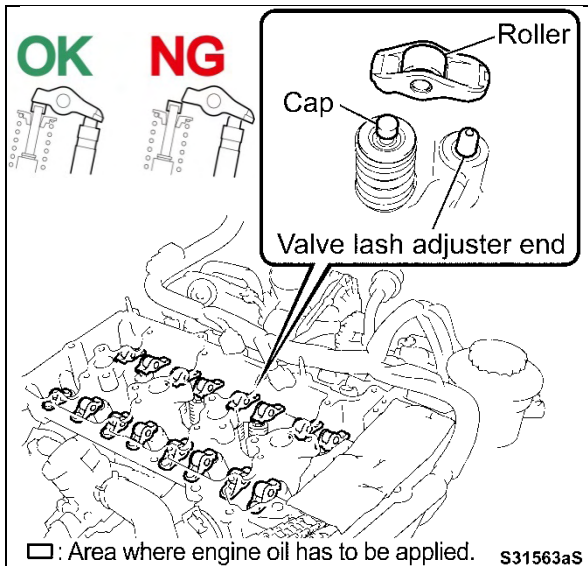
### 2. REINSTALL VALVE ROCKER ARMS

- Apply engine oil to the top end of the valve lash adjusters and valve stem caps.
- Reinstall the 16 rocker arms to their original positions.
- Ensure that the rockers are properly placed on the lash adjuster and valve stem caps.

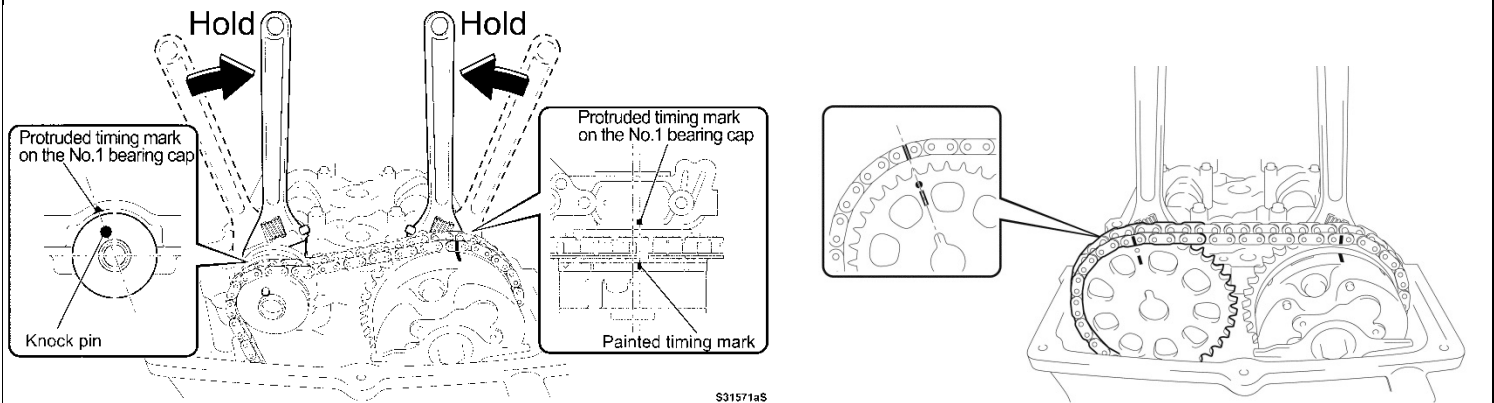
- g) While holding the camshafts in position the other technician will reinstall the timing chain sprocket making sure to align the corresponding timing marks on the chain, sprocket and bearing cap as shown.
