**RE: Defect Information Report – Supplemental Report No. 5  
13V-604NSB, 13V-606SB, FL-654, IMMI Seat Belt Buckles  
Revised Dealer Notice**

**SECOND REVISED NOTICE**

## **Subject: IMMI Seat Belt Buckles**

**Models Affected:** Specific Freightliner 108SD, 114SD, 122SD, Argosy, Business Class M2, Cascadia, Columbia, and Coronado vehicles; Western Star 4700, 4900, and 6900 vehicles; and Thomas Built Buses Saf-T-Liner C2, HDX, and Minotour vehicles with certain IMMI seat belt assemblies.

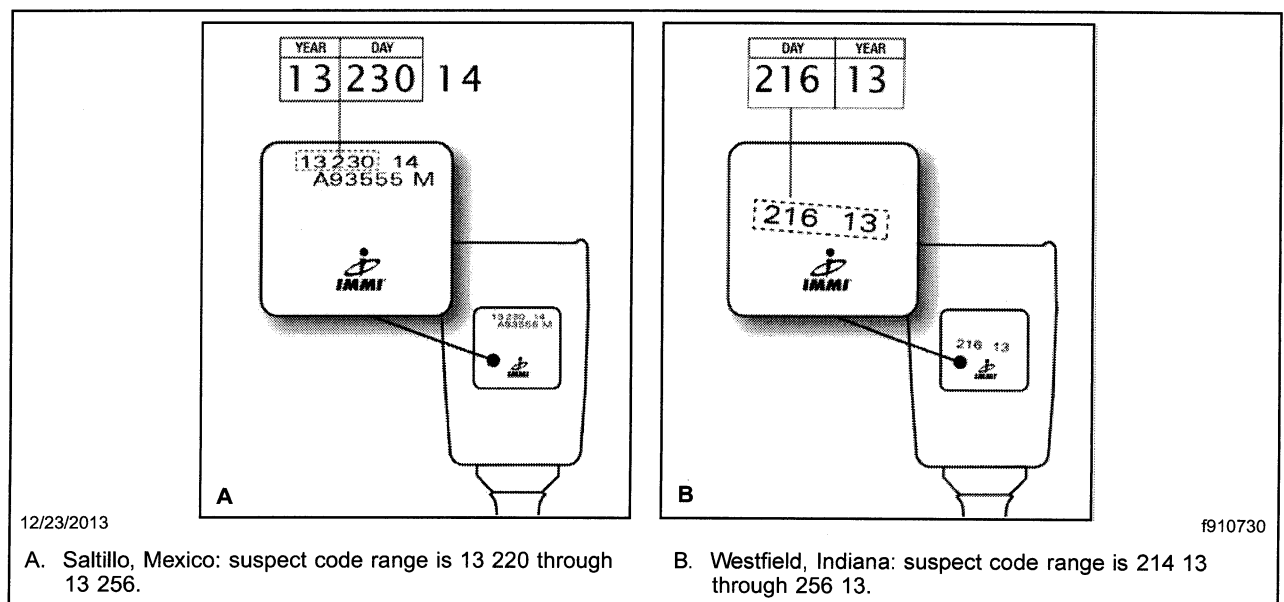
Fig. 3, Buckle Date Code Ranges

If the date code is included in the ranges shown in **Fig. 3**, the buckle needs to be replaced. If the date code is outside these ranges, the buckle does not need to be replaced.

6. If the vehicle has buckles that need to be replaced, go to "Buckle Replacement – School Buses" or "Buckle Replacement – Trucks" as appropriate in these Work Instructions.

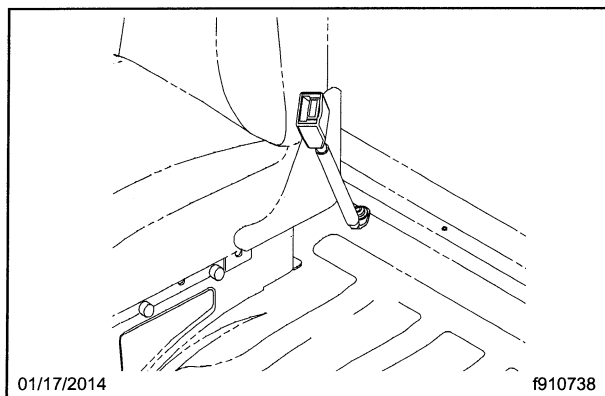
**Fig. 10, Floor-Mounted Buckle**

- Static seats have the buckles mounted directly to the cab floor. See **Fig. 10**.
  - Air suspension seats have buckles mounted to the ICP (intermediate-connection-point bar or bracket), with a tether belt attached to the cab floor. See **Fig. 11**.
  - Bench seats may have floor-mounted buckles at the ends, and floor-bracket-mounted buckles in the middle. One or two buckles may be mounted to each floor bracket. See **Fig. 12** and **Fig. 13**.
1. Go to the replacement steps below for the applicable type of seat belt assembly:
    - Floor-Mounted Buckles
    - ICP-Bar-Mounted Buckles
    - Floor-Bracket-Mounted Buckles
