RE: Part 579 submittal; Ultimate Floor Liner by Quadratec®
Quadratec, Inc. campaign 13E-010 (rept. date: 2/22/13)

IMPORTANT SAFETY RECALL

Hook Guard Installation for Ultimate or Tread Lightly! Floor Liner

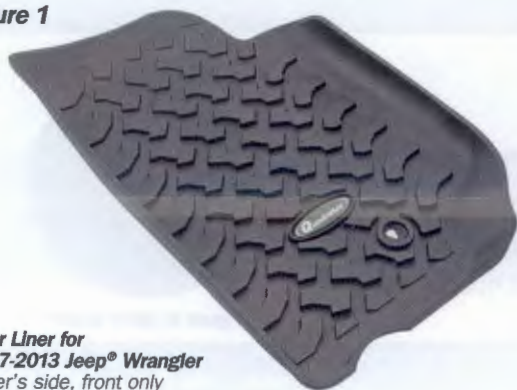
Figure 1

Floor Liner for
2007-2013 Jeep® Wrangler
Driver's side, front only

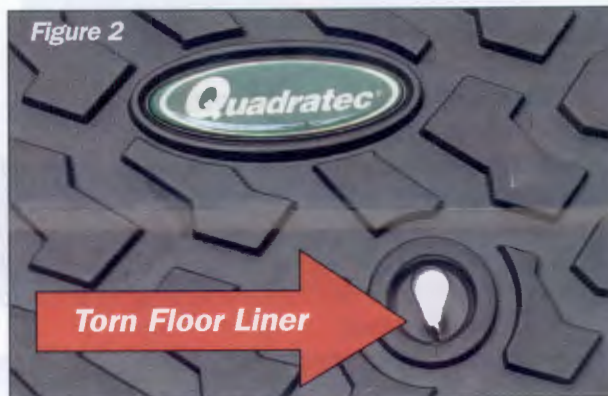
The defect is the potential for the Floor Liner to tear in the region of the retaining anchor hole and slide forward enough to interfere with the accelerator pedal. This may restrict pedal operation or may allow the Floor Liner to shift forward onto the pedal causing unintended acceleration which may lead to an accident with property damage or serious personal injury. This defect may not exist in all Floor Liners and is thought to relate to a combination of high interior temperatures and load forces in the area where the driver's side liner is anchored to the originally-supplied Jeep carpeting. Prior warning of this defect appears through visible tearing of the Floor Liner in the area of the anchor and increased movement of the Floor Liner during use. Refer to Figure 2 (above) illustrating the tear around anchor point.

ANY Floor Liner which shows evidence of tearing (Figure 2 - above) will be replaced at **NO CHARGE** by calling our toll free hotline (800-463-2998). Once you have received your replacement liner the torn liner should be sent back to Quadratec at **NO CHARGE**. Please use the provided return label and box.

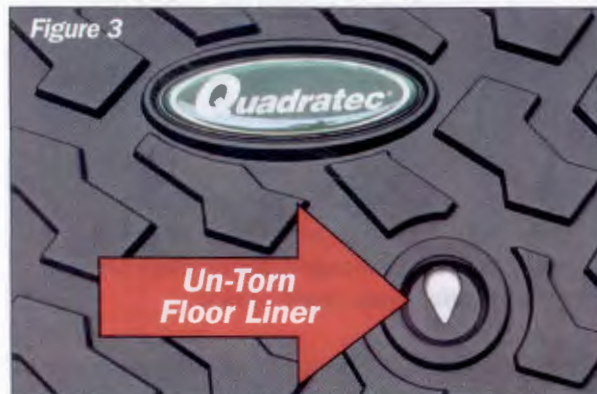
Figure 3

If there is no tearing around the anchor point on your driver's side Floor Liner, (Figure 3) then please install the enclosed Hook Guard (Figure 5) as shown in Figure 4 and according to the installation instructions provided (see pages 3-4 of this document). If you are unable or unwilling to install the Hook Guard you may call our toll-free hotline (800-463-2998) for a replacement Floor Liner with the Hook Guard installed.

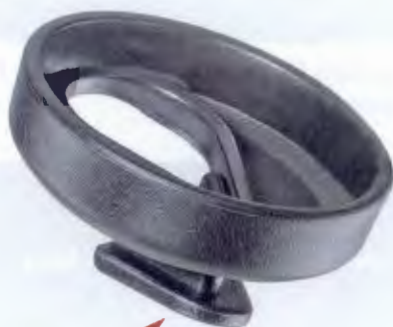
Figure 5: Hook Guard

Hook Guard

"Barb"

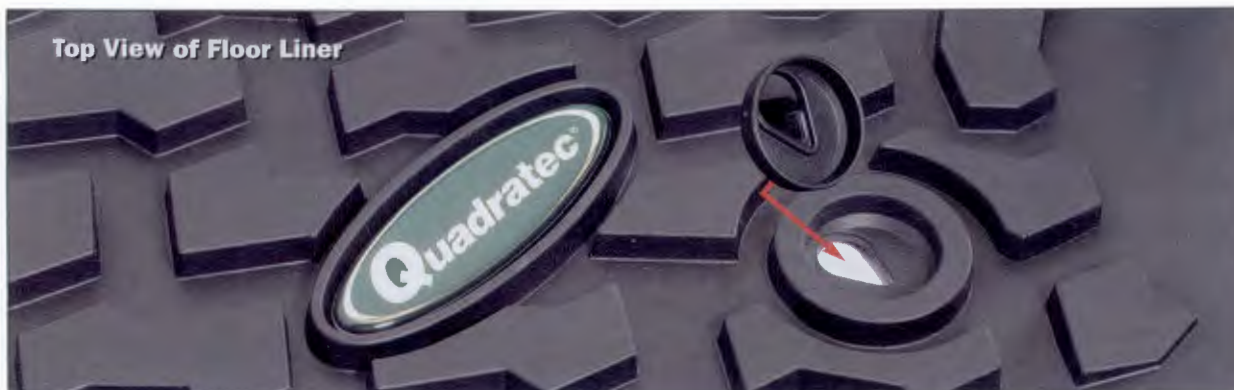
Top View of Floor Liner

Step 1: Remove Floor Liner from vehicle. Insert the Hook Guard "Barb" through the teardrop anchor hole in the liner while making sure that the barb is secured at the bottom of the liner as shown in Step 4. (see next page)

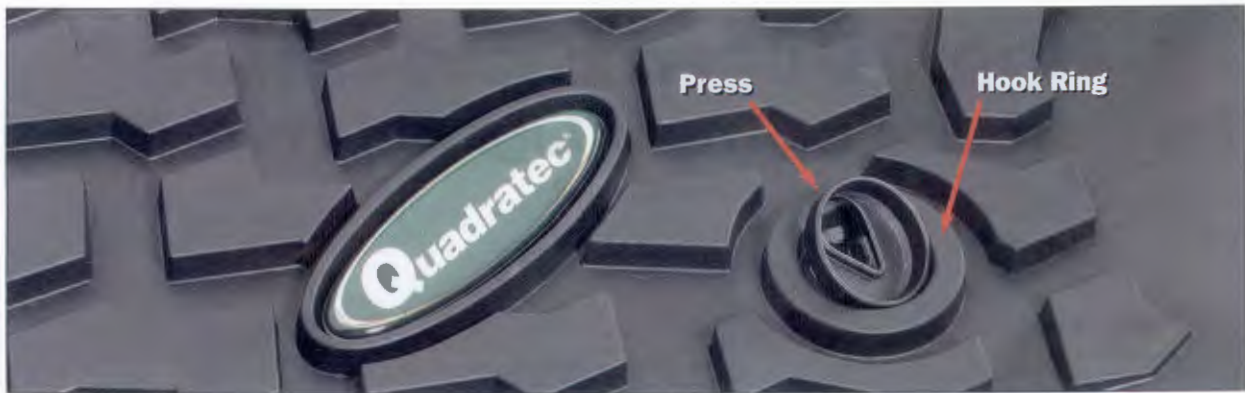
Step 2: Press the Hook Guard downward at an angle and through Floor Liner anchor hole. Finish pressing the Hook Guard into place as shown in figure above.

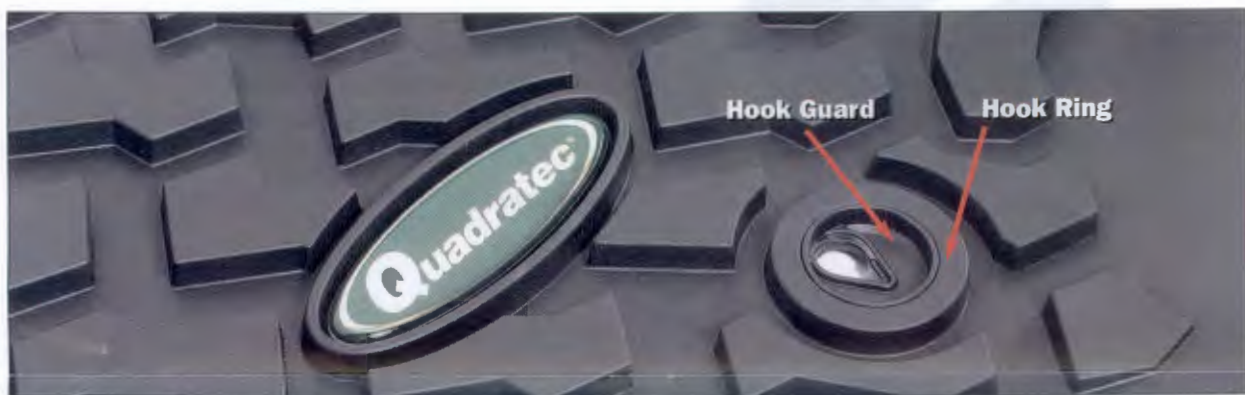
Step 3: After pressing the Hook Guard into the floor liner Hook Ring, make sure that the Hook Guard is flush with the Hook Ring as illustrated above.

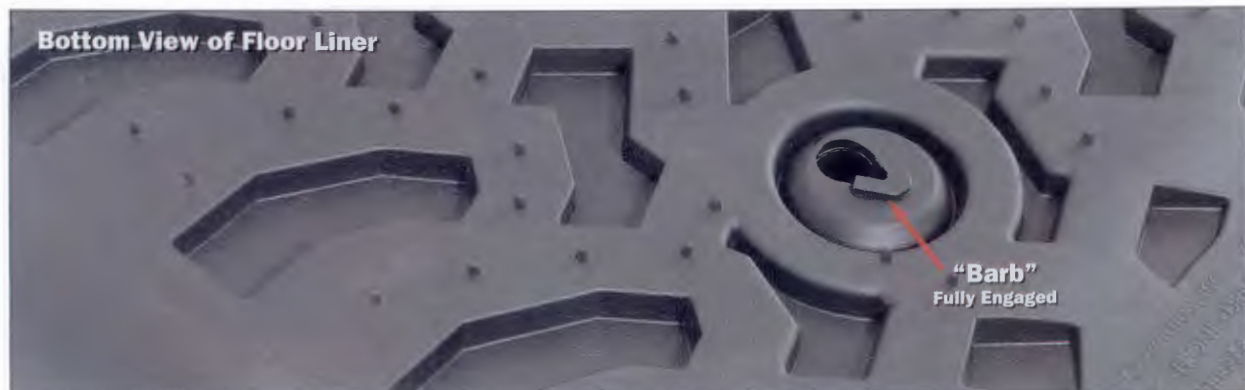
Step 4: Inspect bottom of the Floor Liner to ensure that the Hook Guard "Barb" is completely through the teardrop hook hole and fully engaged with the bottom of the anchor hole as illustrated above. Tuck any wrinkles under the "Barb" with a small screw driver or your finger nail. Install is now complete. Reinstall Floor Liner in vehicle.
