SUBJECT: Campaign #128 – Range Enclosure

INSTRUCTIONS TO PERFORM CAMPAIGN 128

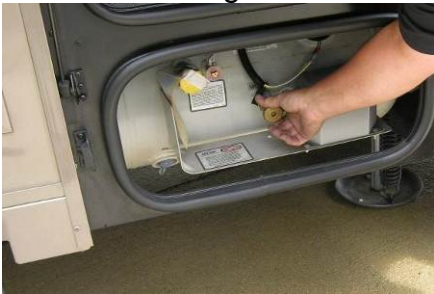
1. Shut off the LP gas on outside of coach.

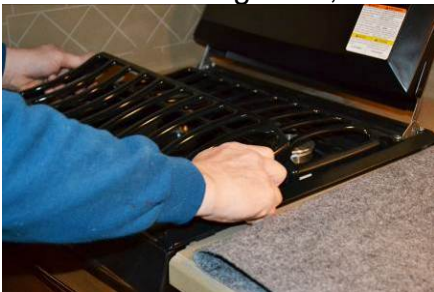
2. (**Atwood**) Remove (2) grates, (3) burners and disconnect igniters, then remove range top.

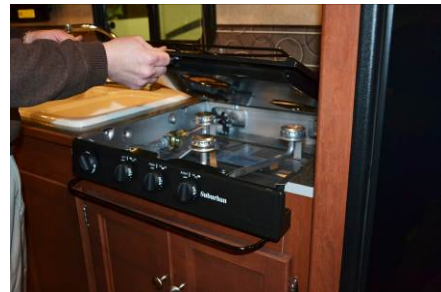
2. (**Suburban**) Remove range top.

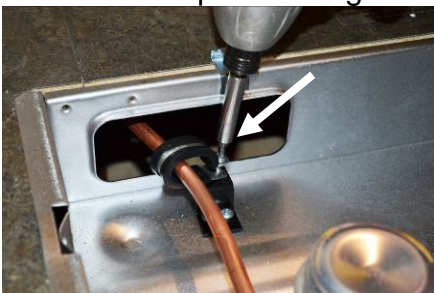
3. Remove clamp from LP gas line.

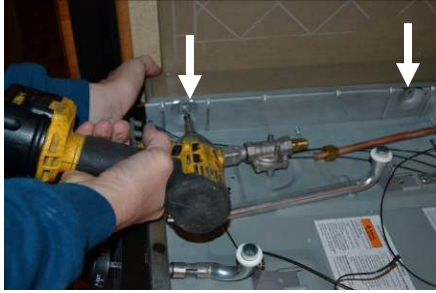
4. Remove four screws to loosen range for removal (two on each side).

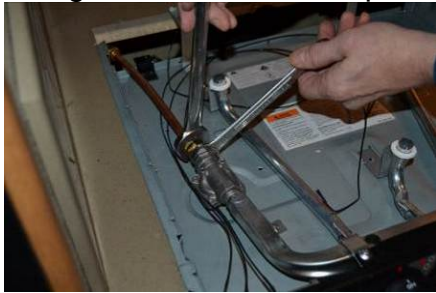
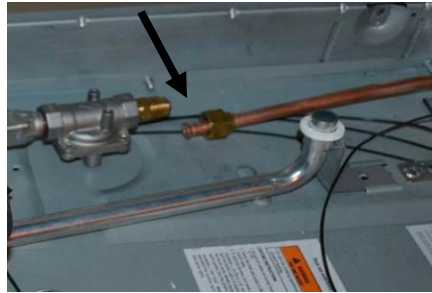
5. Using a 5/8" and 13/16" open-end wrench, loosen and disconnect LP gas line.

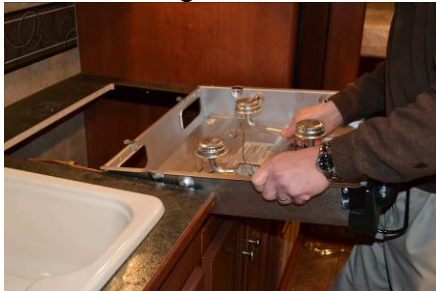
6. Remove range.

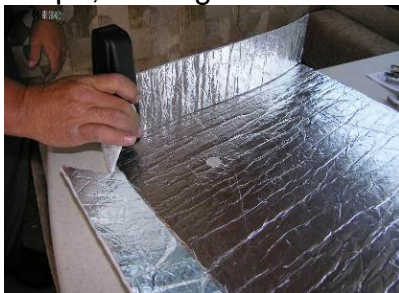
7. Using the perforated lines, fold the stove enclosure into rectangular position and staple to hold shape, making sure the outer lip is stapled to the outside of the stove enclosure.

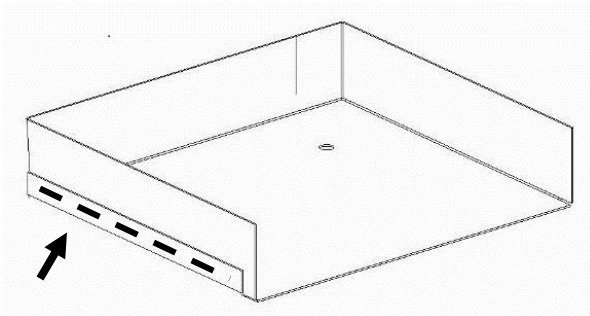
**Atwood &
Suburban Range
Enclosure**

Staple along this
edge.

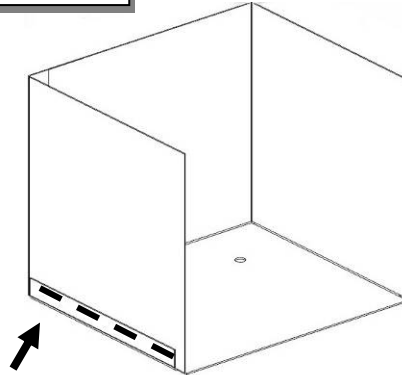
**Atwood Range
with Oven
Enclosure**

Staple along this
edge.

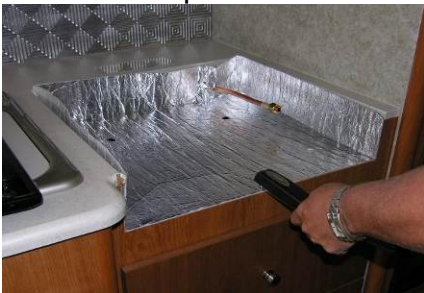
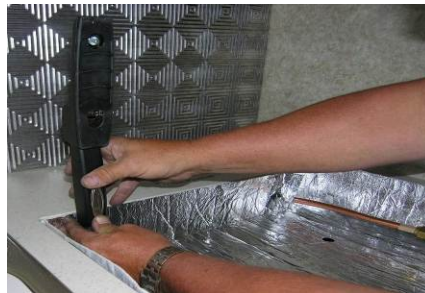
8. Insert stove enclosure making sure to bring the LP gas line through the stove enclosure hole. Attach to all sides of the countertop/cabinet assembly using a stapler to hold the stove enclosure in place.

**NOTE: Be sure
to staple
perimeter of
enclosure to
cabinet face.**

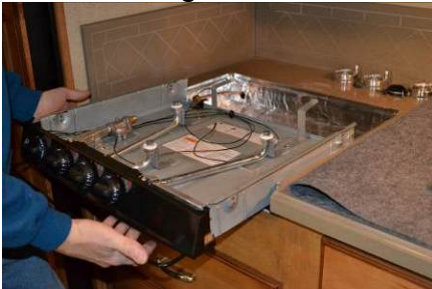
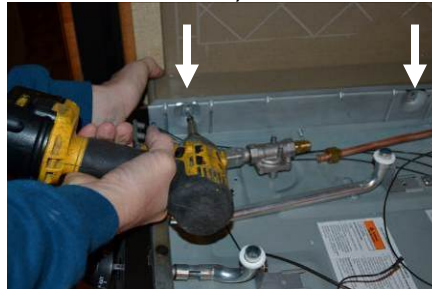
9. Reinstall range and four screws (two on each side) to secure range into place.

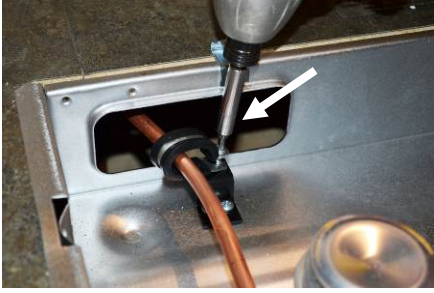
10. Reinstall clamp for LP gas line.

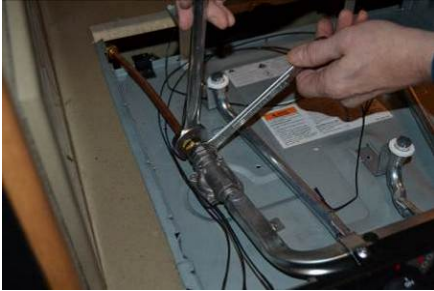
11. Reconnect LP gas Line.

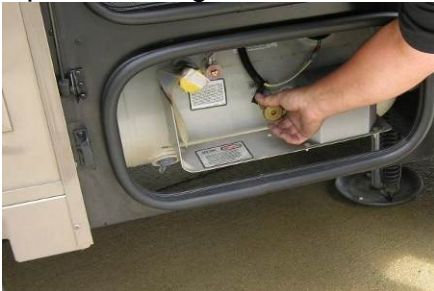
12. Open the LP gas valve on the outside of coach.

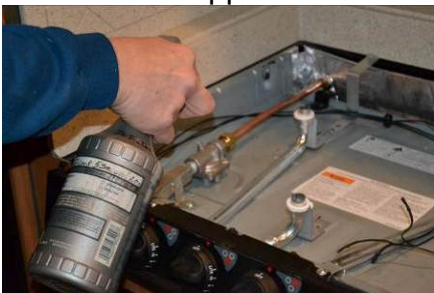
13. Perform an LP leak test by spraying LP leak detector solution on the LP gas line fitting, if bubbles/leak appears correct and retest.

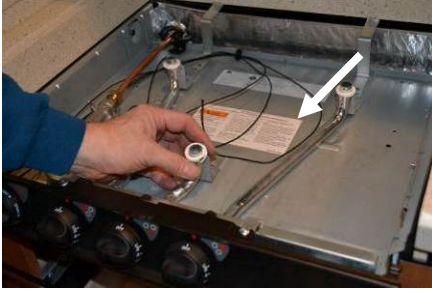
- (Atwood)** If the LP leak test passed, continue with the following steps (a-c)
- a. Place fabric washers on each burner post.

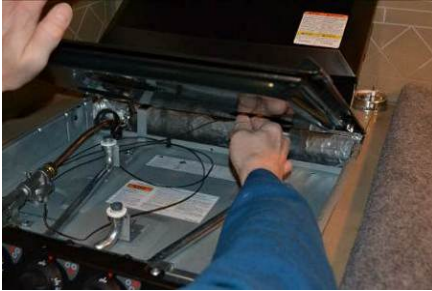
- b. Reinstall range top and insert the igniter leads through the burner holes.

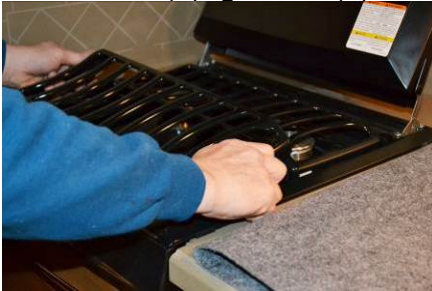
- c. Reconnect (3) igniters, (3) burners and Reinstall (2) grates.

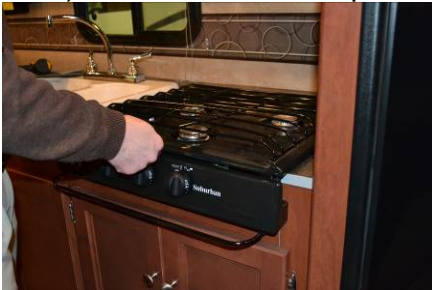
- (Suburban)** If the LP leak test passed, reinstall the range top.
