## INTERIM NOTICE SAFETY RECALL 13517

JANUARY 2014

Navistar has decided that a defect which relates to motor vehicle safety exists in certain ProStar® model trucks built 12 December 2012 thru 8 August 2013 with feature code 16XSA, 16XSB, 16XSC, or 16XSD chassis skirts.

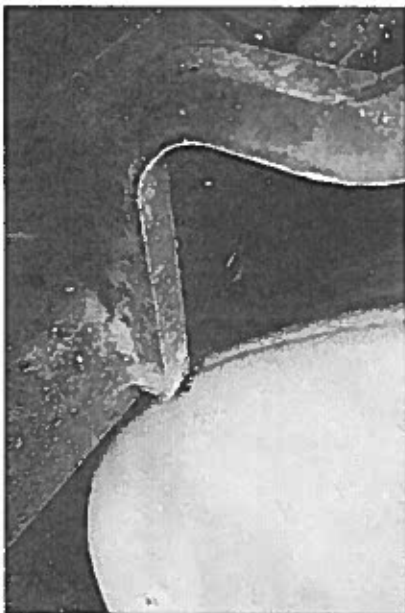
Figure 1.

1. Standing at the left side of the vehicle rear of the cab and looking toward the front, inspect for contact between the chassis skirt upper horizontal support S-bracket and the fuel tank or punctures in the fuel tank (Figure 1).

2. Standing at the right side of the vehicle rear of the cab and looking toward the front, inspect for contact between the chassis skirt upper horizontal support S-bracket and the fuel tank or punctures in the fuel tank (Figure 1).

During vehicle operation, the rear chassis skirt upper horizontal support S-bracket may contact the fuel tanks during frame twist and it is possible for the bracket to wear a hole in the top of the fuel tank which may result in a fuel leak.

To prevent the occurrence of this defect in the interim period, inspect for signs of contact or punctures of right and left side fuel tanks by the chassis skirt upper horizontal support S-bracket per the instructions on the backside of this letter. If any signs of contact or punctures in the fuel tanks are found and the truck can be safely transported, bring your truck to the nearest International® dealer.
