## **LA 45 COMPO: FRONT RADIUS ROD BRACKET**

### **INSPECTION AND REWORK**

**Property name and top bus number:** LA 45CLFW, 95000, 218000, 269000, 286000

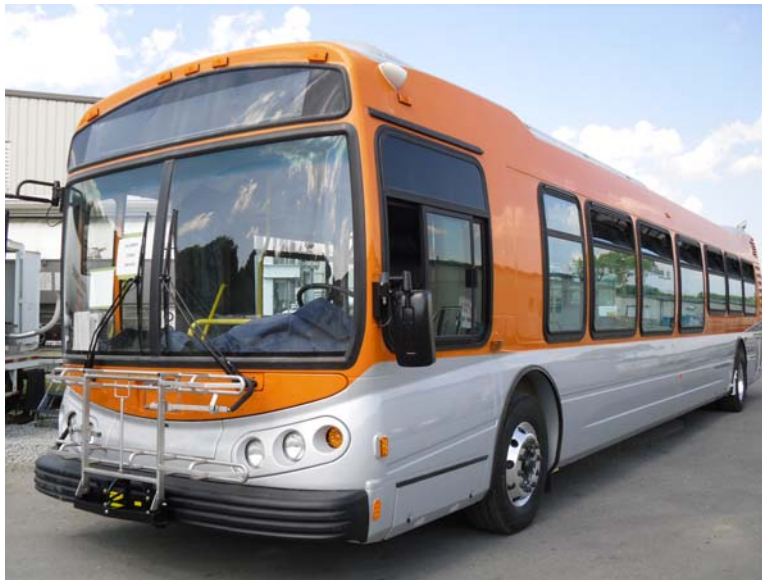
**Issue:** Loose bolts at the front lower radius rod mounting bracket.

**Reason/ cause:** There are two bolts/nuts with no access for re-torquing.

**Solution:** Cut access opening per this SOI (only if bolts were found loose).

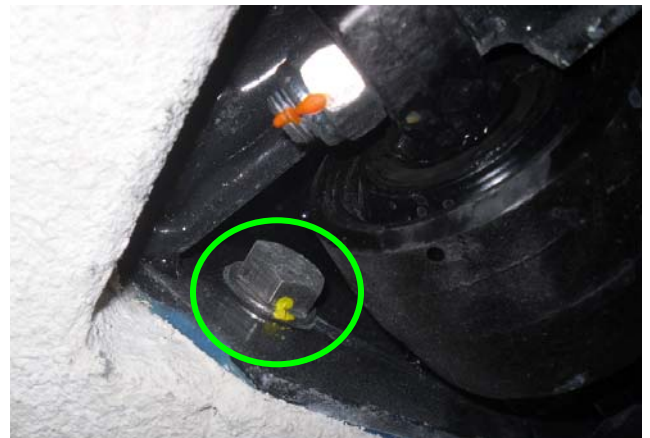
1. Park the bus above a service pit and apply the parking brake or lift the bus and place stands underneath the official jacking pads.
2. Locate the front lower radius rod mounting bracket.

3. Check the torque of the bolts by using a 24 mm size socket. The torque has to be **150 lb-ft** for all bolts. Use a 24 mm size wrench to check the outer bolts (both the street side and curbside) and see if these two bolts are loose (see green circle above and top right picture on page 4<sup>th</sup>). If these two bolts are tight and torques of all other bolts are correct then no further actions are required.
4. If loose **vertically installed bolts** are found on the bracket (see marked 6 pieces bolts below) then re-torque bolts to **150 lb-ft** and apply torque seal onto the head of the bolts.

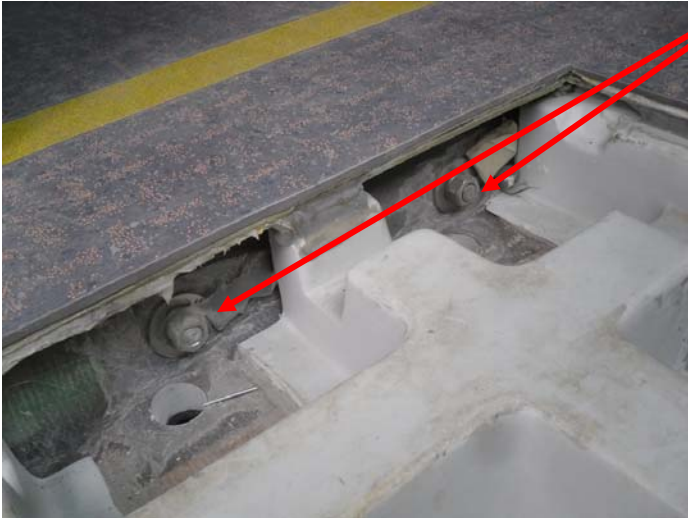
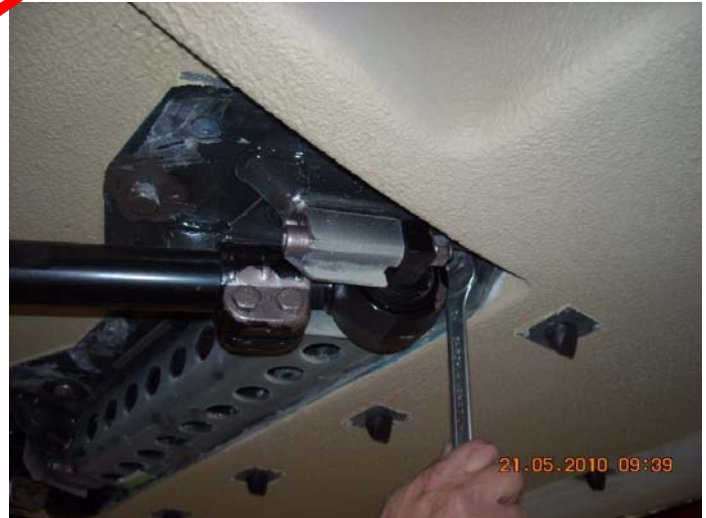
5. If the **two forward (horizontally installed) bolts** are loose on the curb side then:

- Remove wheel chair ramp to access to the nuts of these bolts.

- Re-torque them to **150 lb-ft** and apply torque seal onto the nuts.
- Reinstall wheel chair ramp.

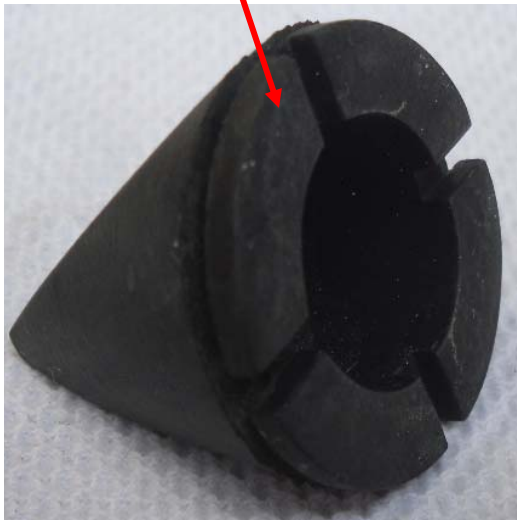
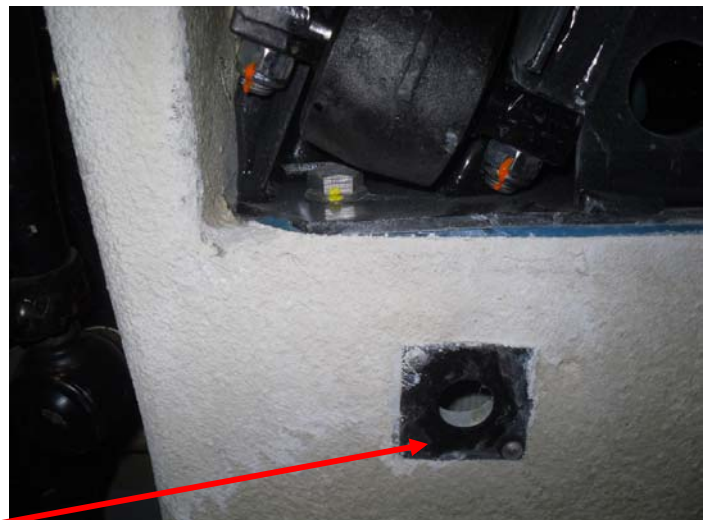
6. If the **two bolts are loose on the street side (SS)** then:

- Remove drain from the composite body.

- Remove small plate of drain attached to the composite body.
- Cut access slot as picture shows below by using hole saw, cutting wheel with a high speed air tool and/or by using a reciprocate saw. Position the slot symmetrical in front of the bolt (see picture and drawing below).

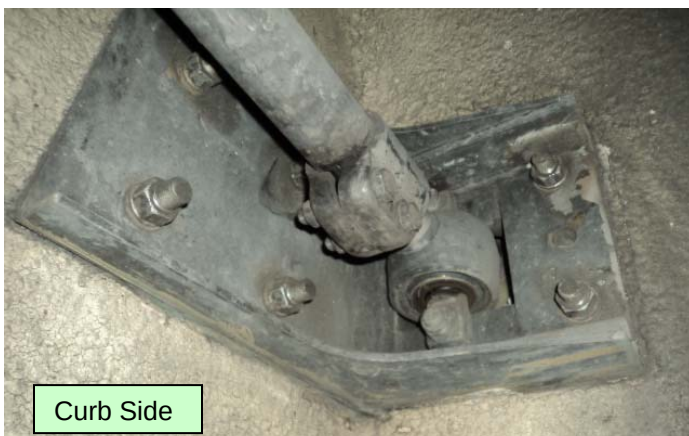
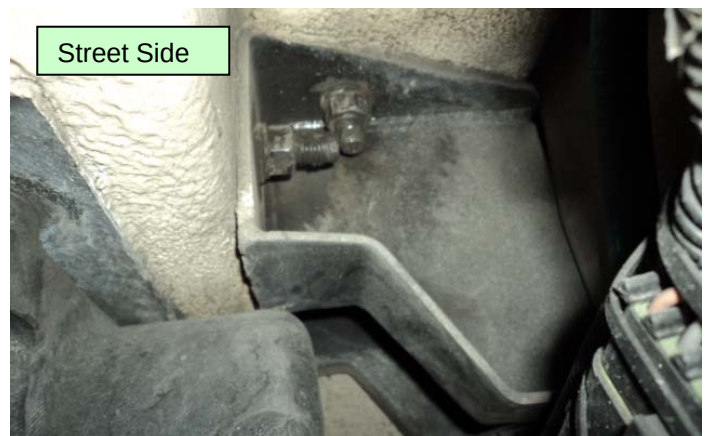
### Upper radius rods brackets mounting stud/nut inspection

- Check the torque of the CS (6 nuts) and SS brackets nuts (4 nuts) by using a 24 mm size socket. Remove all zip ties on hoses and harnesses to access street side upper radius rod mounting bolts. The torque has to be **150 lb-ft**.
