Safety Recall Notice

Service Bulletin 38129

Toe Pan Panel Modification

Applicable for Toyota Lowered Floor Minivan Conversions Built 5/8/2012 to 1/4/2013

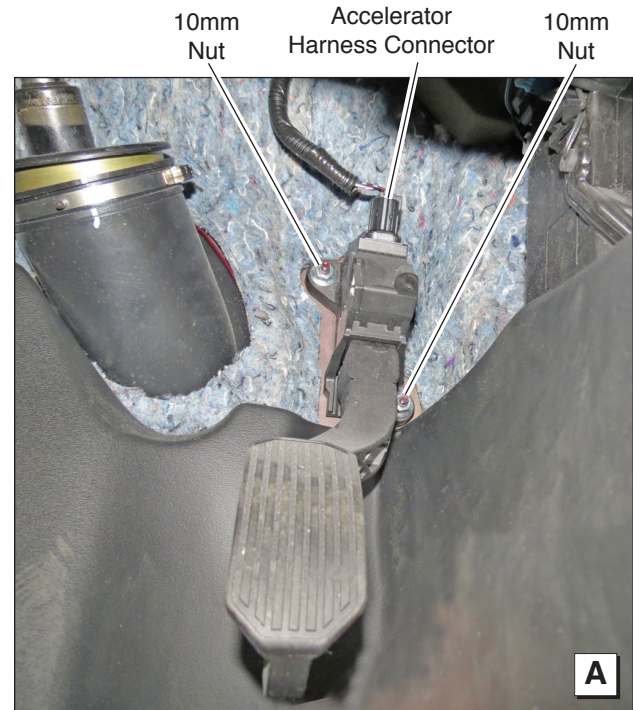
1. Remove step & roll driver seat per minivan conversion operator's manual.
2. Remove accelerator pedal. Remove two 10mm nuts and disconnect harness from pedal. See Photo A.
3. Mark area of toe pan panel to be removed. See Photos B and C.

5. Install accelerator pedal. Torque mounting nuts to 48 in/lbs each. Refer to Photo A.

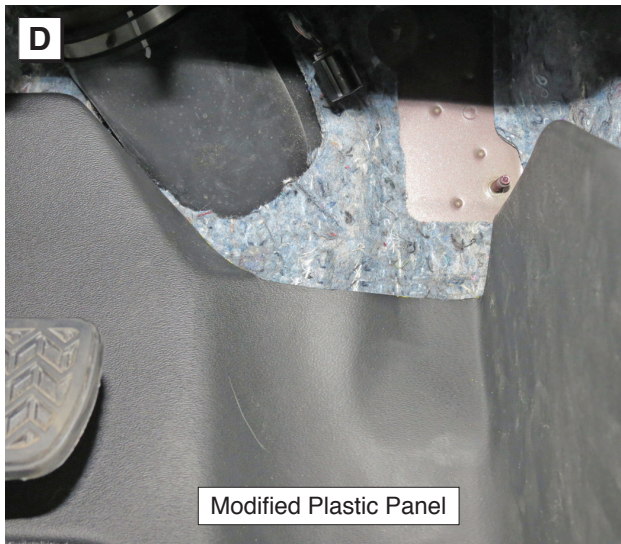
4. Remove area marked in Step 3. See result in Photo D.

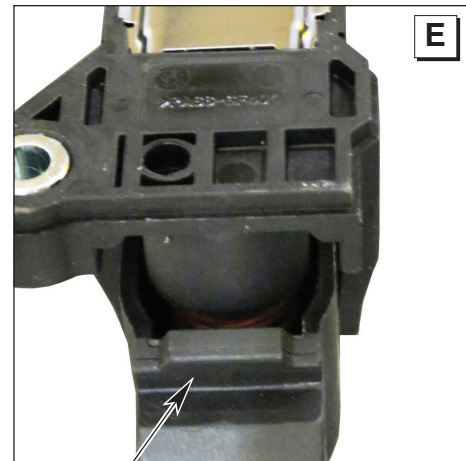
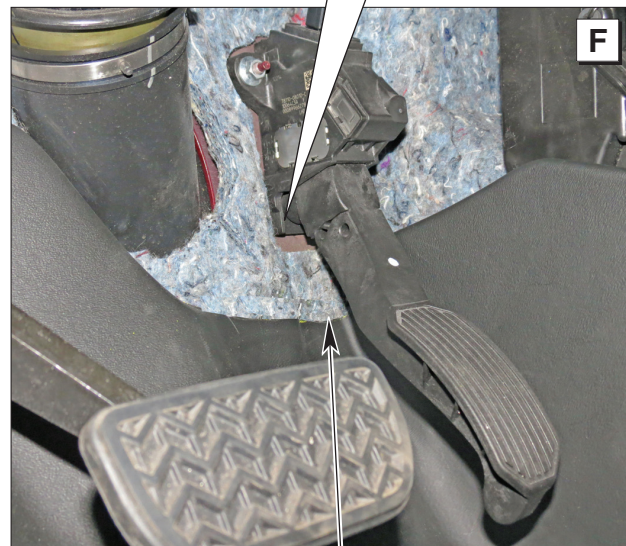
6. Operate accelerator pedal and confirm protrusion on rear of pedal will not contact the top edge of the toe pan panel. See Photos E and F.
