Applies To: **2011–13 Odyssey** – Check the iN VIN status for eligibility
2009–13 Pilot – Check the iN VIN status for eligibility

January 18, 2013

Safety Recall: Driver's Airbag Missing Rivets

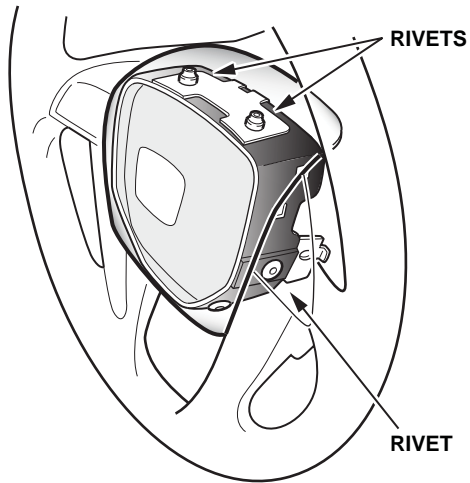
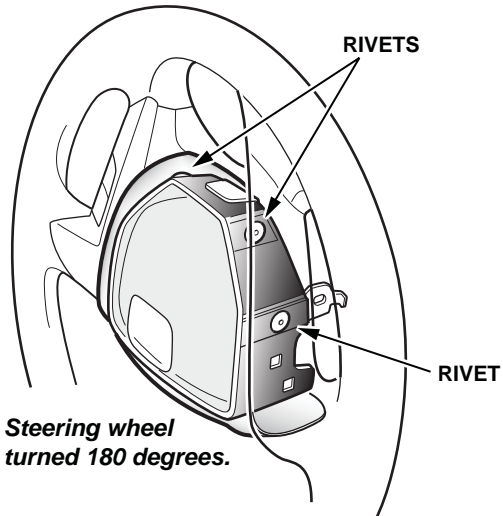
- There should be six rivets in the places indicated.
- If the airbag module needs replacement, do not return the vehicle to the customer until the airbag module is replaced. Contact your DPSM if you need to arrange alternate transportation.

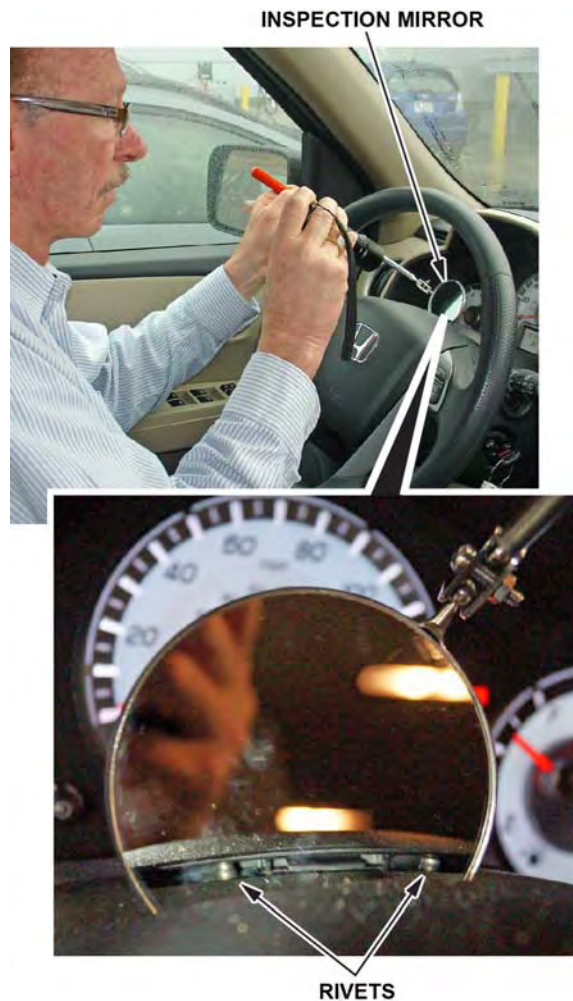
3. Place an inspection mirror in the gap between the upper steering column cover and the steering wheel. Adjust it so that you can check if the shanks of the two rivets are visible.

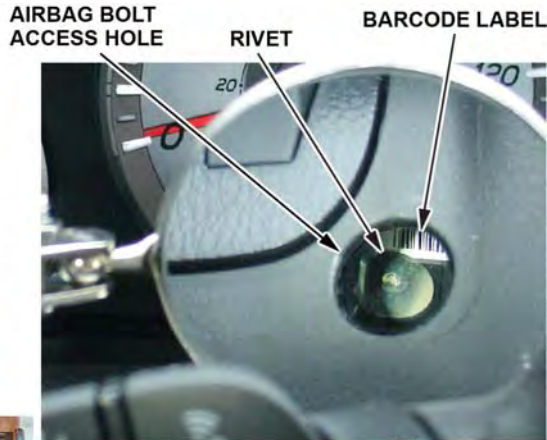
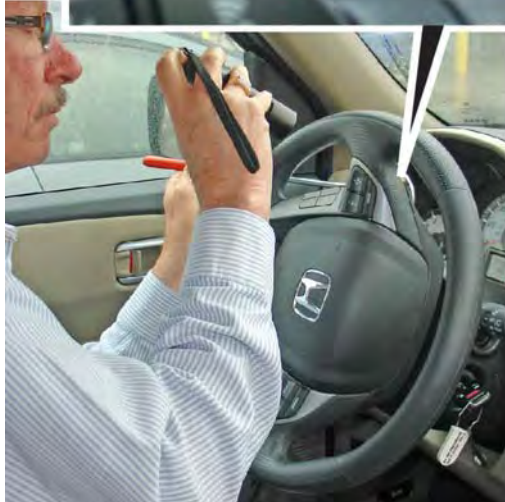
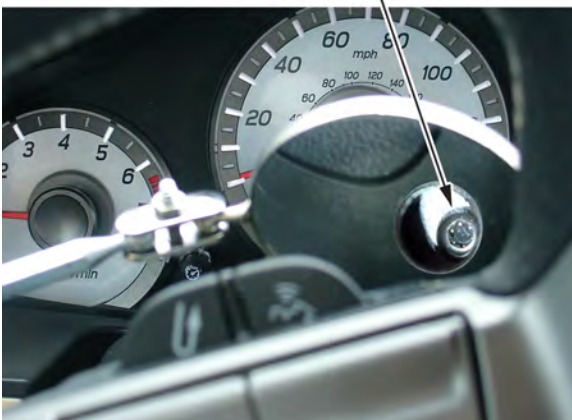
AIRBAG RETAINING BOLT

- Turn the steering wheel 90 degrees to the right. Using the mirror and a flashlight, look through the airbag bolt access hole for a rivet near the base of the bar code label.

- The bolt is located close to the barcode label.
- Do not confuse the airbag retaining bolt for the rivet head.

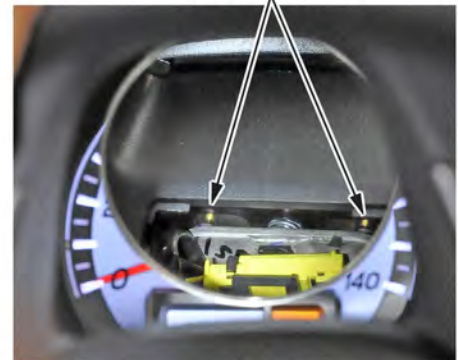
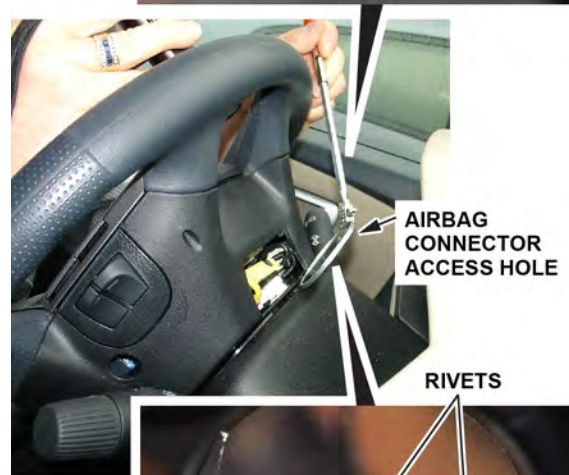
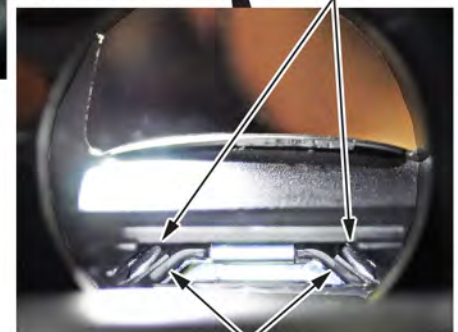
RIVETS

- Using the mirror and a flashlight, locate the brass-colored horn contacts. Tilt the mirror away from you until you see the edge of the airbag module. Check that there are two rivets visible along the angled edge.

BRASS COLORED HORN CONTACTS

ANGLED EDGE

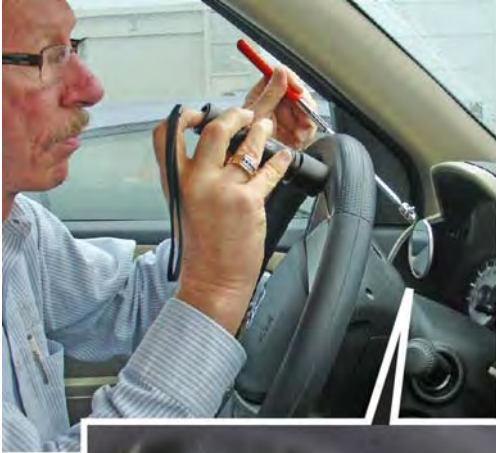
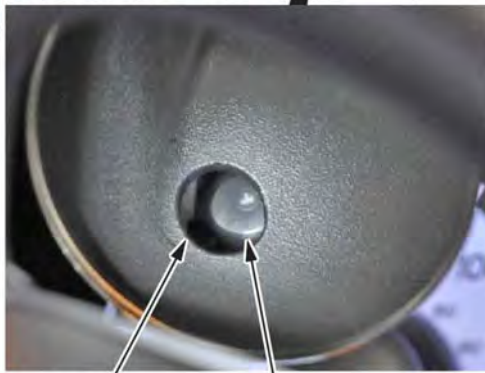
**AIRBAG BOLT
ACCESS HOLE**

- Turn the steering wheel an additional 90 degrees to the right. Using the mirror and a flashlight, look through the airbag bolt access hole for a rivet near the base of the bar code label.

- The bolt is located close to the bar code label.
- Do not confuse the airbag retaining bolt for the rivet head.

RIVET

- There should be six visible rivets on the airbag.
 - If you were able to see all six rivets during this inspection, the airbag is OK.
 - If you saw fewer than six rivets, go to REPAIR PROCEDURE.
