Applies To: **2011–13 Odyssey** – Check the iN VIN status for eligibility  
**2009–13 Pilot** – Check the iN VIN status for eligibility

## Safety Recall: Driver's Airbag Missing Rivets

(Supersedes 13-008, dated January 18, 2013, to revise the information marked by the black bars)

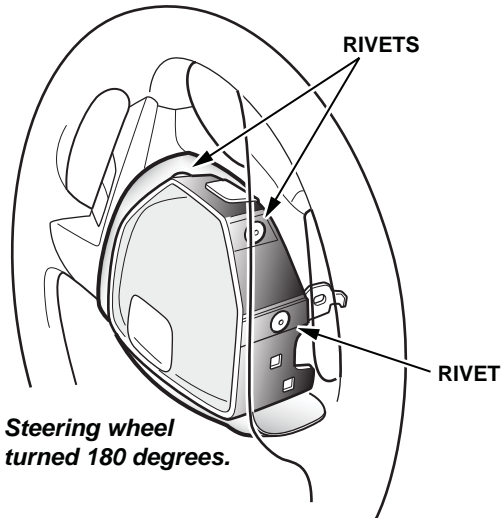
- There should be six rivets in the places indicated.
- If the airbag module needs replacement, do not return the vehicle to the customer until the airbag module is replaced. Contact your DPSM if you need to arrange alternate transportation.

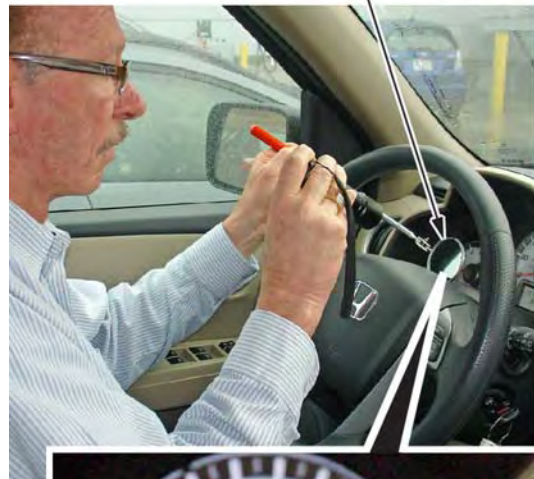
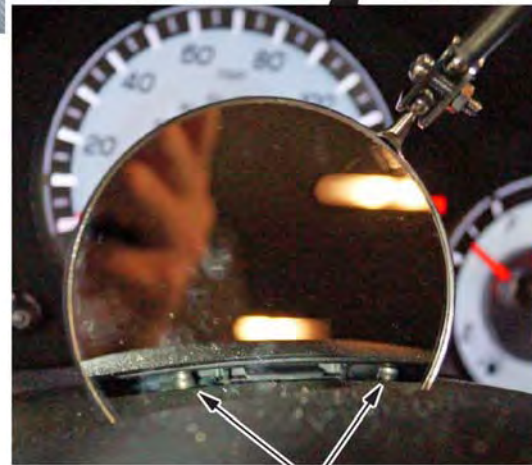
### INSPECTION MIRROR

3. Place an inspection mirror in the gap between the upper steering column cover and the steering wheel. Adjust it so that you can check if the shanks of the two rivets are visible.

NOTE: Use a flashlight to help you see the rivets.

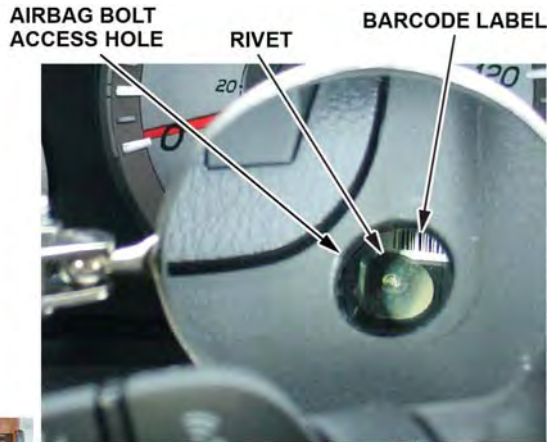
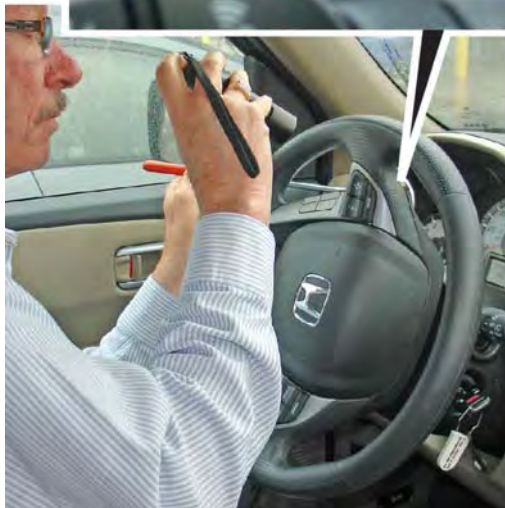
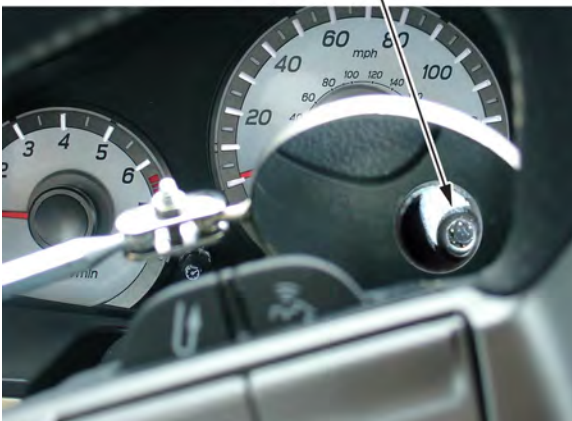
**AIRBAG RETAINING BOLT**

- Turn the steering wheel 90 degrees to the right. Using the mirror and a flashlight, look through the airbag bolt access hole for a rivet near the base of the bar code label.

- The rivet is located close to the barcode label.
- Do not confuse the airbag retaining bolt for the rivet head.
- The rivet may be covered by a label. If it is, go to step 11.

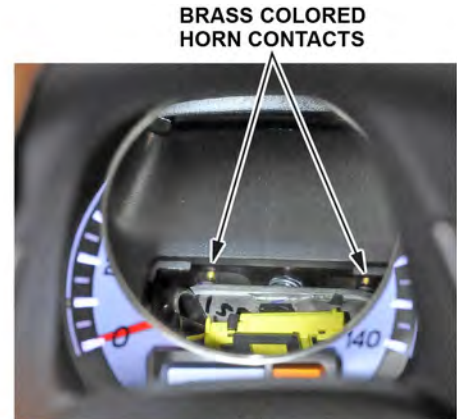
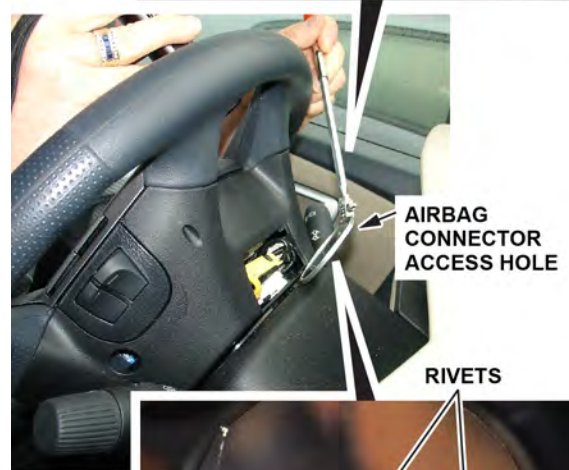
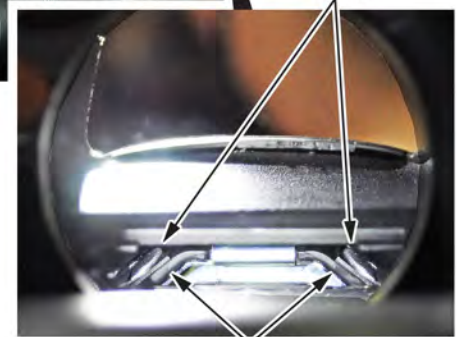
- Turn the steering wheel an additional 90 degrees to the right.
- Remove the airbag connector cover.
- Using the mirror and a flashlight, locate the brass-colored horn contacts. Tilt the mirror away from you until you see the angled edge of the airbag module. Check that there are two rivets visible along the angled edge.

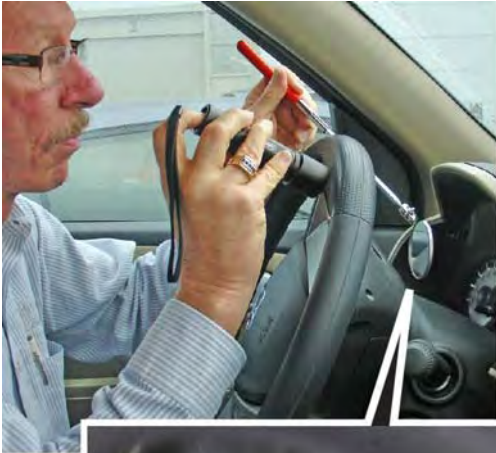
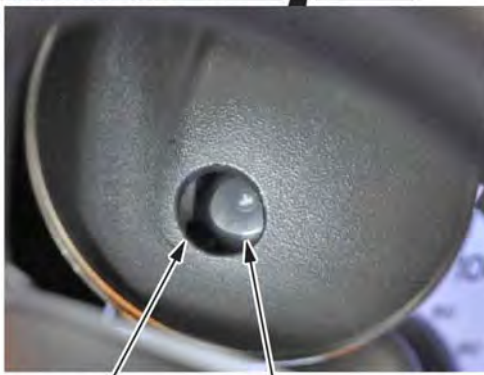
AIRBAG BOLT ACCESS HOLE RIVET

9. Turn the steering wheel an additional 90 degrees to the right. Using the mirror and a flashlight, look through the airbag bolt access hole for a rivet near the base of the bar code label.

- The rivet is located close to the bar code label.
- Do not confuse the airbag retaining bolt for the rivet head.
- The rivet may be covered by a label. If it is, go to step 11.

10. There should be six visible rivets on the airbag.
- If you were **able to see all six rivets** during this inspection, the airbag is OK.
  - If you were **unable to see all the rivets because the rivet is covered by a label**, go to step 11.
  - If you saw **fewer than six rivets**, go to REPAIR PROCEDURE.
11. Do the battery terminal disconnection procedure as shown in the applicable online service manual, then wait at least three minutes before starting work.

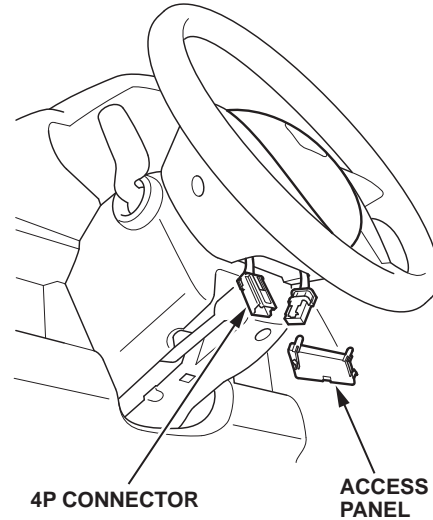
12. Remove the driver's airbag connector cover, then disconnect the driver's airbag 4P connector from the cable reel 4P connector.

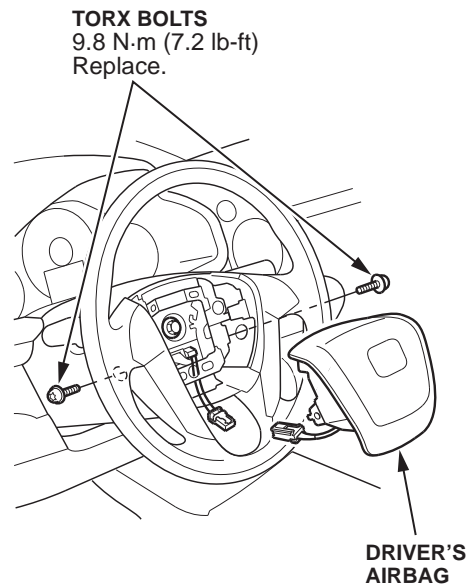
13. Remove the TORX bolts, then remove the driver's airbag.

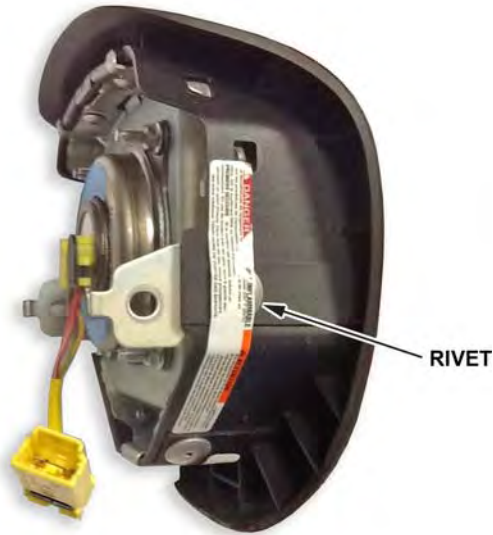
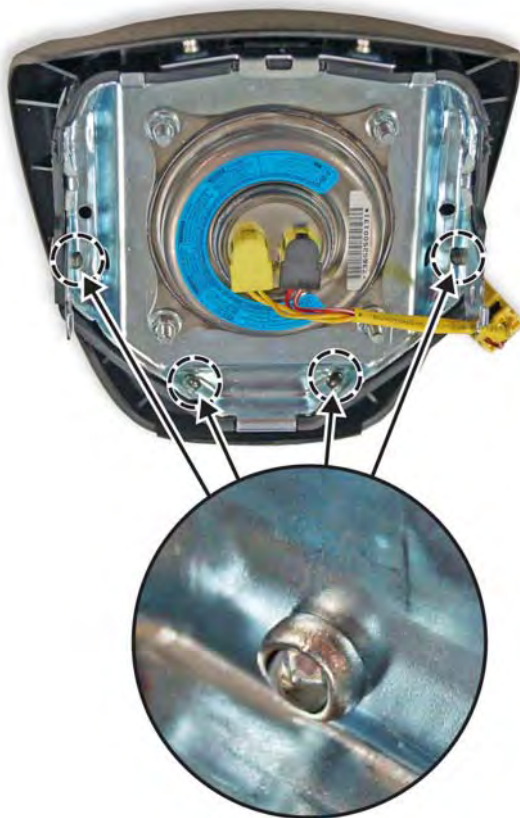
14. There should be six visible rivets on the airbag.

NOTE: Even if the rivet has a label over it, you should be able to see there is a rivet installed. Do not remove the label.

- If there are **six rivets** installed, the airbag is OK. Reinstall the airbag, and secure it with new TORX bolts. Torque the bolts to **9.8 N•m (7.2 lb-ft)**, then do the terminal battery reconnection procedure.
- If there are **fewer than six rivets**, go to step 4 of the REPAIR PROCEDURE to replace the airbag.

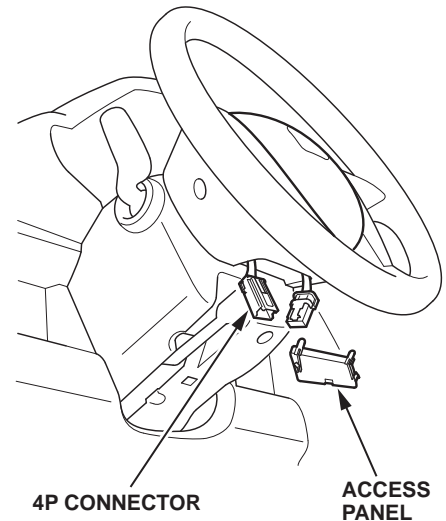
1. Do the battery terminal disconnection procedure as shown in the applicable online service manual, then wait at least three minutes before starting work.
2. Remove the driver's airbag connector cover, then disconnect the driver's airbag 4P connector from the cable reel 4P connector.

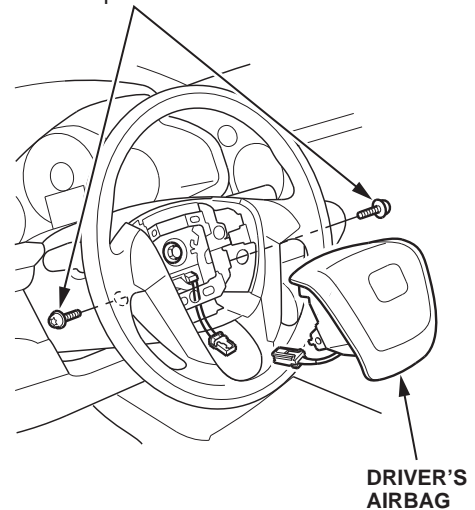
**TORX BOLTS**  
9.8 N•m (7.2 lb-ft)  
Replace.

3. Remove the TORX bolts, then remove the driver's airbag.

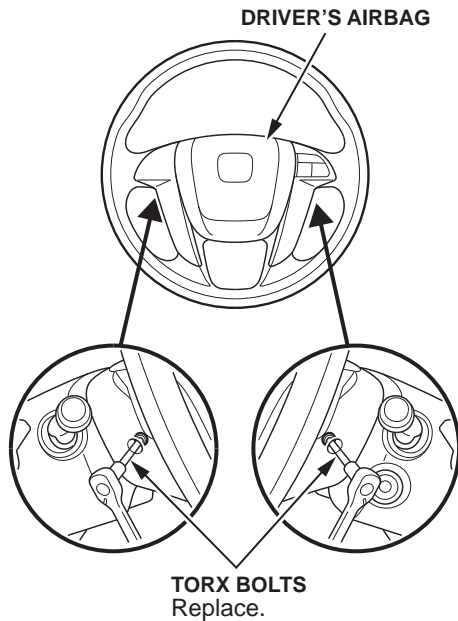
- Place the replacement airbag in the steering wheel, and secure it with new TORX bolts. Torque the bolts to **9.8 N•m (7.2 lb-ft)**.

- Reconnect the driver's airbag connector, then reinstall the connector cover.
- Do the battery terminal reconnection procedure.
