## 2011 ActiveE Drivetrain: Transmission Input Shaft Sealing

- The following procedure for inspection and lubrication of the transmission shaft, using the updated kit (P/N 27 21 8 604 187), must only be performed to each vehicle one time. Subsequent service visits will not require this procedure. Once it has been performed, this procedure is no longer necessary. Before attempting this procedure, check the vehicle’s warranty history to determine if it has already had the updated sealing procedure performed.

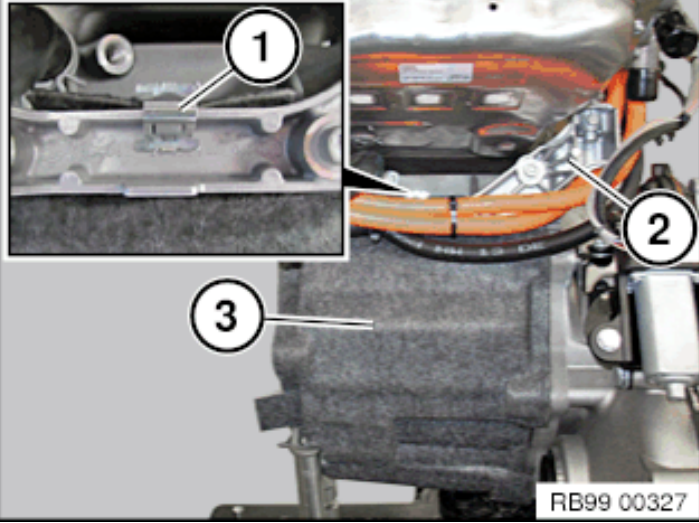
| | <ol style="list-style-type: none"> <li>1. Remove the rear axle assembly following RA 33 31 000, “R&amp;I Complete Rear Axle Support,” found in the ISTA ActiveE.</li> <li>2. Keep the EME/E-Motor assembly positioned on the MHT 1200 Mobile Lifting Table.</li> <li>3. Detach the HV cables from the EME/E-Motor bracket (2).</li> <li>4. Remove the transmission cover retaining clip (1) from the EME bracket (2).</li> <li>5. Pull the transmission cover (3) downwards.</li> </ol> <p><u>Installation notes:</u><br/>Make sure to position the cover snugly around the transmission. Secure the HV cables with wire ties to the EME bracket (2).</p> |

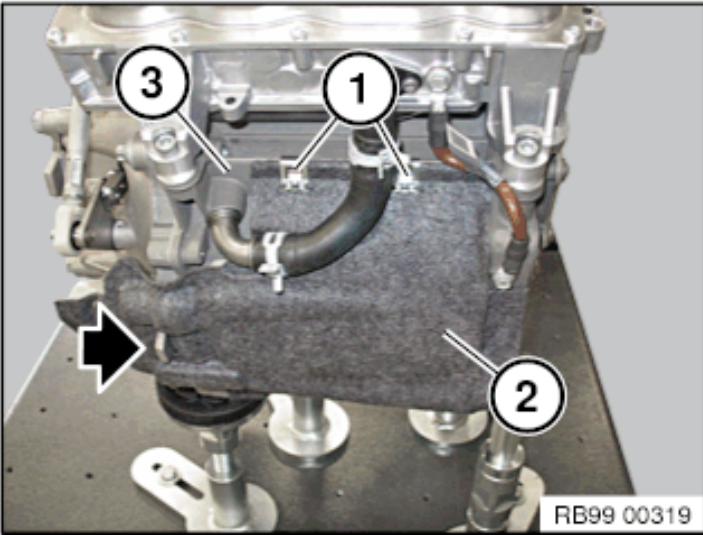
| | <ol style="list-style-type: none"> <li>6. Remove the transmission cover retaining clips (1) on the E-Motor (3).</li> <li>7. Pull the transmission cover (2) downwards and remove it from the E-Motor.</li> </ol> |

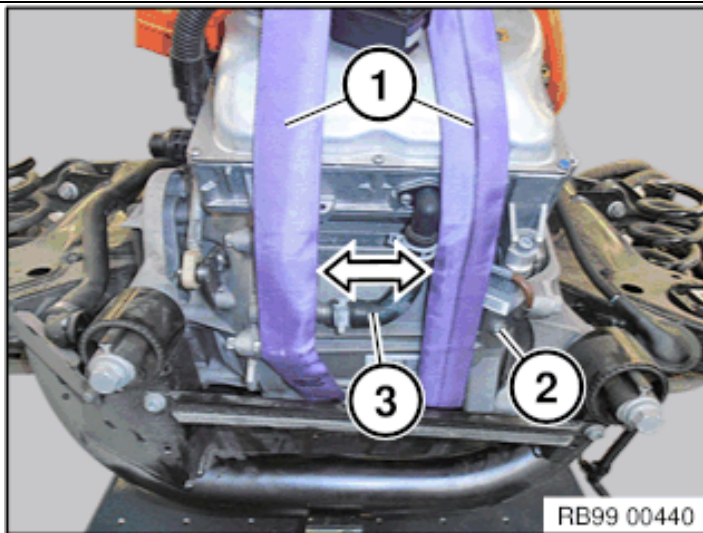
8. Use suitable woven lifting straps (1) for removing the EME/E-Motor assembly (2) from the rear axle sub frame.

Important notes: Do not use chains or unshielded steel cables, which may damage surfaces of the EME/E-Motor.

Make sure your lifting straps are not damaged (cut), and are rated in excess of 300 lbs.

9. Place the lifting straps under the EME/E-Motor assembly, making sure that they are spread apart sufficiently. Rear view: lifting straps should be positioned outboard of the cooling hose (3).

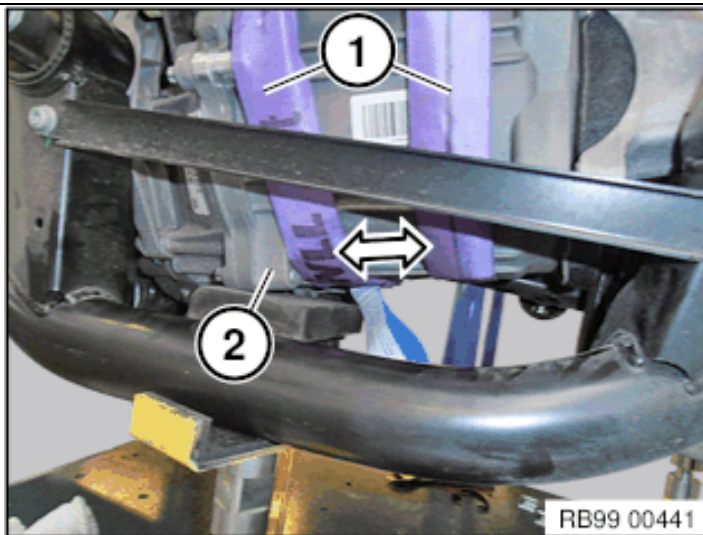
10. Position the lifting straps (rear view, bottom) so that both straps (1) are placed separately on the E-Motor housing (2).

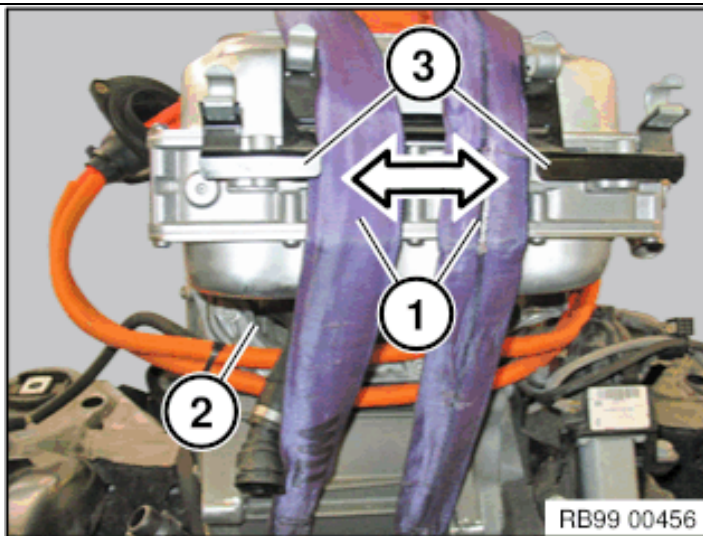
11. Position the lifting straps (front view, top) so that both straps are placed separately between the cable brackets on the EME.

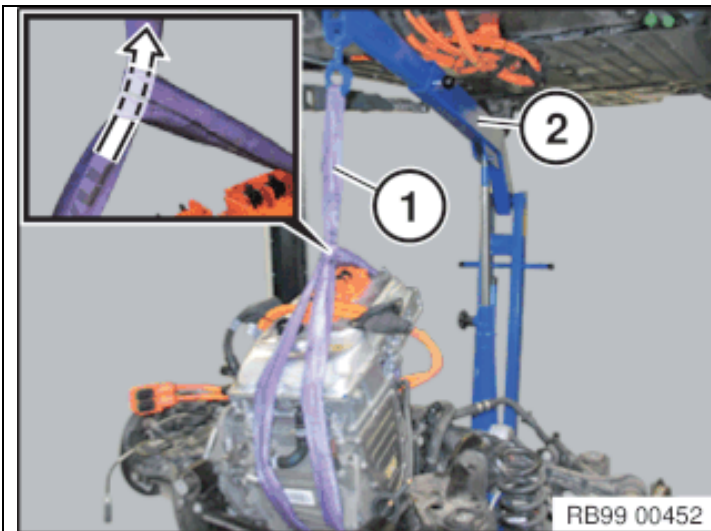
12. Attach the lifting straps (1) to the BMW approved engine crane (2). Place a slight tension on the straps

Make sure the lifting strap loop is placed above the EME connector to prevent tilting of the unit when lifted.

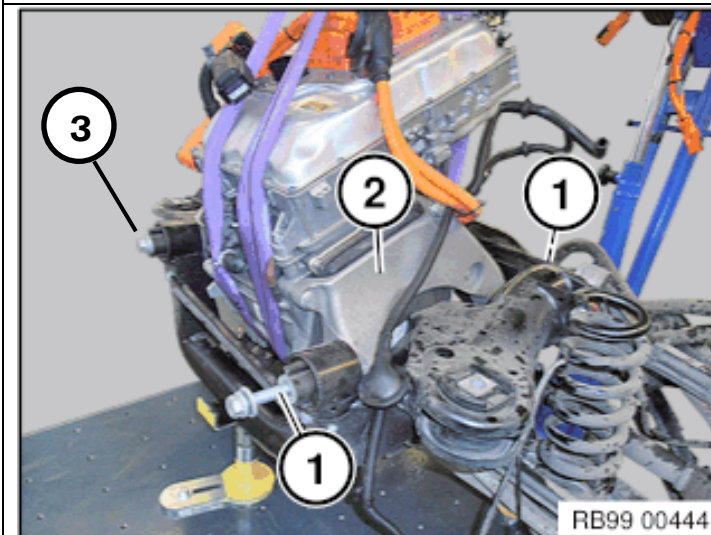
13. Remove the bolts (1) from the right side of the Drive Unit. When reinstalling, torque them to 165 Nm.

14. Loosen the bolts (3) from the left side of the Drive Unit. When reinstalling, torque them to 165 Nm.

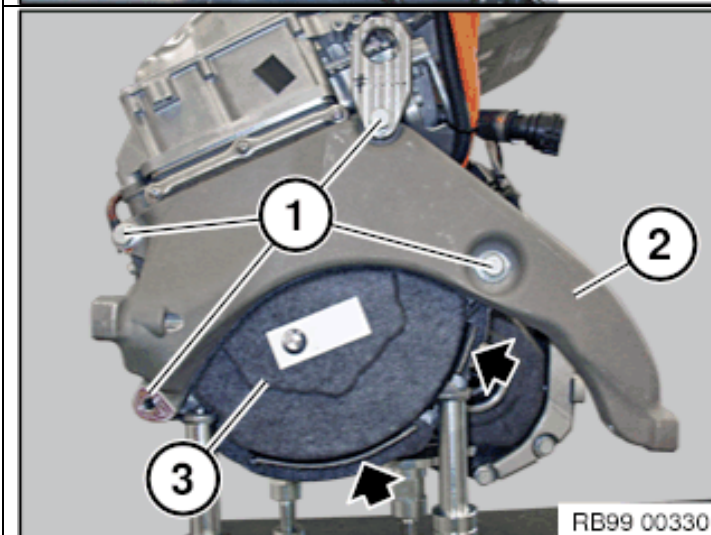
15. Remove the 4 bolts (1), support bracket (2) and the motor cover (3) from the right side of the E-Motor.

When reinstalling, torque the bolts to 56 Nm.

For clarity reasons, the picture shows the EME/E-Motor assembly, which has already been removed from the rear sub-frame.

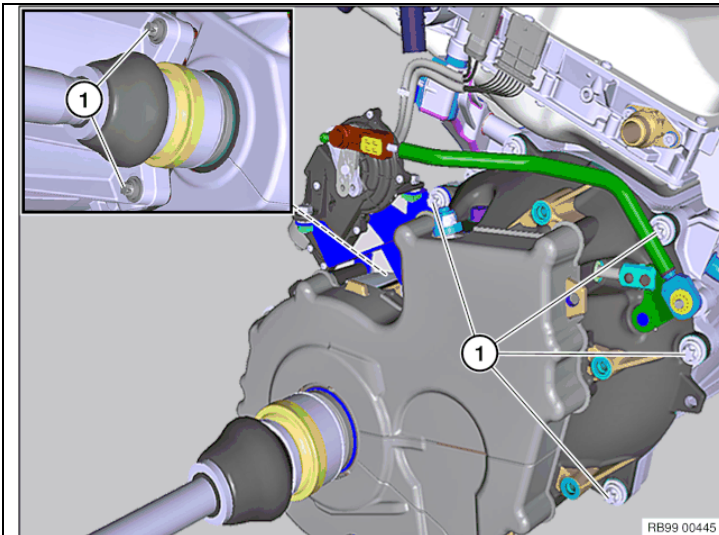
17. Detach the gear selector rod (green) from the transmission.

18. Detach and remove all 7 Torx bolts (1) between the transmission and the E-Motor.

19. Disconnect the park lock actuator harness connectors from the EME.

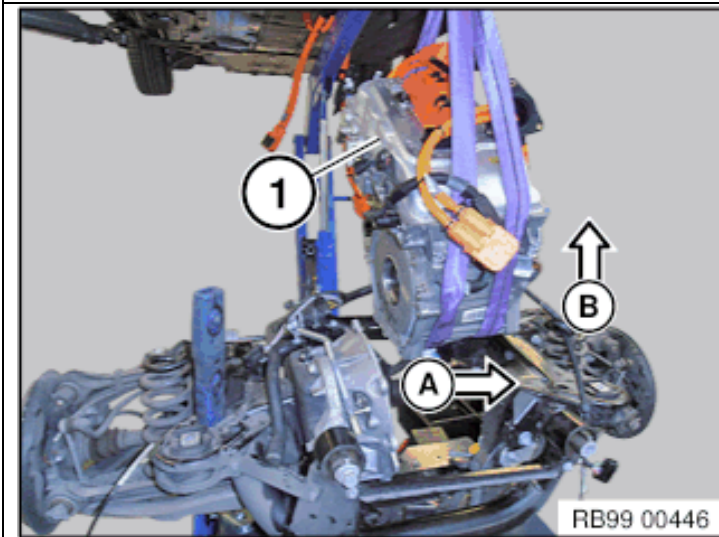
20. Carefully push the EME/E-Motor assembly (1) away from the transmission (direction A) and then upwards (direction B) from the sub-frame assembly.

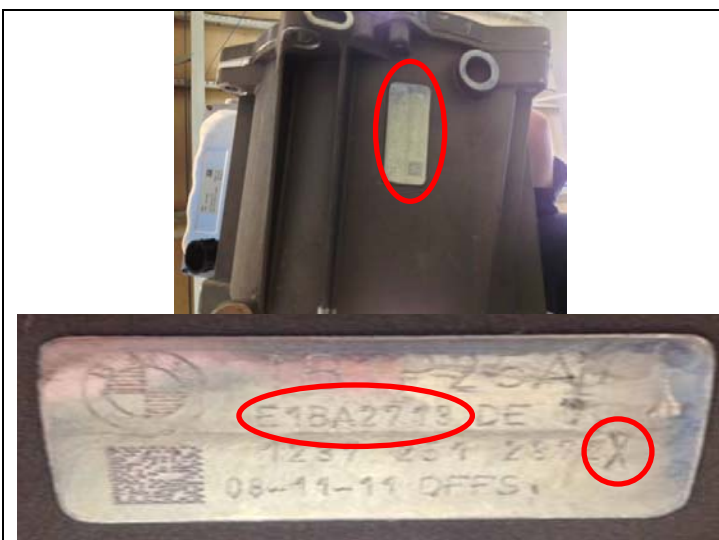
In every case, the E-Motor serial numbers have to be recorded.

22. The E-Motor serial number of the new and the old unit is found underneath the E-Machine on the type plate.

23. Write down both E-Motor numbers (old and new) with the additional stamped "X" and include them in the PuMA case, e.g.: "New#: E1BA2713X".

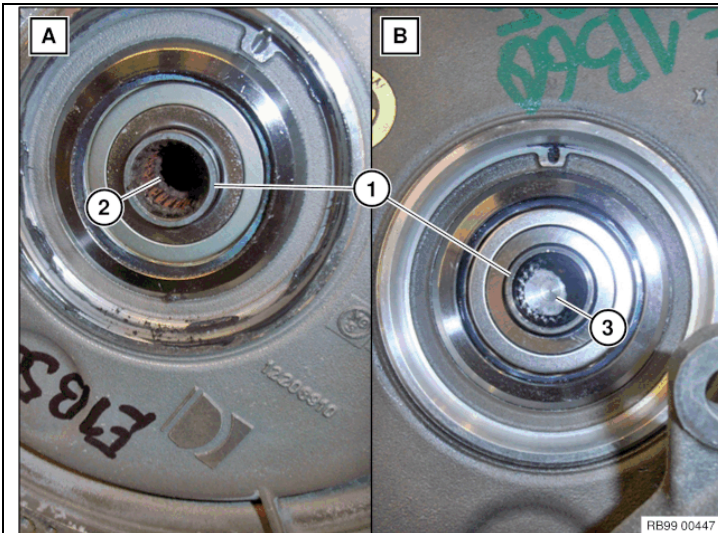
25. Check and record the E-Motor version by inspecting the E-Motor output hub (1):

**Version A** – the motor output hub (hollow shaft) is **OPEN** in the back (without a grease pocket) – detail (2) on picture **A**.

The EME/E-Motor assembly must be replaced using the updated part P/N 05 74 2 512 372. The updated part has a closed end in the hub, which serves as a grease pocket.

Update the PuMA case and attach a picture of the E-Motor output hub (open back), in order to receive an authorization for the EME/E-Motor replacement.

If the EME/E-Motor is replaced, skip to step 35 for the greasing procedure to be performed on the new part.

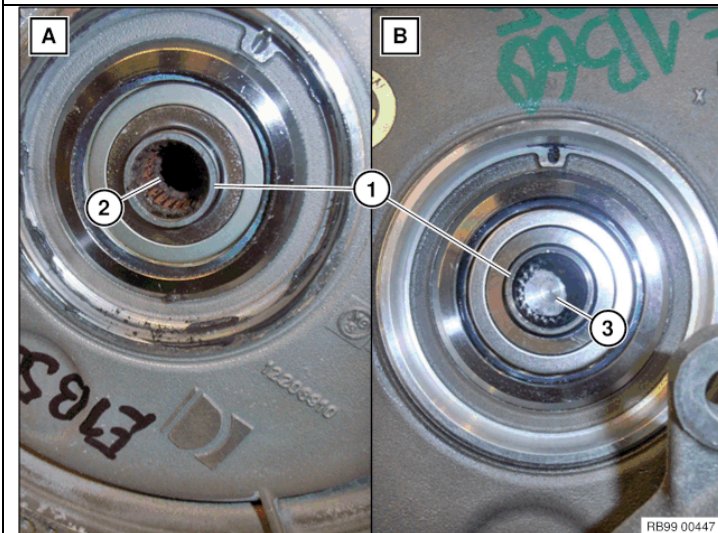
26. Check and record the E-Motor version by inspecting the E-Motor output hub (1):

**Version B** – the motor output hub (hollow shaft) is **CLOSED** in the back (with a grease pocket) – detail (3) on picture **B**.

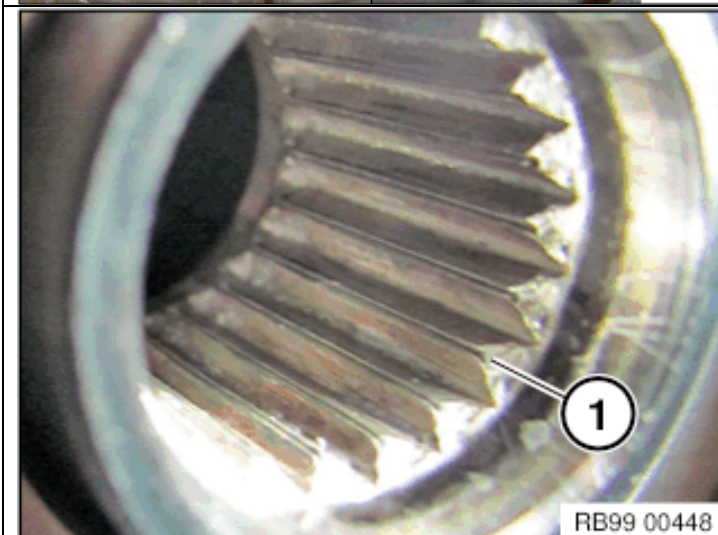
27. Before cleaning the splines of the E-Motor output hub (1), document their condition with a clear photo. In addition, also document the condition of the transmission input shaft with a photo.

Update the already submitted PuMA case with your findings, and attach pictures of the E-Motor output hub and the transmission input shaft (in their original condition, prior to cleaning).

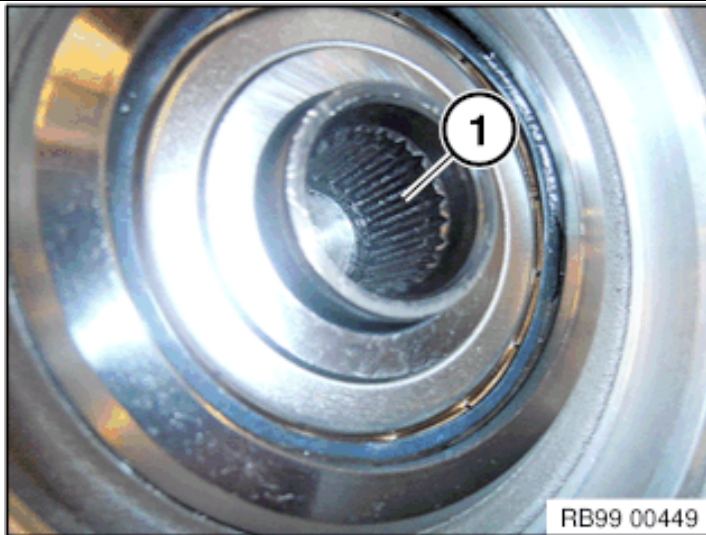
28. Using an appropriate wire brush, thoroughly clean the hub splines to remove all corrosion and rust/debris particles.

Clean the hub using a cloth moistened with "Reiniger R1 Autobody Repair Primer" (P/N 83 19 2 211 217).

Update the already submitted PuMA case with your findings, and attach pictures of the E-motor output hub after cleaning.

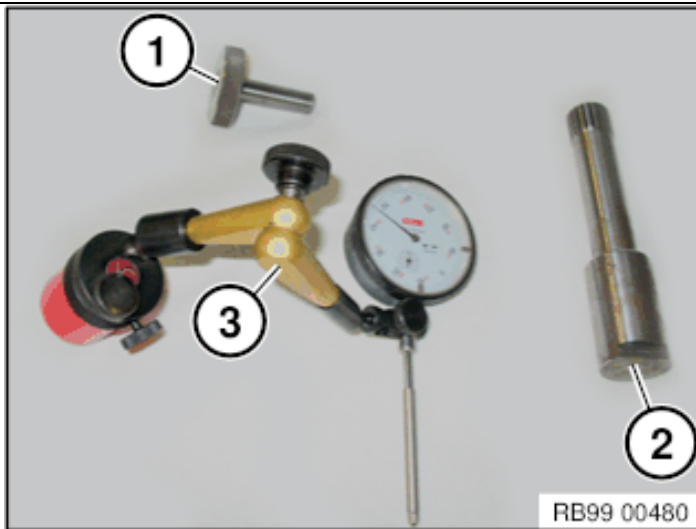
29. Obtain the tools from the special tool kit to measure the wear of the hub splines. This consists of a Dial Gauge Mount (1), Measuring Shaft (2), and a Dial Gauge (3).

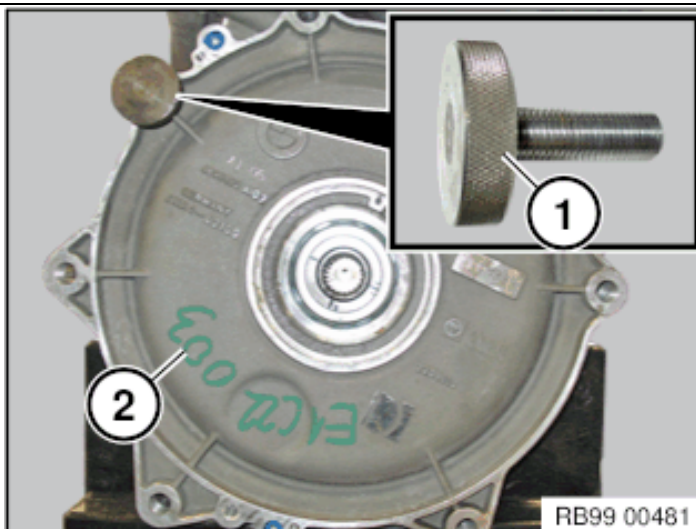
30. Thread the dial gauge mount (1) into the upper left E-Machine (2) mounting hole as shown.

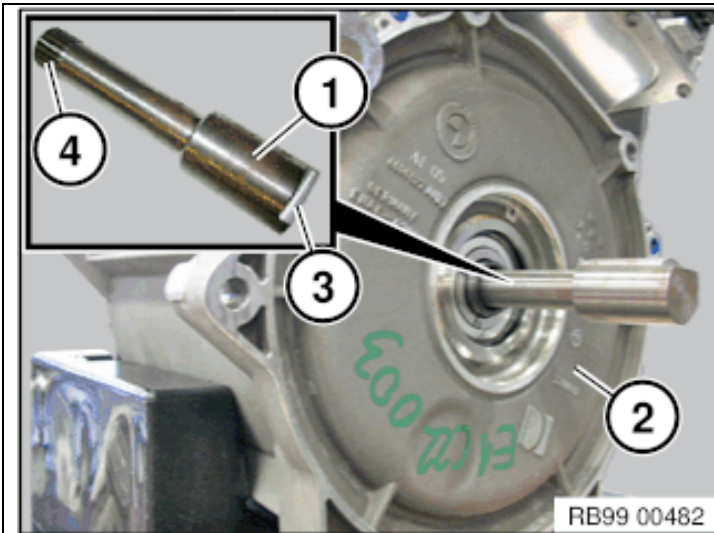
31. Clean the measuring surface for the Measuring Shaft (3) and the splines for the Measurement Shaft (4).

Insert the Measuring Shaft (1) fully into the E-Machine's hub (2). The measuring surface (3) should be approximately horizontal once installed.

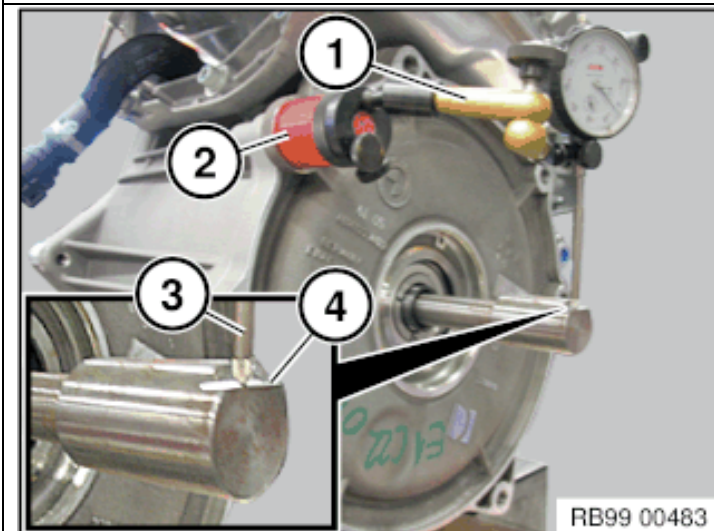
32. Secure the dial gauge (1) to the dial gauge mount (2).

Position the tip of the gauge onto the center of the measuring surface of the measuring shaft.

Position the gauge (3) so that slight pressure exists on the measuring shaft (4).

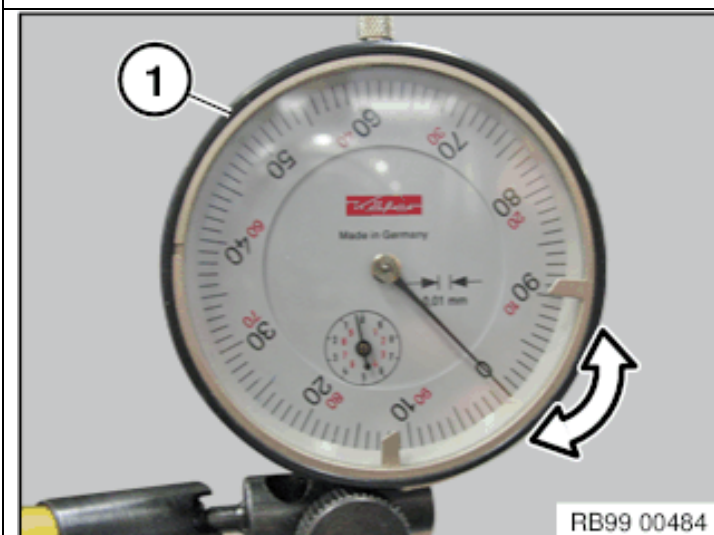
33. Adjust the needle on the gauge (1) so that it reads 0.

NOTE: When reading the gauge, the small inner gauge displays the number of full mm, while the large outer gauge displays hundredths of a mm. For example, a difference of 1 on the inner gauge and 30 on the outer gauge would be a reading of 1.30 mm.

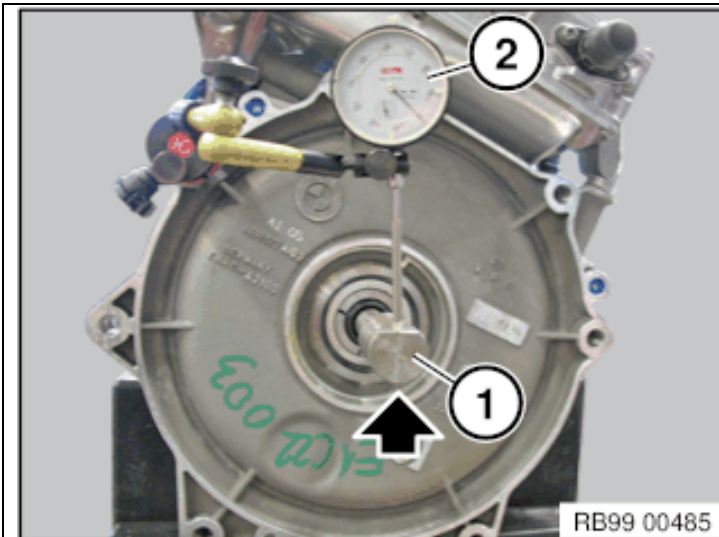
34. Measure the free play of the Measuring Shaft (1) inside the hub by pressing upward on the shaft until it tops out. Only minimal force is required. Record the measurement.

After the first measurement, remove the gauge (2), grasp the measuring shaft, and rotate the E-Machine approximately 60 degrees. Then set up the gauge and shaft, and repeat the measurement. The measurement should be performed 5 times in a row following this procedure.

Important: Update the PuMA case with the measurement results and photos for replacement authorization if necessary. Transfer and record the E-Machine serial numbers (as per steps 21-24) in all cases.

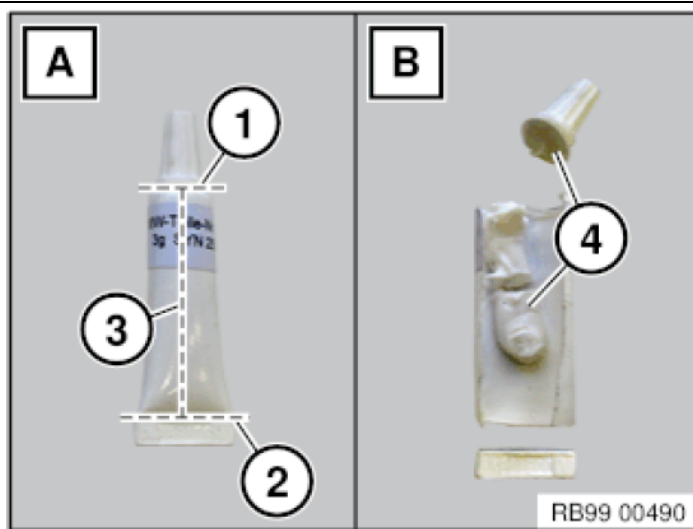
35. Cut off both ends of the tube (1 and 2). Then cut the tube lengthwise (3) and apply the complete contents of the grease to the splines of the E-Machine with your finger.

Note: Use P/N 27 21 8 604 187.

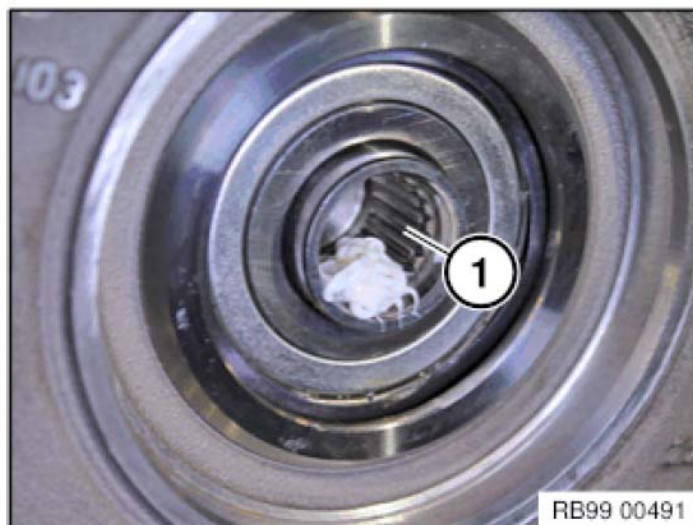
36. Using your finger, spread the grease evenly over all the splines in the output hub (1). Make sure to use all the grease from the tube.

Note: If all the grease is not used, future damage to the hub can occur. Use the residual grease from your finger on the O-ring in step 41 and the half shells in step 50.

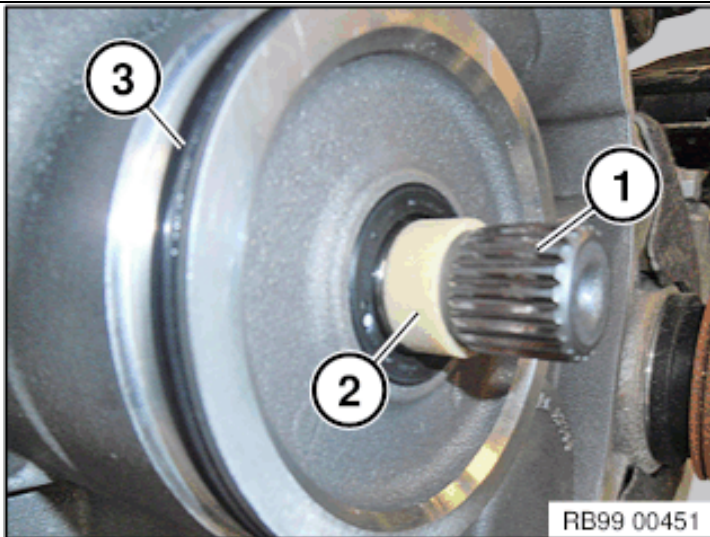
37. Remove the plastic bushing (2) from the transmission input shaft (1) and discard it.
38. Using an appropriate wire brush, thoroughly clean the splines, removing all corrosion.
39. Inspect the condition of the input shaft splines. If the splines are damaged (excessive wear), the gearbox will need to be replaced.
40. Inspect the O-ring seal (3) for signs of damage or cuts. Replace it if required.
41. Lightly moisten the O-ring (3) with the leftover grease from the repair kit.  
**Important:**  
Take clear digital pictures of the transmission input shaft after the cleaning has been performed. Attach these photos and those of the E-Motor output hub to the applicable PuMA case in order to receive necessary replacement authorizations.

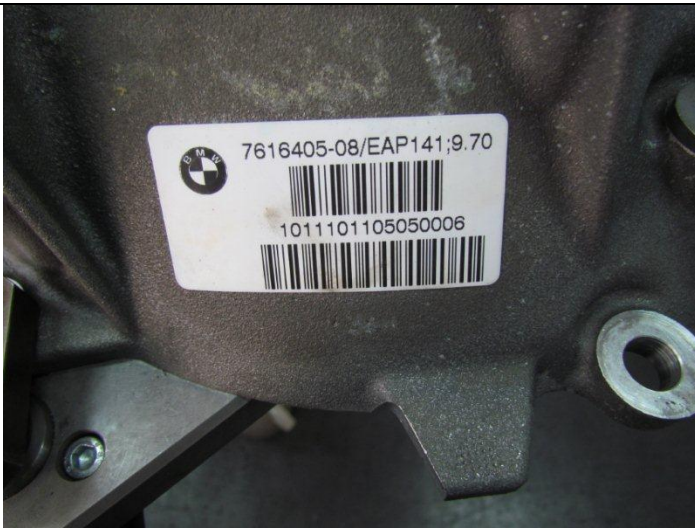
42. In case the transmission needs to be replaced, the gearbox serial numbers have to be recorded.
43. The transmission serial number is found in the middle of the part identification sticker, attached to the gearbox housing (e.g., 1011101105050006).
44. Write down both transmission serial numbers (old and new) and include them in the PuMA case.
45. **Important:**  
Update the already submitted PuMA case with your findings, and attach pictures of the transmission input shaft after cleaning.

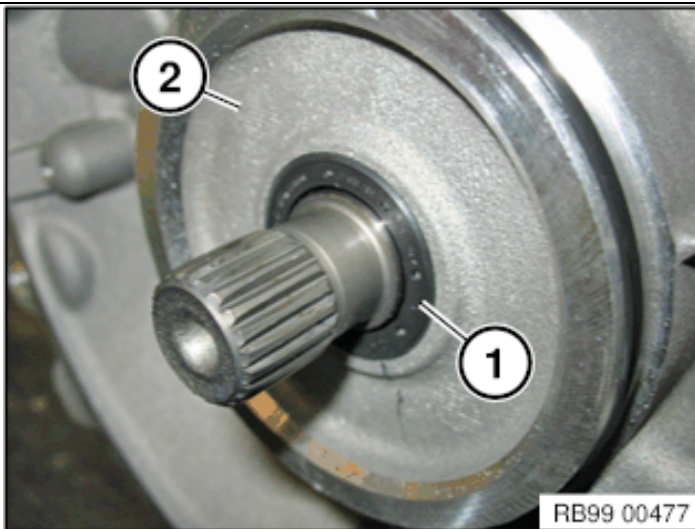
46. Examine the radial shaft seal (1) to determine if it's sitting flush against the transmission housing (2). If it protrudes at all, follow steps 51-53 to properly seat the seal.

In addition, inspect the seal to determine if it is damaged or leaking per the following images.

In case of substantial oil leakage from the area of the transmission's radial seal, the EME has to be replaced.

**NOTE:** If it is necessary to seat or replace the radial seal, update the PuMA case with that detail.

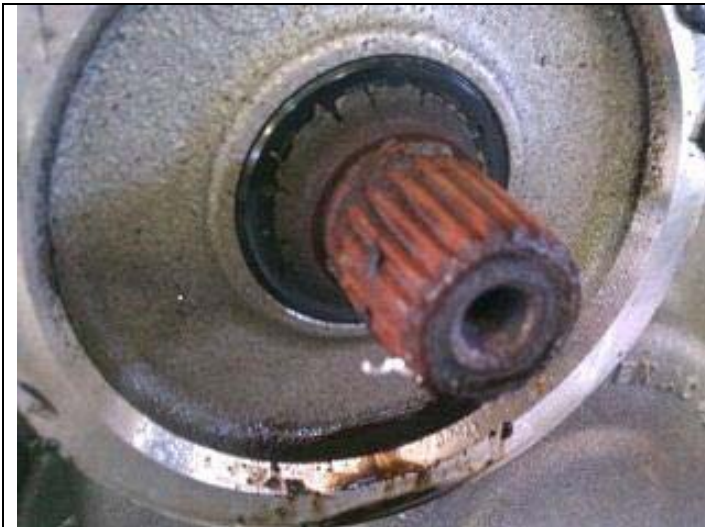
47. This image shows an example of the seal leaking from the transmission side (the radial seal P/N 27 21 7 628 759 must be replaced).

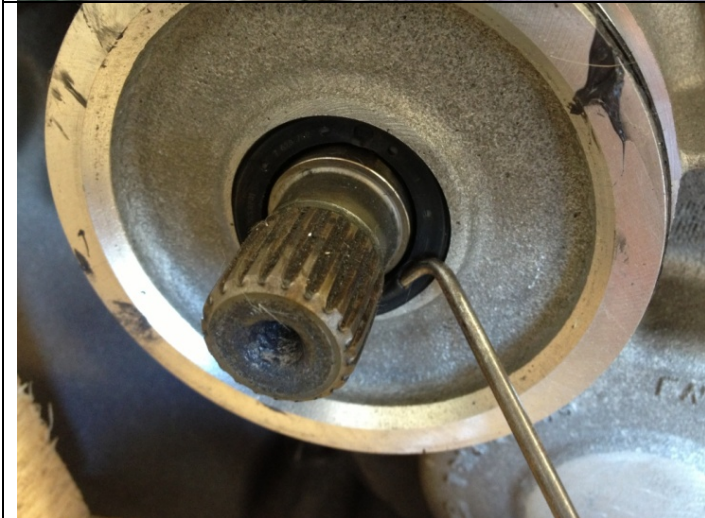
48. If the radial seal is to be replaced, it should be removed using a pick to pierce the seal and pull it out. The shaft or housing of the transmission must not be touched by the pick, as it is easily damaged.

Oil will leak out of the transmission when the seal is removed. Following the replacement, the oil level must be checked and filled as needed.

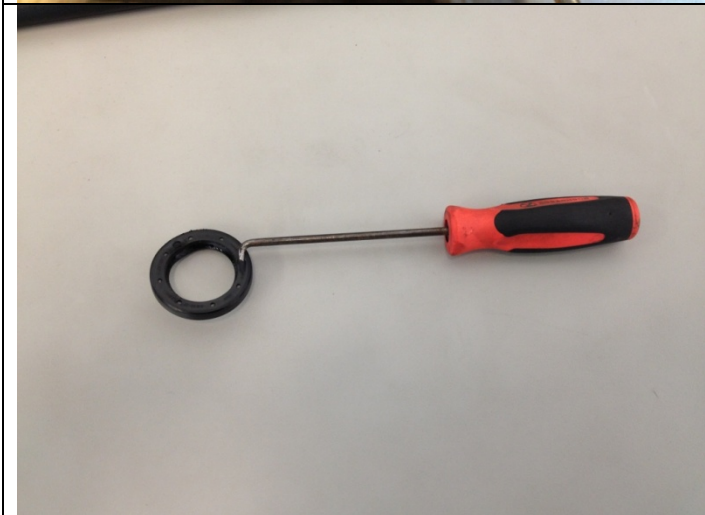
49. Remove the radial seal with the pick in place.

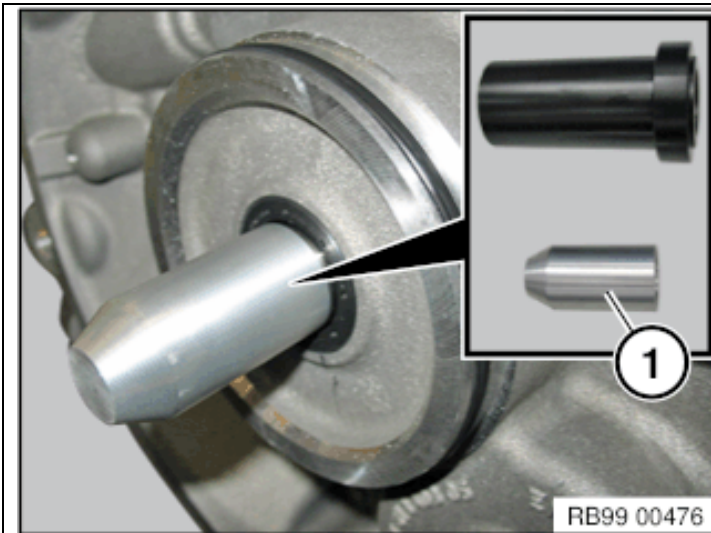
#### 50. Installing a new Radial Seal:

Place the guide sleeve (1) from the special tool kit over the input shaft of the transmission.

NOTE: Always use the guide sleeve. The sharp-edged trans shaft may damage the radial shaft seal.

Apply a small amount of oil to the guide sleeve and the radial shaft seal. Carefully position the radial shaft seal over the guide sleeve. Follow steps 52-53 to properly seat the seal.

NOTE: If the transmission oil needs to be refilled, drain the complete transmission oil and refill with 500ml of BOT448 Gear Lubricant (P/N: 83 22 2 295 532). Do not fill it up to the bottom line of the fill hole. The oil level is approx. 30mm/1.2 inches under that line. Update the PUMA case with how much oil you were able to drain.

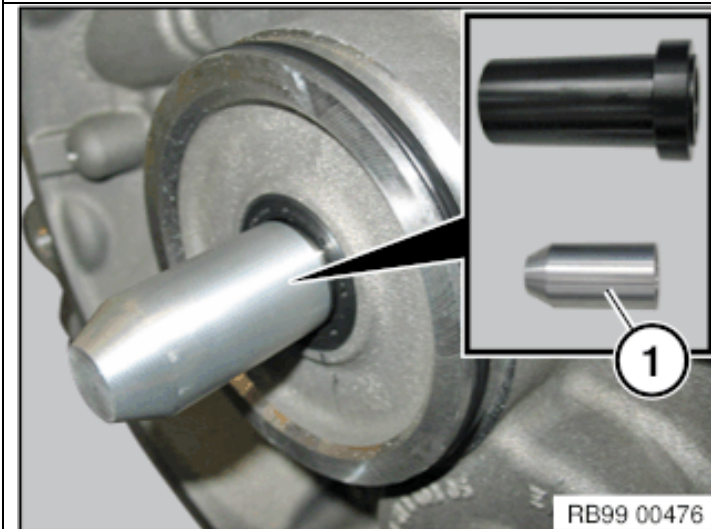
#### 51. Seating the existing Radial Seal:

Place the guide sleeve (1) from the special tool kit over the input shaft of the transmission.

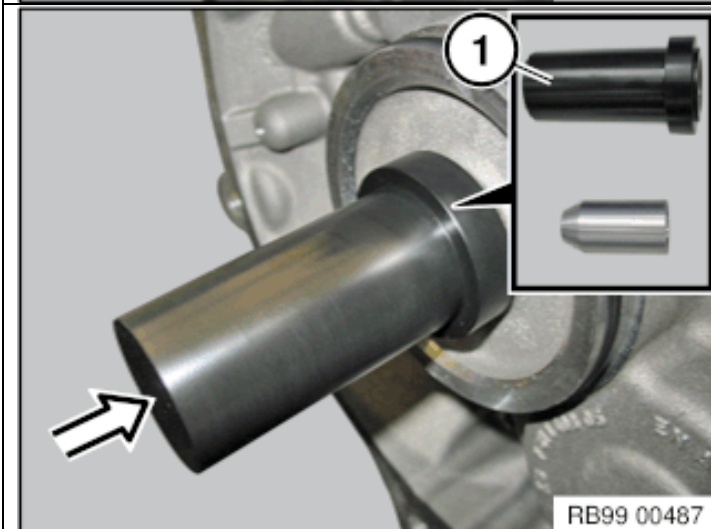
52. Install the seal tool (1) over the guide sleeve until it contacts the seal.

53. Rotate the seal tool while applying pressure to it (in the direction of the arrow), until the point where the seal is flush with the transmission housing.

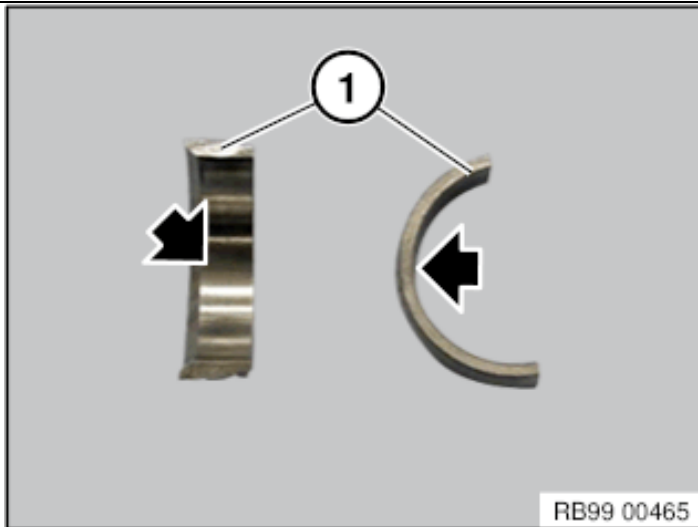
54. Apply a small amount of leftover grease from step 35 to the inside of the bearing shells (1). This will ease the installation of the half shells around the input shaft.

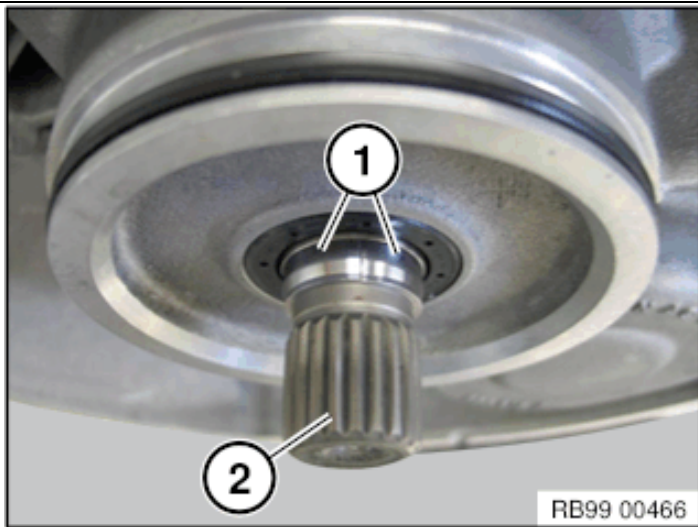
55. Position the lightly lubricated half shells (1) over the transmission input shaft (2), as shown.

Slide the half shells toward the transmission until they bottom out on the input shaft collar. They should not contact the seal. The shells are tapered on the inside and outside. The taper on the inside of the shells should point toward the transmission.

NOTE: The taper on the inside of the shells MUST point inward, toward the inside of the transmission. As a result, the outside of the shells creates a ramp to ease installation of the metal ring.

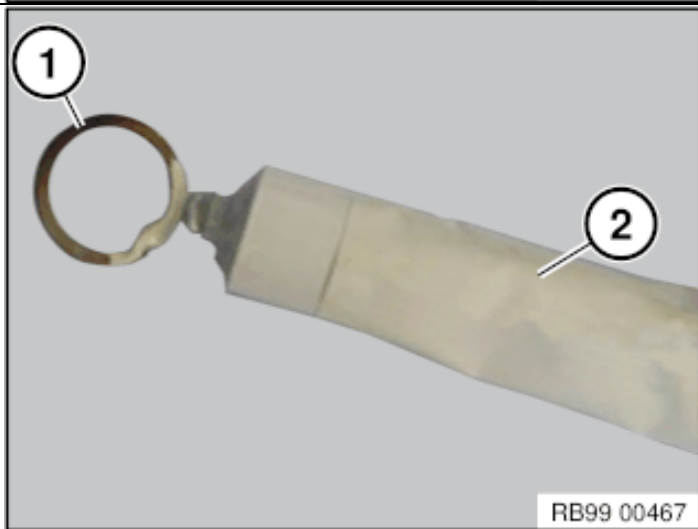
56. Lightly coat the surface on the tapered side of the metal ring (1) with non-metallic grease (2) (P/N 83 23 2 344 250). Only a few very small dots of grease are necessary.

NOTE: The taper on the ring is on the inside circumference. It is very small and can be difficult to see. Only a few dots of grease are necessary.

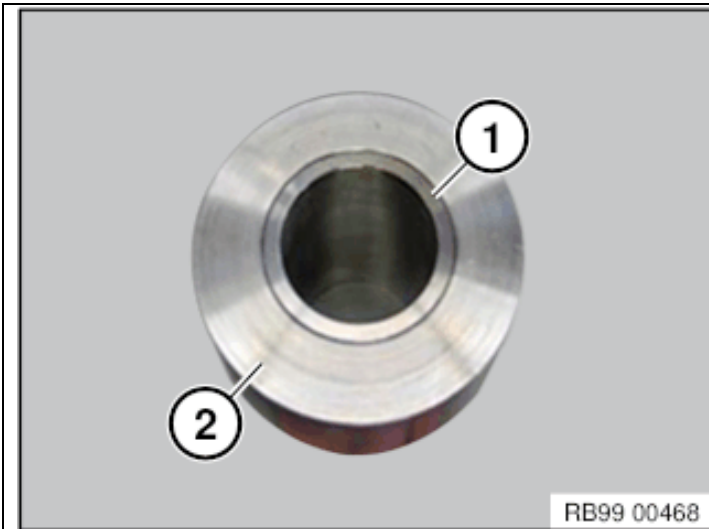
57. Place the greased metal ring (1) into the recess of the mounting tool (2), grease-side down. The intention of the grease is to hold the ring to the mounting tool when positioned for installation.

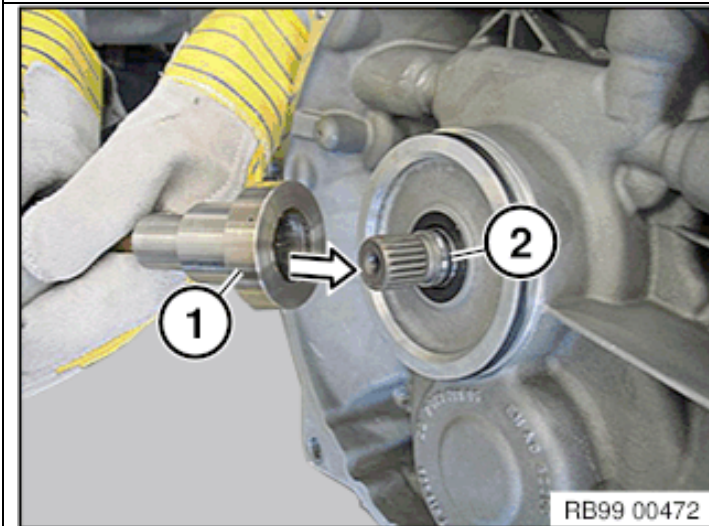
58. Position the mounting tool (1) over the input shaft and up to the half shells (2). With light effort, the metal ring should fit over the half shells and be fully seated. Do NOT use a mallet or excessive force to position the metal ring.

59. If the metal ring will not go over the half shells easily, follow steps 60-65 to properly heat the ring for installation. Otherwise, skip to step 66.

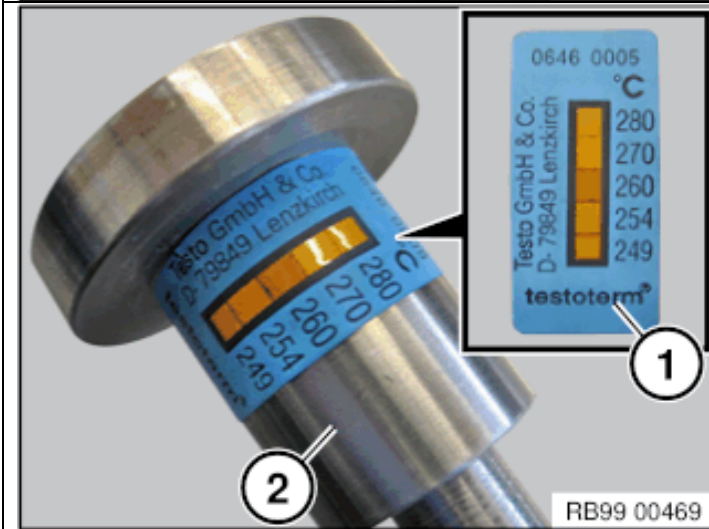
60. Clean the surface of the mounting tool (2) in the area where the temperature gauge is shown.

61. Position the adhesive-backed temperature gauge (1) to the mounting tool (2) as shown. All areas of the gauge must be flush with the mounting tool.

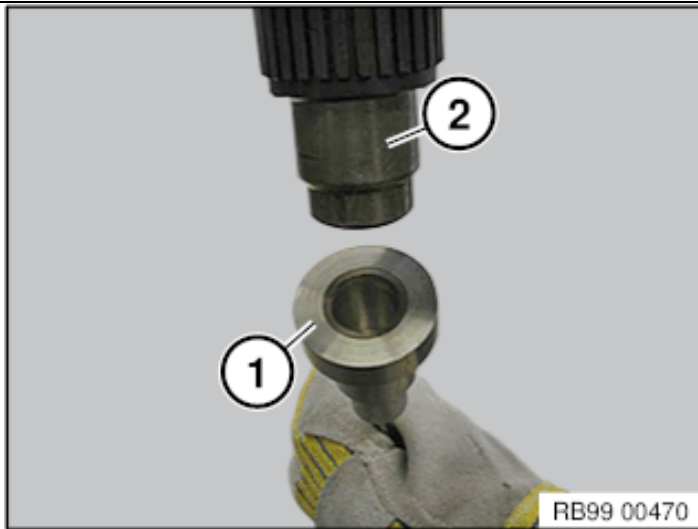
62. With heat-protective gloves on, hold the installation tool (1) with the metal ring facing up.

Use a heat gun (2) to warm the metal ring while keeping an eye on the temperature gauge.

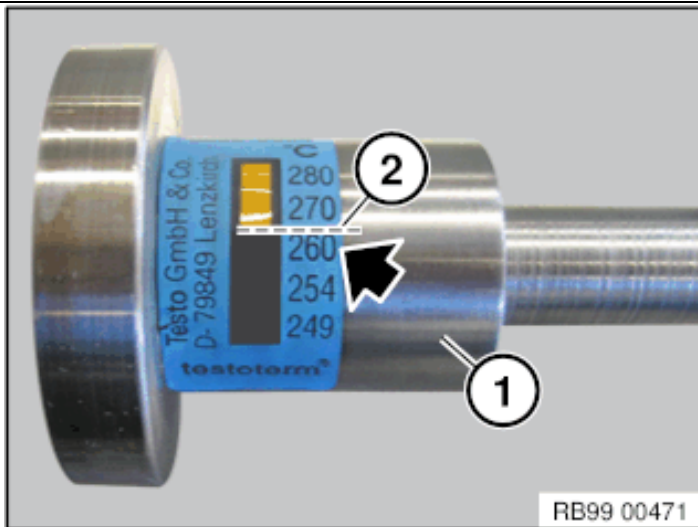
63. Continue heating the metal ring/mounting tool (1) until the temperature gauge (2) reads 260°C.

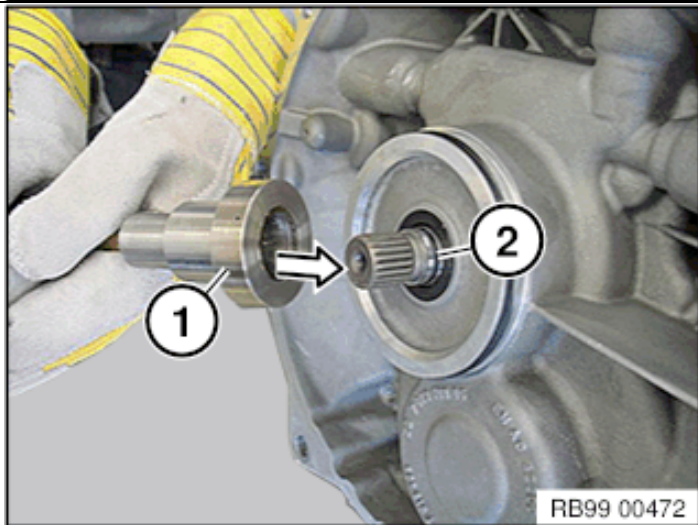
64. Place the warmed mounting tool with the metal ring (1) over the input shaft and half shells (2). Using light pressure, seat the metal ring over the half shells.

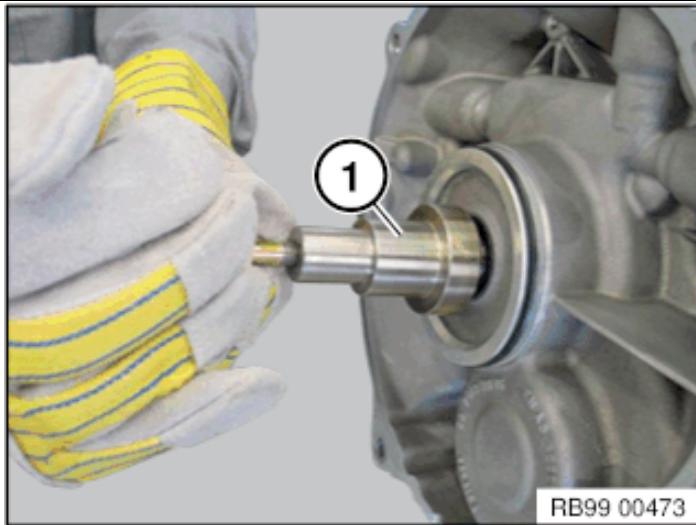
65. If the metal ring does not easily seat over the half shells, press and lightly tap on the end of the mounting tool (1) until seated.

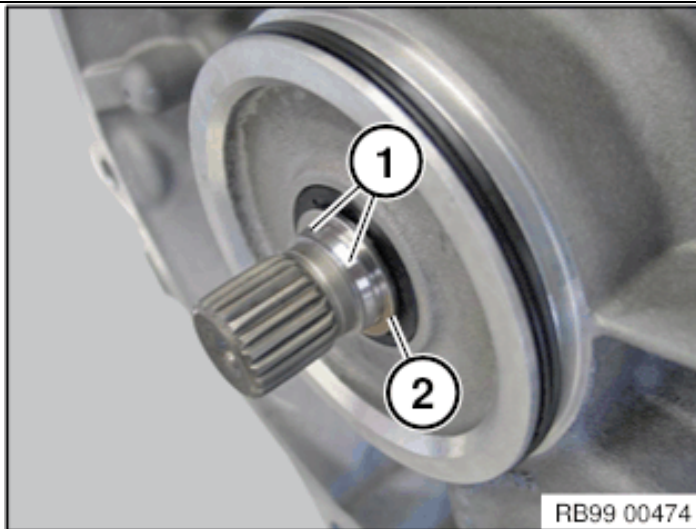
66. In the final seated location, the metal ring (2) may not be in contact with the radial shaft seal but will be over the half shells (1).

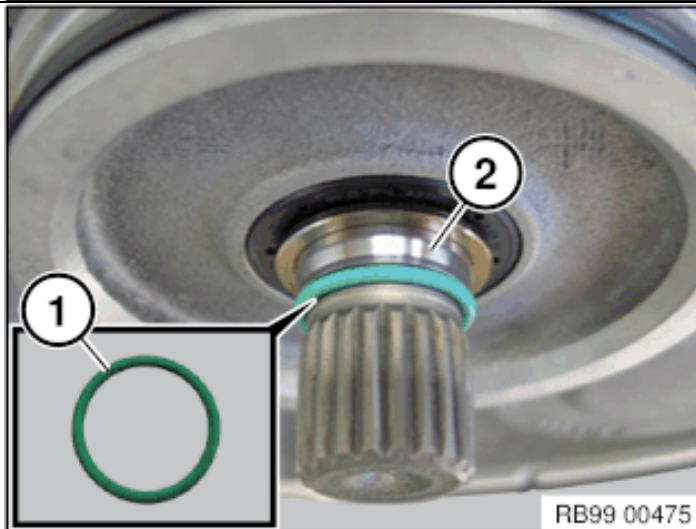
67. Install the O-ring (1) from the grease kit over the splines of the input shaft, to the point where it is flush against the half shells (2).

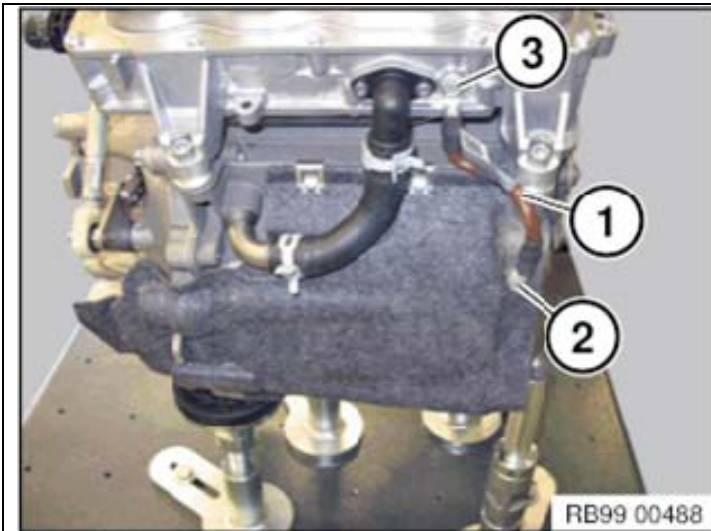
68. Prior to EME/E-Motor reinstallation, make sure the ground cable (1) between the electronic unit (3) and the motor (2) is installed. If the cable is installed, verify the correct torque of 8 Nm. Do not break the connection loose.
69. In case the ground cable is missing, transfer the ground cable (1) from the replaced EME unit and tighten the two hex bolts M5.5x10 to 8 Nm.
70. In sporadic situations when the ground cable is not found on either EME/E-Motor assemblies, order and install ground cable P/N 12 42 7 629 294 and two hex bolts M5.5x10 (torque to 8 Nm).

When installing the ground cable, have a second person on-site to verify the correct torque of the two hex bolts.

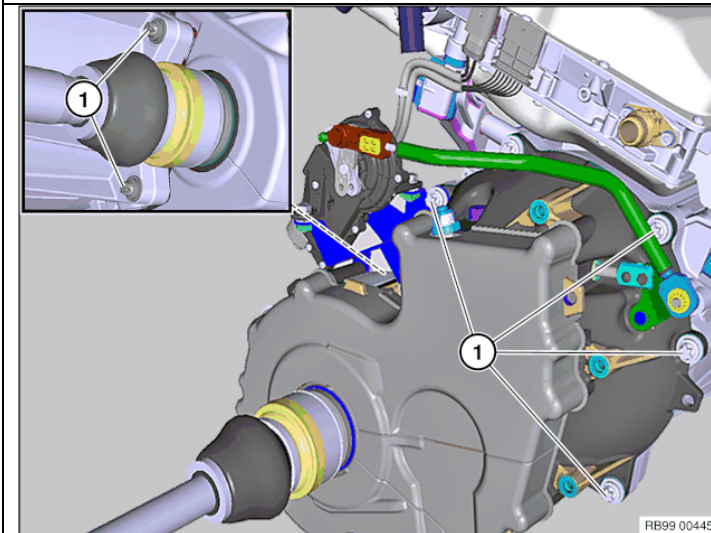
71. Carefully reconnect EME/E-Motor with the transmission.
72. Install and hand-tighten the 7 Torx bolts (1) between the transmission and the E-Motor.

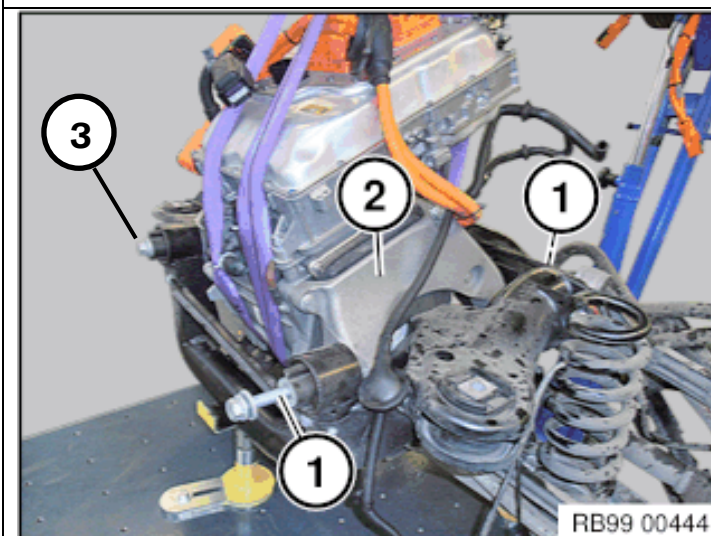
73. Install the right-side transmission bracket (torque bolts to 56 Nm).
74. Reinstall the bolts (1) between the rear axle support and the transmission/motor brackets (2). Apply the final torque of 165 Nm.
75. Reinstall the bolts (3) and torque them to 165 Nm.

When installing the screws and bolts, start them "by hand" to prevent any damage to the threads.

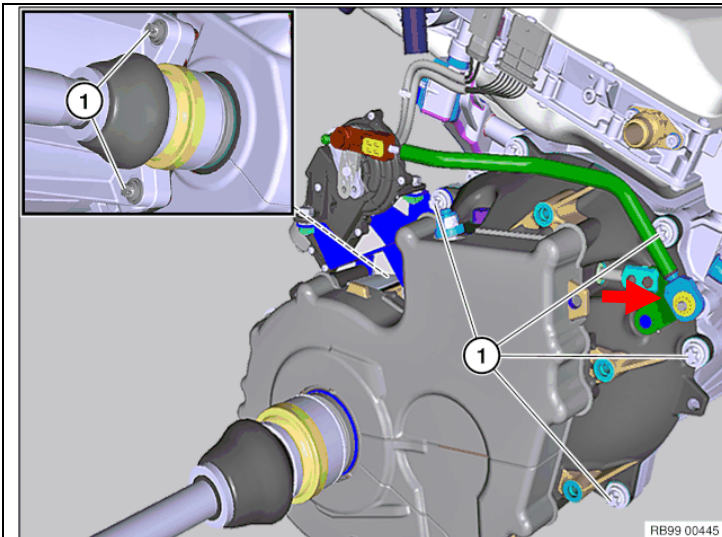
76. Apply the initial joining torque of 10 Nm to all 7 Torx bolts (1) in a diagonal pattern.
77. Loosen the bolts (1) again.
78. Hand-tighten the screws (1) again.
79. Push the gear selector lever (red arrow) all the way down.
80. Rotate the brake discs two complete revolutions, keeping the same direction and speed.
81. Push the gear selector lever up, into the previous position.
82. Apply the initial joining torque of 10 Nm to the bolts (1) in a diagonal pattern.
83. Apply the final tightening torque of 56 Nm in a diagonal pattern.
84. Reattach the gear select rod (green) to the selector lever.
85. Reconnect park actuator harness connectors at the EME.
