RECALL CAMPAIGN BULLETIN

NTB13-024

VOLUNTARY SAFETY RECALL 2013 NISSAN SENTRA FUEL TANK

CAMPAIGN ID #: PM353
APPLIED VEHICLE: 2013 Nissan Sentra (B17)
NHTSA #: 13V-068

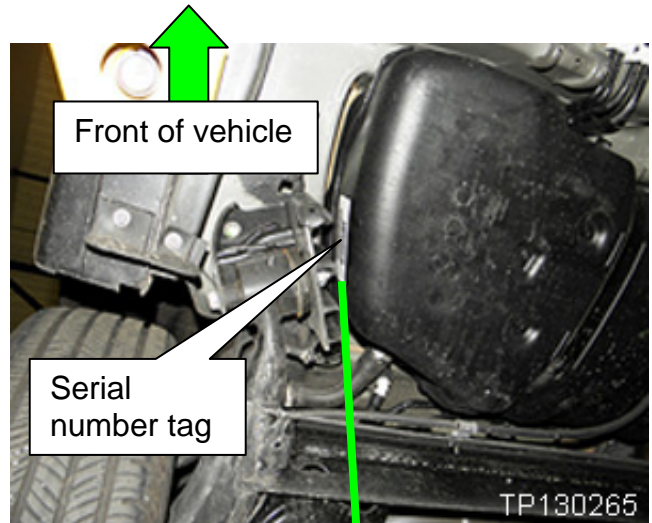
Figure 1

1. Place vehicle on a lift and inspect the right side of the fuel tank next to the right rear I-beam pivot.
 - a. Confirm if the fuel tank serial number is listed below in Table A.
 - If fuel tank **is** in the serial number Table A, proceed to step 2 and **replace** the fuel tank with the part number listed in the PARTS INFORMATION table.
 - If the fuel tank **is not** in the serial code Table A, **do not** replace the fuel tank. The inspection is complete; claim inspection with Op Code PM3530.

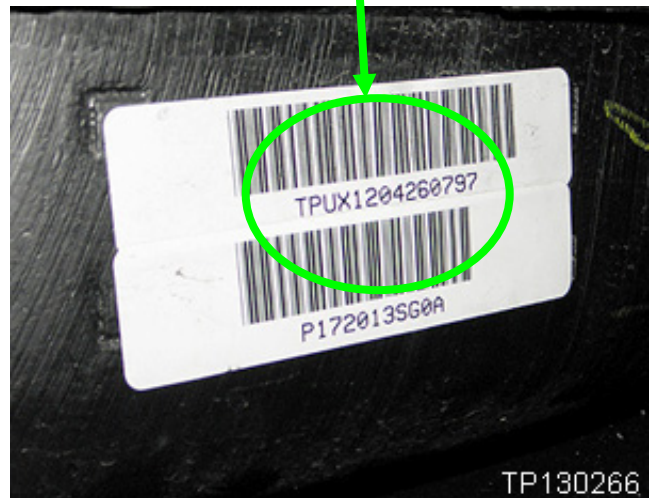
Figure 2 shows close up of serial label on the side of the fuel tank.

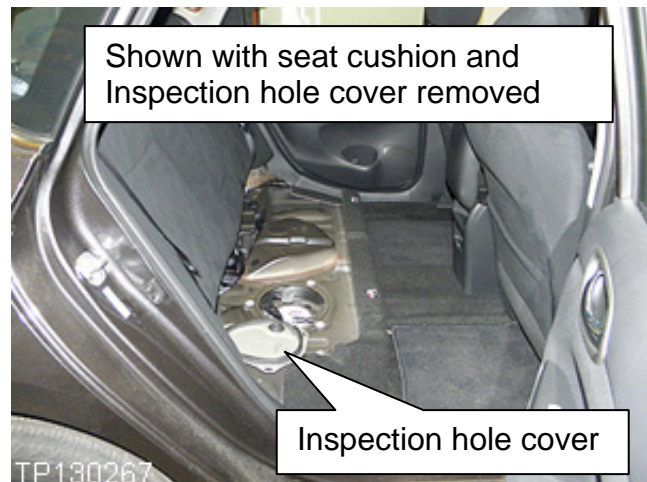
Figure 3

2. Set vehicle on a lift.
 3. Open fuel filler lid.
 4. Open filler cap to release the vapor pressure inside fuel tank.
 5. Release the fuel pressure from the fuel lines.

- Refer to ESM EC-142, "Work Procedure".
 6. Check the fuel level with the vehicle on a level surface. If the fuel gauge indicates more than 1/2 full, drain the fuel from the fuel tank until the fuel gauge indicates a level at or below 1/2 full.

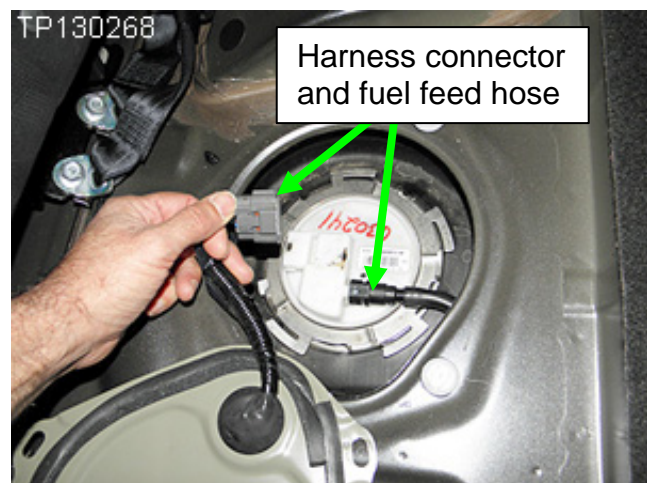
Figure 4

7. Remove rear seat cushion assembly.
 8. Remove inspection hole cover.
 9. Disconnect harness connector, fuel feed hose, and quick connector from fuel level sensor unit, fuel filter and fuel pump assembly (Figure 4).

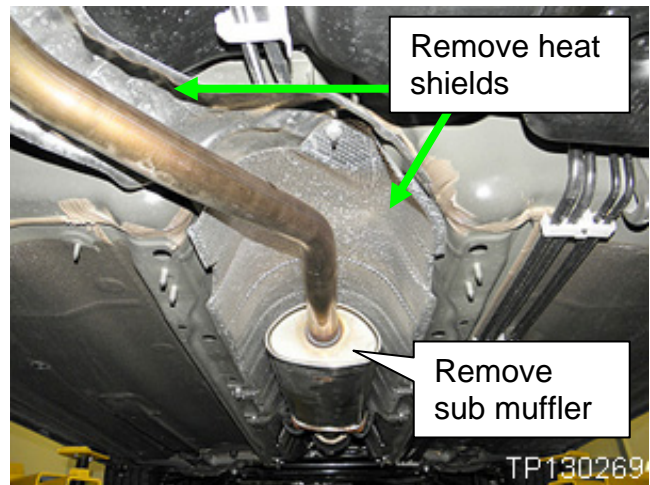
Figure 5

12. Remove the tunnel stay (cross brace) and then the sub muffler.
13. Remove the center and rear heat shields.

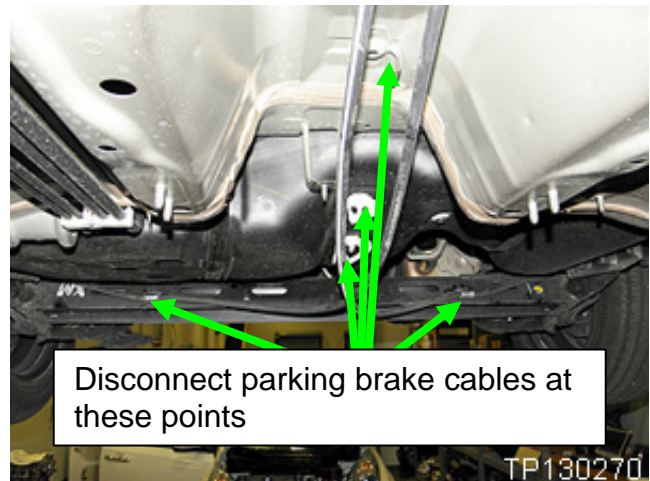
Figure 6

14. Disconnect the rear parking brake cables from the rear axle (10mm bolts) and from locator brackets and then position the cables aside.

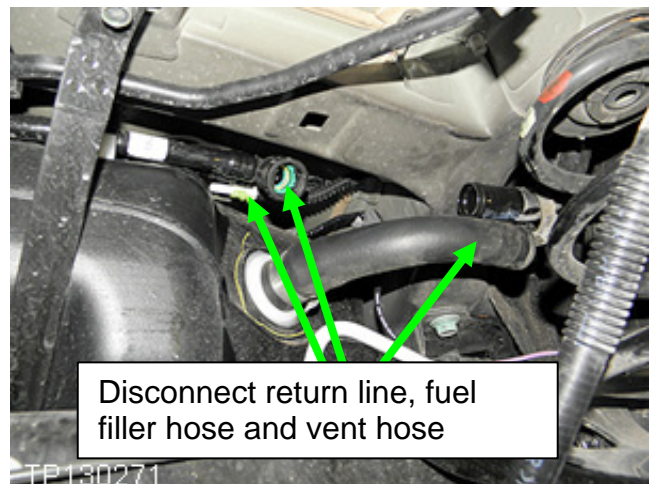
Figure 7

15. Disconnect recirculation line from fuel tank.
16. Disconnect fuel filler hose.
17. Disconnect vent hose from fuel tank.

- Do not bend or twist resin tube during installation and disconnection.
- To keep the connecting portion clean and to avoid damage and foreign materials, cover them completely with plastic bags (A) or something similar.
- Do not insert plug, preventing damage on O-ring in quick connector.

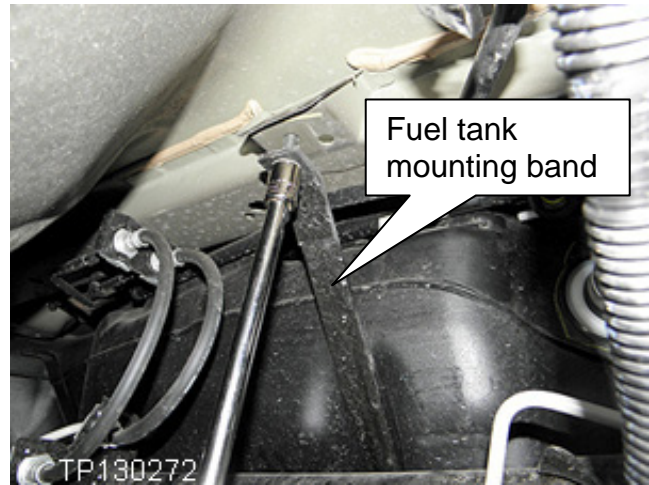
Figure 8

18. Support the center of the fuel tank with a suitable jack and secure the fuel tank to the jack.

- Securely support the fuel tank with a piece of wood.
- Fuel tank may be in an unstable condition, due to the shape of the fuel tank bottom. Be sure to secure tank at all times.

19. Remove both of the fuel tank mounting bands (RH/LH).

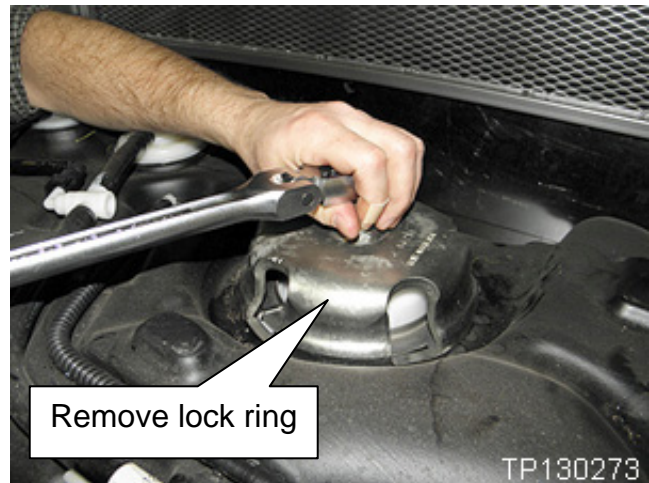
Figure 9

22. Remove lock ring for fuel level sensor unit, fuel filter and fuel pump assembly with Tool by turning counterclockwise (if necessary).

- Tool number: KV991J0090 (J-46214)

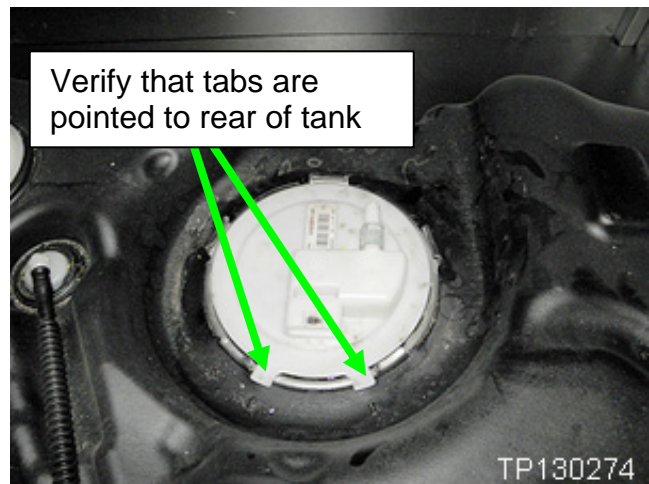
Figure 10

23. Transfer fuel level sensor unit, fuel filter and fuel pump assembly to the new fuel tank with a new o-ring.

- Confirm that pump assembly orientation is correct before locking ring.

- Do not bend float arm during removal.
