Applies To: **2005 Pilot** – Check the iN VIN status for eligibility

Safety Recall: VSA System Unexpectedly Activates

(Supersedes 13-026, dated March 22, 2013, to revise the information marked by the black bars)

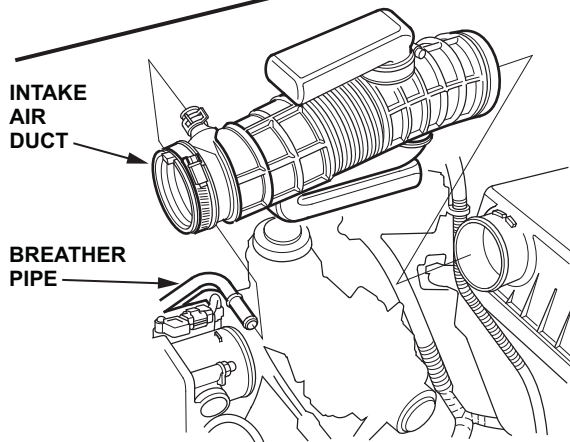
1. Turn the ignition switch to LOCK (0).
2. Remove the engine cover and the intake air duct.

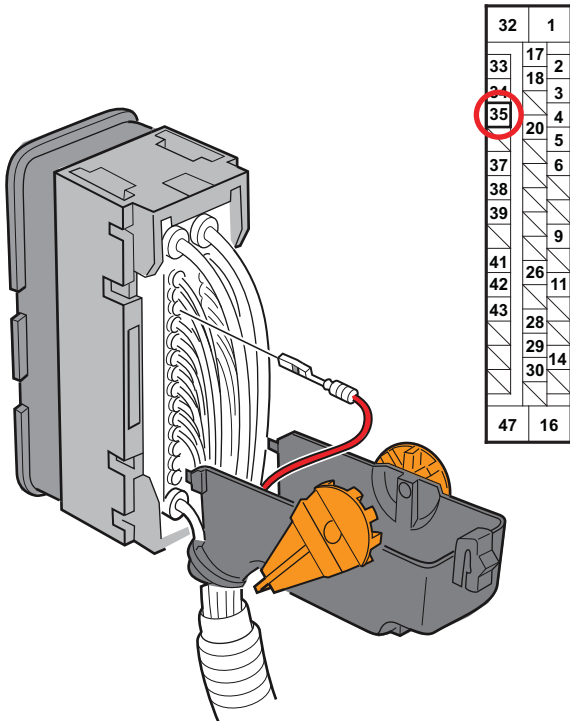
- Remove the No. 35 red wire terminal from the connector while pushing up on the lance release housing.

NOTE: Take note of the orientation of the notch in the terminal when it comes out because you'll insert the new terminal the same way.

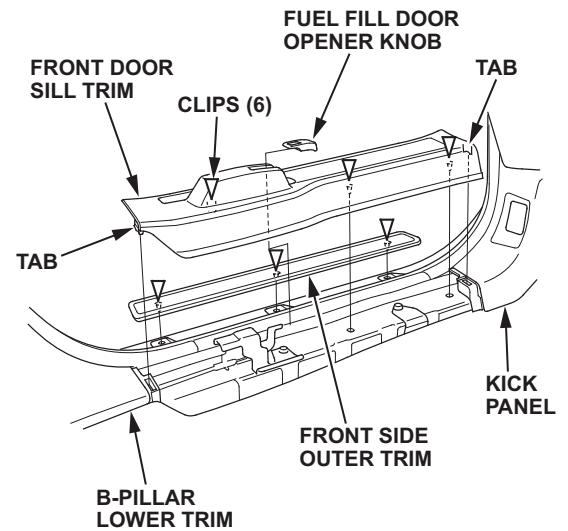
1. Remove the fuel fill door opener knob.

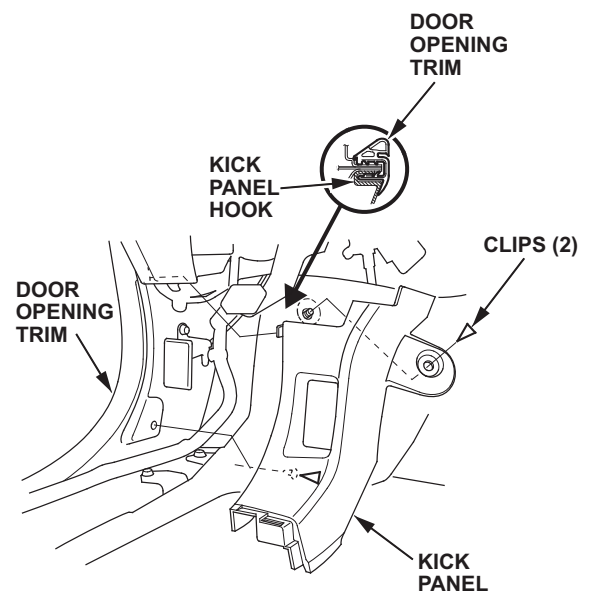
2. Remove the driver's front door sill trim.
3. Remove the driver's kick panel.

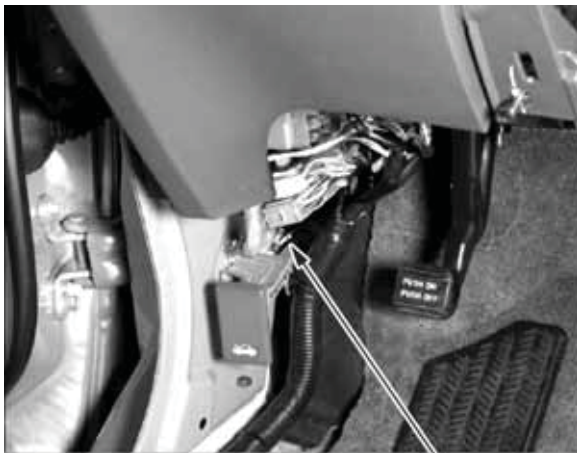
4. Remove the G302 bolt.

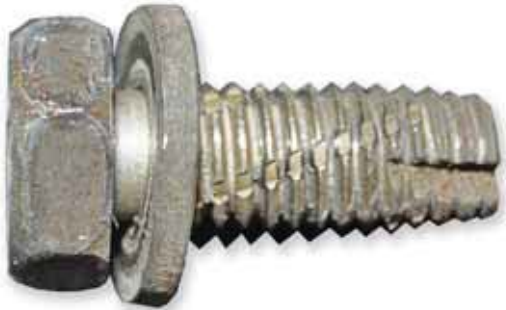
GROUND BOLT

5. Inspect the bolt for the following issues:
 - Corrosion
 - Damage
 - Cross-threading
 - The bolt is a regular bolt, not a ground bolt
 - If the bolt has any of the above issues, replace it before going to step 6.
 - If the ground bolt does not have any of the listed issues, it is OK. Go to step 6.

6. Check the ground terminal on the harness and the mounting surface on the body for the following:
 - Corrosion
 - Damage
 - Excess paint
 - Cross-threading
 - If the ground terminal on the harness or the mounting surface has any of the above issues, repair it before going to step 7.
 - If the ground terminal on the harness and the mounting surface are OK, go to step 7.
7. Reinstall the G302 bolt and torque between **6.9–11.8 N•m (5.1–8.7 lb-ft)**.
8. Reinstall the driver's kick panel.
9. Reinstall the driver's front door sill trim and the fuel fill door release knob.
10. Start the engine and make sure the VSA system indicator goes off.
