Applies To: **2005–06 MDX** – Check the iN VIN status for eligibility
2005 RL – Check the iN VIN status for eligibility

Safety Recall: VSA System Unexpectedly Activates

Supersedes 13-013, dated July 3, 2013, to revise the information highlighted in **yellow**

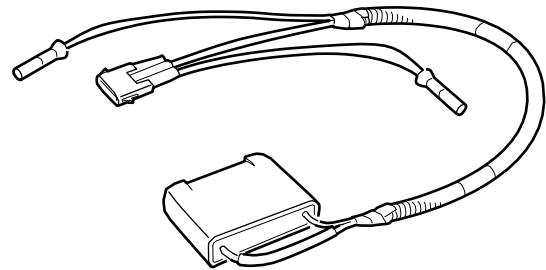
MDX VSA Subharness: P/N 06326-SFE-000

SUBHARNESS WITH CAPACITOR

3P SHORT CONNECTOR

WIRE TIES

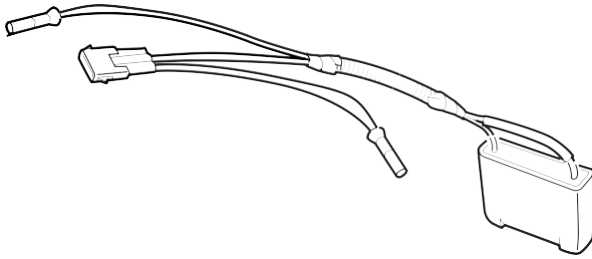
RL VSA Subharness: P/N 06326-SJK-000

SUBHARNESS WITH CAPACITOR

3P SHORT CONNECTOR

WIRE TIES

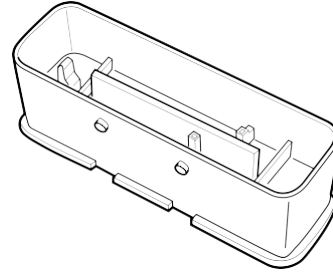
Service Tool Pack 1: T/N 06324-SFE-000

LANCE RELEASE HOUSING

LANCE RELEASE TOOL

WIRE TIES

- The lance release housing should only be used 10 times before replacing it by ordering a new service tool pack.
- Order replacements for Service Tool Pack 1 through normal parts ordering.

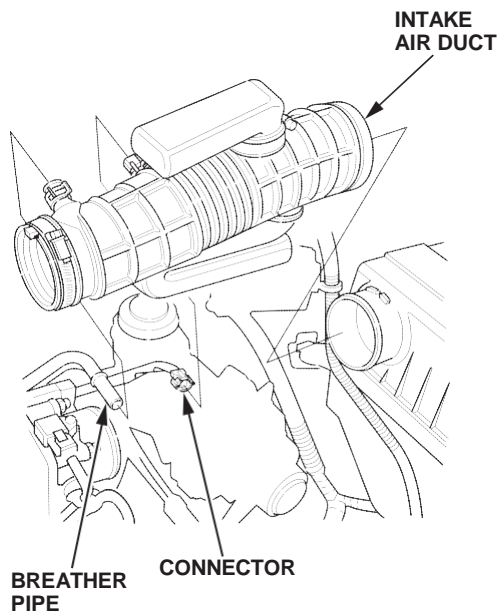
1. Turn the ignition switch to LOCK (0).
2. Remove the engine cover and the intake air duct.

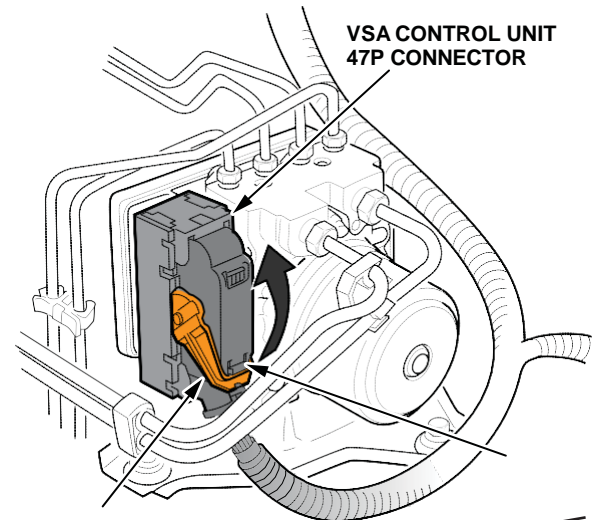
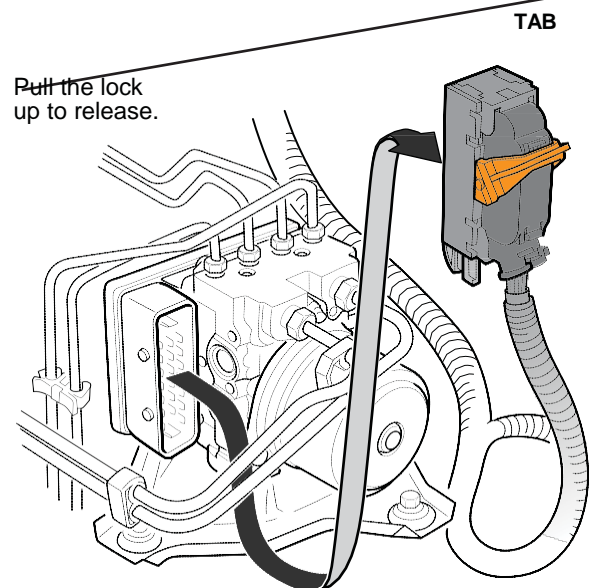
3. Disconnect the VSA modulator-control unit 47P connector.

- Do not force the lock because if you break it, the entire harness must be replaced. Make sure that you press the release tab before trying to move the lock. If needed, wiggle the connector while moving the lock to release the sliding mechanism in the connector.
- Disconnect the harness clips as needed to access the harness.

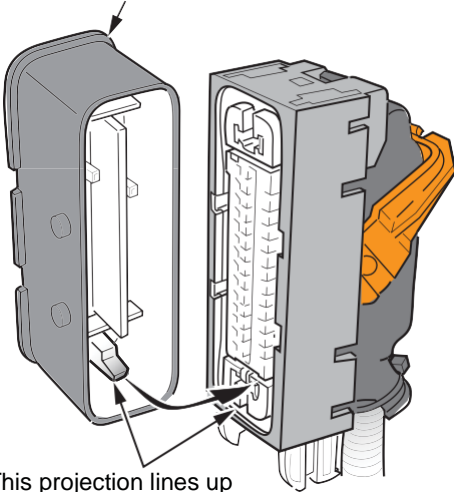
4. Insert the lance release housing into the 47P connector.

LANCE RELEASE HOUSING

This projection lines up with the primary lock at the bottom of the connector.

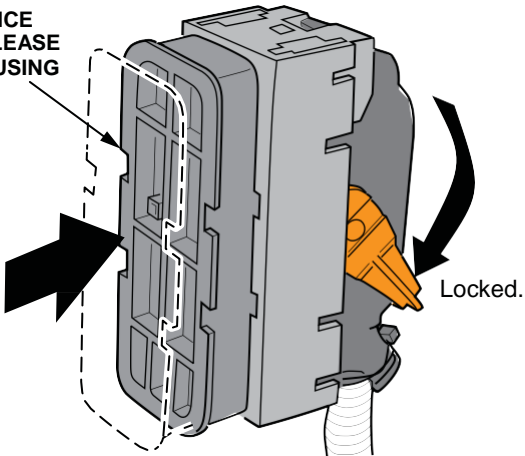
5. Move the lock to the locked position. The lance release housing is fully drawn into the connector and clicks into place.

- Do not apply excessive force.
- If the lock sticks or will not move smoothly, return the lock to its original position, recheck the position of the lance release housing, and try again.

LANCE RELEASE HOUSING

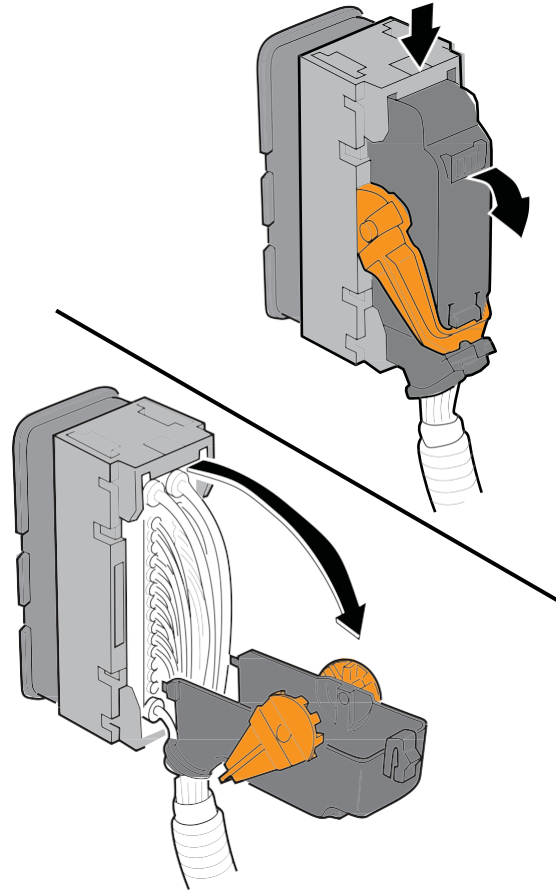
6. Use a small screwdriver to unlock and remove the lock assembly from the 47P connector.

Press to release lock assembly.

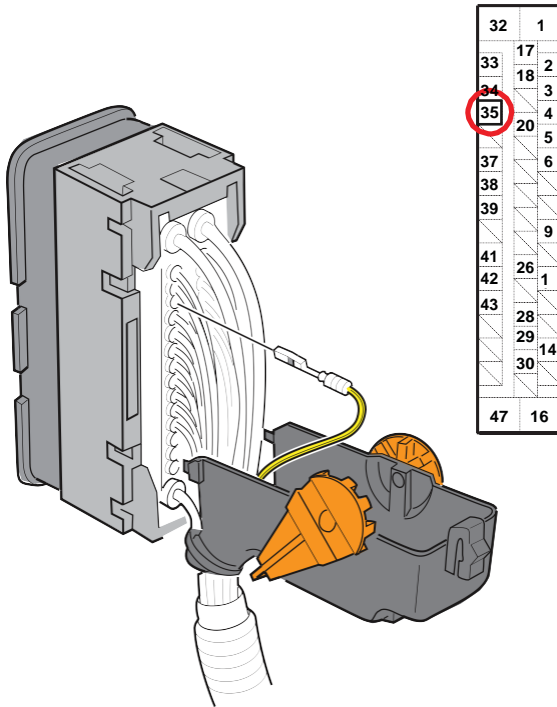
- Remove the No. 35 yellow/black wire terminal from the connector while pushing up on the lance release housing.

NOTE: Take note of the orientation of the notch in the terminal when it comes out because you'll insert the new terminal the same way.

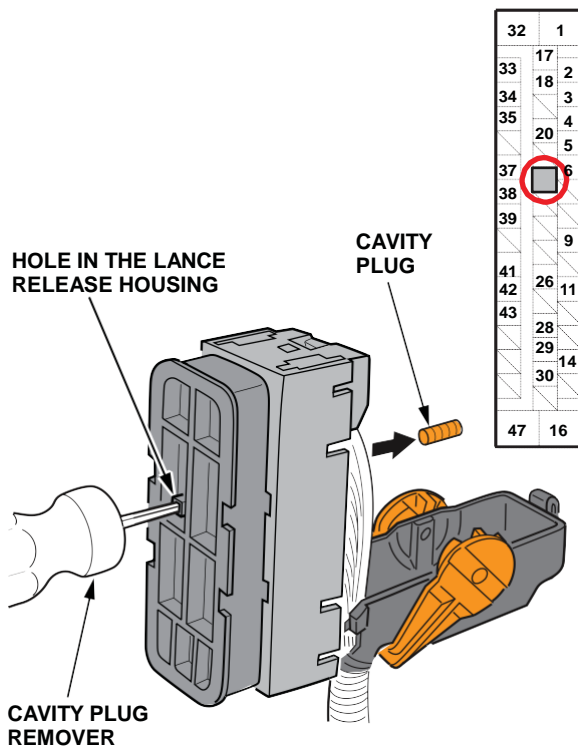
- Insert the cavity plug remover into the hole in the lance release housing as shown, and push out the plug from the No. 22 cavity.

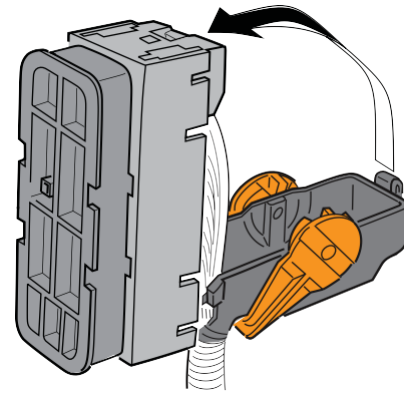
- Tuck the loose terminal and wire into the housing, then install the lock assembly onto the 47P connector as shown.

- Make sure the harness and the wire are not pinched.
- Make sure the lock is properly aligned.

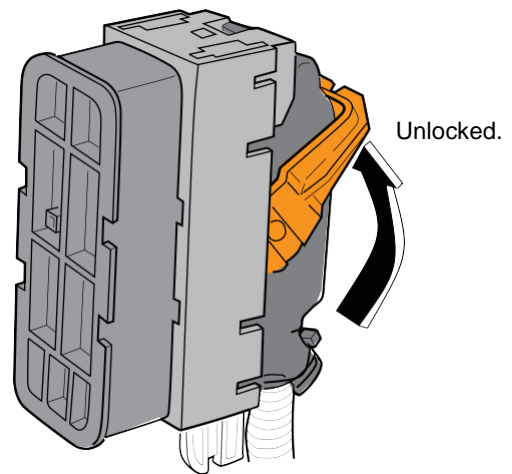
- Press the lock release tab, then move the lock to the unlocked position. The lance release housing also moves into the unlocked position.

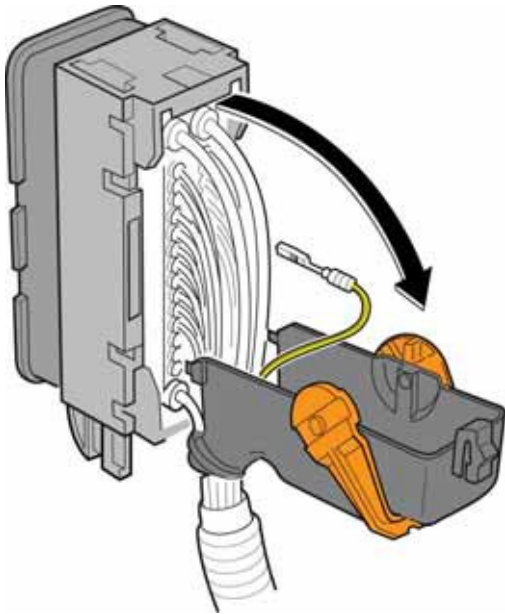
11. Using a small screwdriver, unlock and remove the lock assembly from the 47P connector.

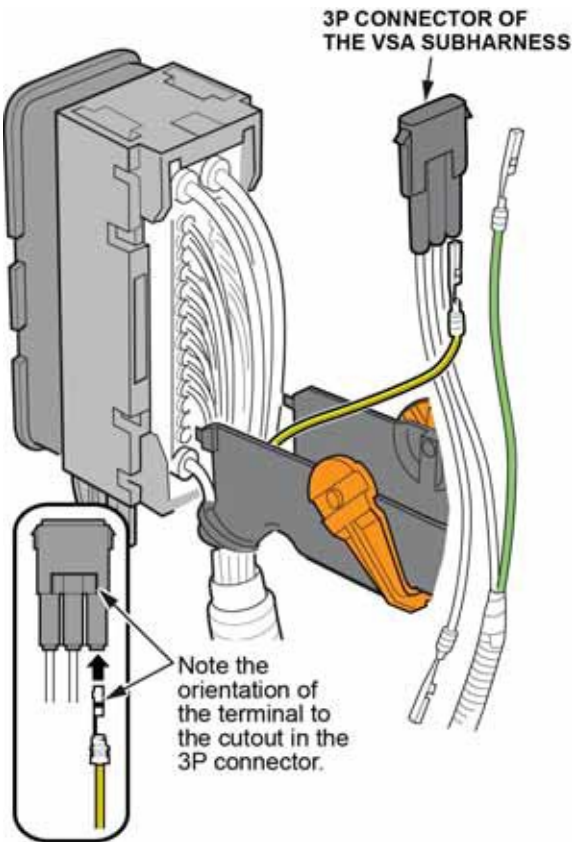
12. Install the VSA subharness.

- Make sure the terminal and connector are properly oriented; the notched part of the terminal should be aligned as shown.

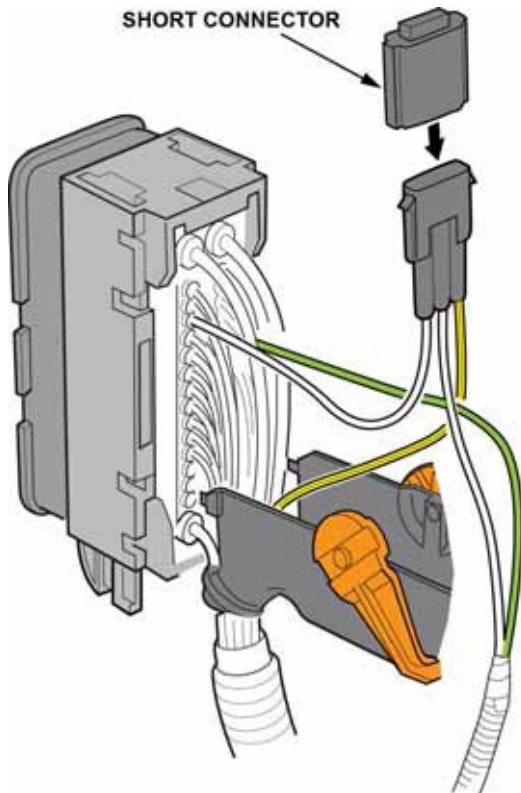
13. Install the short connector to the 3P connector.
> 3P Short Connector

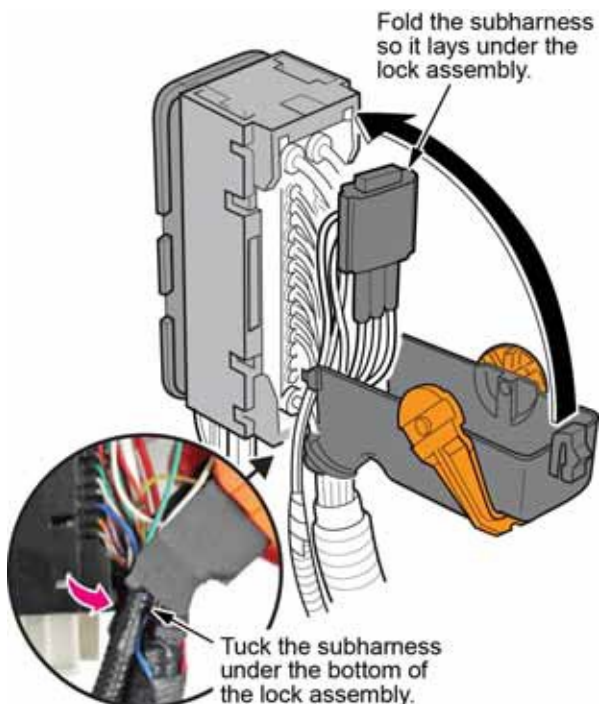
14. Lay out the subharness as shown, then install the lock assembly.

- Make sure the subharness is not pinched.
- Make sure the lock is properly aligned.

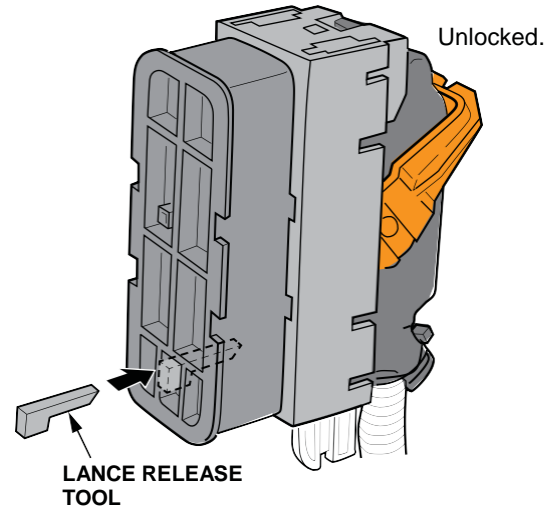
15. Make sure the lance release housing is in the unlocked position, then fully insert the lance release tool into the hole as shown.

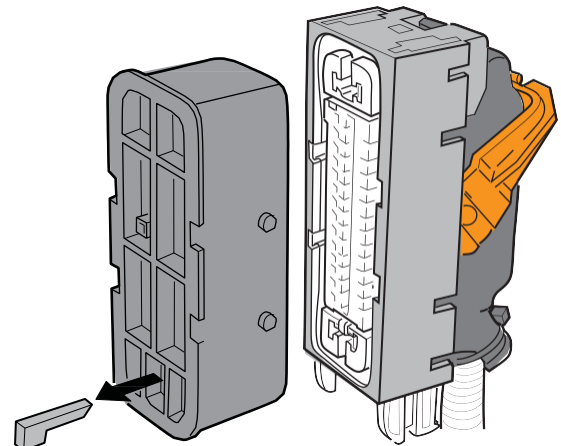
16. Remove the lance release tool, then remove the lance release housing.

NOTE: You may have to slightly squeeze the ends of the connector to remove the lance release housing.

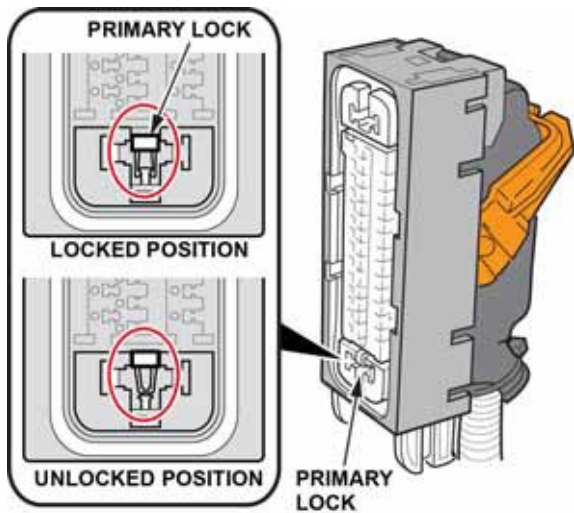
17. Inspect the primary lock to make sure it is in the locked position.

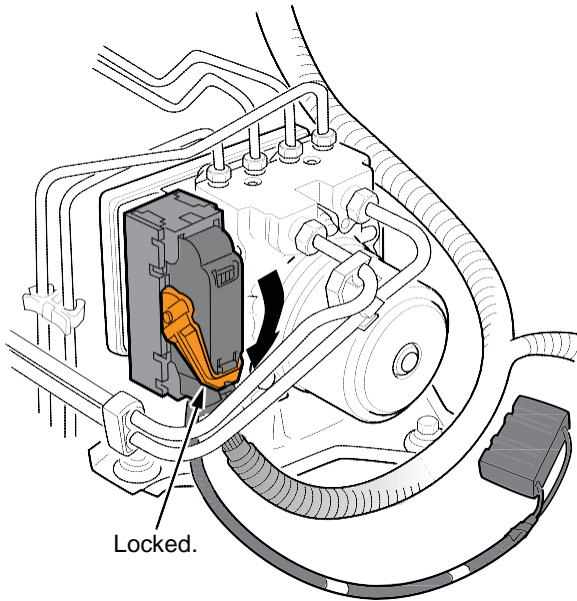
18. Reconnect the 47P connector to the VSA modulator-control unit by making sure it is properly aligned, then moving the lock to the locked position.

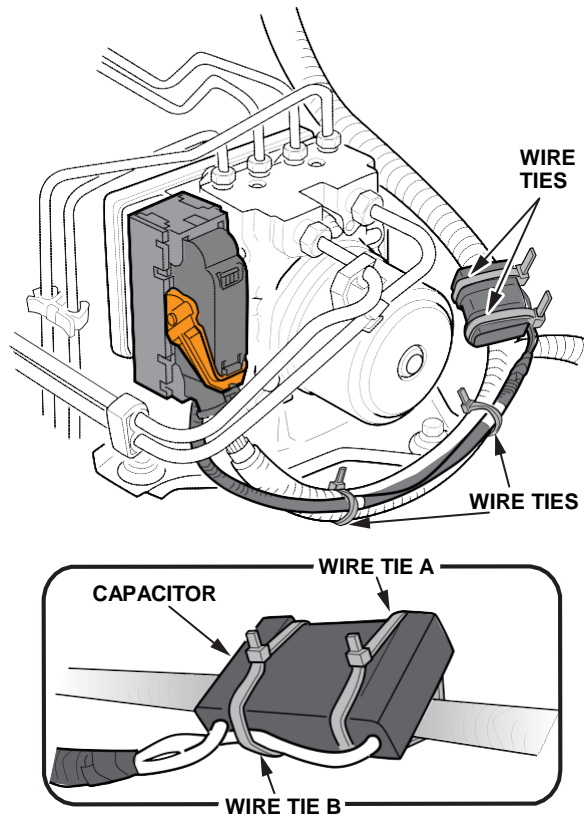
19. Route the subharness as shown. Use the two wire ties provided in the kit to secure the capacitor to the wire harness.

- Wrap wire tie A around the capacitor and the vehicle harness only. Do not wrap it around the VSA subharness.
- Wrap wire tie B around the capacitor, the vehicle harness, and the VSA subharness.

20. Secure the VSA subharness to the vehicle harness in the area of the white tape as shown, then reconnect any disconnected wire harness clips.

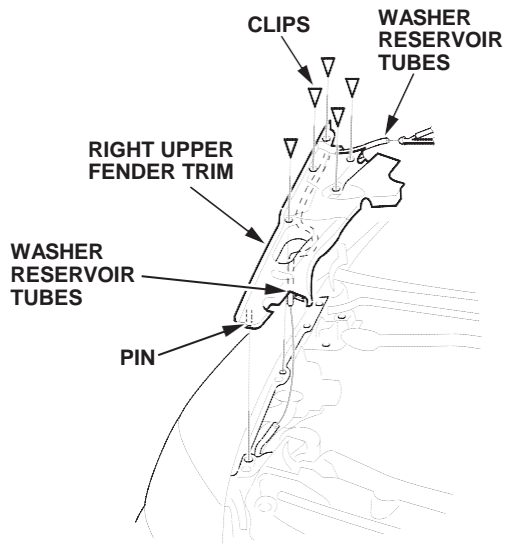
1. Turn the ignition switch to LOCK (0).
2. Remove the right upper fender trim.

3. Disconnect the windshield washer hose from its holder.

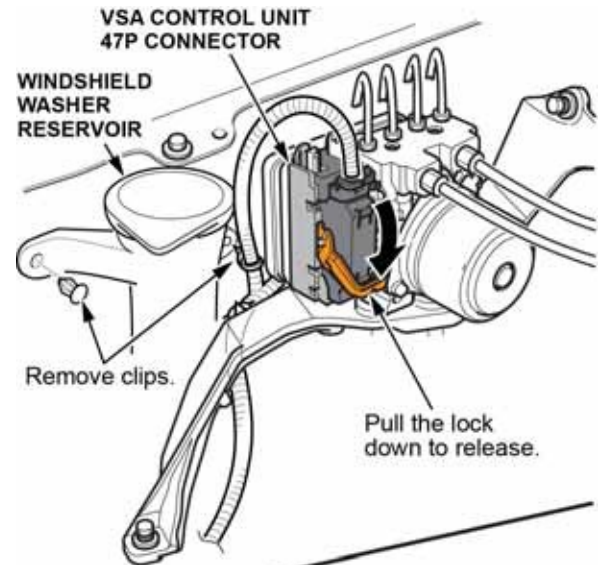
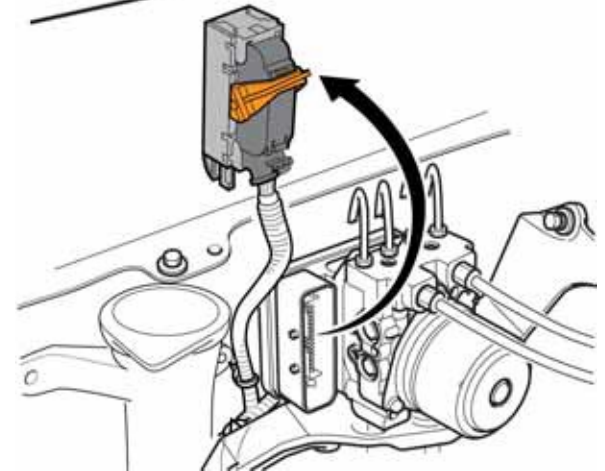
4. Disconnect the VSA modulator-control unit 47P connector.

- Do not force the lock because if you break it, the entire harness must be replaced. Make sure that you press the release tab before trying to move the lock. If needed, wiggle the connector while moving the lock to release the sliding mechanism in the connector.
- Disconnect the harness clips as needed to access the harness.

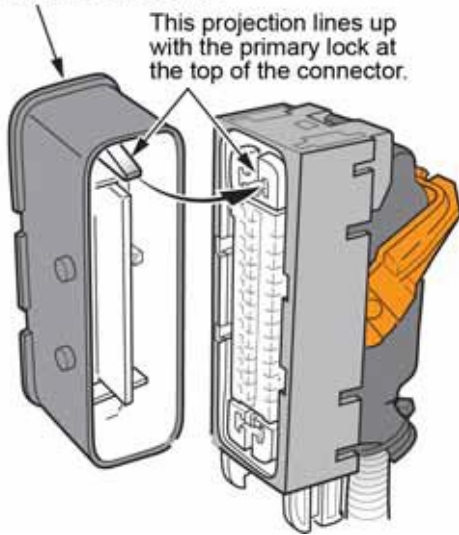
5. Insert the lance release housing into the 47P connector.

LANCE RELEASE HOUSING

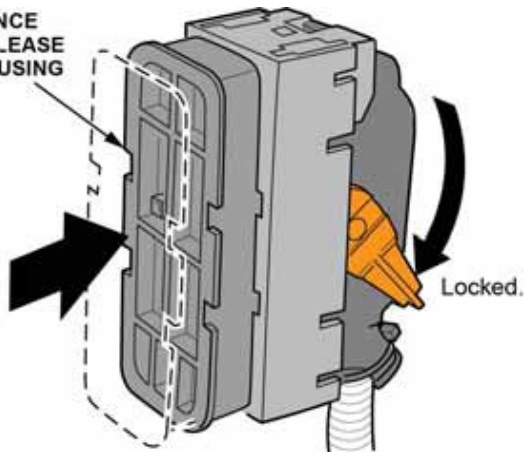
6. Move the lock to the locked position. The lance release housing is fully drawn into the connector and clicks into place.

- Do not apply excessive force.
- If the lock sticks or will not move smoothly, return the lock to its original position, recheck the position of the lance release housing, and try again.

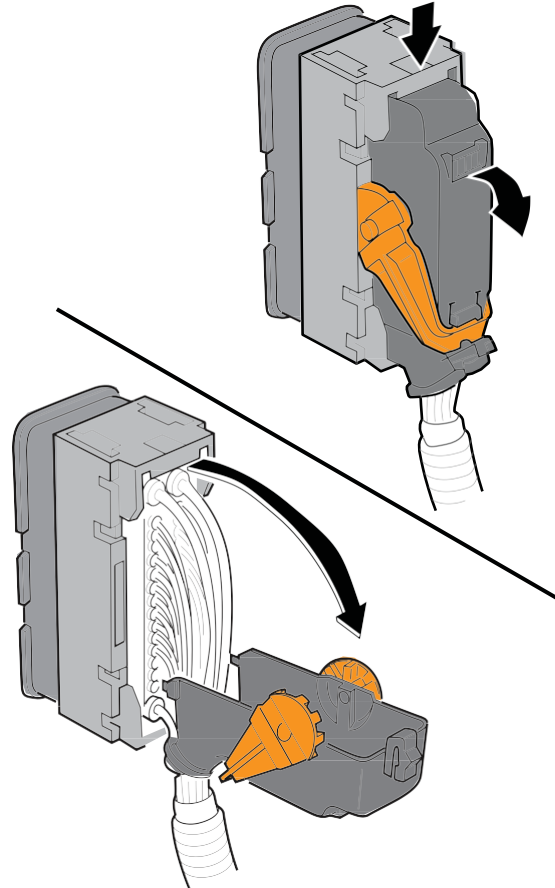
7. Use a small screwdriver to unlock and remove the lock assembly from the 47P connector.

Press to release lock assembly.

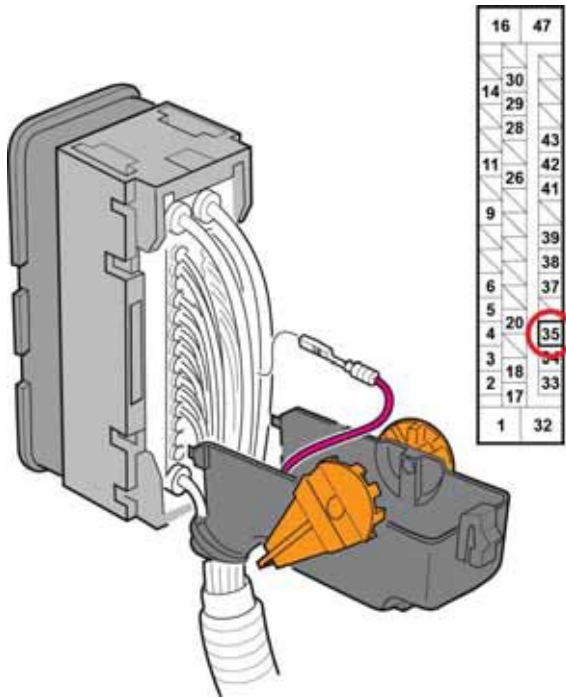
- Remove the No. 35 pink wire terminal from the connector while pushing up on the lance release housing.

NOTE: Take note of the orientation of the notch in the terminal when it comes out because you'll insert the new terminal the same way.

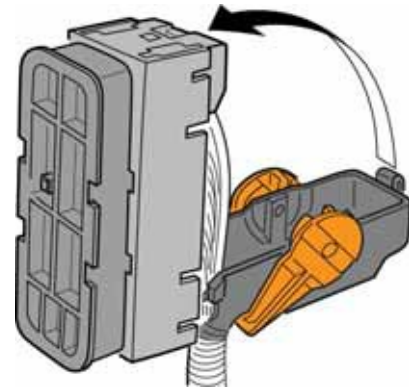
- Tuck the loose terminal and wire into the housing, then install the lock assembly onto the 47P connector as shown.

- Make sure the harness and the wire are not pinched.
- Make sure the lock is properly aligned.

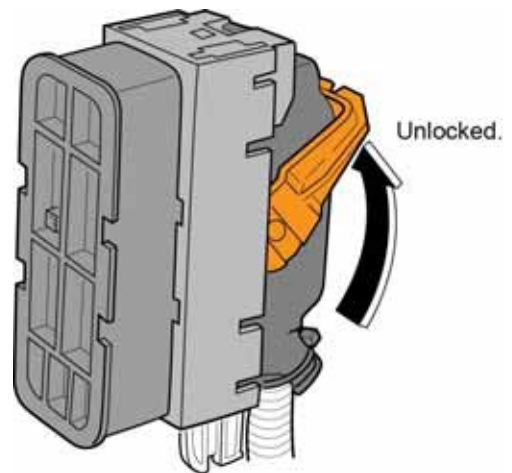
- Press the lock release tab, then move the lock to the unlocked position. The lance release housing also moves into the unlocked position.

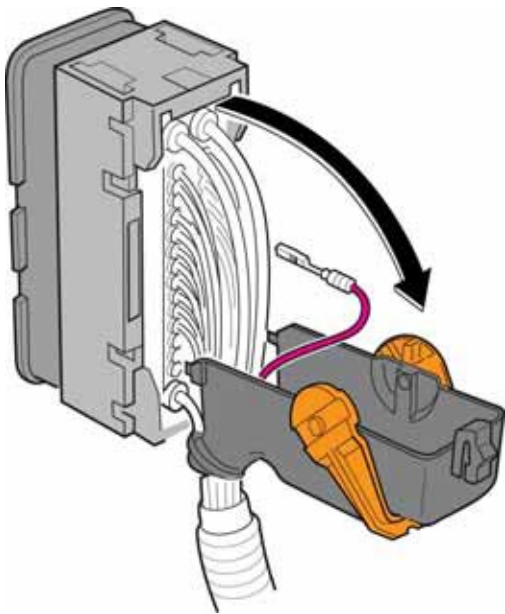
12. Using a small screwdriver, unlock and remove the lock assembly from the 47P connector.

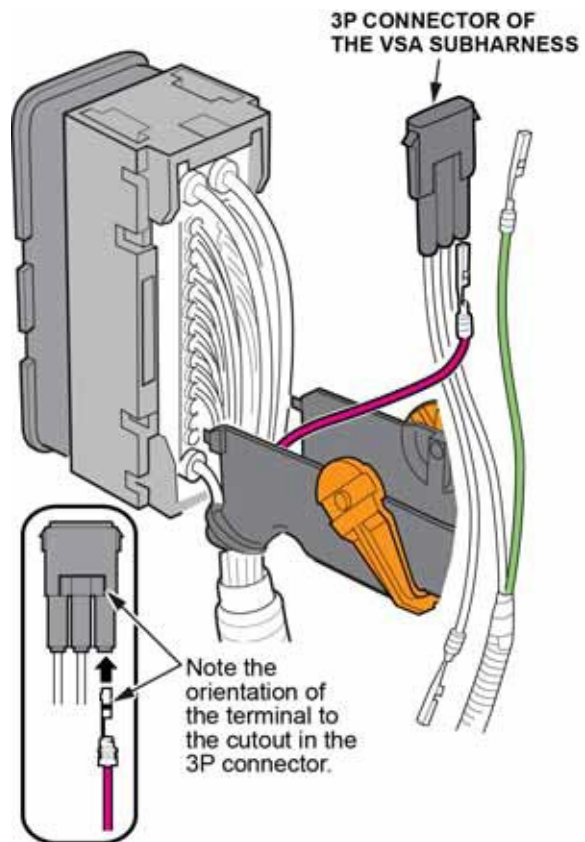
13. Install the VSA subharness.

- Make sure the terminal and connector are properly oriented; the notched part of the terminal should be aligned as shown.

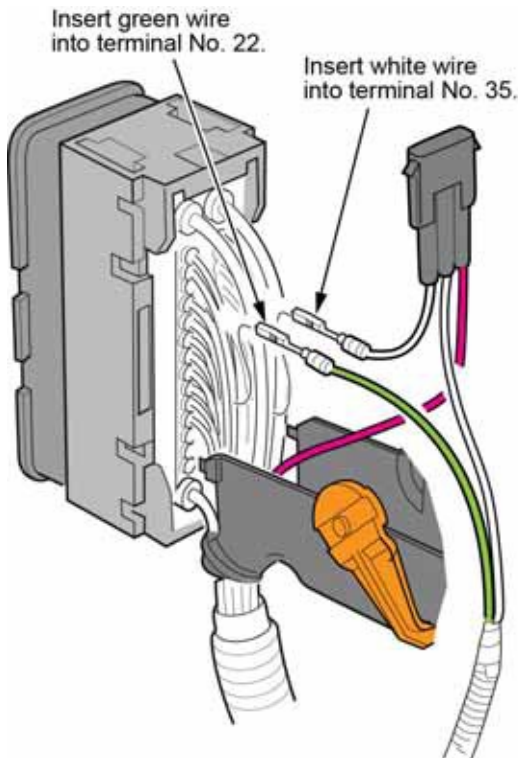
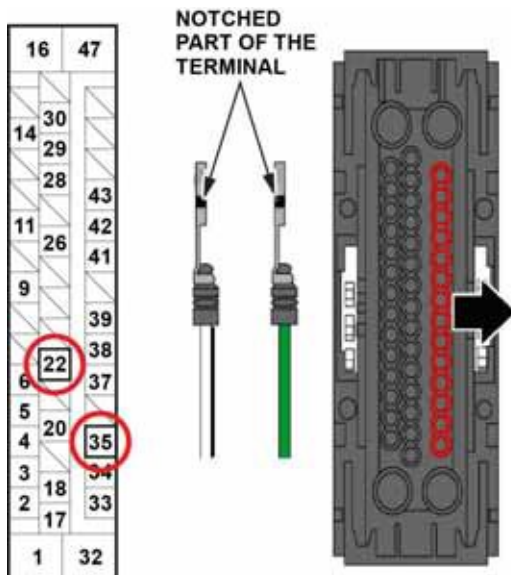
- Do not force the terminal into the connector to avoid damaging the terminals.
- You may hear a click when the terminal is seated in the 3P connector.
- After inserting the terminal into the 3P connector, gently pull on the wire to make sure it is locked into place.

- Insert the pink wire terminal that was removed from cavity No. 35 into the 3P connector of the VSA subharness.
- Insert the VSA harness white wire into the VSA control unit 47P connector terminal No. 35.
- Insert the VSA harness green wire into the VSA control unit 47P connector terminal No. 22.

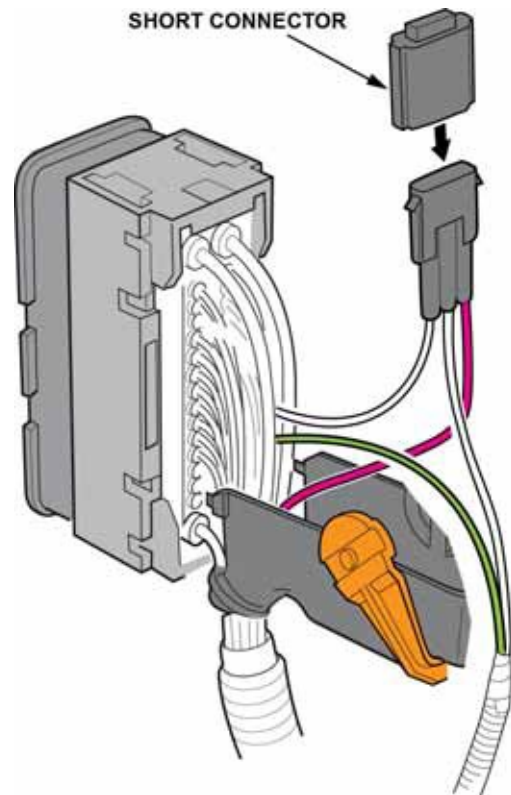
14. Install the short connector to the 3P connector.
 - > 3P Short Connector

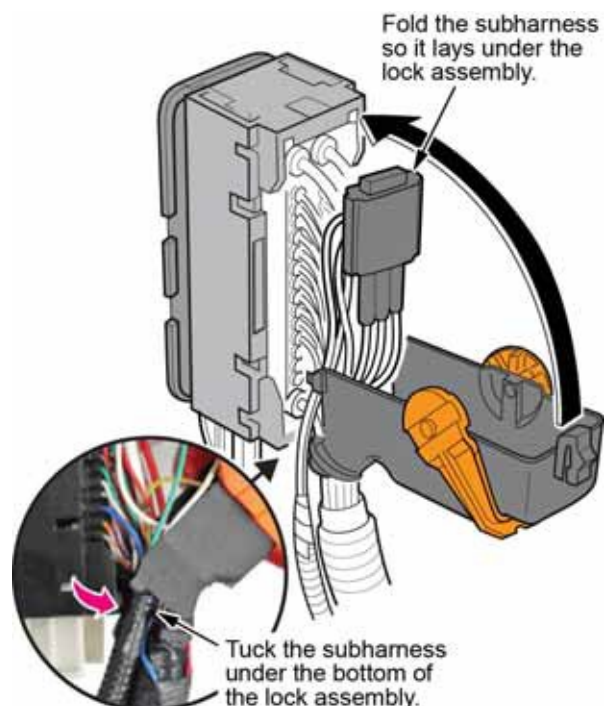
15. Lay out the subharness as shown, then install the lock assembly.

- Make sure the subharness is not pinched.
- Make sure the lock is properly aligned.

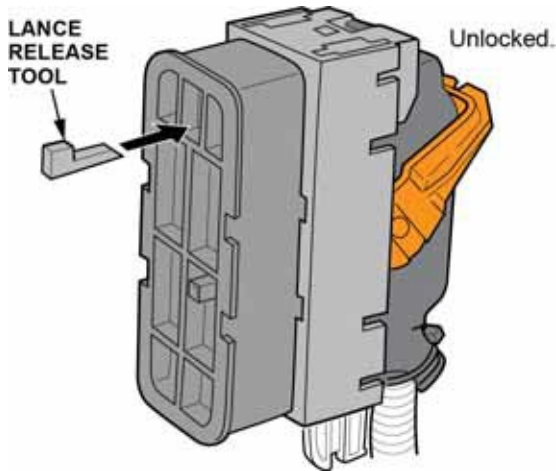
16. Make sure the lance release housing is in the unlocked position, then fully insert the lance release tool into the hole as shown.

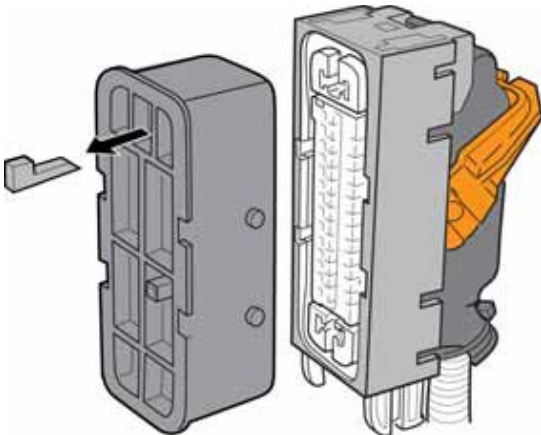
17. Remove the lance release tool, then remove the lance release housing.
NOTE: You may have to slightly squeeze the ends of the connector to remove the lance release housing.

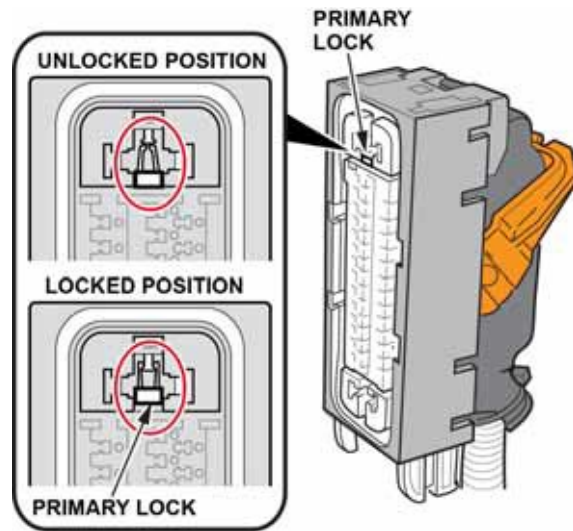
18. Inspect the primary lock to make sure it is in the locked position.

19. Reconnect the 47P connector to the VSA modulator-control unit by making sure it is properly aligned, then moving the lock to the locked position.

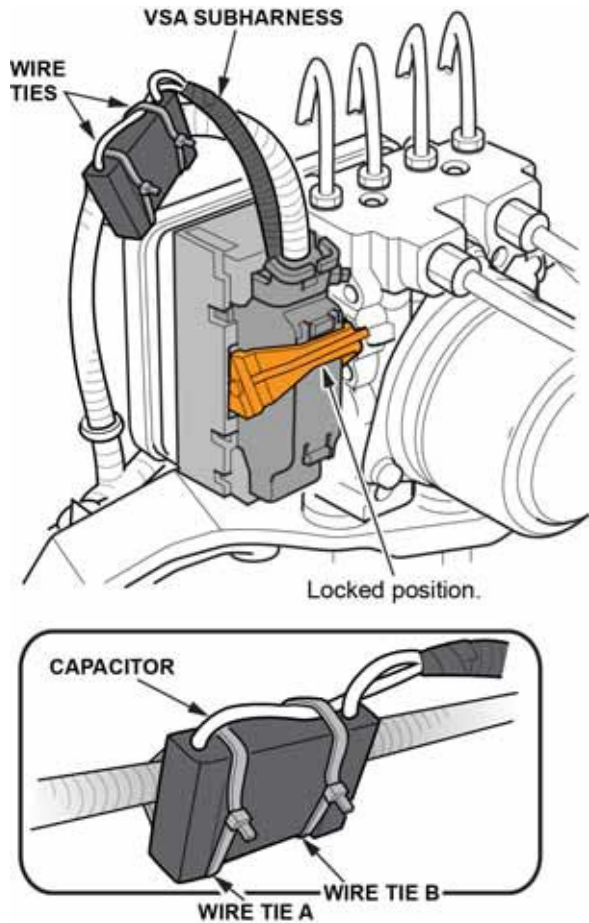
20. Route the subharness as shown. Use the two wire ties provided in the kit to secure the capacitor to the wire harness.

- Wrap wire tie A around the capacitor and the vehicle harness only. Do not wrap it around the VSA subharness.
- Wrap wire tie B around the capacitor, the vehicle harness, and the VSA subharness.
