SAFETY RECALL BULLETIN

SUBJECT:			No: SR-13-005
2013 OUTLANDER SPORT/RVR AWD FUEL GAUGE – SAFETY RECALL CAMPAIGN			DATE: April, 2013
			MODEL: 2013 Outlander Sport/ RVR
CIRCULATE TO:	<input type="checkbox"/> GENERAL MANAGER	<input type="checkbox"/> PARTS MANAGER	<input type="checkbox"/> TECHNICIAN
<input checked="" type="checkbox"/> SERVICE ADVISOR	<input checked="" type="checkbox"/> SERVICE MANAGER	<input checked="" type="checkbox"/> WARRANTY PROCESSOR	<input checked="" type="checkbox"/> SALES MANAGER

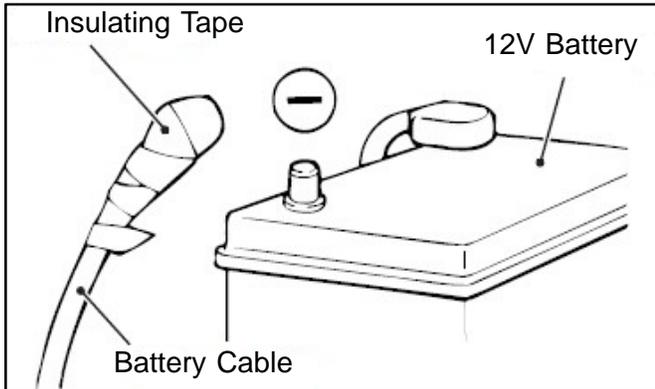
1. With the vehicle parked, set the parking brake and open the hood. Disconnect the negative (-) terminal of the battery and insulate it with electrical tape. Wait at least 60 seconds before proceeding.

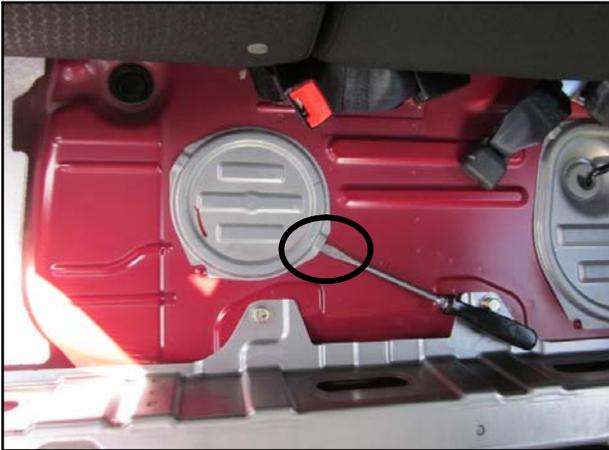
2. Remove the rear seat cushion.
3. Remove the access cover. You must use a flat head screwdriver and carefully pry it off.

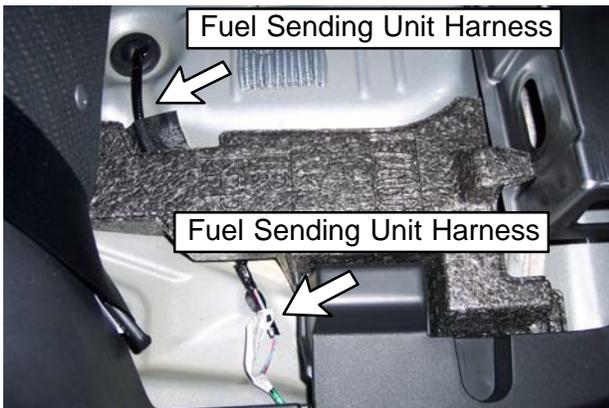
4. On the right hand side of the rear seat area, check for the presence of the fuel sending unit harness. If present, continue to step 5. **If absent, proceed to the Replacement Procedure section.**

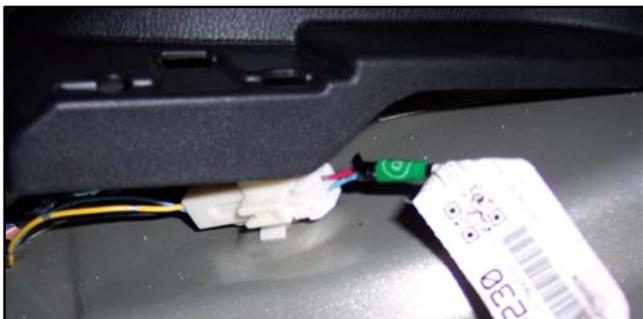
5. Ensure that the fuel sending unit harness is properly connected to the body harness connection located near the right scuff plate. If not connected, connect it.

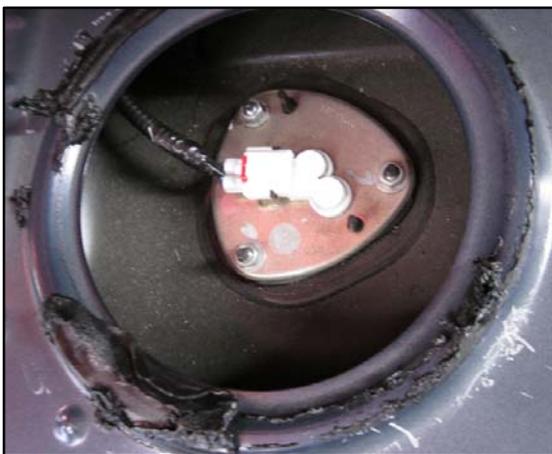
6. Ensure that the fuel sending unit harness is properly connected to the sub-sending unit. If not connected, connect it.

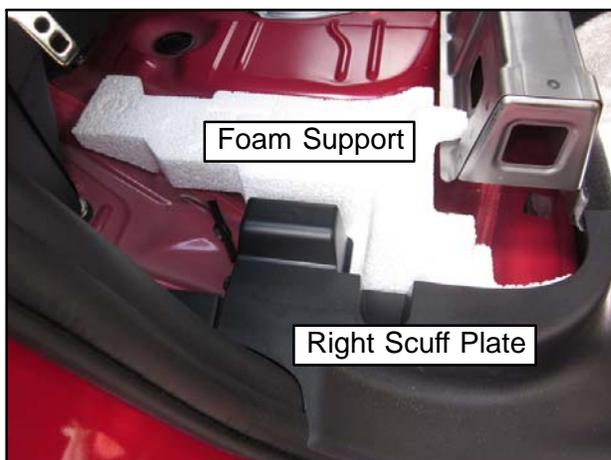
1. Carefully remove the right scuff plate and foam support.

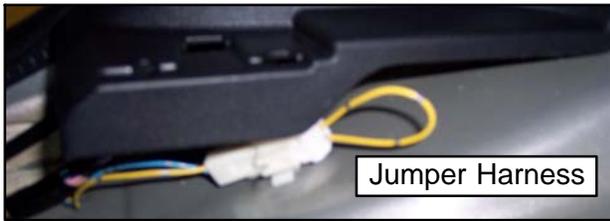
2. Verify if the jumper harness is connected to the body harness connector located near the right scuff plate. If connected, remove it.

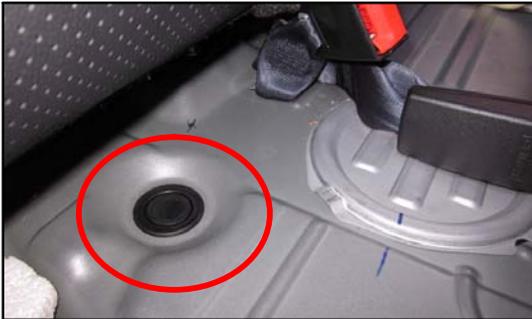
3. Remove the body plug where the fuel sending unit harness is to be installed.

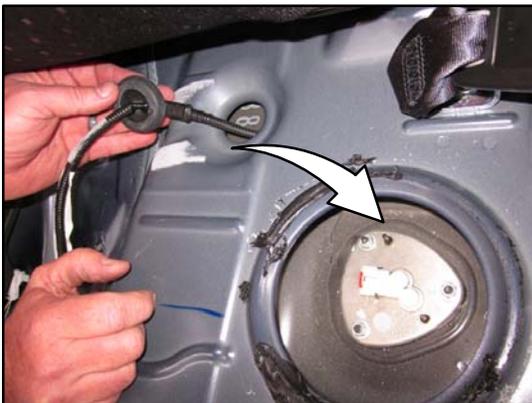
4. Install the fuel sending unit harness.
 - a. Place the connector through the hole and direct it to the sub-sending unit.

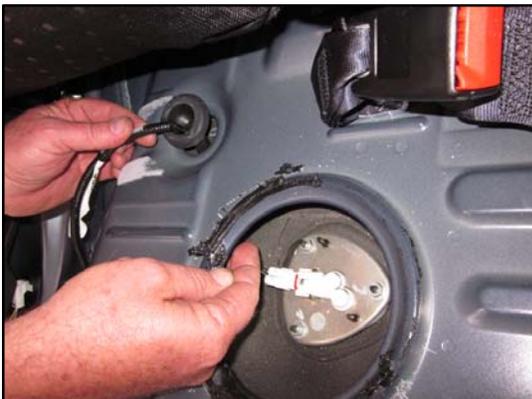
- b. With your right hand, reach under the vehicle floor through the access cover opening and pull the fuel sending unit harness through it.

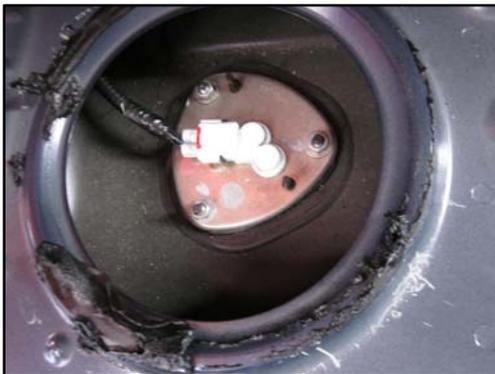
- c. Connect the fuel sending unit harness to the sub-sending unit.

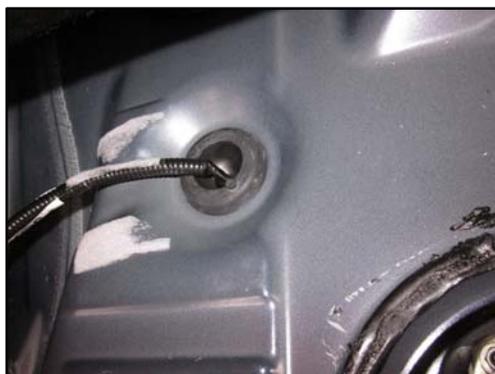
- d. Firmly seat the grommet in the hole.

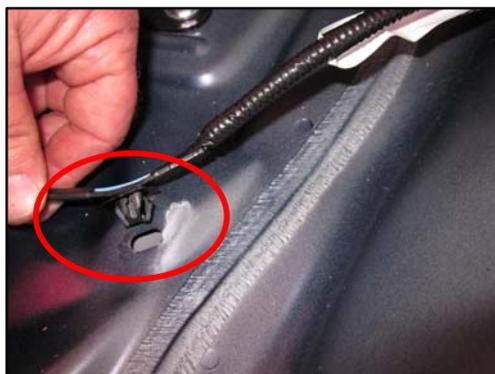
- e. Locate the wire harness clip and clip it to the floor.

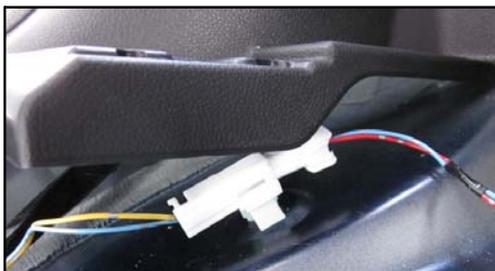
- f. Connect the other end of the fuel sending unit harness to the body harness connector near the right scuff plate.

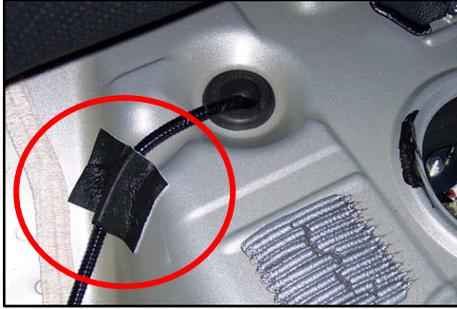
- g. Use vinyl tape to secure the wiring harness to the floor.

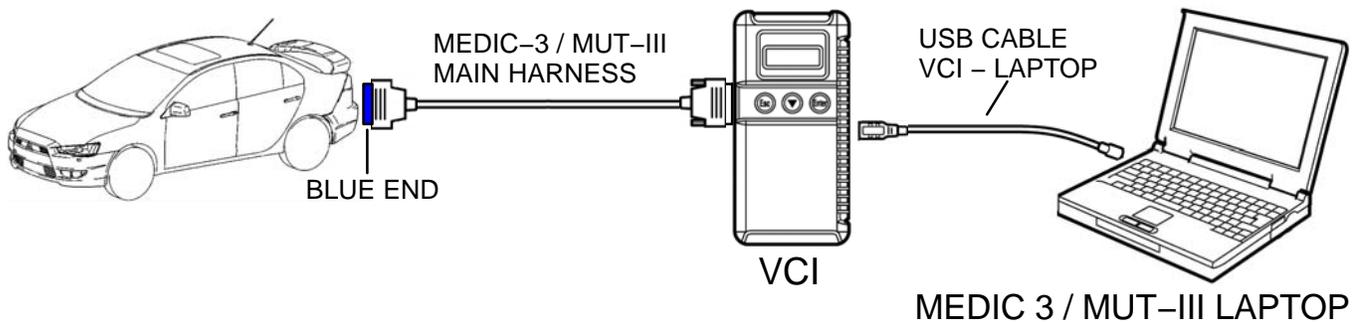
1. Connect the equipment as follows:
- Turn the laptop computer on.
 - Connect the USB cable to the VCI.
 - When the laptop displays the MUT-III main screen, connect the USB cable to the laptop.
 - Connect the MUT-III main harness with the blue DLC connection to the VCI.
 - Connect the blue connector of the MUT-III main harness to the vehicle's data link connector.

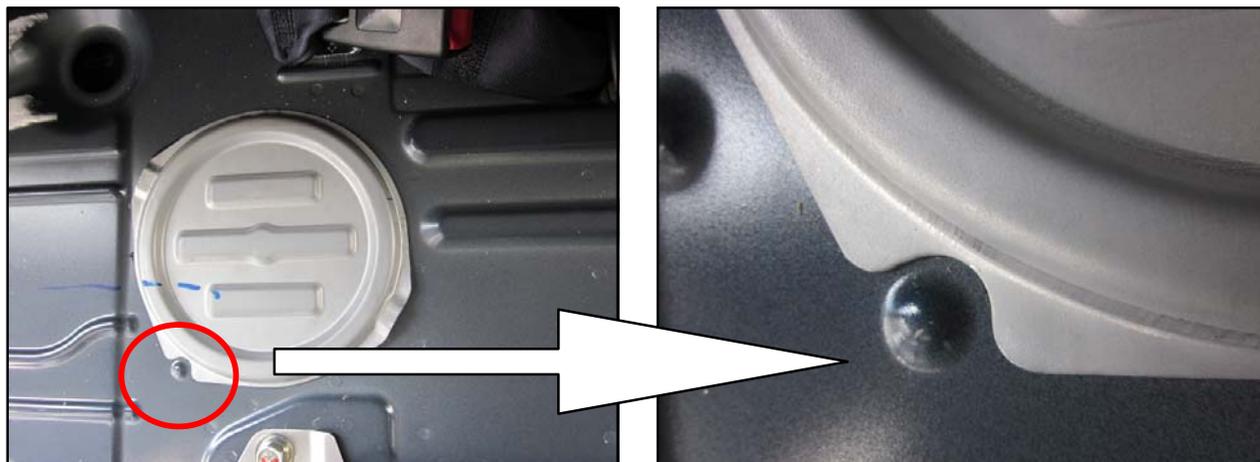
1. Reinstall the access cover. If the old adhesive is not re-usable, you must apply new adhesive to properly seal the vehicle interior. Use 3M Window-weld™ Ribbon Sealer – Auto Glass Replacement Kit Part No. 05113508610 or equivalent. Once the adhesive is properly set, line the groove of the access cover to the dimple on the vehicle floor and firmly reinstall the access cover.
