**HYUNDAI**NEW THINKING.
NEW POSSIBILITIES.**Technical Service Bulletin**

13-01-021

See Below**SUBJECT: STOP LAMP SWITCH REPLACEMENT (RECALL 110)***** IMPORTANT******* Dealer Stock and Retail Vehicles *****

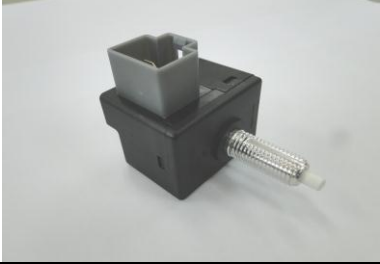
Model	Specification	Replacement Part		
		Part No.	Figure	Connector Color
Elantra Sedan (HD)	With Cruise Control	93810-4DR0AQQH

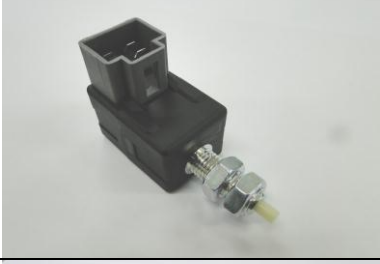
Gray
	Without Cruise Control (Automatic Transmission)	93810-3KR0AQQH

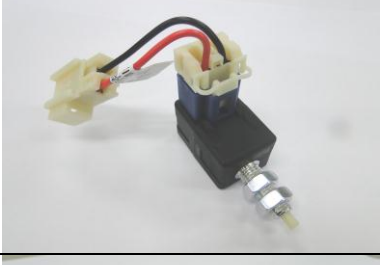
Gray
	Without Cruise Control (Manual Transmission)	93810-26R0BQQH

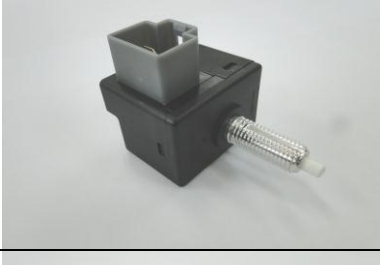
Blue (with adapter harness)
Accent (MC)	With Cruise Control	93810-4DR0AQQH

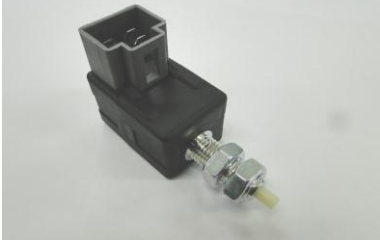
Gray
	Without Cruise Control	93810-3KR0AQQH
