HYUNDAI NEW THINKING. NEW POSSIBILITIES. Technical Service Bulletin	GROUP RECALL	NUMBER 17-01-021
	DATE MARCH 2017	MODEL(S) See Below
SUBJECT: STOP LAMP SWITCH REPLACEMENT (RECALL 110)

Description: This bulletin describes the procedure to replace the stop lamp switch.

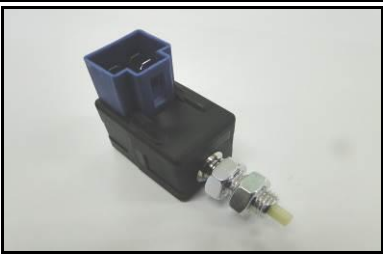
Santa Fe (CMA)	2.4L 4-cylinder & 2.7L V6	Production Date Apr. 1, 2007 to Apr. 30, 2009	93810-3KR0BQQH

Blue
	3.3L V6 & 3.5L V6	Production Date May 1, 2009 to July 31, 2011	93810-4DR0AQQH

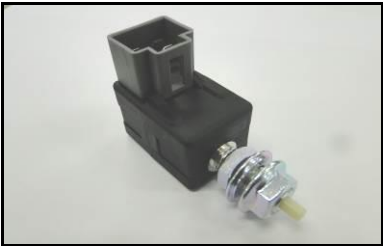
Gray
Sonata (YFA)	2011 Model Year ONLY		93810-3SR0AQQH

Gray (Flange nut type)
Tiburon (GK)	With Cruise Control, With or Without ESC	93810-4DR0AQQH

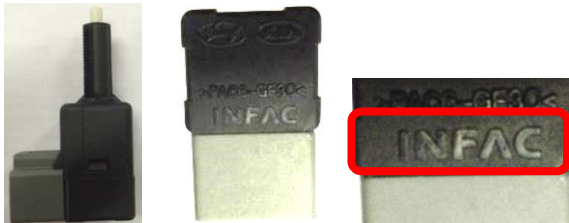
PICTURE	EXPLANATION

For vehicles under this recall, never install the previous version of the stop lamp switch. Refer to the picture in the table below.

The previous version is molded with “INFAC”.

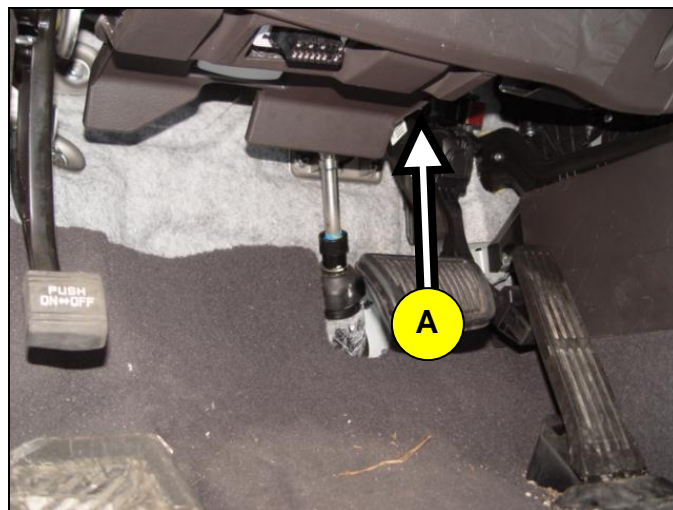
Locate the stop lamp switch (A) above the brake pedal assembly.

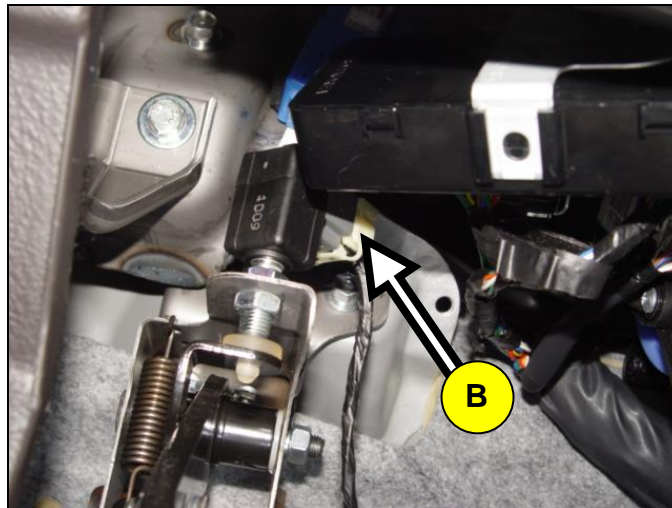
1. Disconnect the stop lamp switch connector (B).

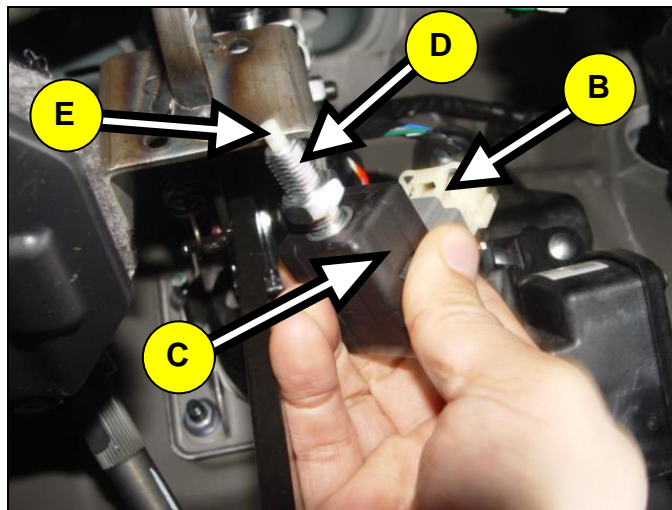
2. Connect the new stop lamp switch (C) with the connector (B).
3. Ground the threaded part (D) of the new stop lamp switch to a near chassis ground and confirm that the stop lamp switch operates normally by depressing and releasing the plunger (E).

Depressing the plunger, the brake lights will turn off. Releasing the plunger, the brake lights will turn on.

It might be necessary to clean the chassis ground to ensure that the threaded part of the new stop lamp switch is grounded properly.

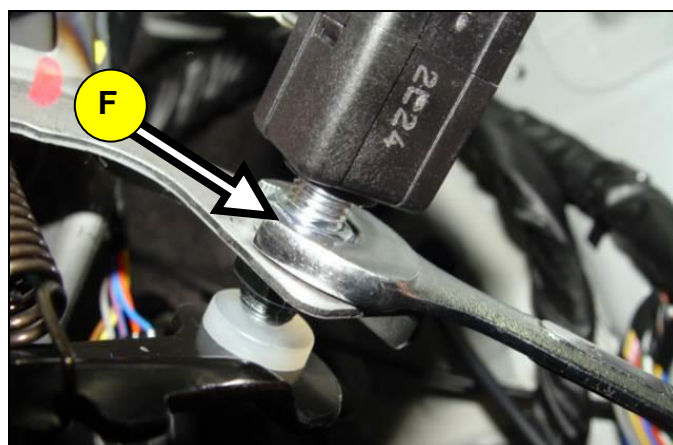
4. Loosen the upper mounting nut (F) of the current stop lamp switch.

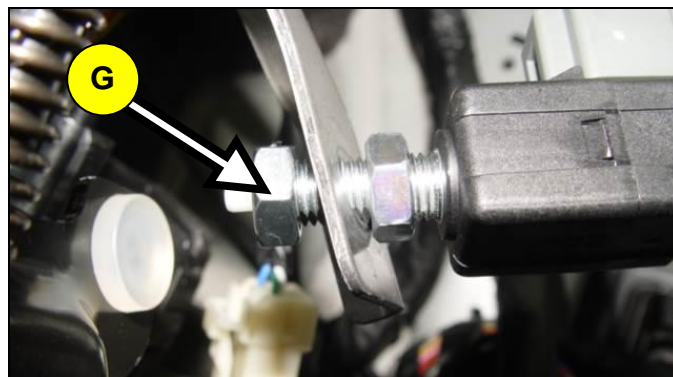
5. Remove the lower mounting nut (G) of the current stop lamp switch.

Apply 5.8 ~ 7.2 lb-ft (0.8 ~ 1.0 kgf.m, 7.8 ~ 9.8 Nm) torque to the lower mounting nut.

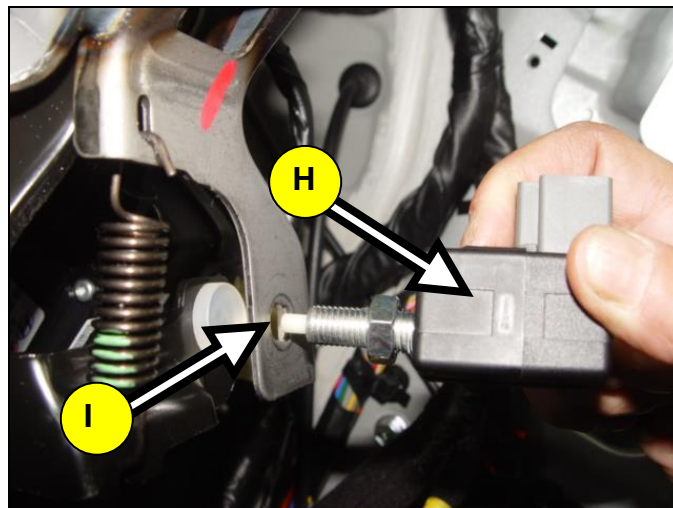
6. Remove the stop lamp switch assembly (H), and install the new stop lamp switch in reverse order of removal.

It might be necessary to clean the area of the bracket around the opening (I) to ensure that the threaded part and mounting nuts of the new stop lamp switch are grounded properly.

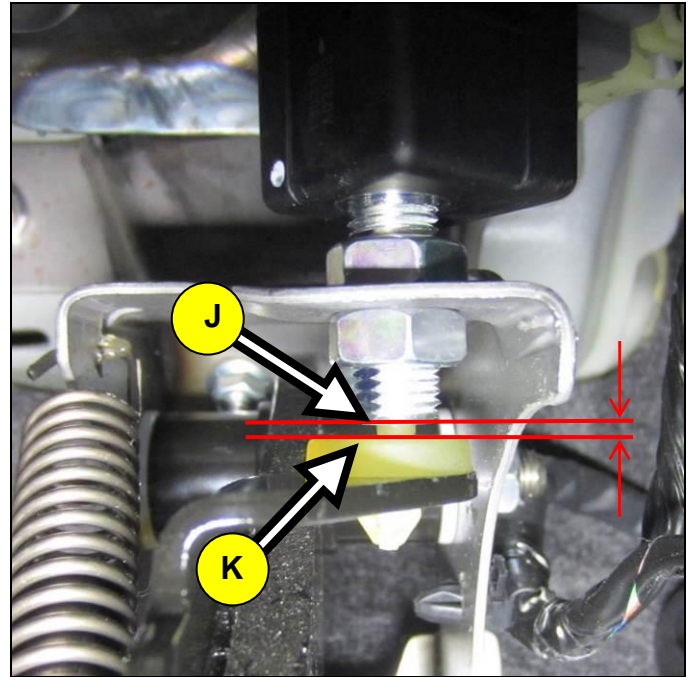
7. Without the brake pedal applied, adjust the gap between the end of the metal threaded housing of the stop lamp switch (J) and the stop lamp switch stopper (K).

Gap Specification:

1.0 ~ 2.0 mm (0.04 ~ 0.08 in)

8. Tighten the upper and lower mounting nuts.

Lower mounting nut torque specification:

5.8 ~ 7.2 lb-ft (0.8 ~ 1.0 kgf.m, 7.8 ~ 9.8 Nm)

9. Recheck the gap as described in step 7.
10. Verify that the rear brake lamps operate normally when applying the brake pedal.

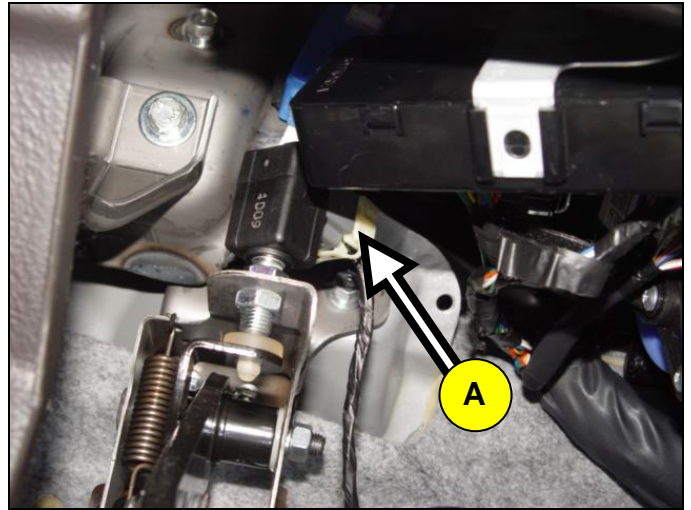
1. Disconnect the stop lamp switch connector (A).

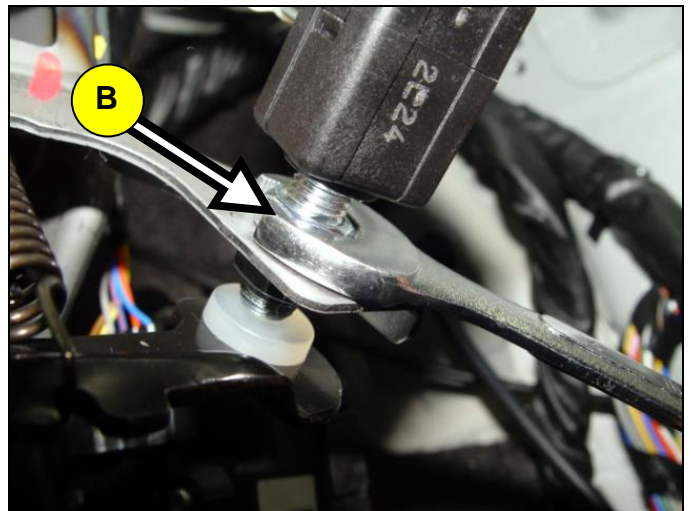
2. Loosen the upper mounting nut (B).

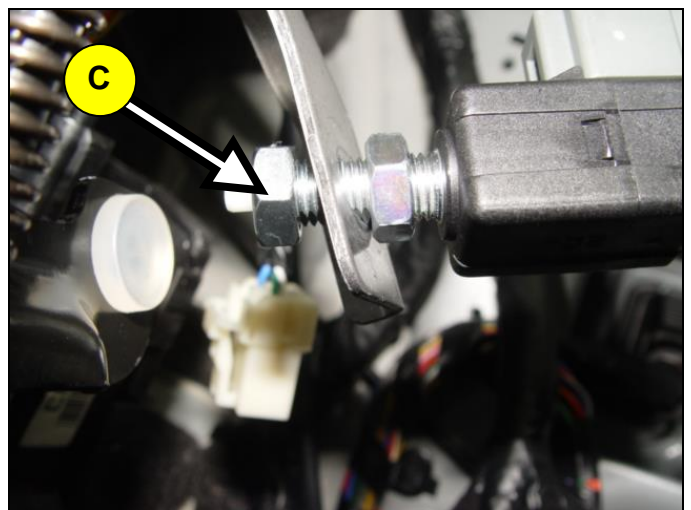
3. Remove the lower mounting nut (C).

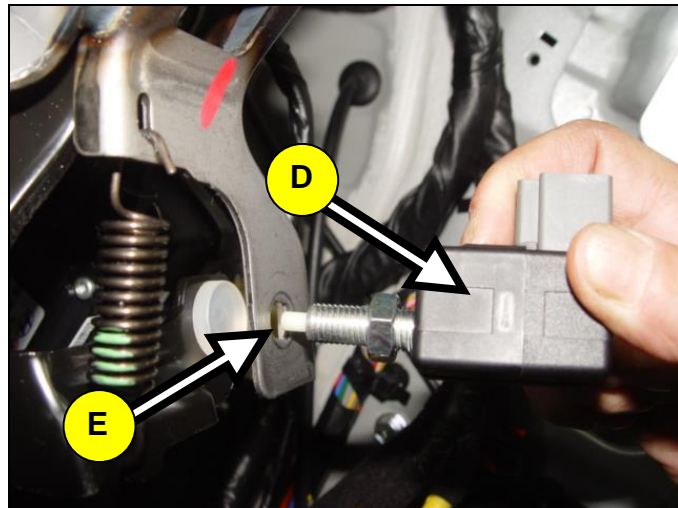
4. Remove the stop lamp switch assembly (D), and install the replacement stop lamp switch in reverse order of removal.

It might be necessary to clean the area of the bracket around the opening (E) to ensure that the threaded part and mounting nuts of the new stop lamp switch are grounded properly.

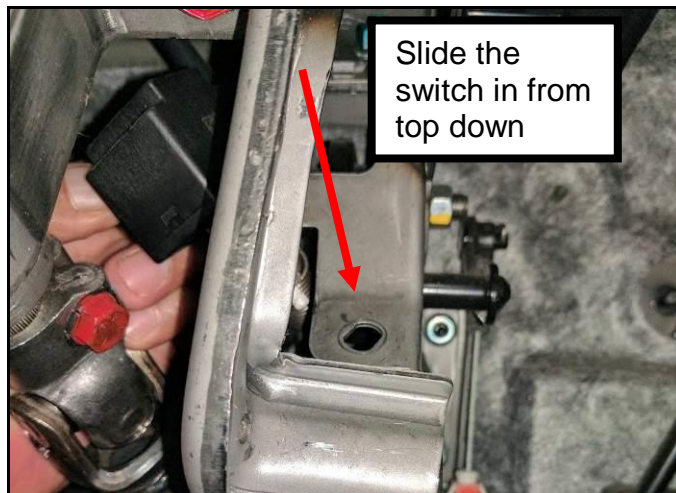
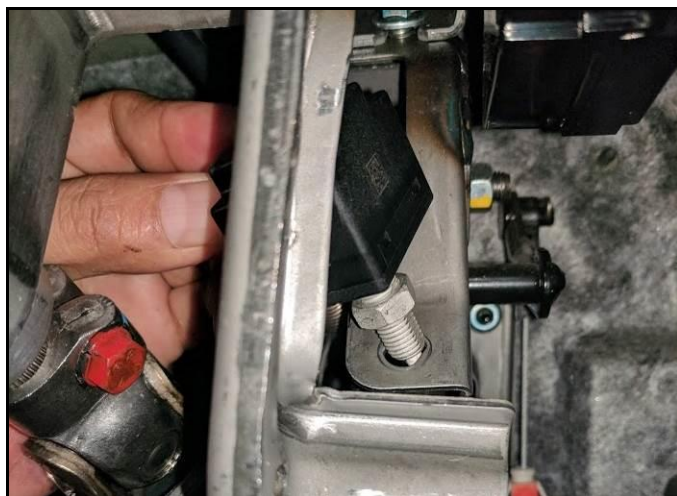
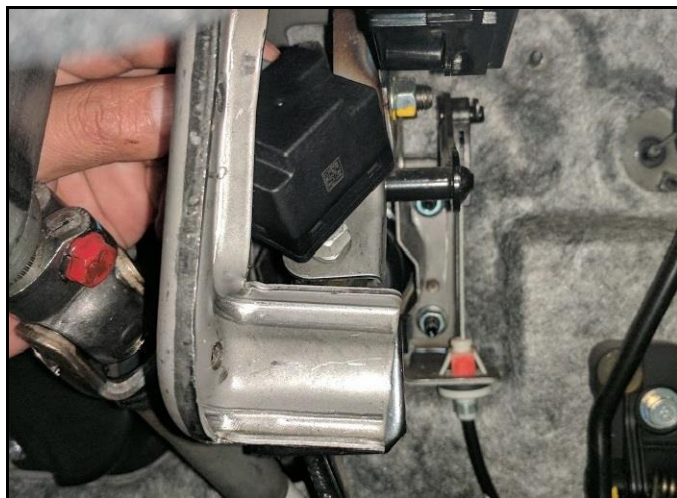
Accent (MC) - Part number 93810-3KR0AQQH has been superseded with 93810-4DR0AQQH. The part is physically larger however; fitment and operation should not be an issue. See below on this page for installation tips.

For **non** cruise control equipped vehicles, it is slightly difficult to install the superseded switch due to space limitation.

1. Grab the stop lamp switch by the connector side with the switch facing downward and place hand behind the steering column.
2. Slide the switch from top to downward and place the switch into the mounting bracket port.

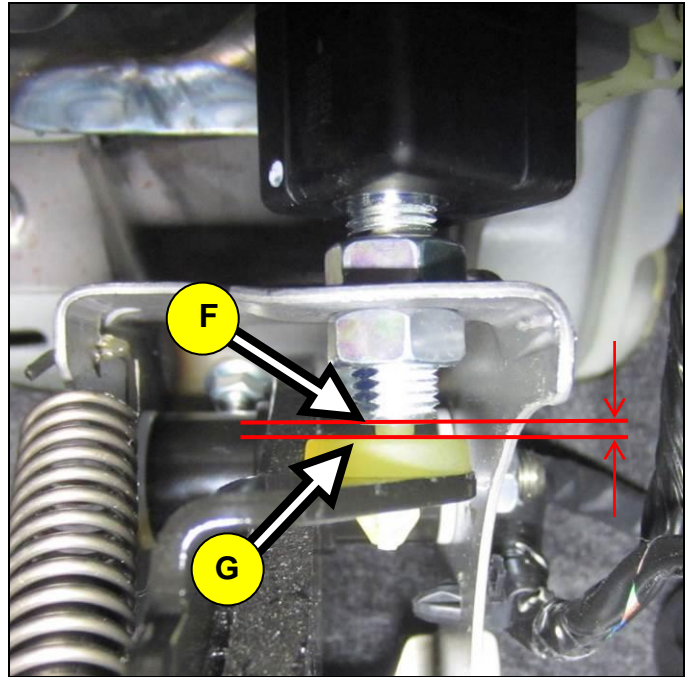
5. Without the brake pedal applied, adjust the gap between the end of the metal threaded housing of the stop lamp switch (F) and the stop lamp switch stopper (G).

Gap Specification:

1.0 ~ 2.0 mm (0.04 ~ 0.08 in)

6. Tighten the upper and lower mounting nuts.

Lower mounting nut torque specification:

5.8 ~ 7.2 lb-ft (0.8 ~ 1.0 kgf.m, 7.8 ~ 9.8 Nm)

7. Recheck the gap as described in step 5.
8. Verify that the rear brake lamps operate normally when applying the brake pedal.

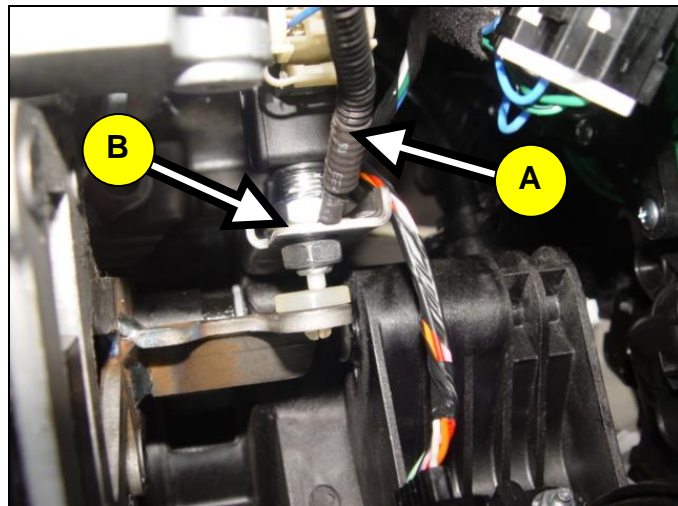
Installation of ground wire for Veracruz (EN) with adjustable pedals

1. Connect one end of the ground wire (A) to the bottom of the upper mounting nut (B).

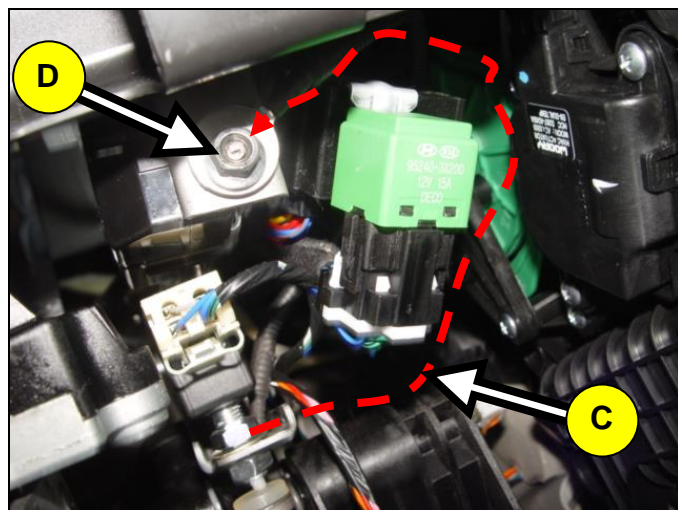
2. Route the ground wire (C) as shown.

Make sure that the ground wire does not interfere with the brake and accelerator pedals.

3. Remove the nut (D) on the bracket located above the stop lamp switch and then connect the other end of the ground wire.

3.6 ~ 4.3 lb-ft (0.5 ~ 0.6 kgf.m, 4.9 ~ 5.9 Nm)

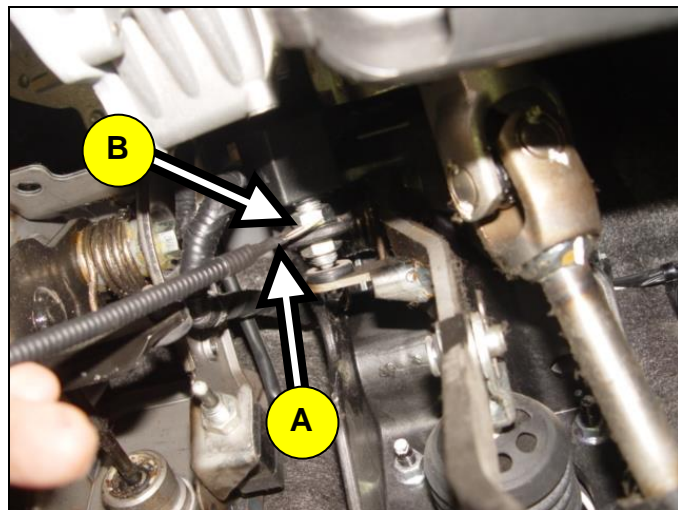
Installation of ground wire for Elantra Touring (FD)

1. Connect one end of the ground wire (A) to the bottom of the upper mounting nut (B).

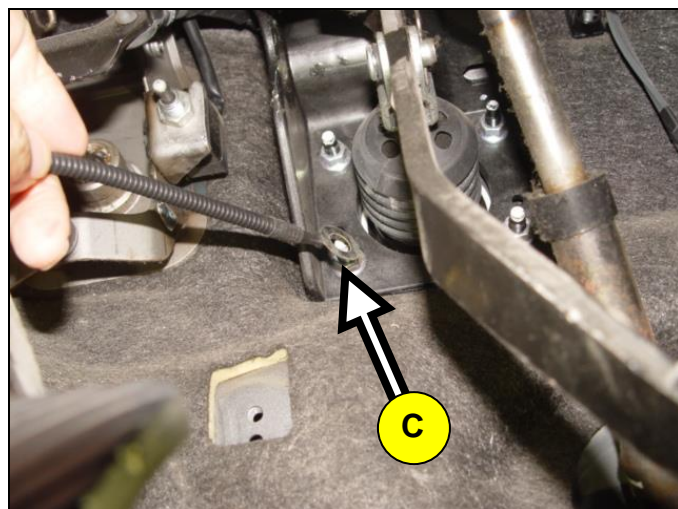
2. Remove the nut (C) located at the brake pedal mounting bracket and then connect the other end of the ground wire.

3.6 ~ 4.3 lb-ft (0.5 ~ 0.6 kgf.m, 4.9 ~ 5.9 Nm)

Make sure that the ground wire does not interfere with the brake and accelerator pedals.

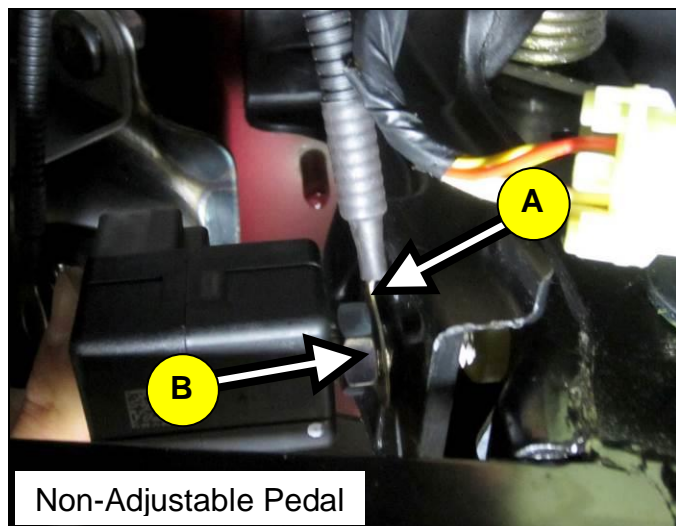
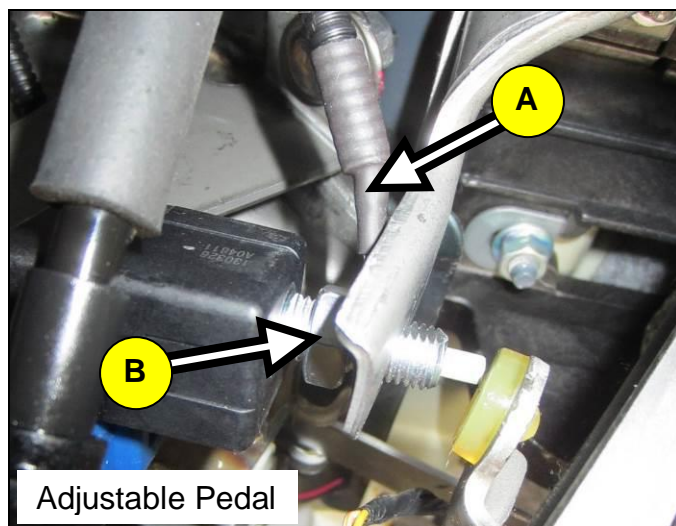
Installation of ground wire for Entourage (EP)

1. Connect one end of the ground wire (A) to the bottom of the upper mounting nut (B).

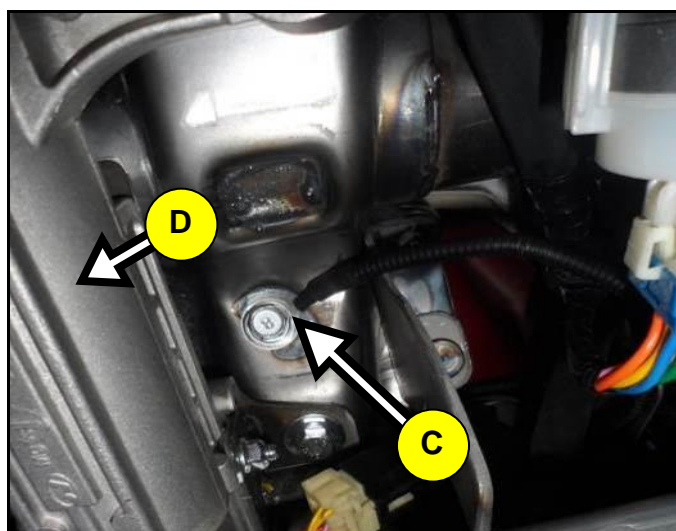
2. Remove the bolt (C) on the cowl cross bar near the steering column assembly (D) and connect the other end of the ground wire.

3.6 ~ 4.3 lb-ft (0.5 ~ 0.6 kgf.m, 4.9 ~ 5.9 Nm)

Make sure that the ground wire does not interfere with the brake and accelerator pedals.

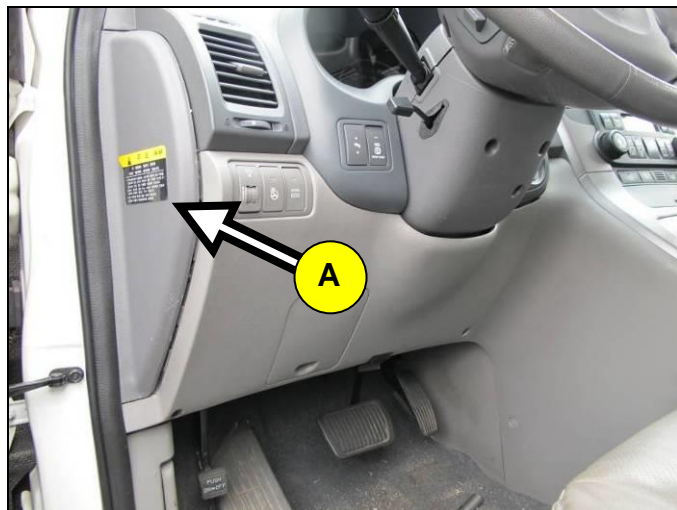
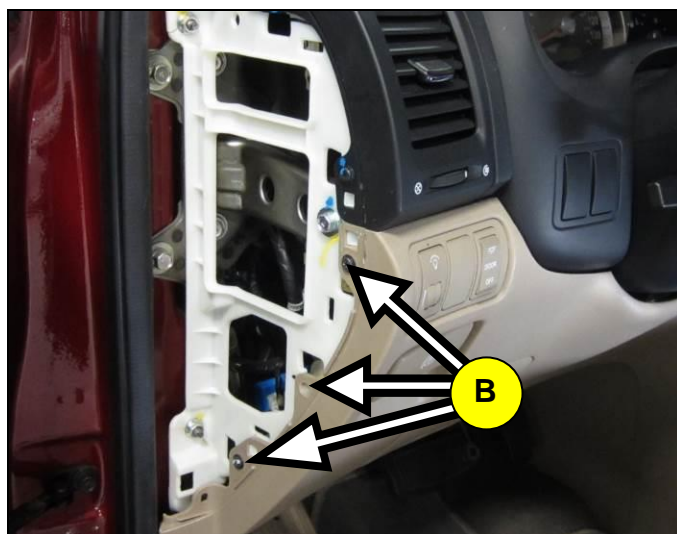
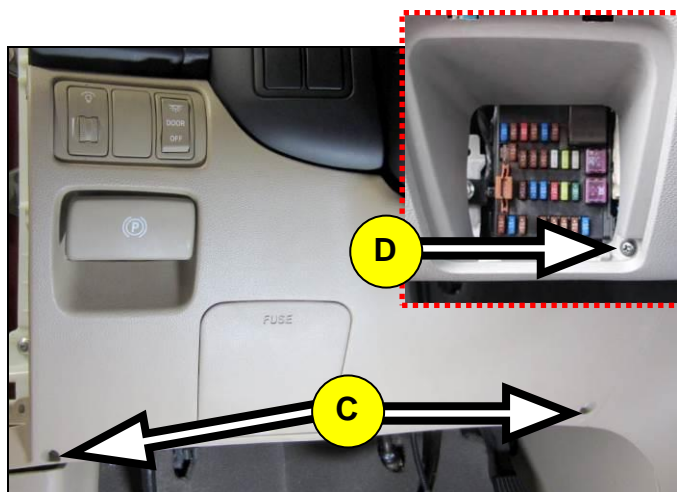
1. Disconnect the battery negative (-) terminal.
2. Remove the left hand side cover (A).

3. Remove three screws (B) from the side of the lower panel and two bolts (C). Uncover the fuse panel and remove the screw (D).

1.4 ~ 2.2 lb-ft (0.2 ~ 0.3 kgf.m, 2.0 ~ 2.9 Nm)

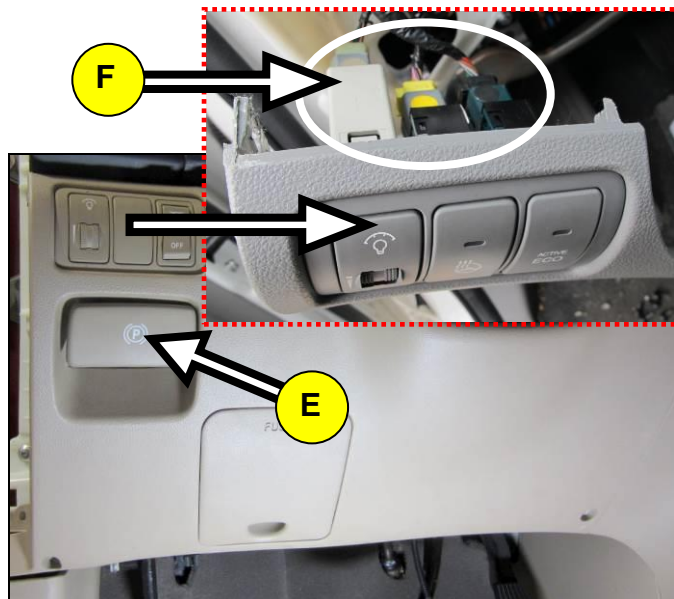
4. Carefully remove the lower panel. Slide the parking brake handle (E) off of the panel and then disconnect the switches (F). Set aside the lower panel.

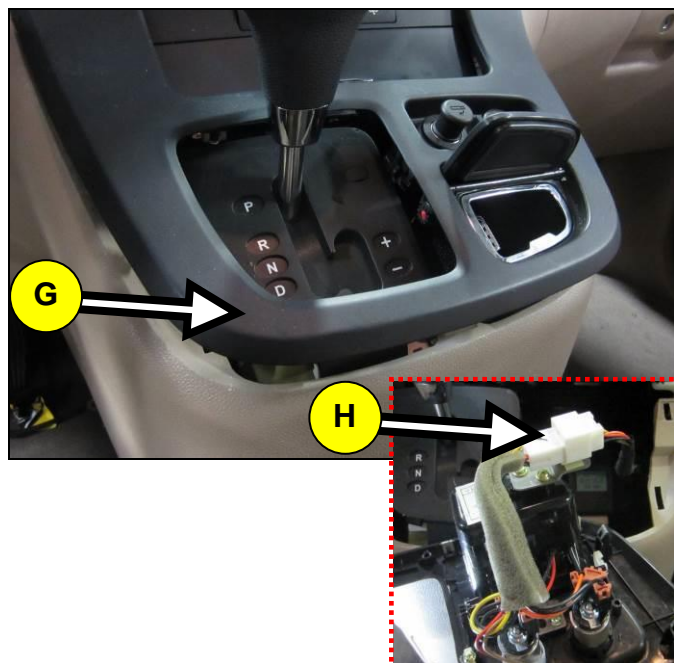
5. Using a plastic trim tool, carefully pry up and remove the upper cover (G) surrounding the shift lever. Disconnect the cigarette lighter and power outlet (H). Set aside the cover.

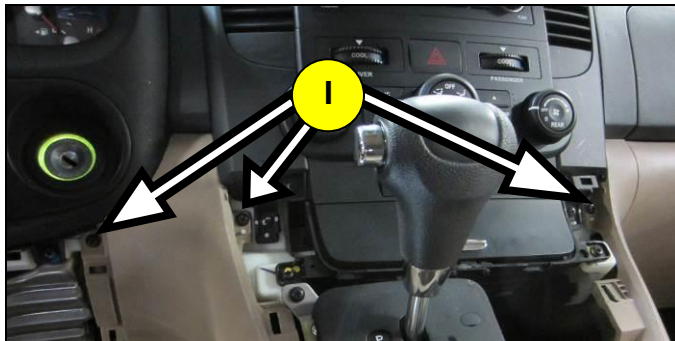
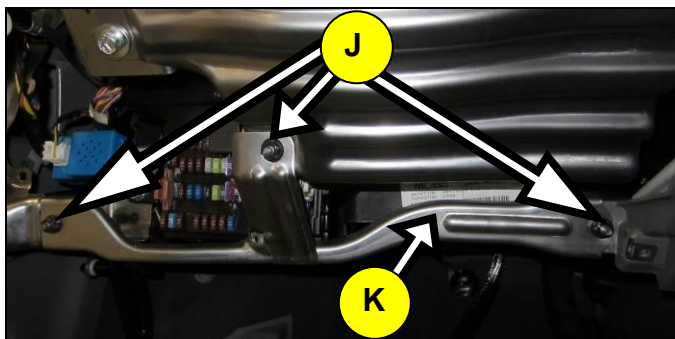
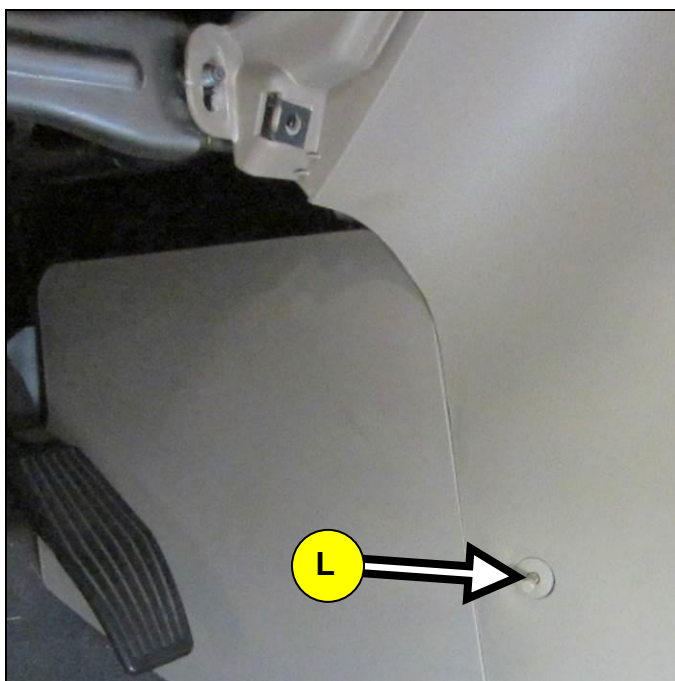
6. Remove the upper three screws (I) of the center floor console, the three nuts (J) of the lower brace (K) and lower left clip (L), holding the center floor console. Remove the lower brace.

1.4 ~ 2.2 lb-ft (0.2 ~ 0.3 kgf.m, 2.0 ~ 2.9 Nm)

3.6 ~ 4.3 lb-ft (0.5 ~ 0.6 kgf.m, 4.9 ~ 5.9 Nm)

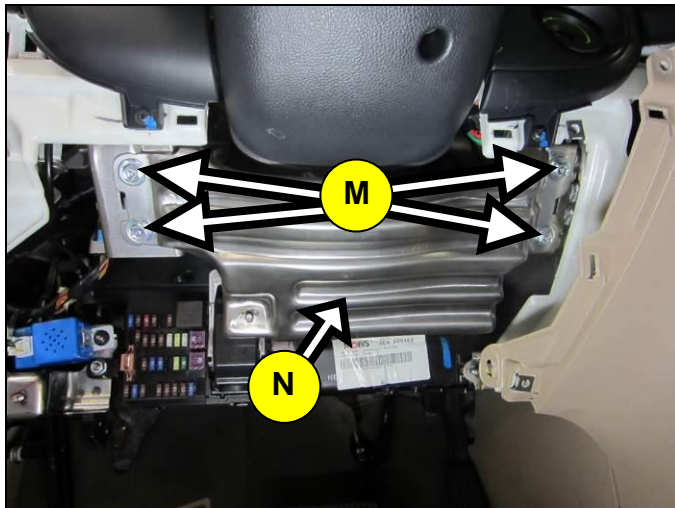
7. Move the center floor console to allow access to the two bolts on the right. Remove all four bolts (M). Remove the metal panel (N).

3.6 ~ 4.3 lb-ft (0.5 ~ 0.6 kgf.m, 4.9 ~ 5.9 Nm)

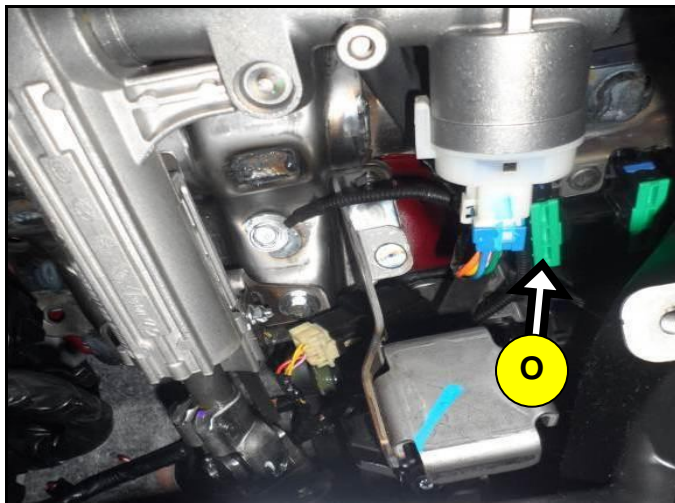
8. Slide the multi-connector (O) off its mounting bracket by gently pulling down. Do not pull off the multi-connector cap.

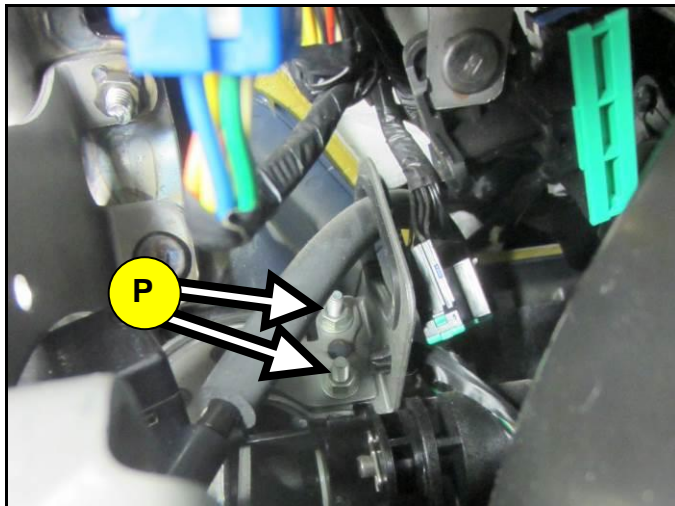
9. Using a universal joint on a ratchet, remove the two nuts (P) to loosen the stop lamp switch bracket. This will allow access to the stop lamp switch.

3.6 ~ 4.3 lb-ft (0.5 ~ 0.6 kgf.m, 4.9 ~ 5.9 Nm)

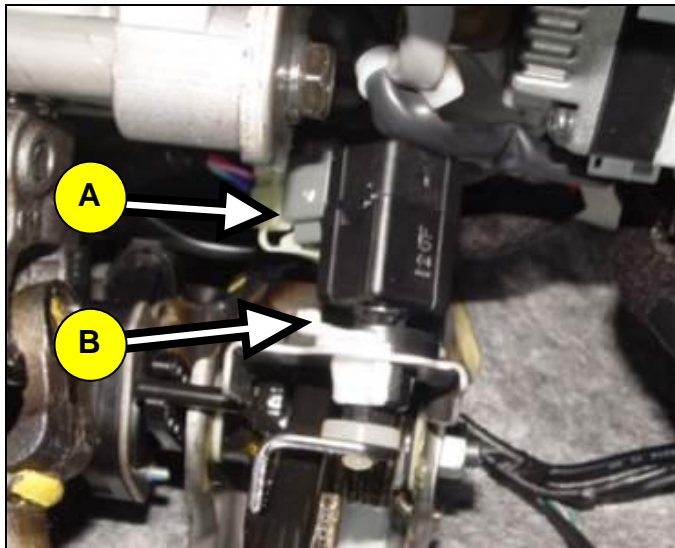
1. Disconnect the stop lamp switch connector (A) and slide out the locking tab (B).

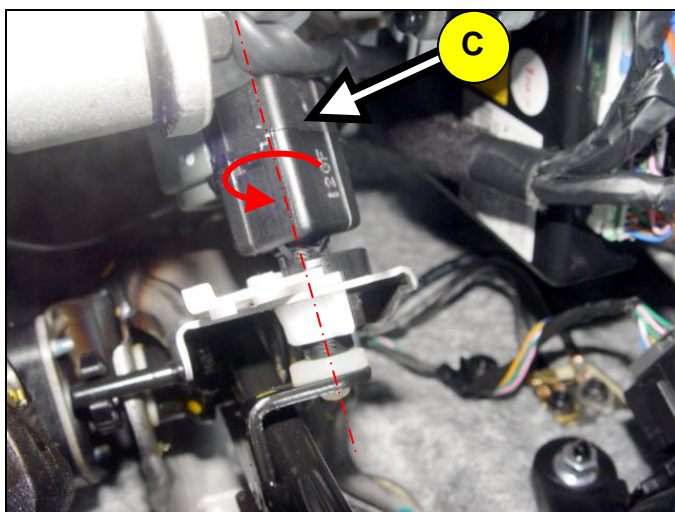
2. Rotate the stop lamp switch (C) clockwise to unlock and remove it.

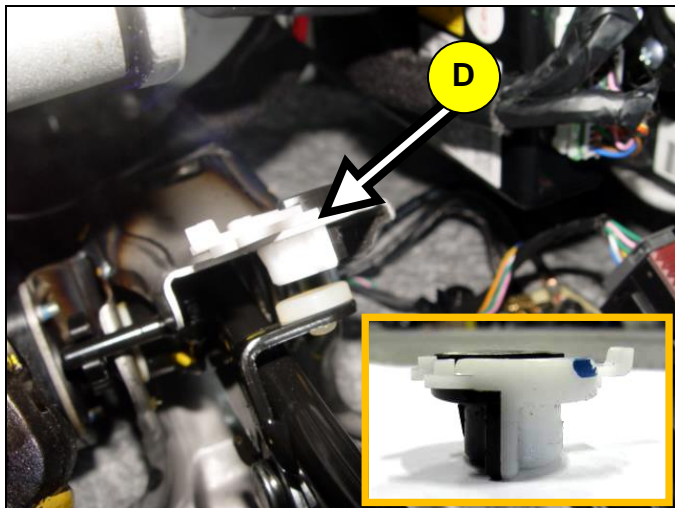
3. Pry out the plastic locking mount (D) with a flathead screw driver and discard.

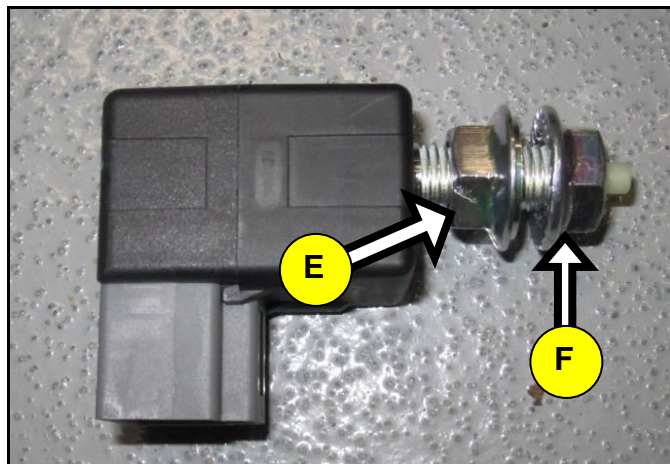
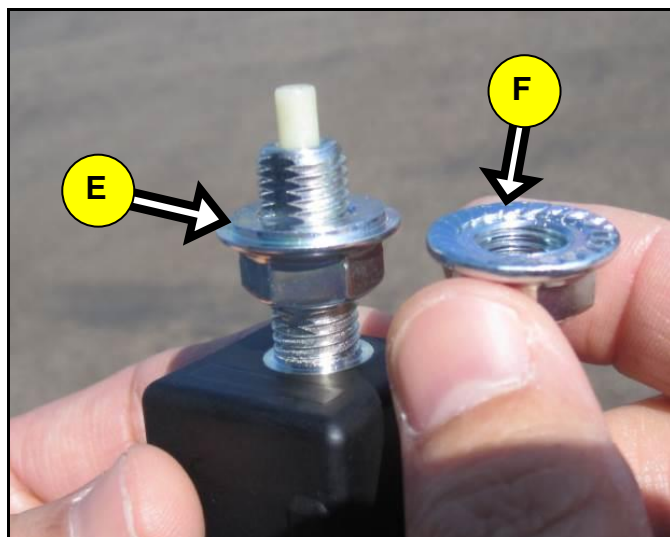
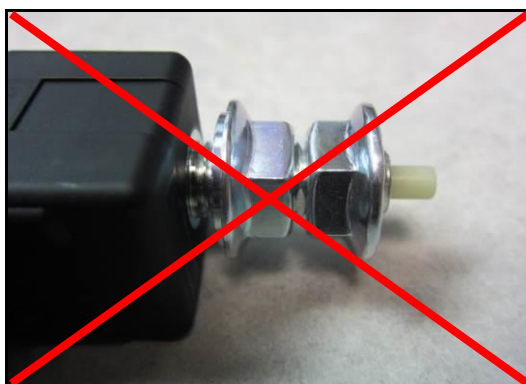
INCORRECT

4. Retrieve the replacement switch. Note that the two flanged nuts that are not identical.

The inside nut (E) (closer to the stop lamp switch body) has a small lip that protrudes out from the flange. This lip will fit inside the mounting bracket to securely locate the switch's position.

The outside nut (F) (farther from the switch body) has a serrated edge.

When installing the replacement part, make sure nut (E) is placed closer to the switch body, and that nut (F) is placed farther.

Also, be sure that the flanges are faced towards each other, not away from each other.

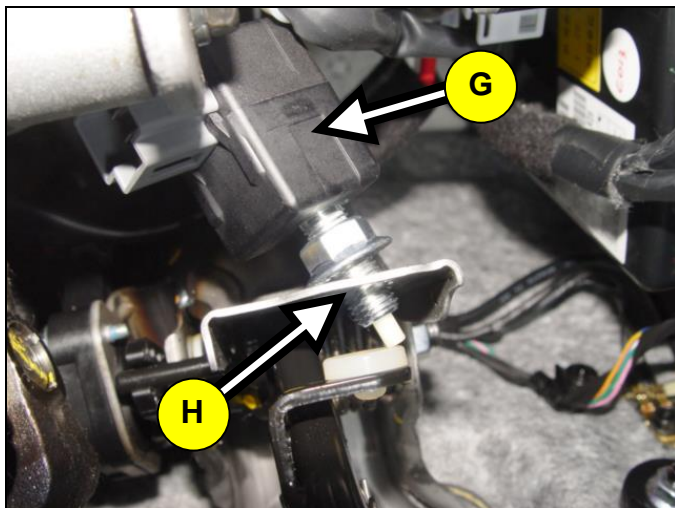
5. Locate the replacement stop lamp switch (G) and fasten the upper and lower mounting flange nuts.

Make sure the inside nut's lip is fully seated into the mounting bracket, so that the nut's flange is flush with the bracket.

It might be necessary to clean the area of the bracket around the opening (H) to ensure that the threaded part and mounting nuts of the new stop lamp switch are grounded properly.

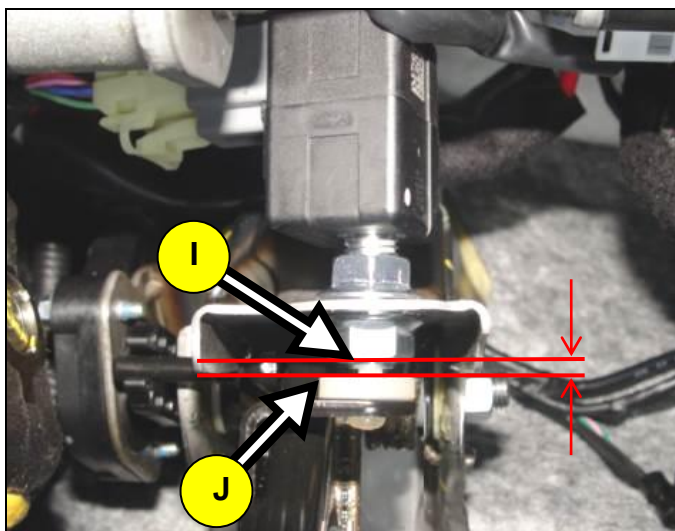
6. Without the brake pedal applied, adjust the gap between the end of the metal threaded housing of the stop lamp switch (I) and the stop lamp switch stopper (J).

Gap Specification:

1.0 ~ 2.0 mm (0.04 ~ 0.08 in)

7. Tighten the upper and lower mounting flange nuts.

Lower mounting flange nut torque specification:

5.8 ~ 7.2 lb-ft (0.8 ~ 1.0 kgf.m, 7.8 ~ 9.8 Nm)

8. Recheck the gap as described in step 6.
9. Verify that the rear brake lamps operate normally when applying the brake pedal.
