**Safety Recall: 2013 RDX Shift Interlock Stopper**

(Supersedes 13-019, dated May 21, 2013, to revise the information marked by the black bars)

Replace the shift interlock stopper.

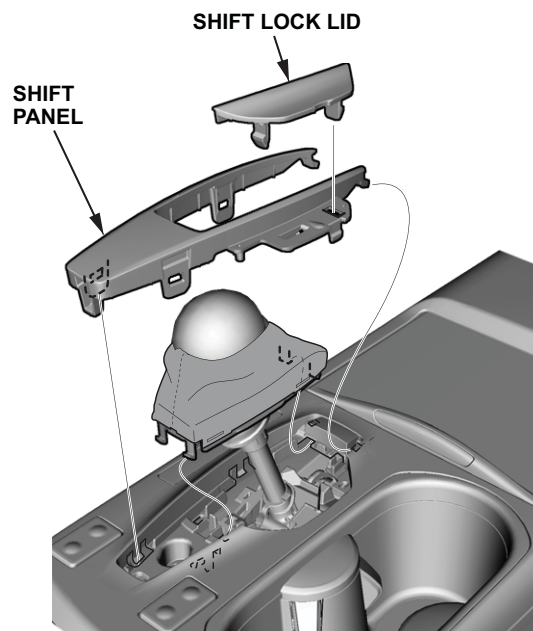
1. Make sure the parking brake is set, then remove the shift interlock lid.

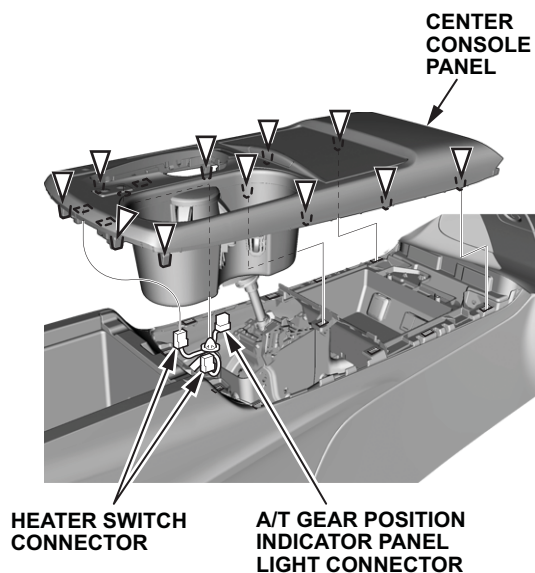
5. Remove the center console panel.

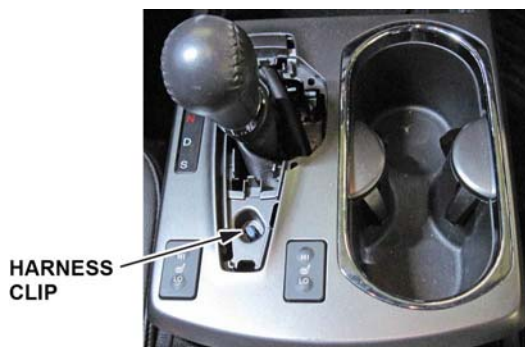
6. Disconnect the seat heater switch connectors and the A/T gear position indicator panel light connector.
7. Disconnect the harness clip from the console.

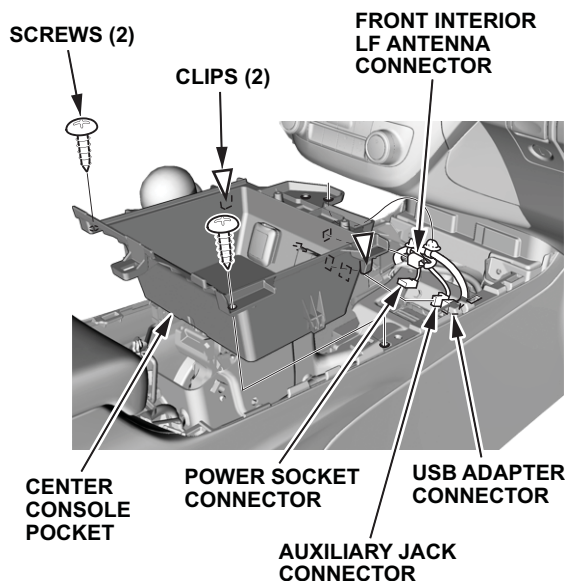
8. Remove the console pocket from the center console panel, and lay it over towards the passenger side.

NOTE: You do not have to disconnect the connectors.

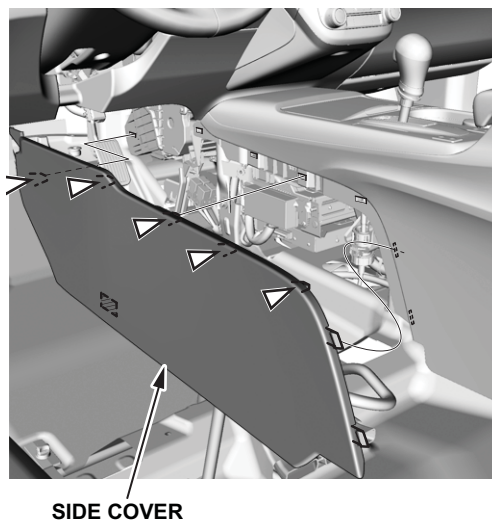
DRIVER'S SIDE:

9. Slide the driver's seat all the way rearward.
10. Remove the driver's side center console side cover.

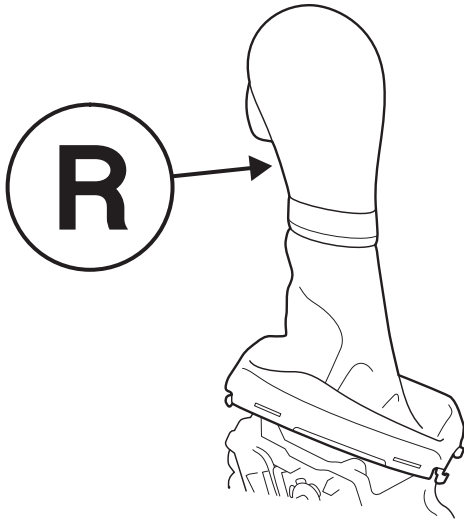
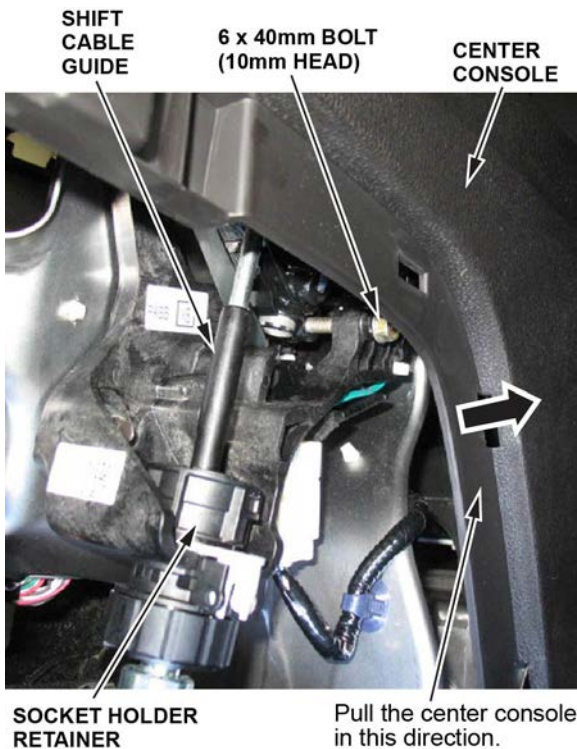
11. Insert a bolt (10 mm head 6 mm x 40 mm) into the positioning holes to lock the shift lever assembly in R.

NOTE: You may need to pull the lower section of the center console away to give you enough space to insert the bolt into the slot.

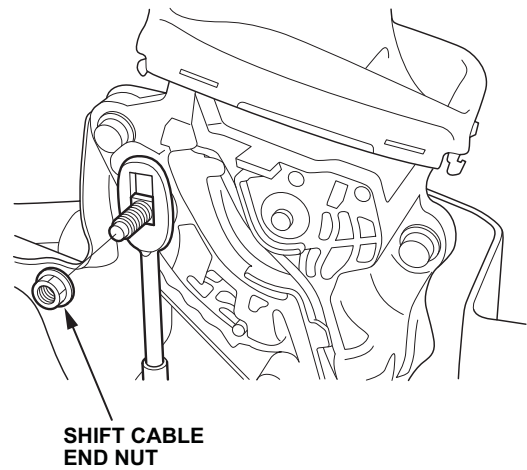
12. Remove the shift cable end nut.

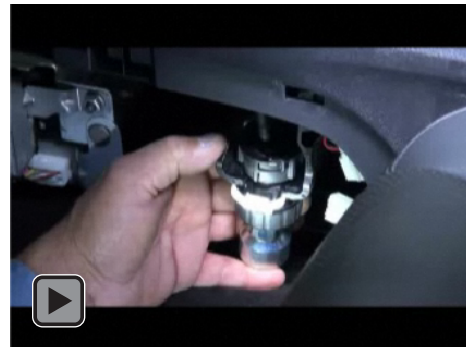
13. Remove the shift cable from the shift cable bracket. First, click on the video below to see how the step is done.

NOTE: The dashboard brackets may have sharp edges. Wear gloves to protect your hands.

- Release the retainer lock.

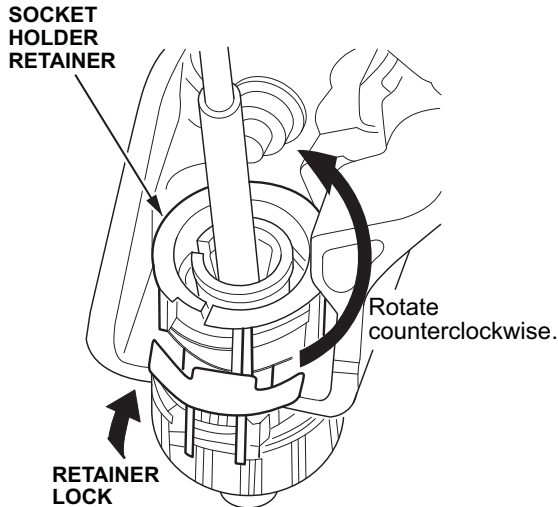
- Rotate the upper half (above the retainer lock) of the socket holder retainer counterclockwise until it stops turning.

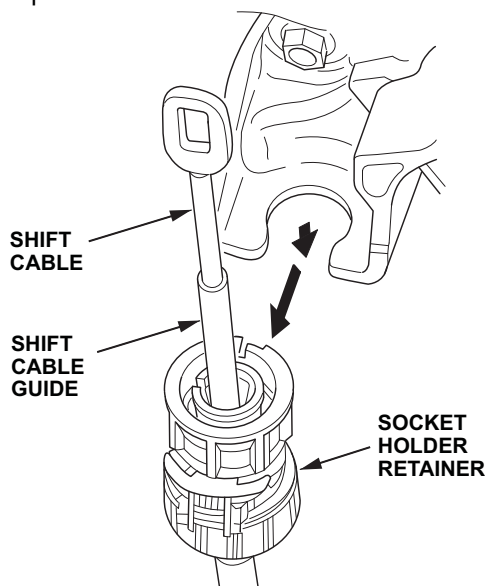
- Push the retainer lock in to lock the socket holder retainer in place.

- Make sure the retainer lock properly locks the retainer because the retainer is spring loaded and will release if let go. If it does release, reset it by rotating the upper half of the socket holder.
- Do not rotate the lower half of the socket holder retainer (below the retainer lock), or it may break.
- Remove the shift cable by holding the socket holder retainer, and sliding it off of the shift cable bracket.

NOTE: Do not remove the shift cable by pulling on the shift cable guide, or the guide may break. If this happens, the entire shift cable must be replaced.

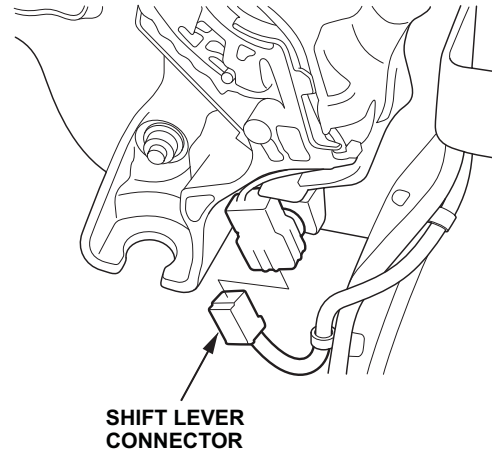
- Disconnect the shift lever connector.

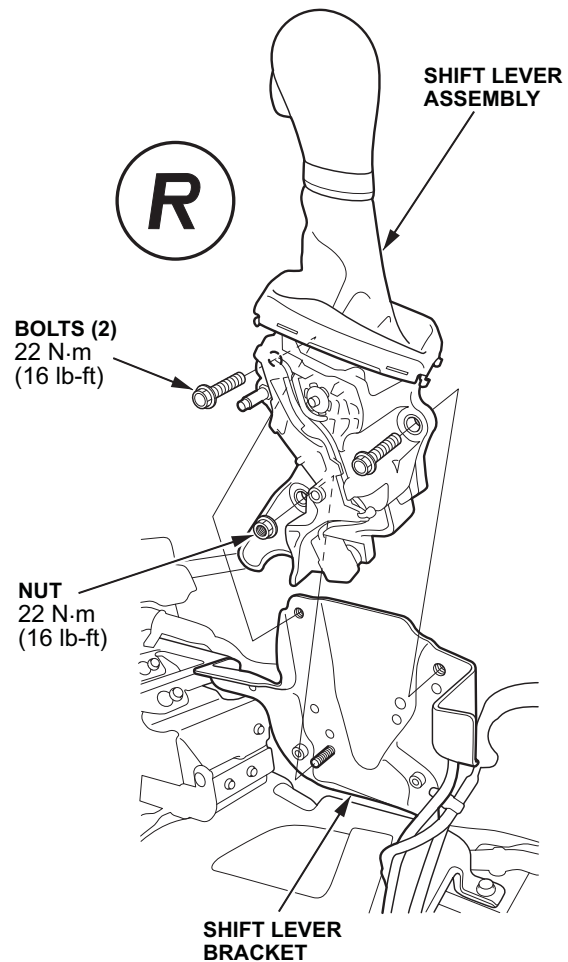
- Remove the shift lever mounting bolts and nut.

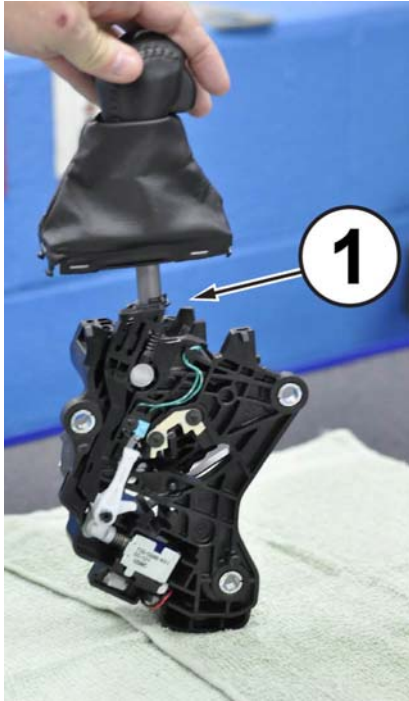
15. Remove the bolt that you inserted earlier to lock the shift lever assembly in the R position.

16. Move the shift lever to 1.

NOTE: Lay the shift lever assembly on a clean cloth to prevent damaging it.

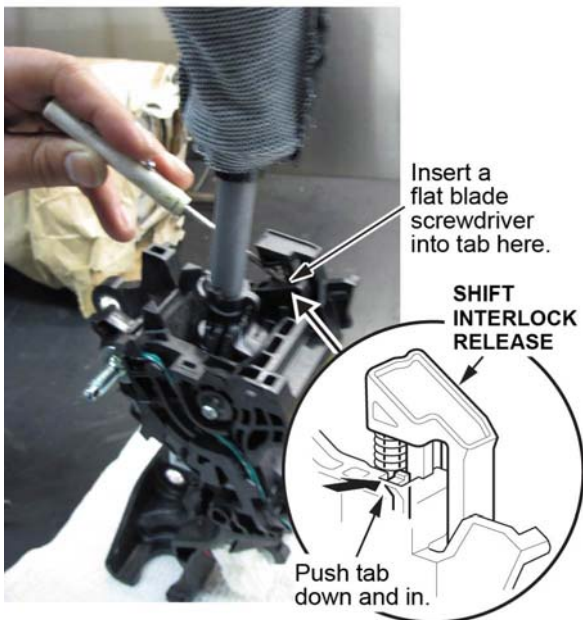
17. Release the shift interlock release by using a pick tool or small flat blade screwdriver (3 mm diameter) to push the tab down and in toward the shift interlock release.

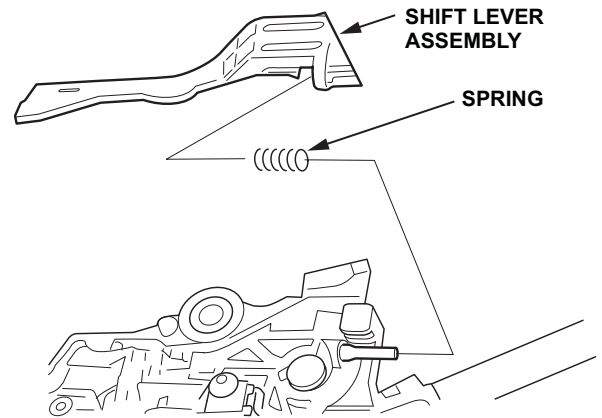
18. Lay the shift lever assembly on its side, and remove the shift interlock release and the spring.

NOTE: Make sure you don't lose or damage the spring.

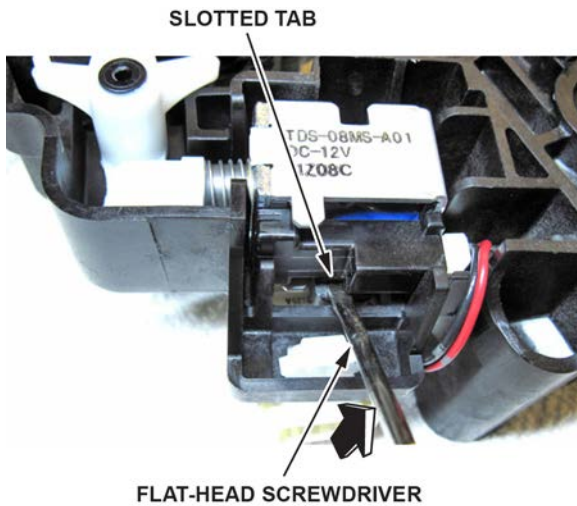
- Insert a flat-head screwdriver into the slotted tab.

NOTE: Make sure you insert the screwdriver in the exact specified location as shown.

If you do not, you can damage the windings when you pry out the solenoid, causing it to short out. This damage will result in the shift lever unable to come out of Park.

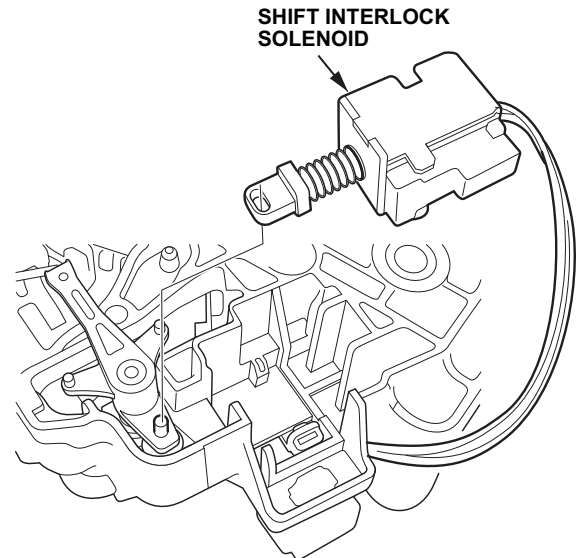
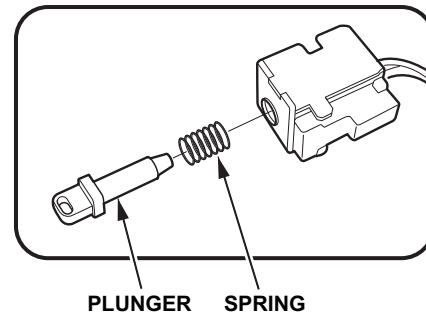
- Move the screwdriver handle up to release the tab and pry out the solenoid.

- Remove the shift interlock solenoid and lay it down next to the shift lever assembly. Do not disconnect the connector.

NOTE: The solenoid plunger and its spring can fall out of the solenoid. If this happens, reassemble the shift interlock solenoid before setting it down.

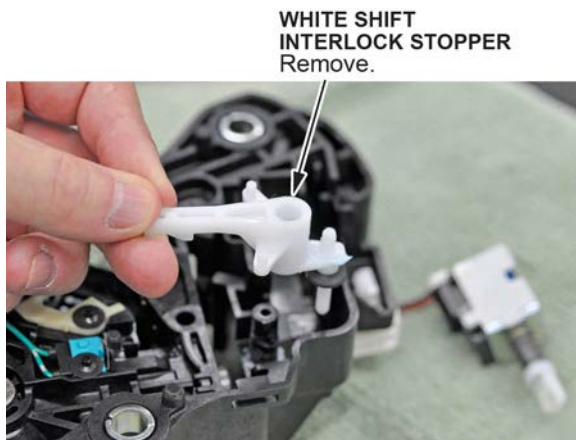
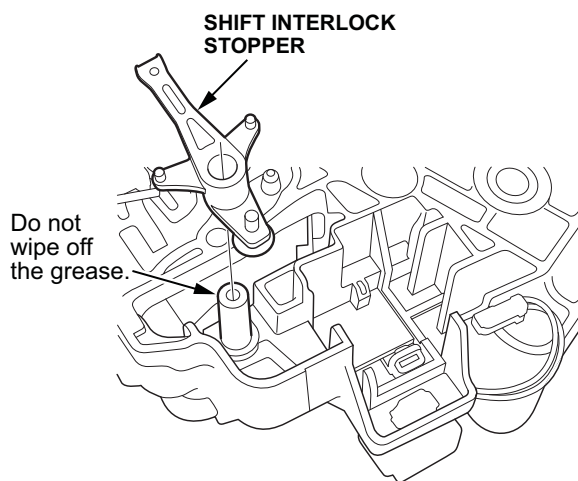
20. Remove the white shift interlock stopper from the shift lever assembly.

NOTE: Do not wipe the grease from the shift lever assembly.

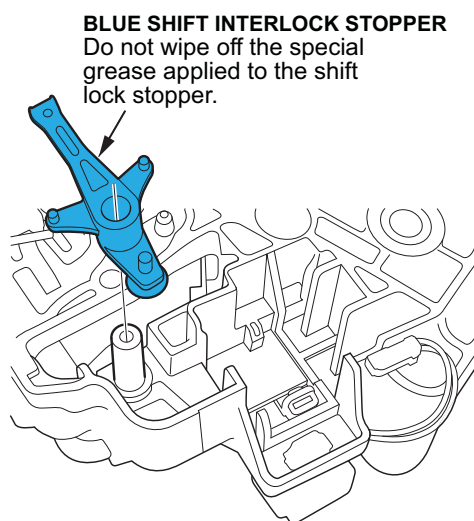
> Shift Interlock Stopper

21. Install the new (blue) shift interlock stopper.

NOTE: Do not wipe the grease off the new shift interlock stopper.

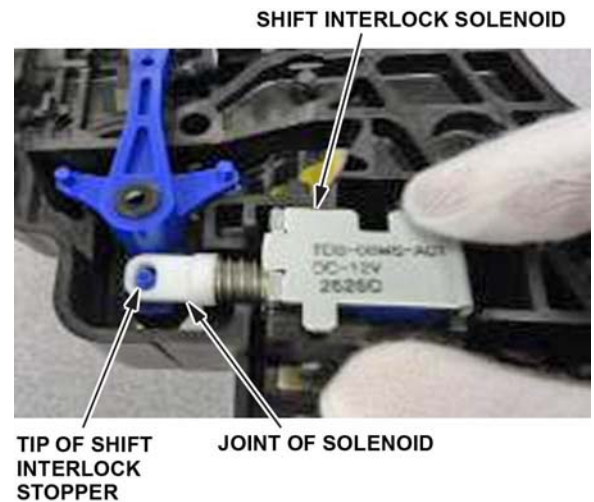
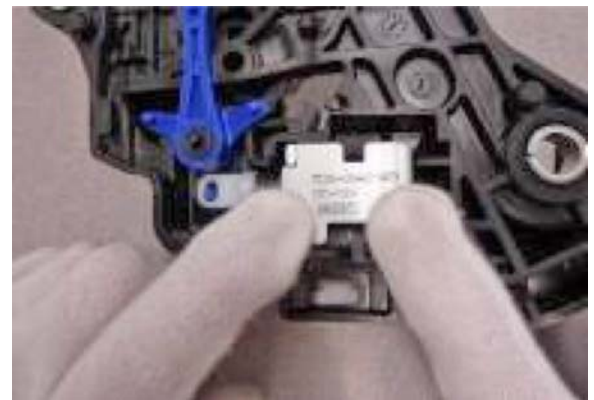
22. Reinstall the shift interlock solenoid by aligning the solenoid plunger joint with the tip of the shift interlock stopper, then push down on the bottom area of the solenoid (side with the printing) until you hear a click.

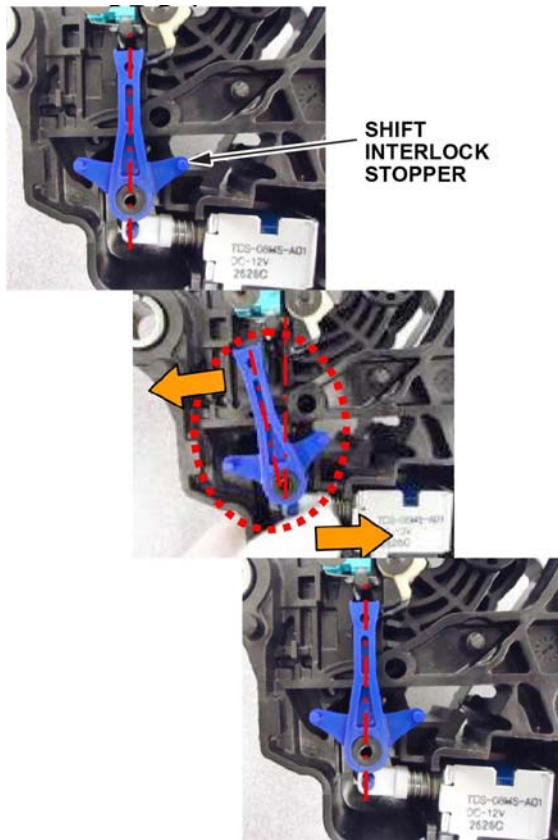
23. Make sure that the shift interlock stopper and solenoid motion is smooth.

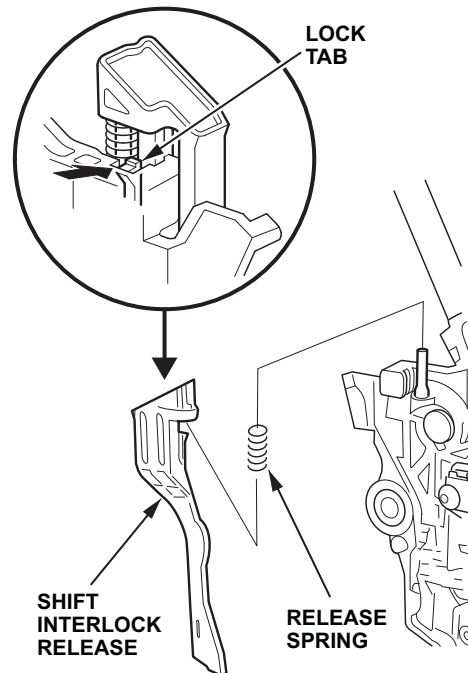
24. Reinstall the release spring and the shift interlock release. Press down on the shift interlock release until you hear a click.

NOTE: Make sure that the slots on the release align with the corresponding grooves on the shift lever assembly.

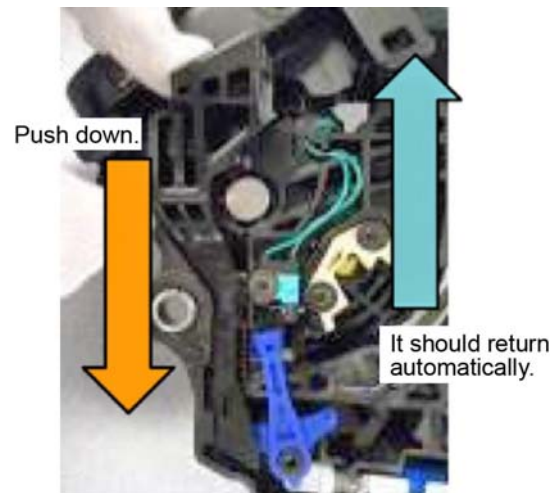
25. Press the shift interlock release button, then release it. Make sure the shift interlock release returns to its original position without sticking or binding.

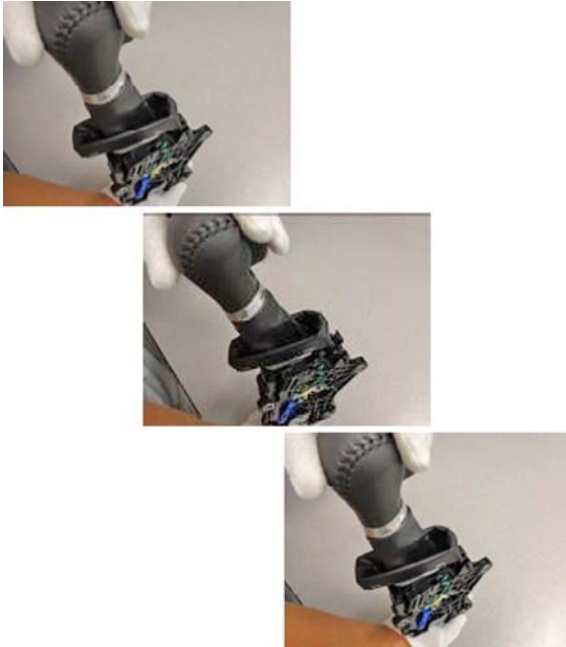
26. Make sure the shift lever moves easily into each gear position. Press the shift interlock release button to move the shift lever out of P.

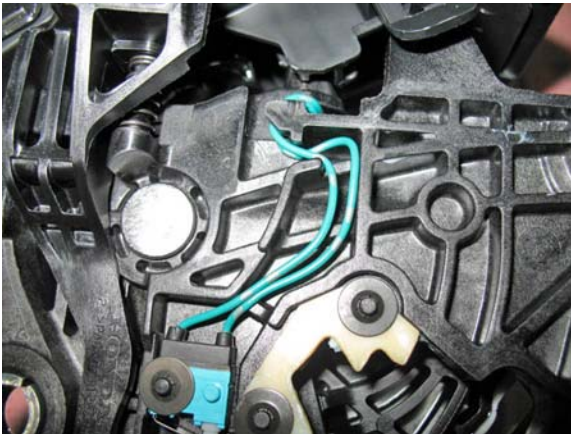
27. Make sure the green wires are properly routed and set in the cavity as shown.

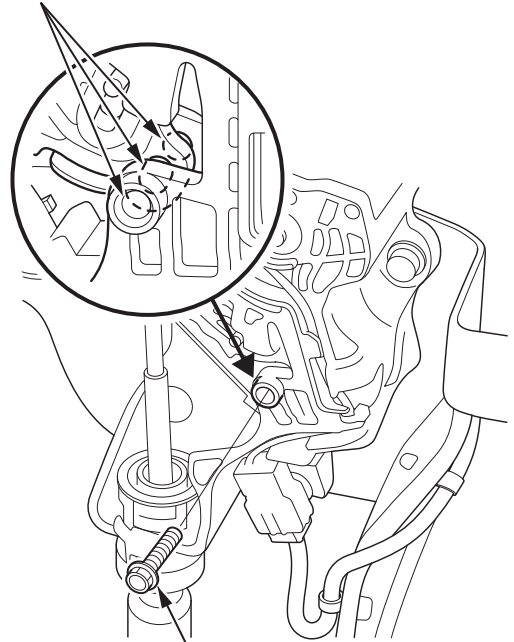
POSITIONING HOLES

- Move the shift lever to R.
- Lock the shift lever in R by inserting the bolt into the positioning holes.

BOLT
6 x 40 mm
(10 mm head)

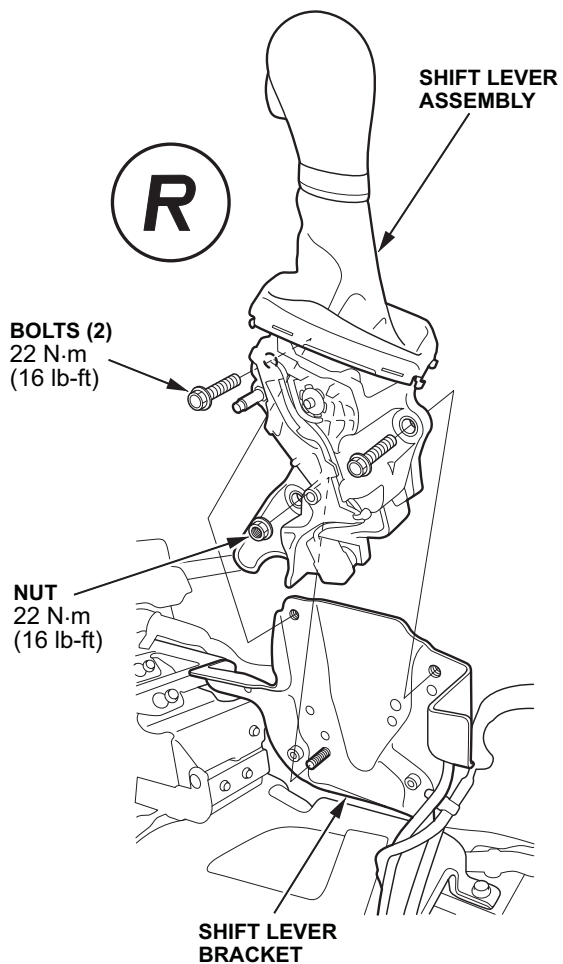
- Set the shift lever assembly into the center console, then install and finger-tighten the two bolts and nut.

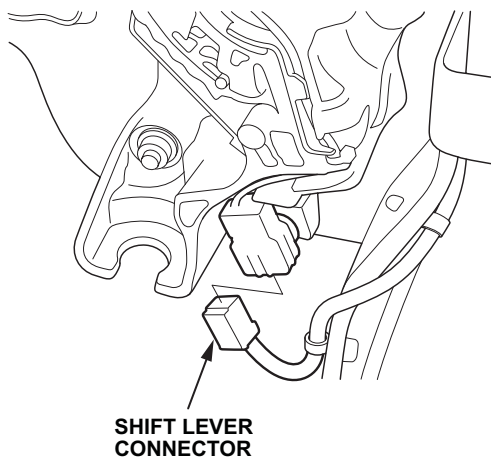
- Torque the two shift lever assembly bolts and nut to **22 N·m (16 lb-ft)**.
- Connect the shift lever connector.

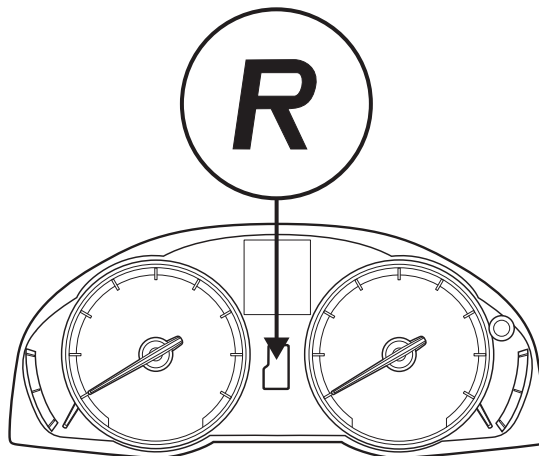
29. Press the engine start/stop button to select the ON mode, and make sure the R position indicator in the instrument panel is on.

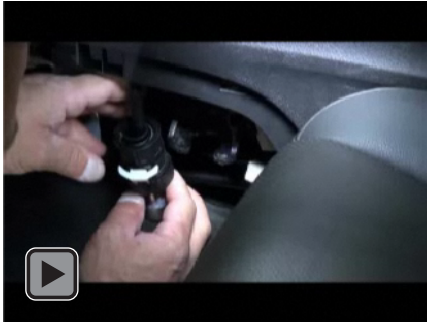
30. Reinstall the shift cable. First, click on the video below to see how the step is done.

- Align the shift cable slot (located between the socket holder and the socket holder retainer) with the opening of the shift cable bracket.

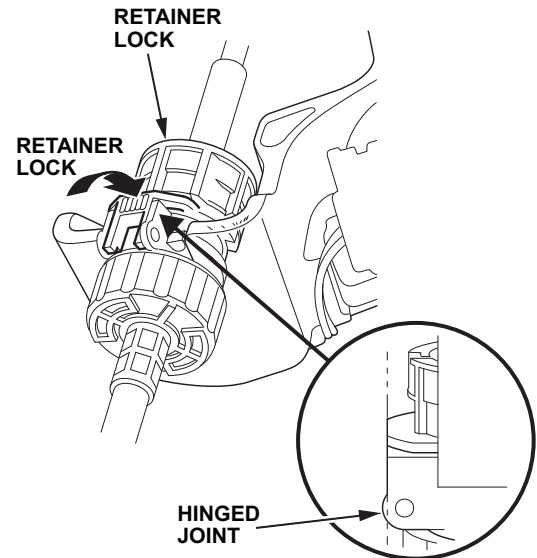
- Slide the socket holder onto the shift cable bracket while installing the shift cable end onto the mounting stud by aligning the square hole with the square fitting at the bottom of the stud.

- Do not install the shift cable by holding the shift cable guide, or the guide may break. If this happens, the entire shift cable must be replaced.
- When the socket holder is installed onto the shift cable bracket, the retainer lock will unhinge. When the retainer lock unhinges, the spring tension is released, securing the shift cable to the bracket.

- Push in the retainer lock to lock the socket holder retainer.

NOTE: Make sure the retainer lock fits into the hinged joint. If it does not, rotate the holder retainer counterclockwise while pushing the retainer lock until it locks.

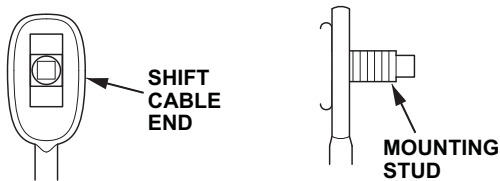
PROPERLY INSTALLED:

Cable end rides on the bottom of the mounting stud.

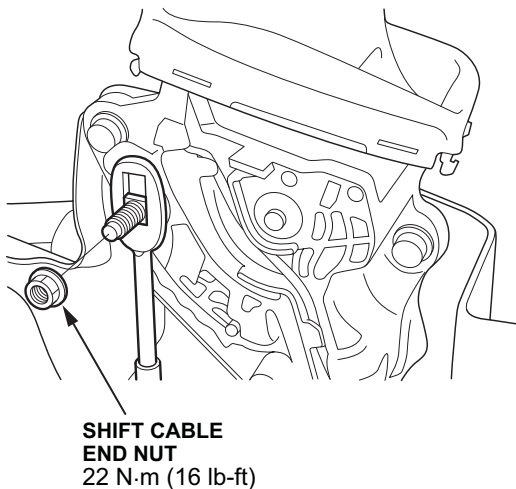
31. Reinstall the nut on the shift cable end and torque it to **22 N·m (16 lb-ft)**.

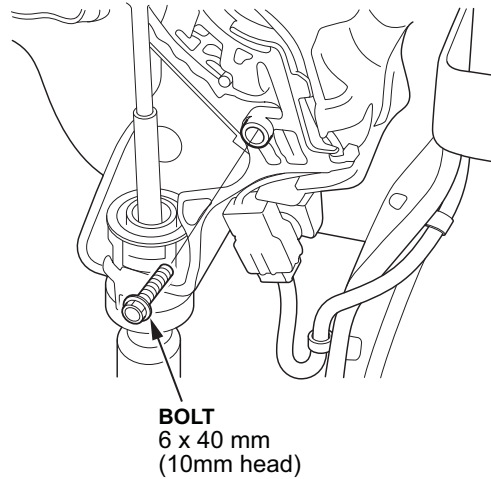
32. Remove the bolt.
