**PREVOST**

## SAFETY RECALL

**SR13-26**

| SUBJECT : EMERGENCY EXIT SEQUENCE AND PROCEDURE ON<br>AWNING WINDOW DECALS | |

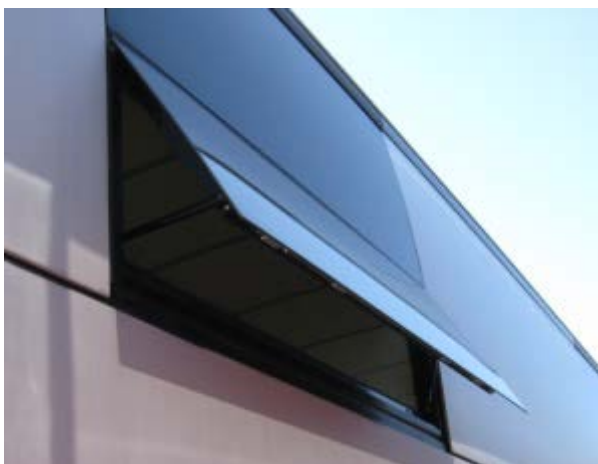
Fig.1 Typical awning-type window

1. Locate the awning window(s) installed on the vehicle (refer to images below for identification).

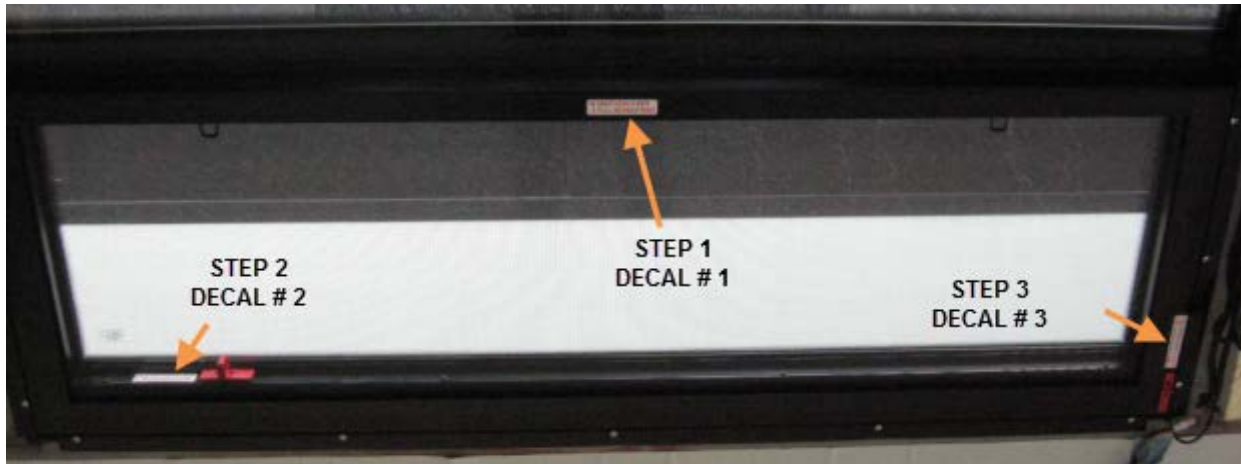
Fig.3 Awning window emergency exit opening sequence.

2. With the window(s) identified, locate the three (3) emergency exit decals around the frame of the window(s).
3. First, make sure that for each identified window, the decals are in the order shown in figure 3.  
In some vehicles, the decals # 2 and # 3 may have been applied in reverse order.

- **IMPORTANT:** The correct emergency opening sequence of the awning-type window is shown below.

On the vehicles affected by this recall, the emergency exit decals applied to the awning windows do not mention a step to open the window. Specifically, the vertical latch must be held down while pushing the window outward to release the track. Additionally, the sequence of steps may also be incorrect.

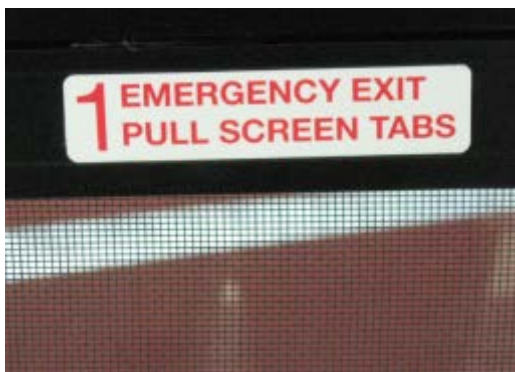
Fig.4 Decal # 1

- Decal # 1 (#790599) is located in the top center of the removable window screen.

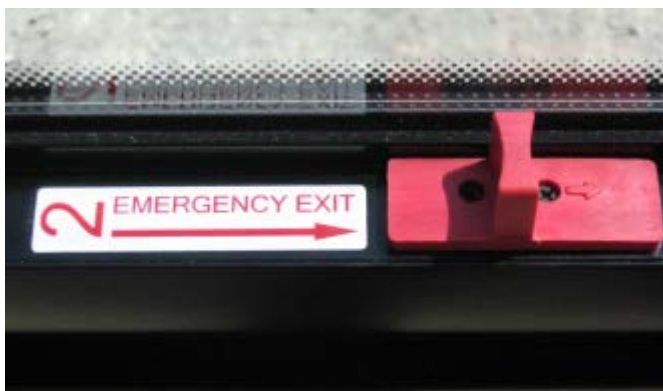
Fig.5 Decal # 2

- Decal # 2 (#790600) must be at the bottom left corner of the window (behind the window screen), pointing toward the safety latch as shown below. If a # 3 decal is present, it must be replaced.

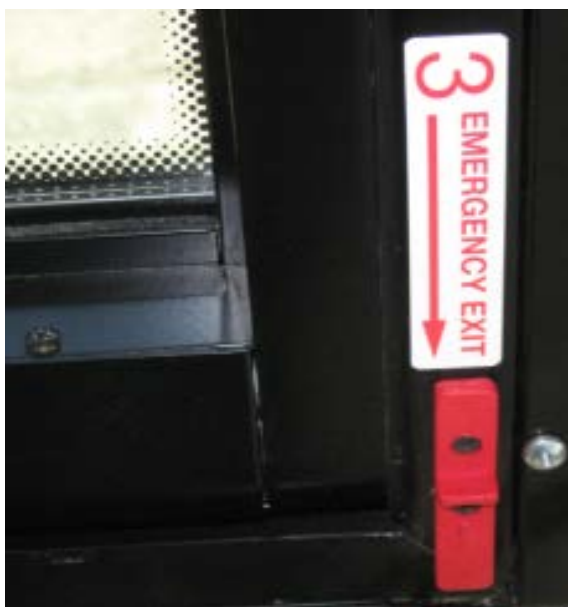
Fig.6b Original Decal To Be Replaced (#790601)

- Decal # 3 (#790601) must be replaced by a new decal (#299098) to provide additional information regarding the opening procedure. It must also be positioned at the bottom right corner of the window, over the second safety latch, pointing downward as shown below.

1. Following the reception of the new decals, prepare the window(s) for the new decals installation. The new decals can be installed over existing ones.  
To ensure proper adhesion, clean the factory installed decals surfaces with household glass cleaner prior to installation.
2. Peel off the protective backside of the new decals and carefully install them over the factory installed decals on the corresponding window.
3. Check for proper emergency exit operation of the window by opening it following the now correct sequence and procedure.
4. Repeat the procedure for each window.
5. Once the replacement is completed, fill out the **"Safety Recall Certification Sheet"** provided with this bulletin and return it to Prevost for recall follow-up and reimbursement purposes.
