REFRIGERATOR CABINET WIRING UPDATE

APPLIES ONLY TO CERTAIN GULF STREAM MOTOR HOMES MANUFACTURED FROM 5/17/2000 THRU 12/31/2000

GULF STREAM COACH MODELS THAT MAY BE AFFECTED: 6316 and 8325

NHTSA RECALL # 13V-197

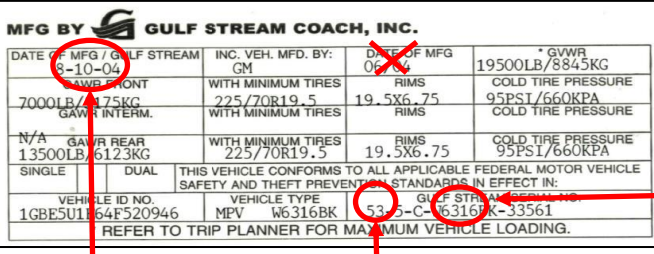
Step	Reference Picture	Process																												
1

If all three requirements are met, proceed to step 2.
 If just one of the requirements is missing, this vehicle IS NOT included in this recall.
 Performing repairs on a vehicle not included will result in non-payment of the claim.

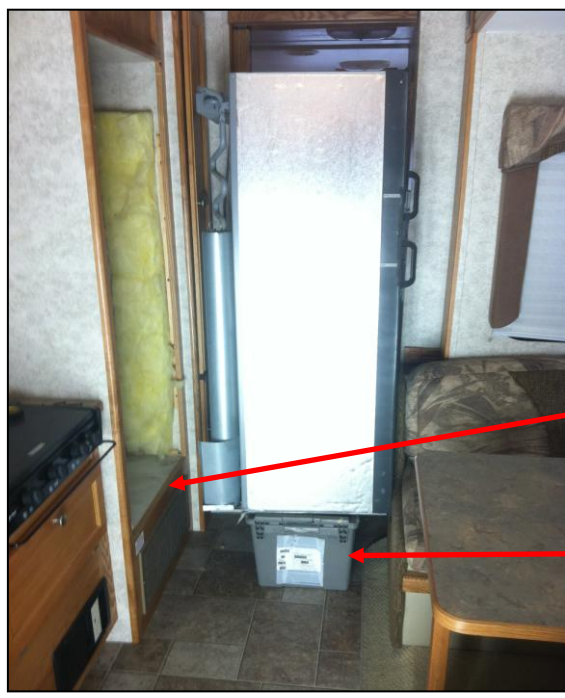
<p>The refrigerator MUST be removed to perform the recall.</p> <p>Disconnect the house battery and turn off the LP supply at the tank. Remove the refrigerator* from the cabinet as per industry guidelines and standards. If you have questions in regard to proper removal, please refer to the attached installation manual for Dometic refrigerators. (Gulf Stream utilized 4 fasteners on the front and 2 at the bottom on the rear of the refrigerator. This may be in addition to any other fasteners installed as part of Dometic's burner housing recall).</p> <p>(The front "feet" of the refer may need to be pryed up slightly to clear the wooden fascia of the cabinet)</p> <p>Take precautions to prevent damage to the interior flooring and cabinets during removal.</p> <p>For ease of removal, you may consider using a sturdy box or platform to rest the refrigerator on after/during removal.</p> <p>*Remove with care. Gulf Stream will not be responsible for damage claims due to removal of the refrigerator!</p>

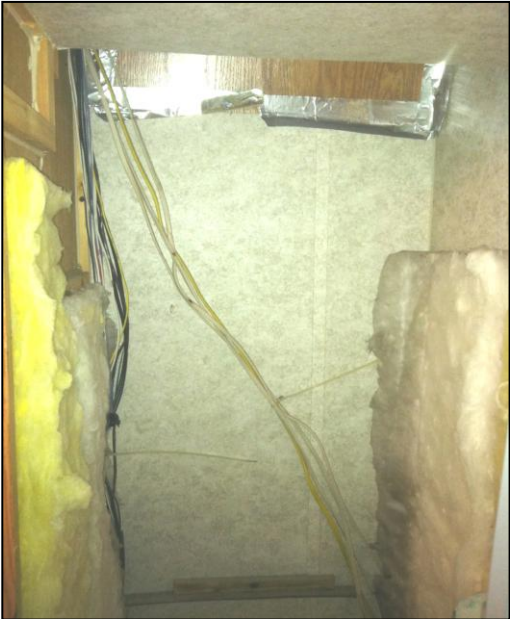
3

<p>After the refrigerator is removed, you will see wiring in the cabinet at shown.* The focus of this recall is on the 120v wiring, but be sure to inspect all wiring in the cabinet.</p> <p>Inspect all wiring for damage from heat. The damage may result from contact with the refrigerator tubing.</p> <p>If no damage is found, proceed to step 8.</p> <p>*exact wiring setup may vary slightly from unit to unit, but the 110 volt wiring will always run diagonally as shown.</p>
4

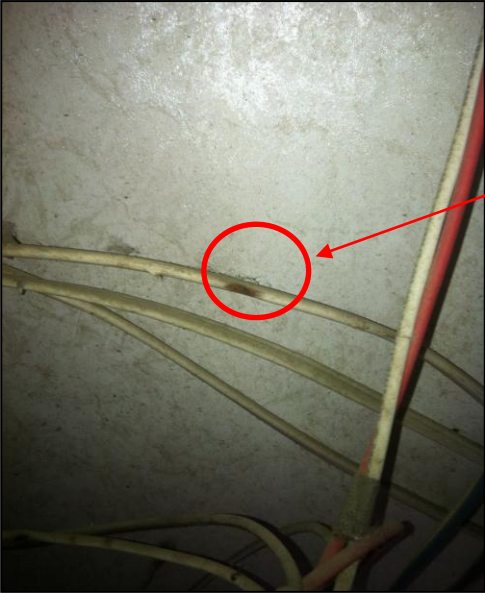
<p>If you find evidence of heat damage, it will look like this:</p> <p>Be sure to inspect the entire length of all wires inside the refrigerator cabinet.</p> <p>Document the damage with a digital camera. Claims for damaged wiring MUST include a picture of the damaged wire!</p>
5

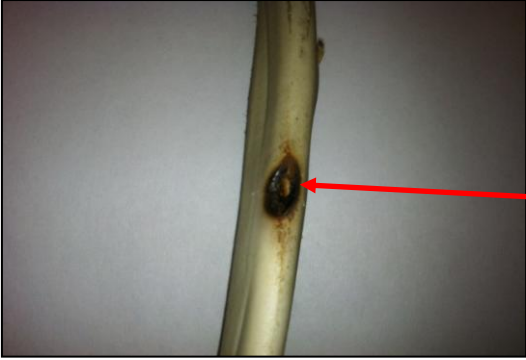
<p>6</p>

<p>If the insulation jacket of the wire has been damaged enough to allow you to see the interior wiring of the jacket, you MUST perform a splice repair as shown in the next step. Example: Interior insulated wire is visible.</p>
<p>7</p>

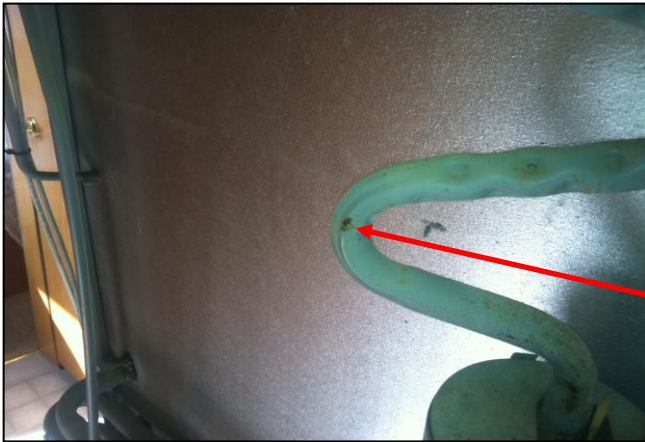
9

Inspect the tubing on the backside of the refrigerator. If the tubing has any evidence of rub marks, you must use a wire brush to clean the tubing and ensure the tubing has not developed any leaks.

Refrigerator tube coating affected by contact with the plastic insulation jacket of 120v wiring.

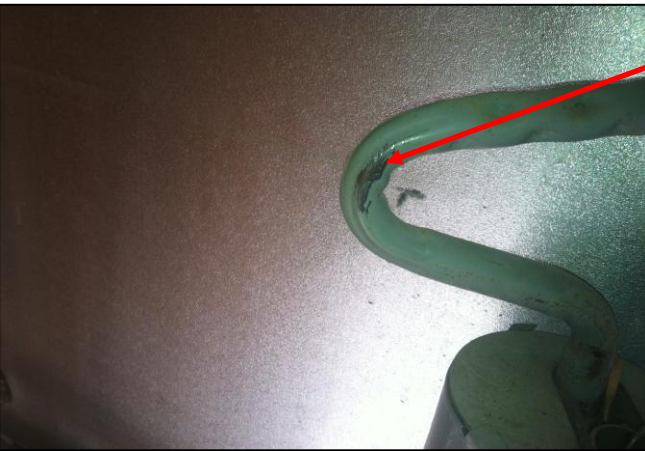
Closely inspect the affected area for signs of leaking chromate. The chromate is yellow in color.

If the refrigerator tube is leaking, do not proceed any further! Contact Gulf Stream Coach for further instruction.

Wire brush must be used to clean the tubing prior to recoating.
