## Second Row Seat Striker Bracket Reinforcement

| <b>Classification</b> | Recall Bulletin | <b>Section/Group</b> | 10 - Body | <b>Country/Region</b> | U.S.A. |
| <b>Year</b> | 2013 | <b>Model</b> | Model S | <b>Version</b> | All |

**NHTSA Recall Campaign Number:** 13V-249

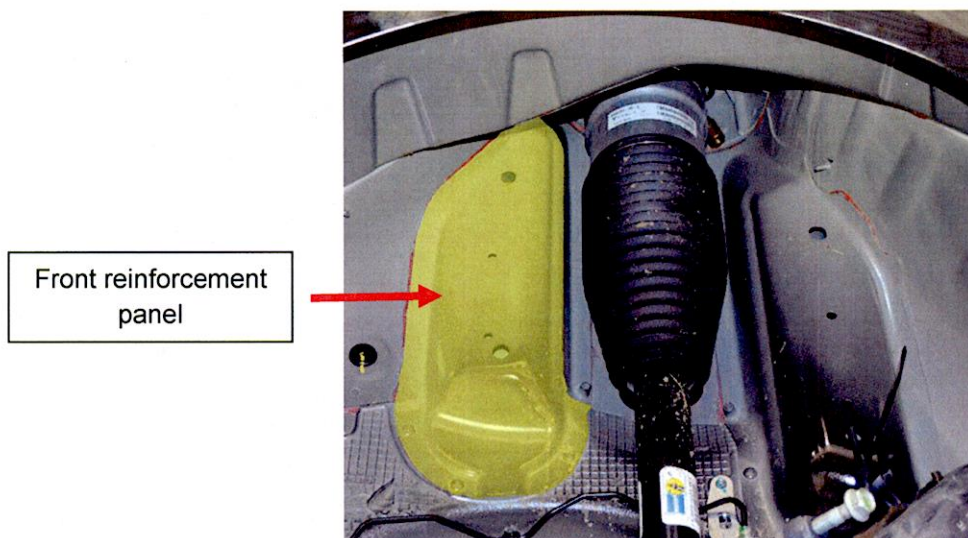
Figure 1

1. Remove the LH rear wheel arch liner (refer to Service Manual procedure 12011102).
2. Check the forward part of the LH rear wheel well for a front reinforcement panel (Figure 1). If one is present, no work is needed. If one is not present, continue this procedure.

On some vehicles, the spot welds on the LH 2<sup>nd</sup> row seat striker bracket could have been damaged during striker alignment at the factory. If damaged, the striker may not retain the seat back in the upright position in the event of a crash.

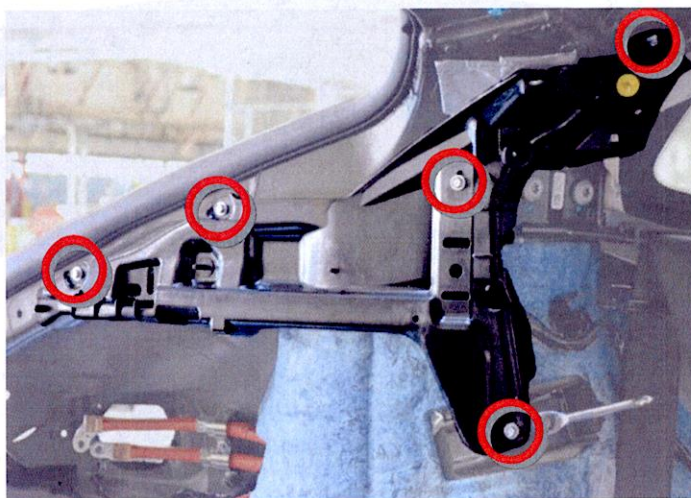
Figure 2

5. Remove the LH C-Pillar bracket by releasing the 5 bolts (Figure 2).

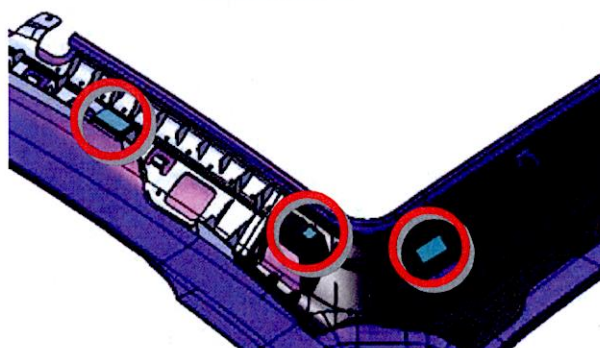
Figure 3 (LH locations of Dual Lock shown)

**NOTE:** Pull down the LH corner of the headliner as needed to access the upper bolt. Headliners in vehicles with panoramic roofs are secured with Dual Lock (Figure 3).

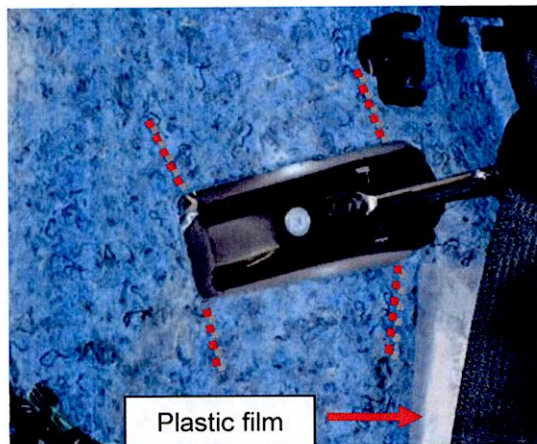
Figure 4

6. Cut the insulation as shown (Figure 4). This creates tabs that can be folded back to access the spot welds on the 2<sup>nd</sup> row seat striker bracket.

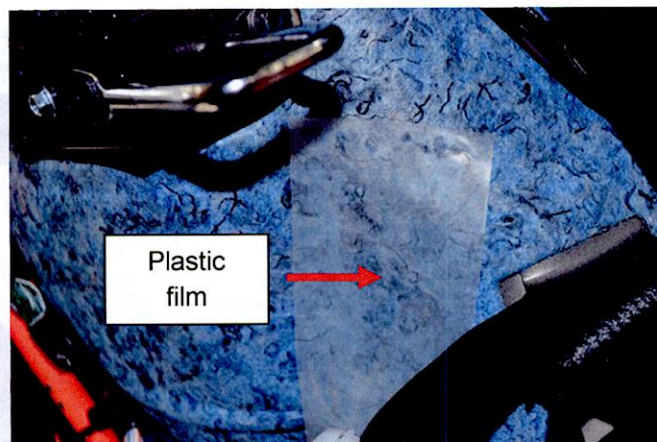
Figure 5

**CAUTION:** Do not cut or peel back the plastic film near the striker (Figure 5).

**NOTE:** If the insulation is already cut, fold it back and check to see if 4 pop rivets or bolts have already been installed at the positions in Figure 5. If so, this procedure has already been performed and no further work is required.

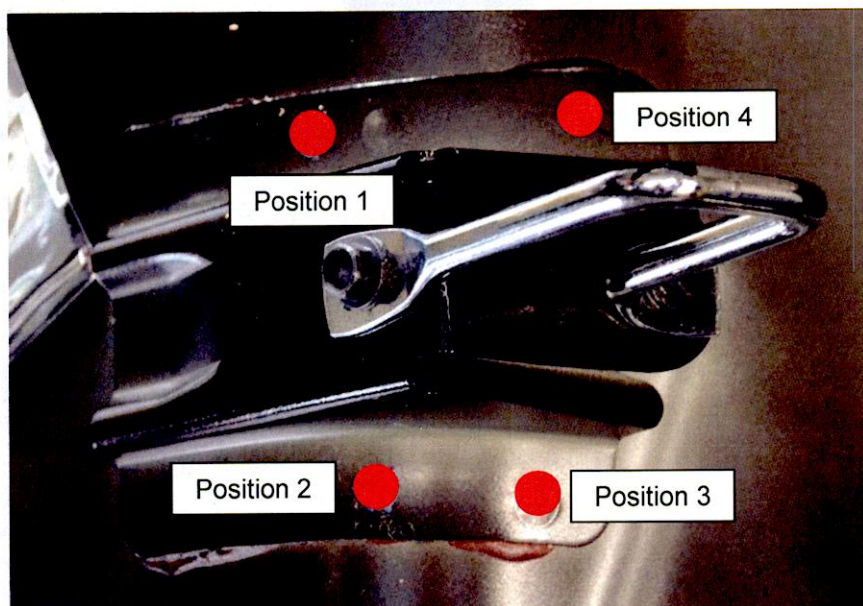
Figure 6

7. Use a marker or paint pen to mark 4 drill points (Figure 6). Do not drill at this time.
- On the top row of spot welds, 60 mm from the rear of the flange, centered top to bottom (Position 1).
  - On the bottom row of spot welds, 60 mm from the rear of the flange, centered top to bottom (Position 2).
  - On the bottom row of spot welds, 20 mm from the front of the flange, centered top to bottom (Position 3).
  - On the top row of spot welds, 20 mm from the front of the flange, centered top to bottom (Position 4).

1. Using a 1/4 in (6.35 mm) drill bit, drill position 3 on the 2<sup>nd</sup> row seat striker bracket (Figure 6). Drill completely through all sheets.
  - ⚠ **CAUTION:** When drilling, ensure that the hole in the flange is centered top to bottom.
  - ⚠ **CAUTION:** When drilling, use a vacuum to catch any debris. Ensure that no debris falls between the striker bracket and wheelhouse panel.
  - ⚠ **CAUTION:** Take care when drilling. Do not damage the shock absorber, which is behind the panels.
2. Use a cotton swab to apply etch primer to the edges and inside of the hole (Figure 9). Allow the primer to dry before continuing.
3. Have an assistant insert the bolt into the hole from the wheel side and hold it in place. Secure the nut on the inside (torque 12 Nm).

1. Using a 1/4 in (6.35 mm) drill bit, drill position 4 on the 2<sup>nd</sup> row seat striker bracket (Figure 6). Drill completely through all sheets.
  - ⚠ **CAUTION:** When drilling, ensure that the hole in the flange is centered top to bottom.
  - ⚠ **CAUTION:** When drilling, use a vacuum to catch any debris. Ensure that no debris falls between the striker bracket and wheelhouse panel.
  - ⚠ **CAUTION:** Take care when drilling. Do not damage the shock absorber, which is behind the panels.
2. Use a cotton swab to apply etch primer to the edges and inside of the hole (Figure 9). Allow the primer to dry before continuing.
3. Have an assistant insert the bolt into the hole from the wheel side and hold it in place. Secure the nut on the inside (torque 12 Nm).

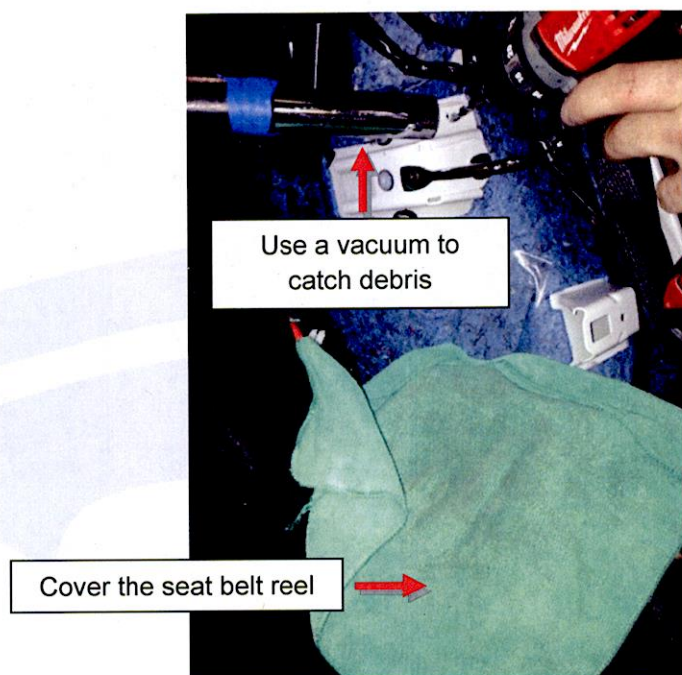
**Figure 7**

**⚠ CAUTION:** Before drilling in later steps, cover the seat belt reel. When drilling, use a vacuum to catch any debris (Figure 7).

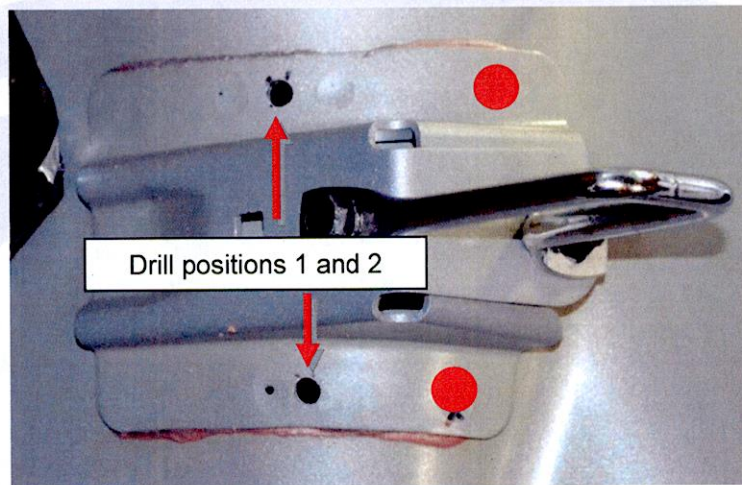
Figure 8

1. Using a 1/4 in (6.35 mm) drill bit, drill positions 1 and 2 on the 2<sup>nd</sup> row seat striker bracket (Figure 8). Drill completely through all panels.

**! CAUTION:** When drilling, ensure that the holes in the flange are centered top to bottom.

**! CAUTION:** When drilling, use a vacuum to catch any debris. Ensure that no debris falls between the striker bracket and wheelhouse panel.

**! CAUTION:** Take care when drilling. Do not damage the shock absorber, which is behind the panels.

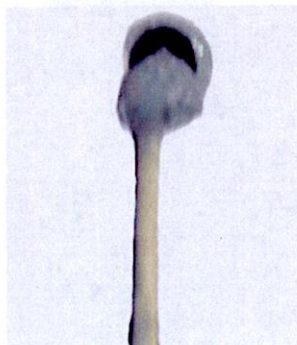
Figure 9

2. Use a cotton swab to apply etch primer to the edges and insides of the holes (Figure 9). Allow the primer to dry before continuing.

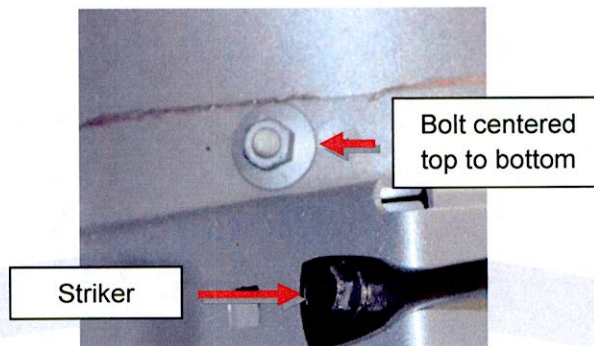
Figure 10 (Position 1 shown)

3. Have an assistant insert bolts into the 2 holes from the wheel side and hold them in place. Secure the nuts on the inside (Figure 10) (torque 12 Nm).

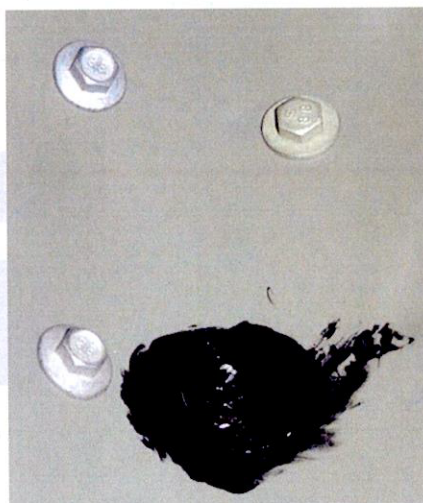
Figure 11

1. Clean up any metal shavings.
2. Completely cover the 4 wheel side bolt heads with sealant (Figure 11).

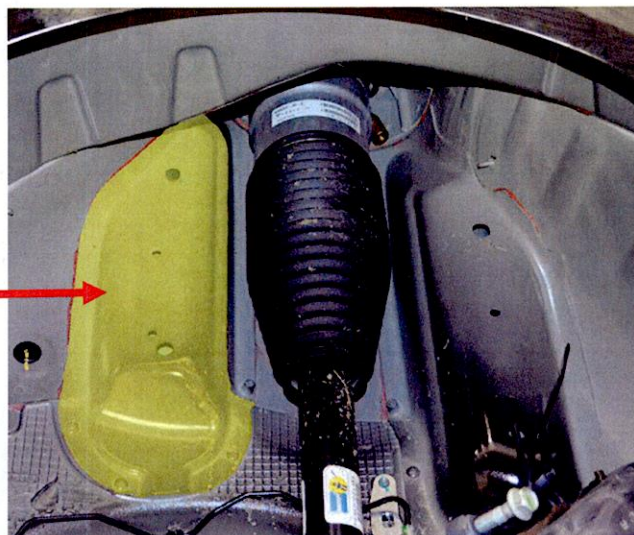
**Figure 1**

1. Remove the LH rear wheel arch liner (refer to Service Manual procedure 12011102).
2. Check the forward part of the LH rear wheel well for a front reinforcement panel (Figure 1). If one is present, no work is needed. If one is not present, continue this procedure.

Front reinforcement  
panel

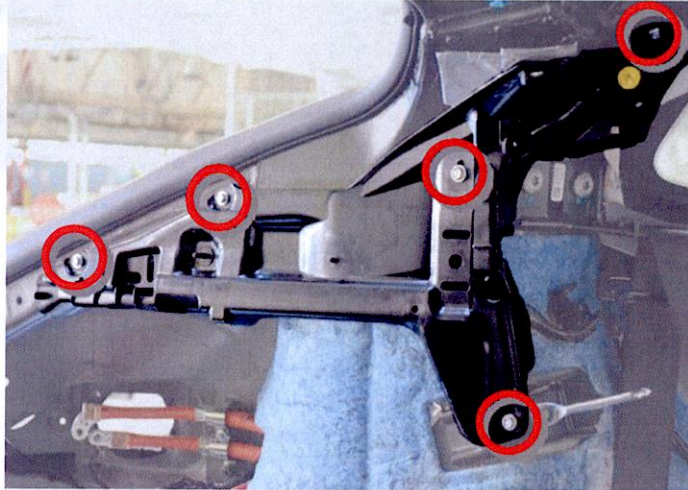
**Figure 2**

4. Remove the LH rear trunk side trim (refer to Service Manual procedure 15245002).
5. Remove the LH C-Pillar bracket by releasing the 5 bolts (Figure 2).

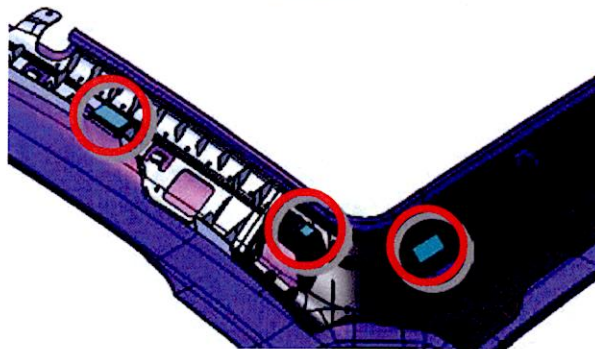
**Figure 3 (LH locations of Dual Lock shown)**

**NOTE:** Pull down the LH corner of the headliner as needed to access the upper bolt. Headliners in vehicles with panoramic roofs are secured with Dual Lock (Figure 3).

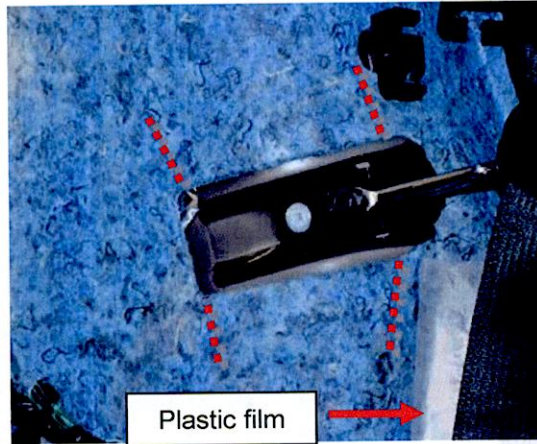
Figure 4

6. Cut the insulation as shown (Figure 4). This creates tabs that can be folded back to access the spot welds on the 2<sup>nd</sup> row seat striker bracket.

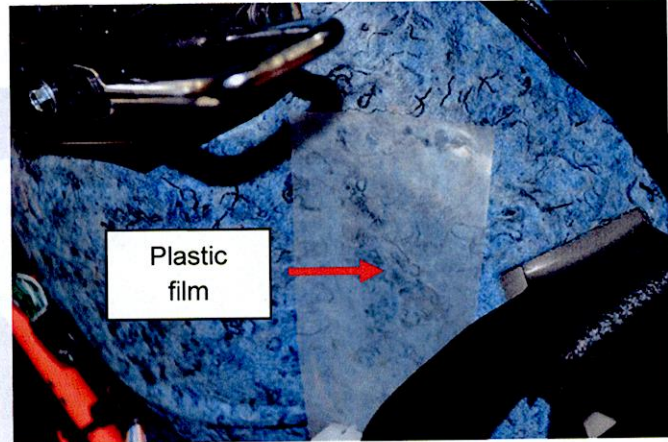
Figure 5

**CAUTION:** Do not cut or peel back the plastic film near the striker (Figure 5).

**NOTE:** If the insulation is already cut, fold it back and check to see if 4 pop rivets or bolts have already been installed at the positions in Figure 5. If so, this procedure has already been performed and no further work is required.

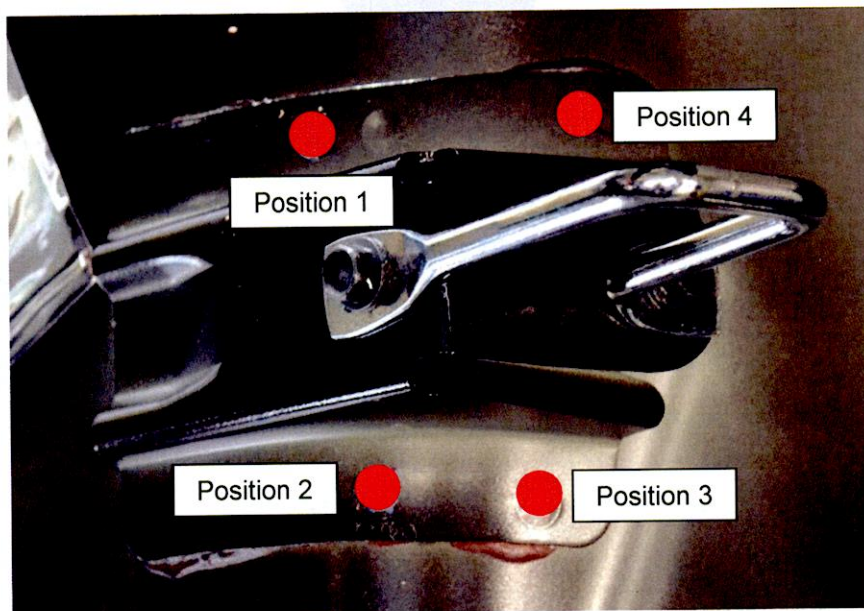
Figure 6

7. Use a marker or paint pen to mark 4 drill points (Figure 6). Do not drill at this time.
- On the top row of spot welds, 60 mm from the rear of the flange, centered top to bottom (Position 1).
  - On the bottom row of spot welds, 60 mm from the rear of the flange, centered top to bottom (Position 2).
  - On the bottom row of spot welds, 20 mm from the front of the flange, centered top to bottom (Position 3).
  - On the top row of spot welds, 20 mm from the front of the flange, centered top to bottom (Position 4).

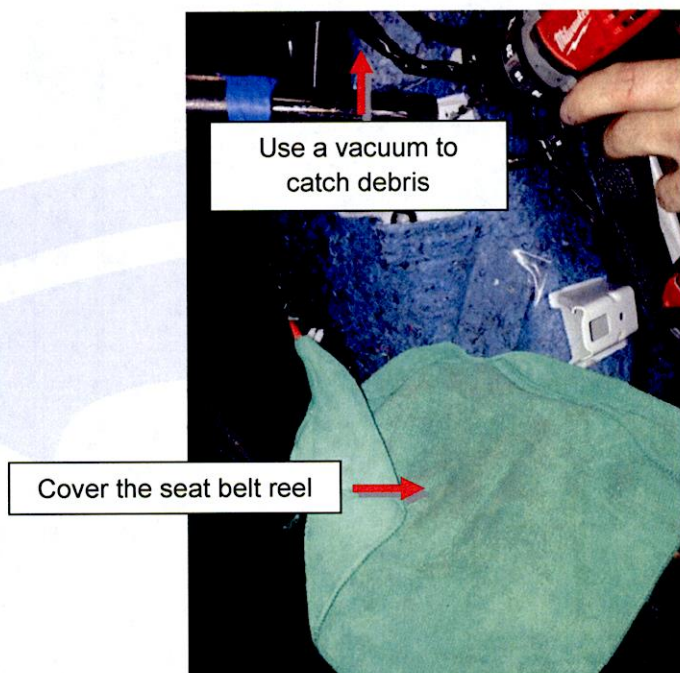
**Figure 7**

**⚠ CAUTION:** Before drilling in later steps, cover the seat belt reel. When drilling, use a vacuum to catch any debris (Figure 7).

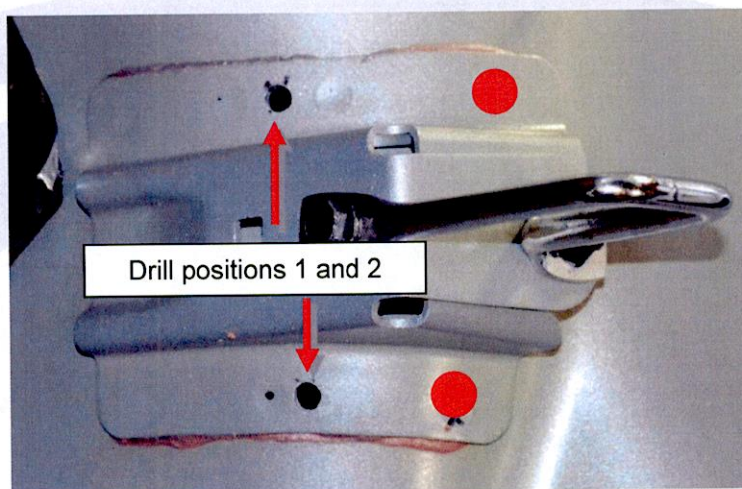
Figure 8

**! CAUTION:** When drilling, use a vacuum to catch any debris. Ensure that no debris falls between the striker bracket and wheelhouse panel.

**! CAUTION:** Take care when drilling. Do not damage the shock absorber, which is behind the panels.

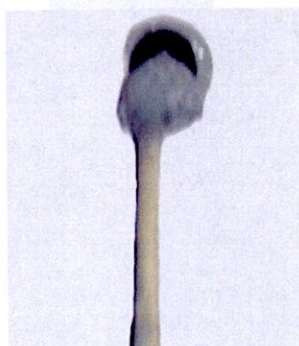
Figure 9

2. Use a cotton swab to apply etch primer to the edges and insides of the holes (Figure 9). Allow the primer to dry before continuing.

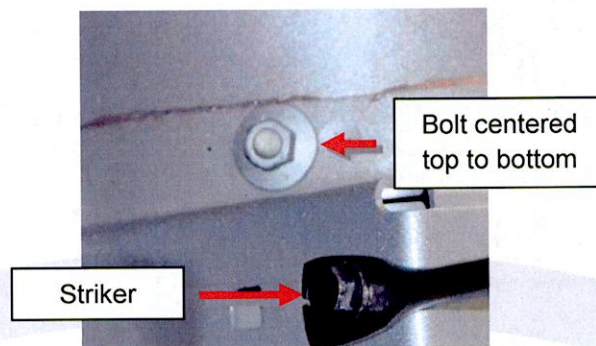
Figure 10 (Position 1 shown)

3. Have an assistant insert bolts into the 2 holes from the wheel side and hold them in place. Secure the nuts on the inside (Figure 10) (torque 12 Nm).

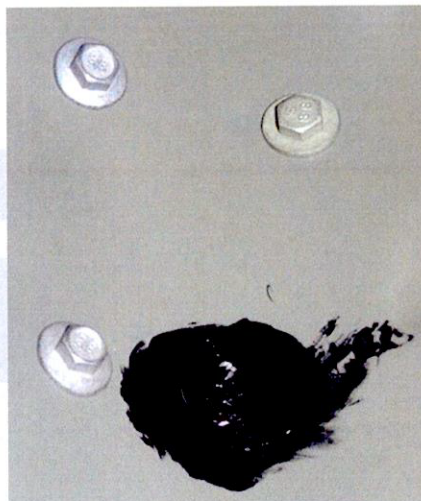
Figure 11

1. Clean up any metal shavings.
2. Completely cover the 4 wheel side bolt heads with sealant (Figure 11).

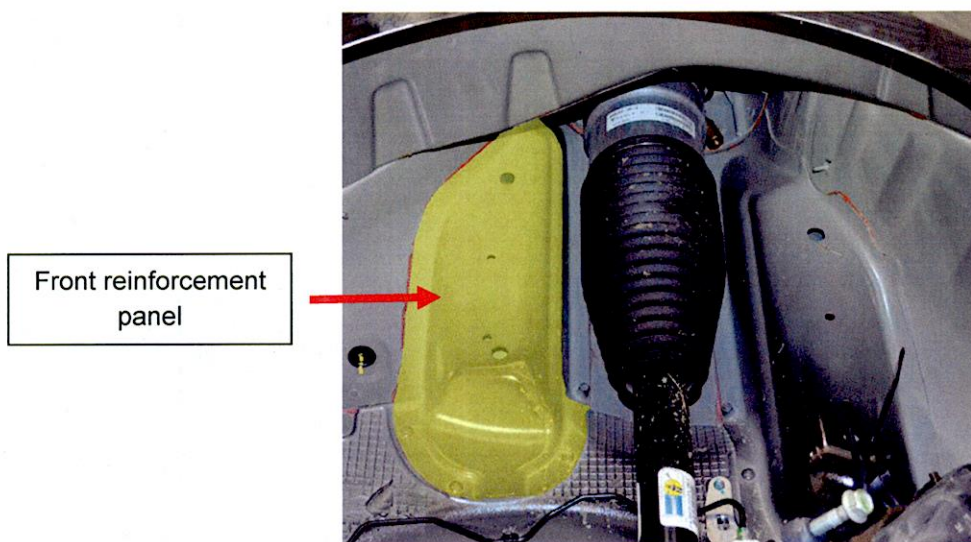
Figure 1

1. Remove the LH rear wheel arch liner (refer to Service Manual procedure 12011102).
2. Check the forward part of the LH rear wheel well for a front reinforcement panel (Figure 1). If one is present, no work is needed. If one is not present, continue this procedure.

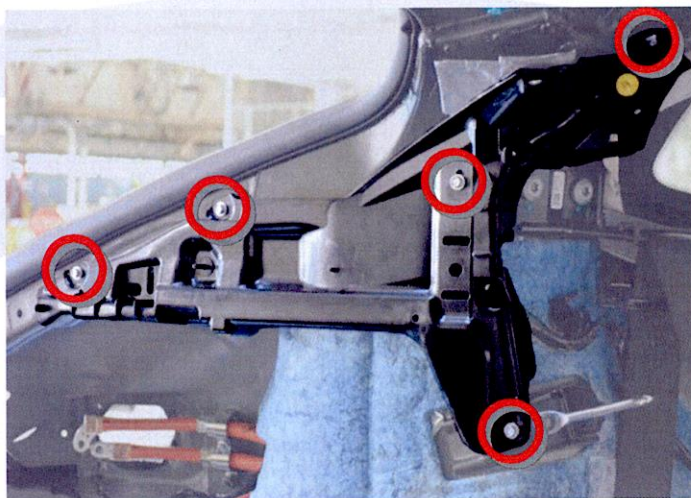
Figure 2

5. Remove the LH C-Pillar bracket by releasing the 5 bolts (Figure 2).

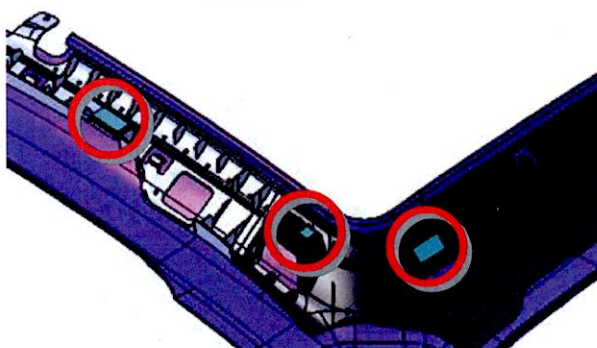
Figure 3 (LH locations of Dual Lock shown)

**NOTE:** Pull down the LH corner of the headliner as needed to access the upper bolt. Headliners in vehicles with panoramic roofs are secured with Dual Lock (Figure 3).

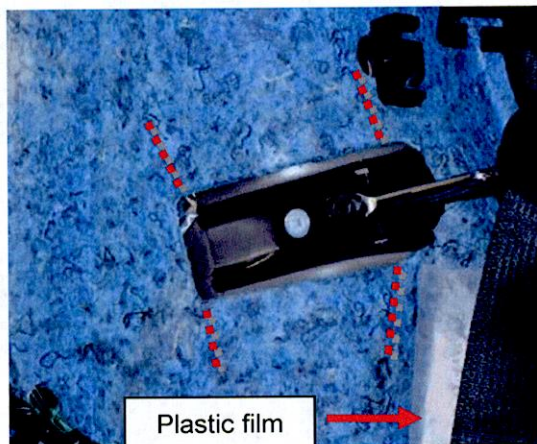
Figure 4

6. Cut the insulation as shown (Figure 4). This creates tabs that can be folded back to access the spot welds on the 2<sup>nd</sup> row seat striker bracket.

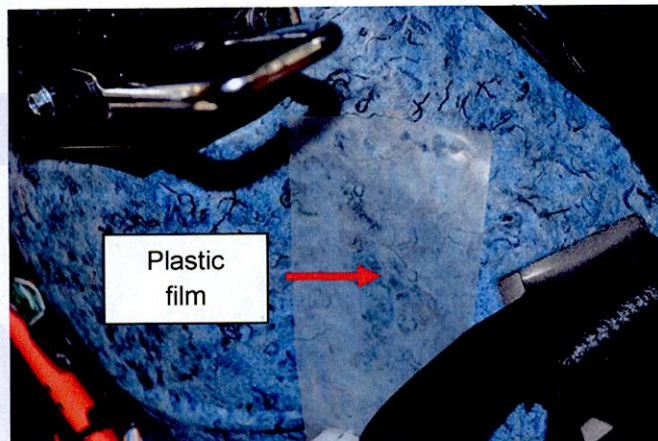
Figure 5

**CAUTION:** Do not cut or peel back the plastic film near the striker (Figure 5).

**NOTE:** If the insulation is already cut, fold it back and check to see if 4 pop rivets or bolts have already been installed at the positions in Figure 5. If so, this procedure has already been performed and no further work is required.

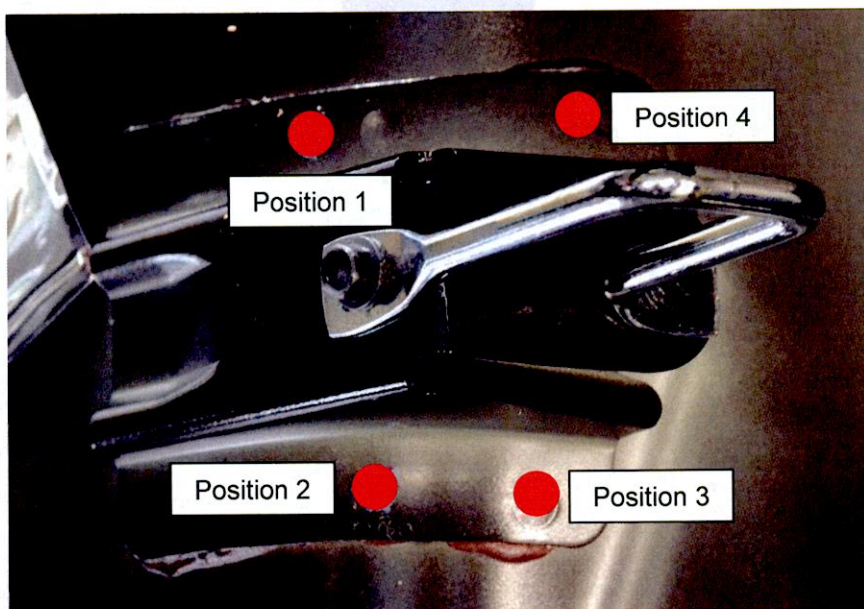
Figure 6

7. Use a marker or paint pen to mark 4 drill points (Figure 6). Do not drill at this time.
- On the top row of spot welds, 60 mm from the rear of the flange, centered top to bottom (Position 1).
  - On the bottom row of spot welds, 60 mm from the rear of the flange, centered top to bottom (Position 2).
  - On the bottom row of spot welds, 20 mm from the front of the flange, centered top to bottom (Position 3).
  - On the top row of spot welds, 20 mm from the front of the flange, centered top to bottom (Position 4).

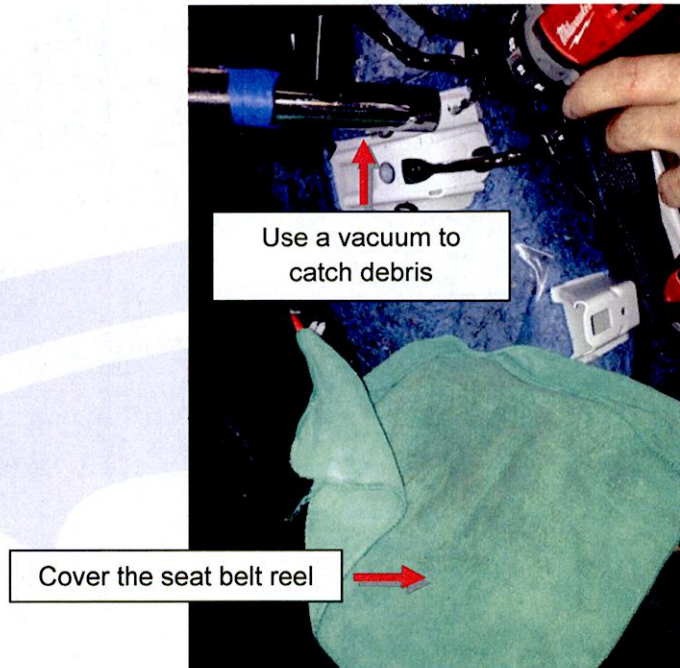
**Figure 7**

**⚠ CAUTION:** Before drilling in later steps, cover the seat belt reel. When drilling, use a vacuum to catch any debris (Figure 7).

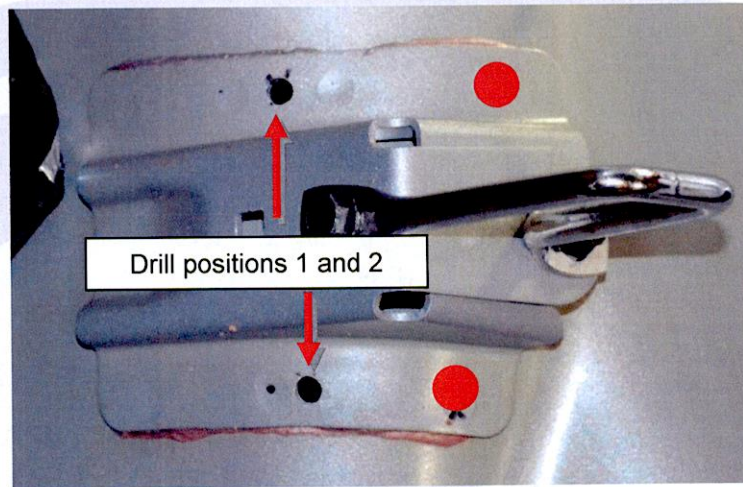
Figure 8

**! CAUTION:** When drilling, use a vacuum to catch any debris. Ensure that no debris falls between the striker bracket and wheelhouse panel.

**! CAUTION:** Take care when drilling. Do not damage the shock absorber, which is behind the panels.

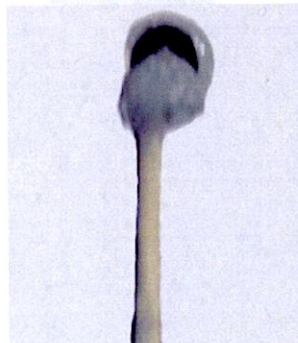
Figure 9

2. Use a cotton swab to apply etch primer to the edges and insides of the holes (Figure 9). Allow the primer to dry before continuing.

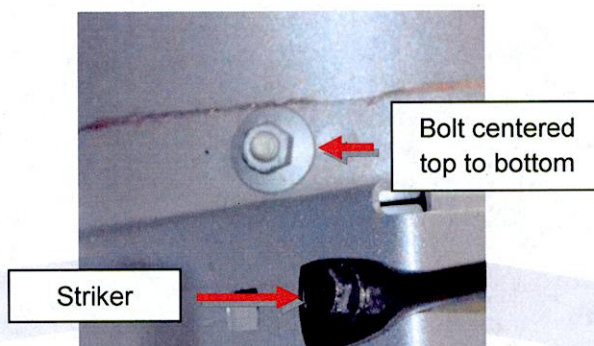
Figure 10 (Position 1 shown)

3. Have an assistant insert bolts into the 2 holes from the wheel side and hold them in place. Secure the nuts on the inside (Figure 10) (torque 12 Nm).

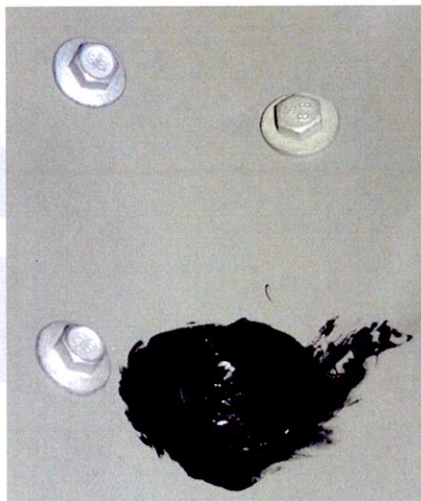
Figure 11

1. Clean up any metal shavings.
2. Completely cover the 4 wheel side bolt heads with sealant (Figure 11).

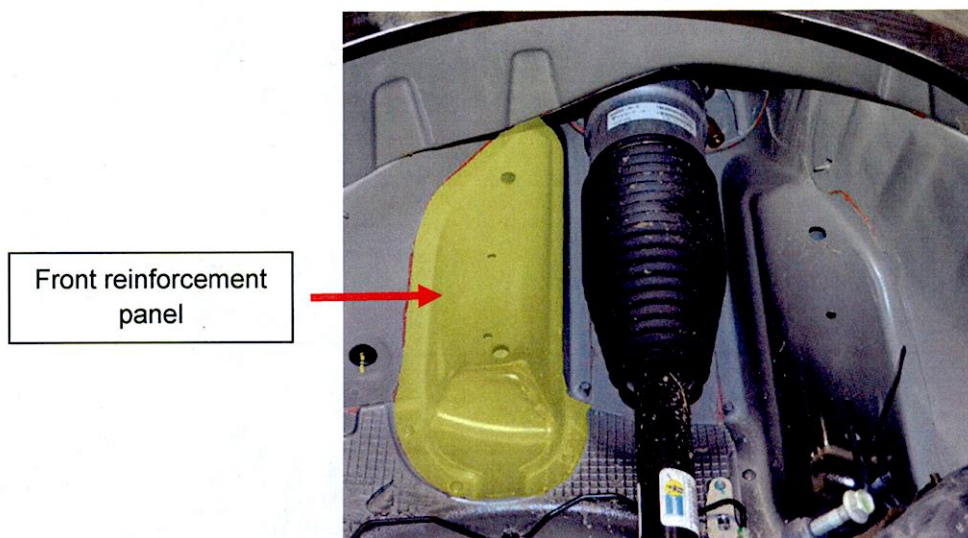
**Figure 1**

1. Remove the LH rear wheel arch liner (refer to Service Manual procedure 12011102).
2. Check the forward part of the LH rear wheel well for a front reinforcement panel (Figure 1). If one is present, no work is needed. If one is not present, continue this procedure.

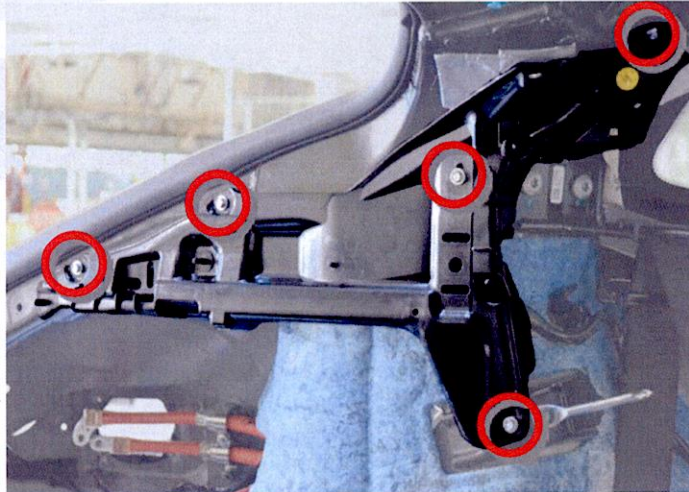
**Figure 2**

4. Remove the LH rear trunk side trim (refer to Service Manual procedure 15245002).
5. Remove the LH C-Pillar bracket by releasing the 5 bolts (Figure 2).

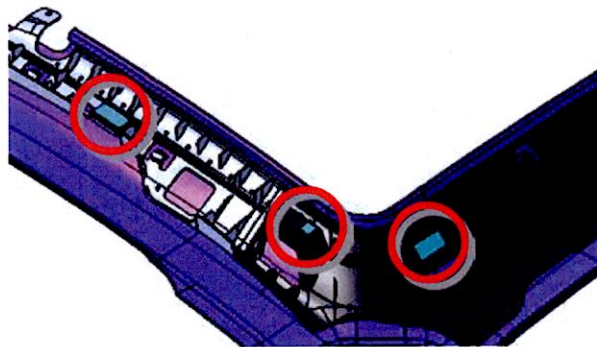
**Figure 3 (LH locations of Dual Lock shown)**

**NOTE:** Pull down the LH corner of the headliner as needed to access the upper bolt. Headliners in vehicles with panoramic roofs are secured with Dual Lock (Figure 3).

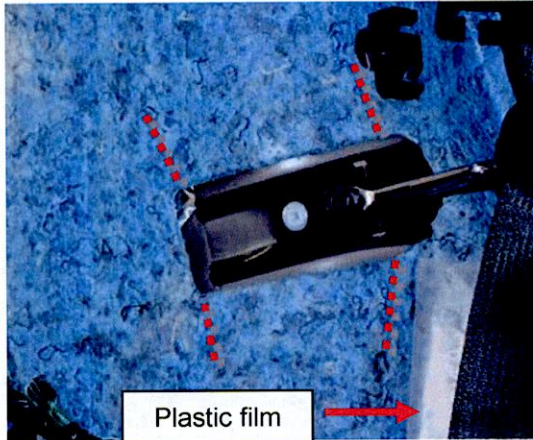
Figure 4

6. Cut the insulation as shown (Figure 4). This creates tabs that can be folded back to access the spot welds on the 2<sup>nd</sup> row seat striker bracket.

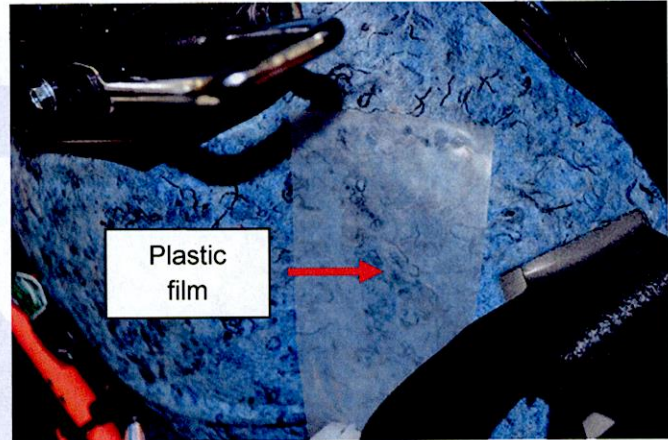
Figure 5

**CAUTION:** Do not cut or peel back the plastic film near the striker (Figure 5).

**NOTE:** If the insulation is already cut, fold it back and check to see if 4 pop rivets or bolts have already been installed at the positions in Figure 5. If so, this procedure has already been performed and no further work is required.

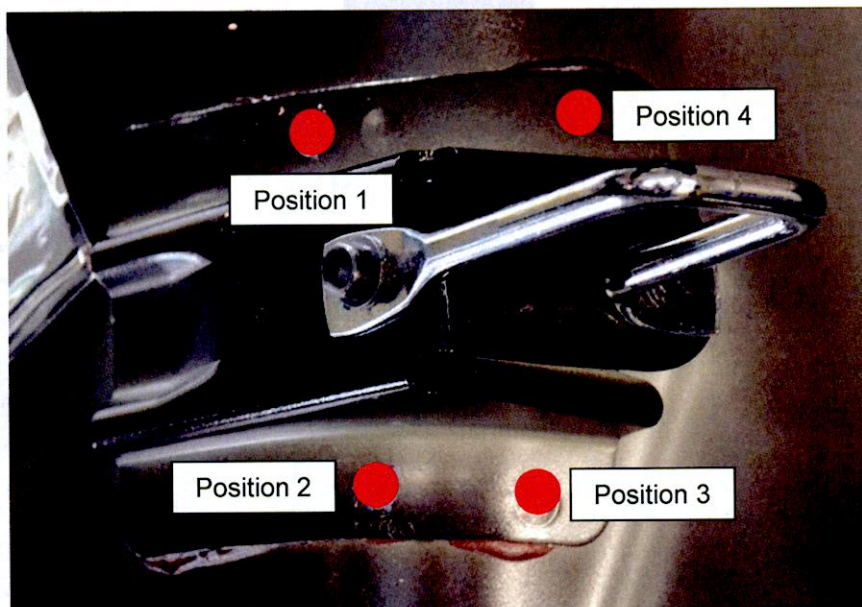
Figure 6

7. Use a marker or paint pen to mark 4 drill points (Figure 6). Do not drill at this time.
- On the top row of spot welds, 60 mm from the rear of the flange, centered top to bottom (Position 1).
  - On the bottom row of spot welds, 60 mm from the rear of the flange, centered top to bottom (Position 2).
  - On the bottom row of spot welds, 20 mm from the front of the flange, centered top to bottom (Position 3).
  - On the top row of spot welds, 20 mm from the front of the flange, centered top to bottom (Position 4).

1. Using a 1/4 in (6.35 mm) drill bit, drill position 3 on the 2<sup>nd</sup> row seat striker bracket (Figure 6). Drill completely through all sheets.
  - ⚠ **CAUTION:** When drilling, ensure that the hole in the flange is centered top to bottom.
  - ⚠ **CAUTION:** When drilling, use a vacuum to catch any debris. Ensure that no debris falls between the striker bracket and wheelhouse panel.
  - ⚠ **CAUTION:** Take care when drilling. Do not damage the shock absorber, which is behind the panels.
2. Use a cotton swab to apply etch primer to the edges and inside of the hole (Figure 9). Allow the primer to dry before continuing.
3. Have an assistant insert the bolt into the hole from the wheel side and hold it in place. Secure the nut on the inside (torque 12 Nm).

1. Using a 1/4 in (6.35 mm) drill bit, drill position 4 on the 2<sup>nd</sup> row seat striker bracket (Figure 6). Drill completely through all sheets.
  - ⚠ **CAUTION:** When drilling, ensure that the hole in the flange is centered top to bottom.
  - ⚠ **CAUTION:** When drilling, use a vacuum to catch any debris. Ensure that no debris falls between the striker bracket and wheelhouse panel.
  - ⚠ **CAUTION:** Take care when drilling. Do not damage the shock absorber, which is behind the panels.
2. Use a cotton swab to apply etch primer to the edges and inside of the hole (Figure 9). Allow the primer to dry before continuing.
3. Have an assistant insert the bolt into the hole from the wheel side and hold it in place. Secure the nut on the inside (torque 12 Nm).

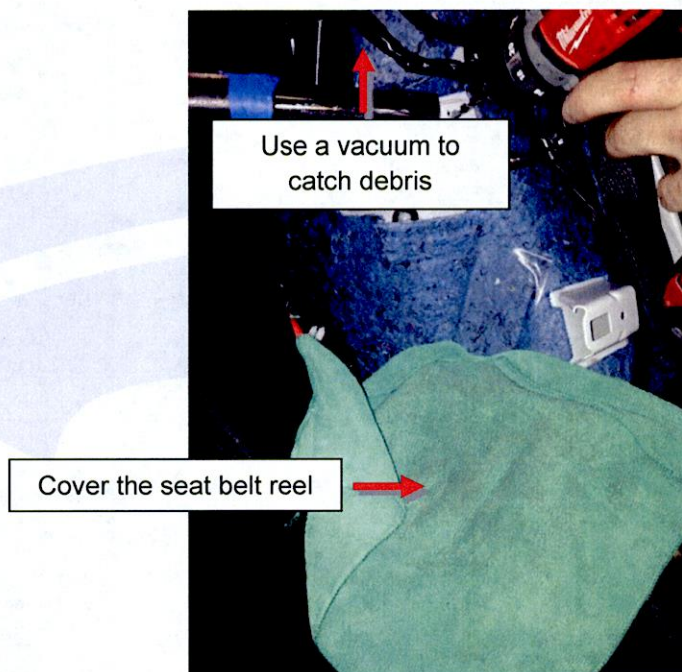
**Figure 7**

**⚠ CAUTION:** Before drilling in later steps, cover the seat belt reel. When drilling, use a vacuum to catch any debris (Figure 7).

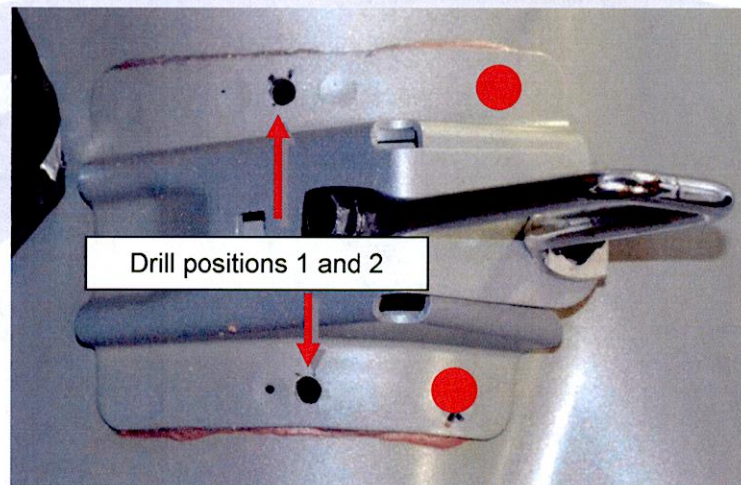
Figure 8

**! CAUTION:** When drilling, use a vacuum to catch any debris. Ensure that no debris falls between the striker bracket and wheelhouse panel.

**! CAUTION:** Take care when drilling. Do not damage the shock absorber, which is behind the panels.

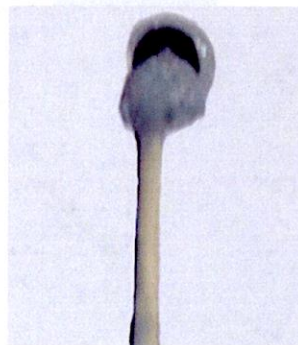
Figure 9

2. Use a cotton swab to apply etch primer to the edges and insides of the holes (Figure 9). Allow the primer to dry before continuing.

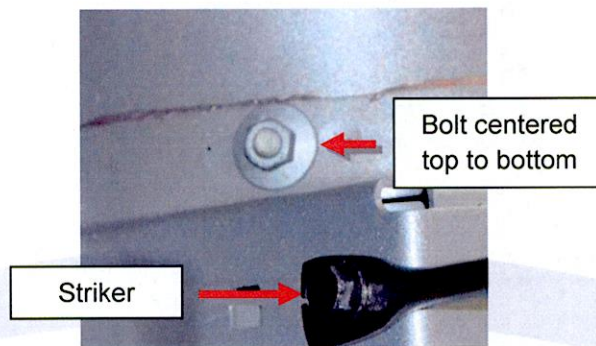
Figure 10 (Position 1 shown)

3. Have an assistant insert bolts into the 2 holes from the wheel side and hold them in place. Secure the nuts on the inside (Figure 10) (torque 12 Nm).

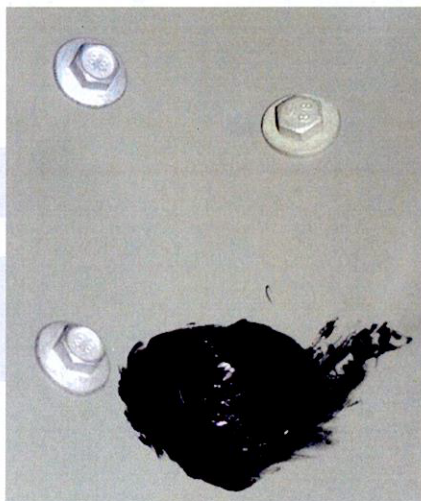
Figure 11

1. Clean up any metal shavings.
2. Completely cover the 4 wheel side bolt heads with sealant (Figure 11).
