# SERVICE BULLETIN

## TS-S37

**Safety Recall / NHTSA Campaign # 13V - 250**

Seat Bolts Replacement

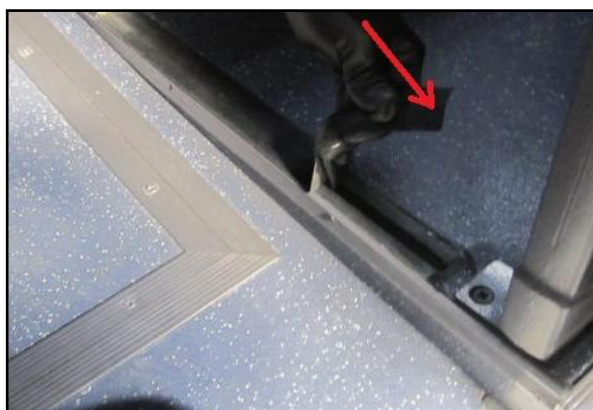
Photo 1

1. Remove the rail covers from the seat rail on the floor.

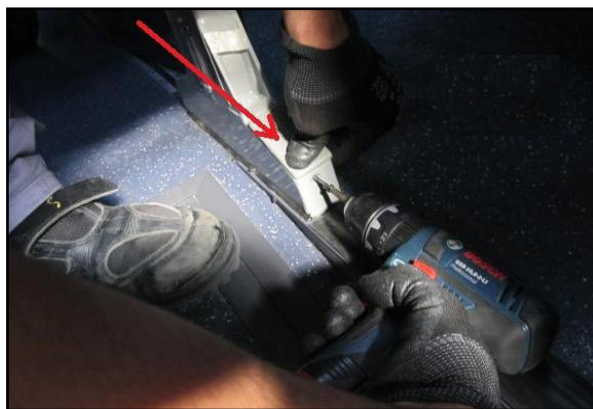
Photo 2

2. Remove the screw cover from the seat leg attached on the floor.

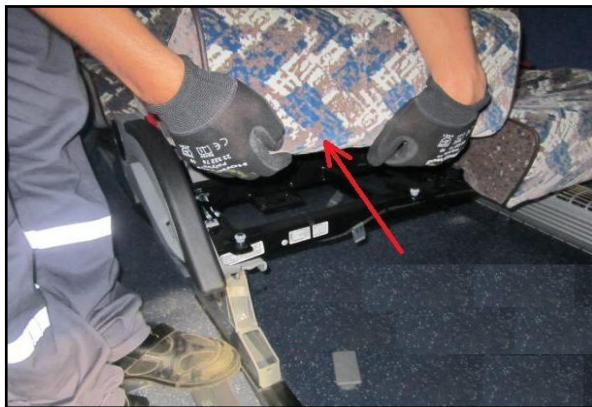
Photo 3

3. Remove seat cushions by pulling the front lower side.

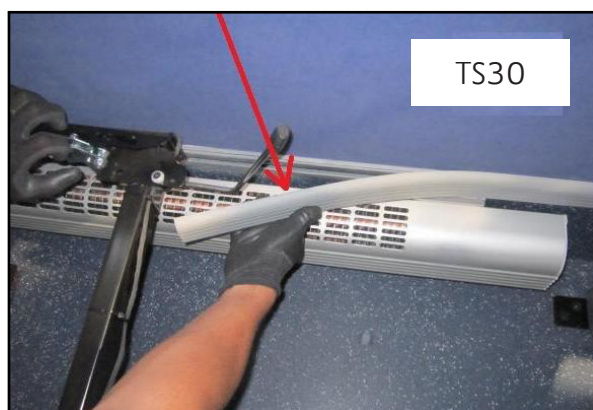
Photo 4

4. Remove side wall seat rail bolt covers. Different covers are used for TS30 & TS35C, both of which can easily be removed by hand.

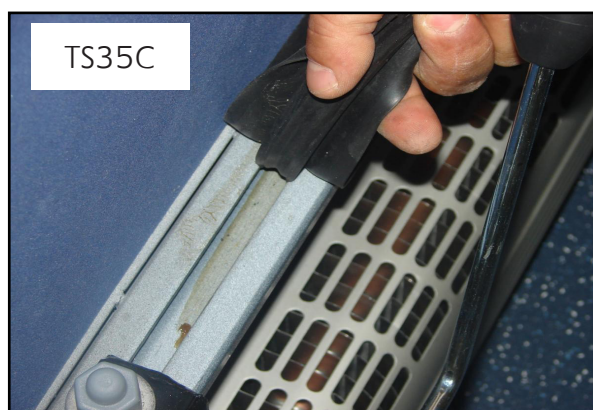
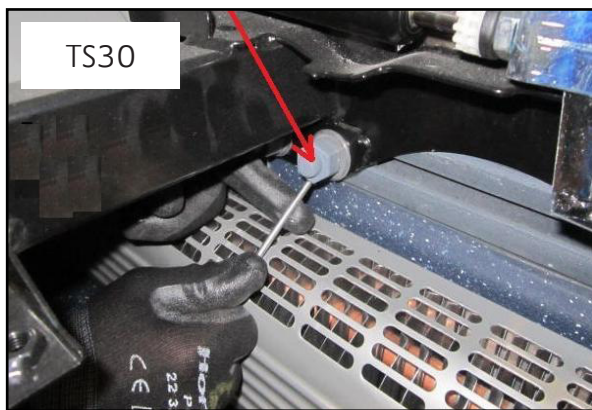
Photo 5

5. Remove blind caps of nuts with the help of a screwdriver.

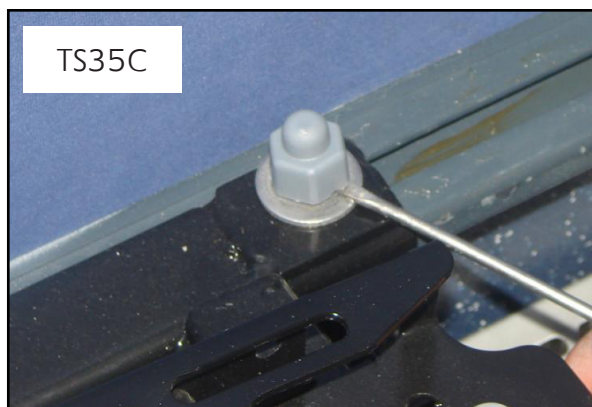
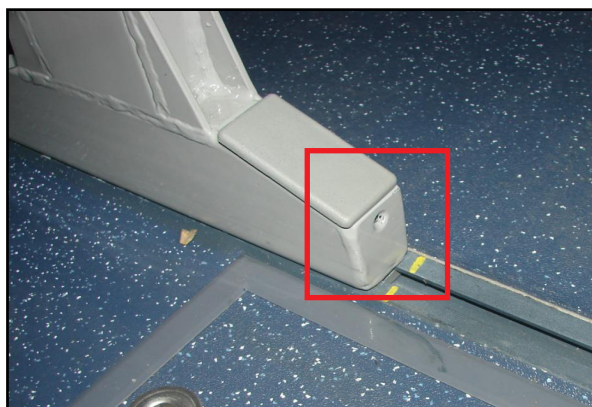
Photo 7

6. Make markings on the floor or the side wall so that you can protect seats from sliding and consequently losing their initial positions.

This process is of vital importance in terms of seat locations

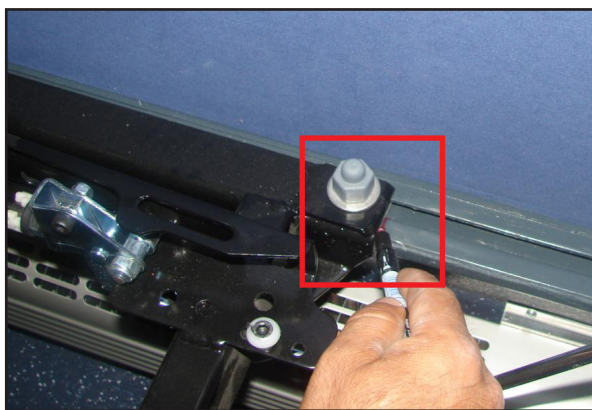
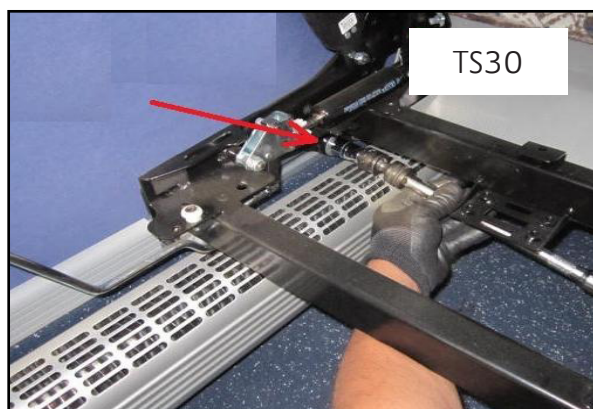
Photo 9

7. Unscrew the bolts and nuts on the sidewall.

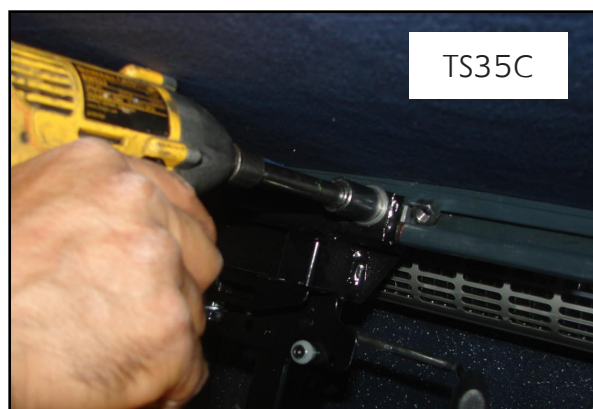
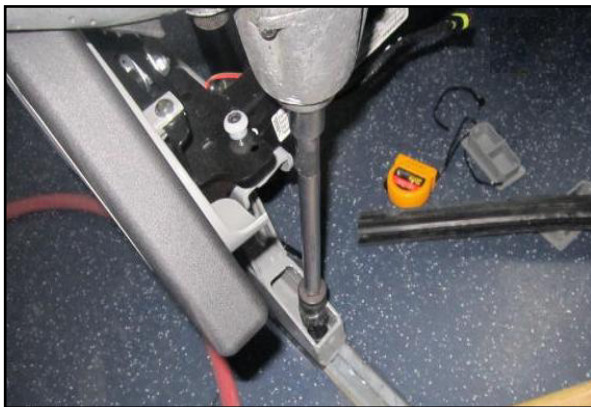
Photo 10

8. Unscrew the seat connection bolts and nuts on the floor.

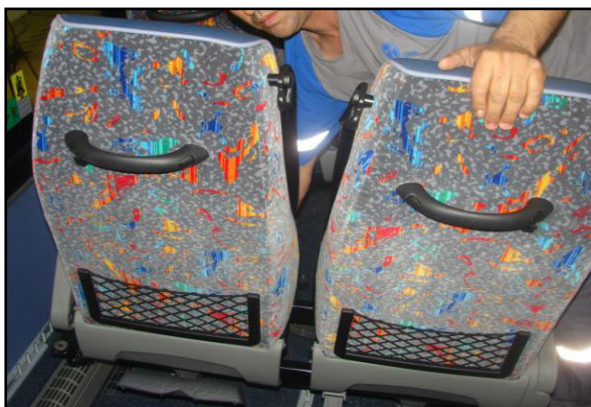
Photo 12

9. Lift the seats and slide the connection bolts through the rail towards the rear end after unscrewing the seat connection elements.

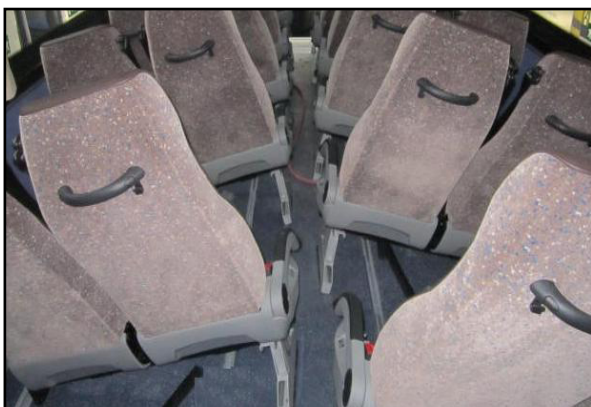
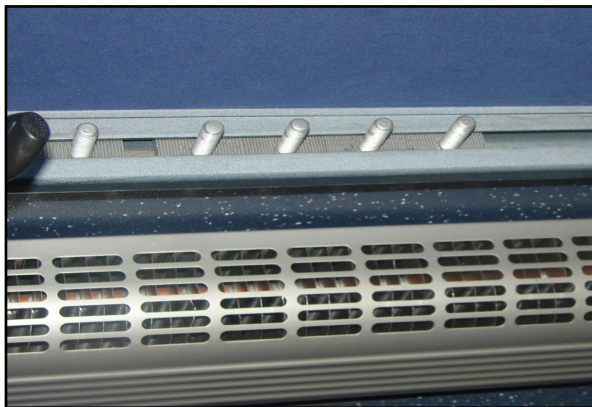
Photo 13

**10.** The process of sliding the T Bolts on the side wall must be started from front seats first and must be proceeded towards the rear seats. Then T Bolts at the very rear side of rails could be removed.

\* Sliding the side wall connection bolts.

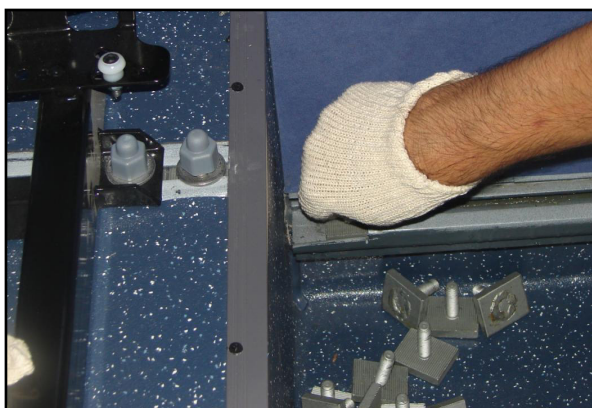
Photo 15

\* Removing the side wall connection bolts.

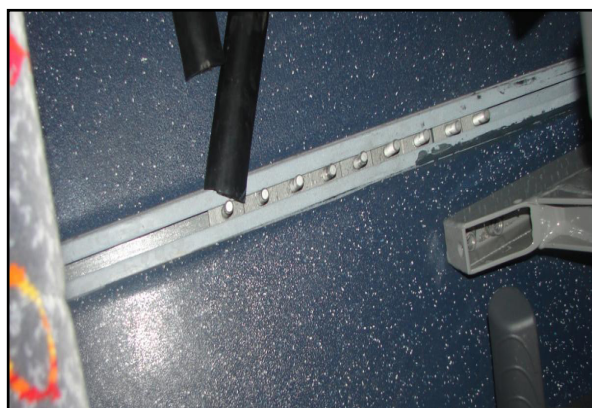
Photo 16

**11.** The process of sliding the T Bolts on the floor must be started from the front seats first and must be proceeded towards the rear seats. Then bolts at the very rear side of rails could be removed.

\* Sliding the connection bolts on the floor.

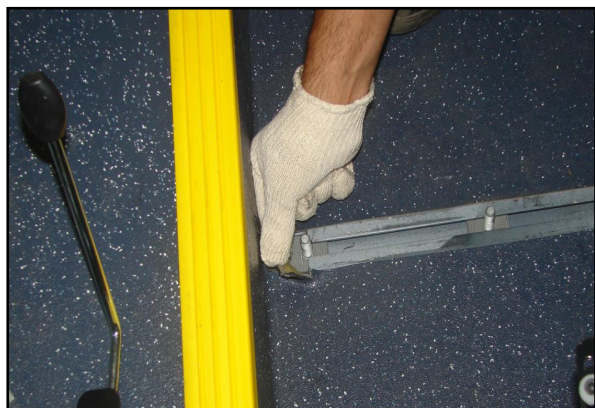
Photo 17

\* Removing the floor connection bolts.

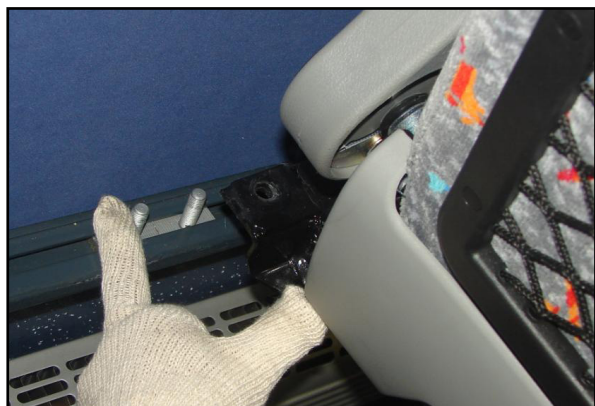
Photo 18

12. Insert new bolts just as many as those removed old bolts. And then, First insert side wall connection elements of seats into the bolts.

**Make sure 10.9 quality T-Bolts and 10 quality nuts are used.**

**Replaced T-Bolts and nuts must be scrapped.**

**Assembly sequence:**  
First install the bolt then add washer on it, after that put the spring washer and finally screw the nut.

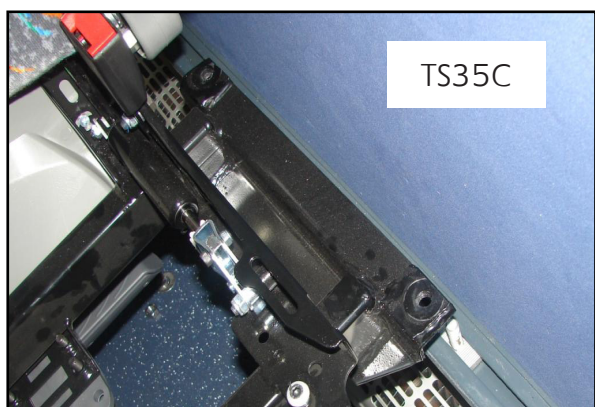
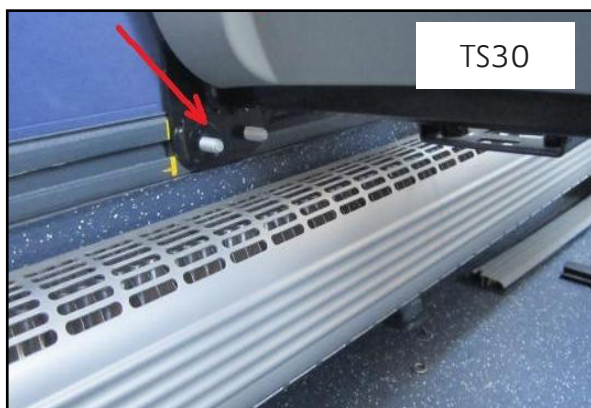
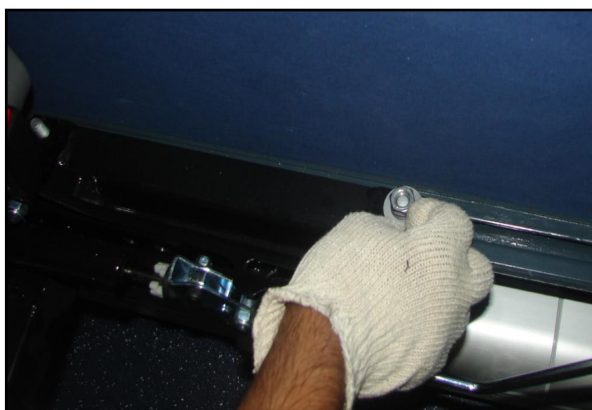
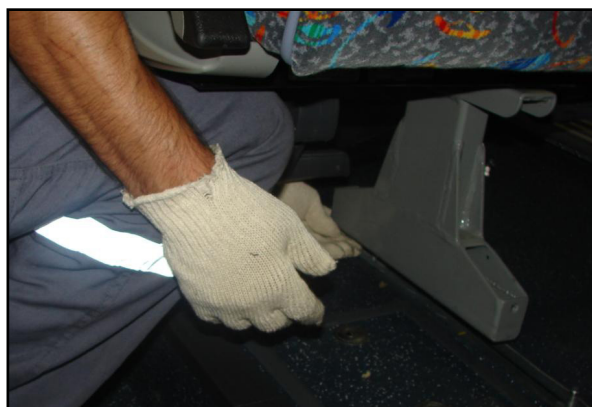
Photo 19

**13.** Secondly, insert the bolts attached on the floor into the seat legs.

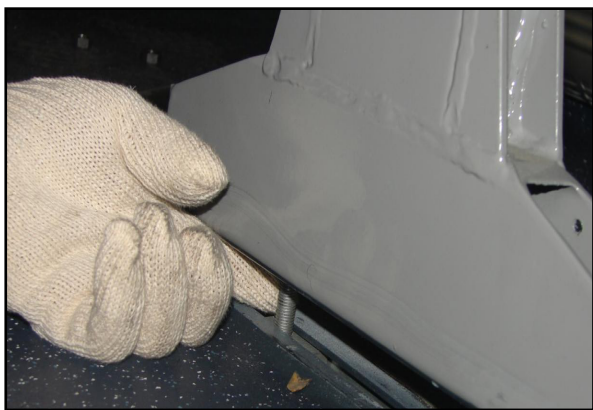
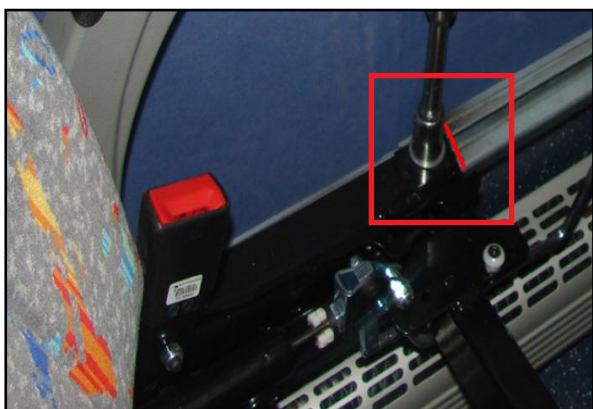
Photo 23

**14.** Slide and locate the seats according to markings that you already made **to locate the seats in their original position which is extremely important. Be sure that they are located in their original position** after inserting the bolts' side wall and seat bottom connections. Start tightening the nuts with side wall connections.

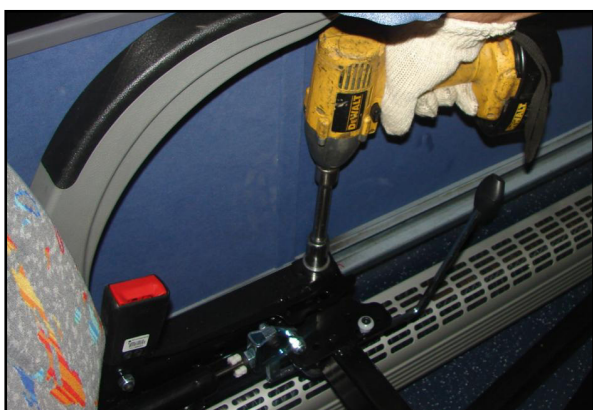
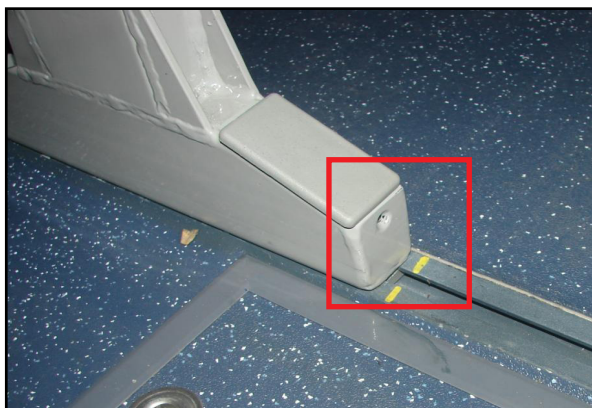
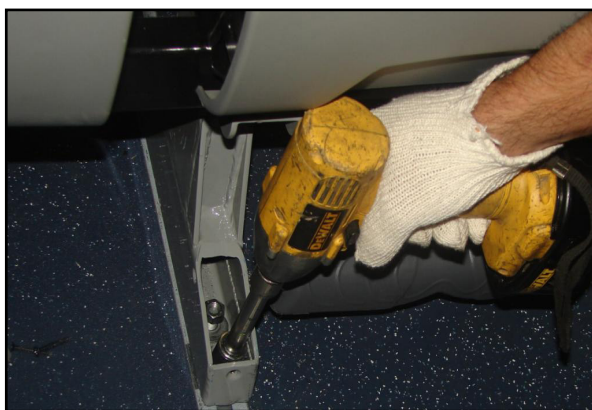
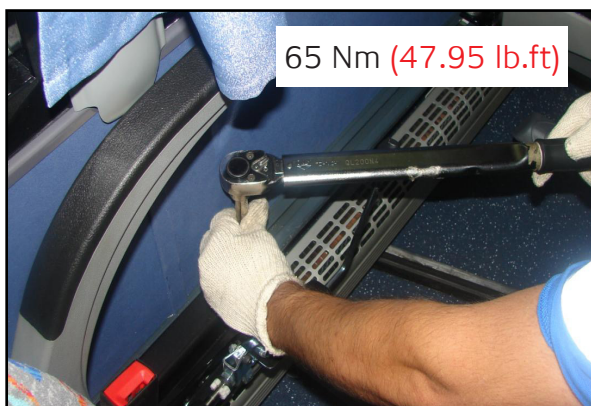
Photo 25

Apply a 65 Nm (47.95 lb.ft) torque to all the bolts and nuts after tightening process. (This process is of vital importance for safety reasons)

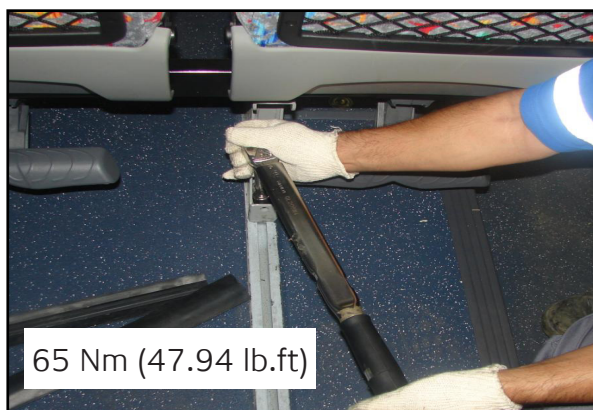
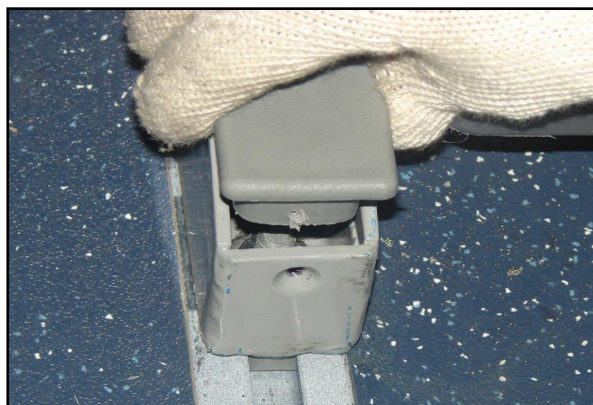
Photo 29

**16.** Insert screw covers and tighten the screws on the seat legs after the previous tightening and torquing process.

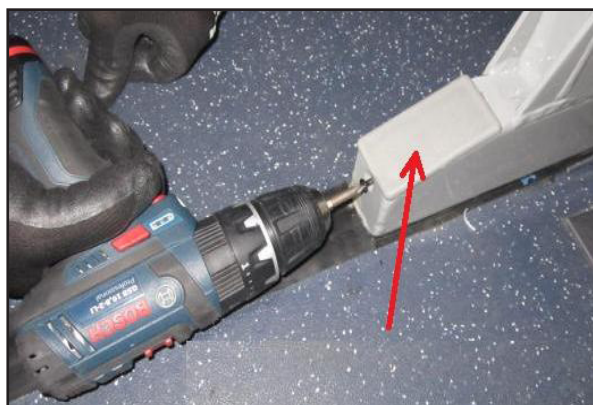
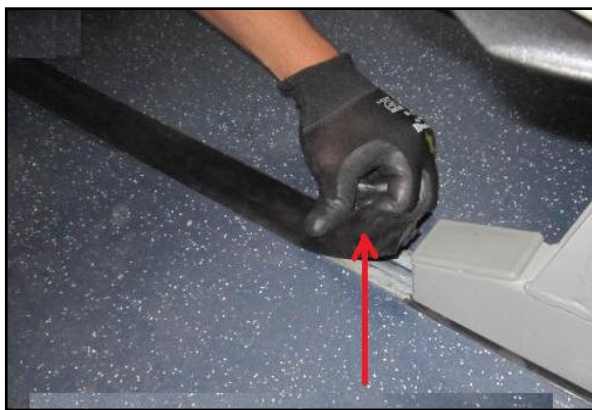
Photo 31

**17.** Insert rail covers back on the floor.

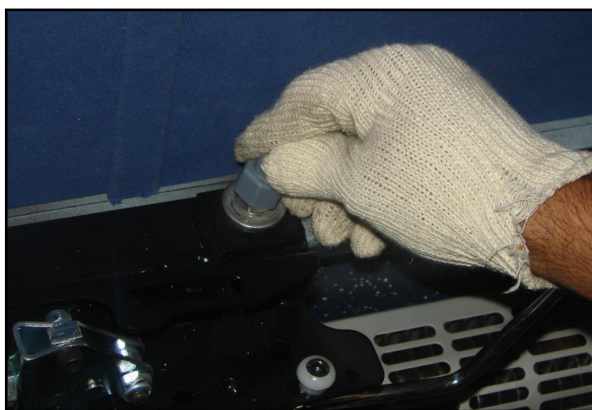
Photo 33

**18.** Insert the blind caps of side wall bolts and nuts back.

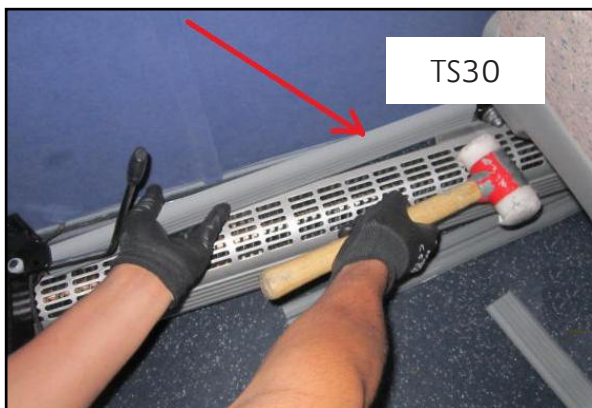
Photo 34

**19.** Insert the side wall rail covers back.

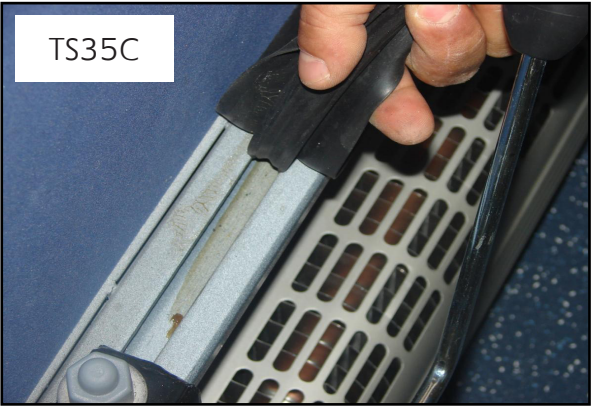
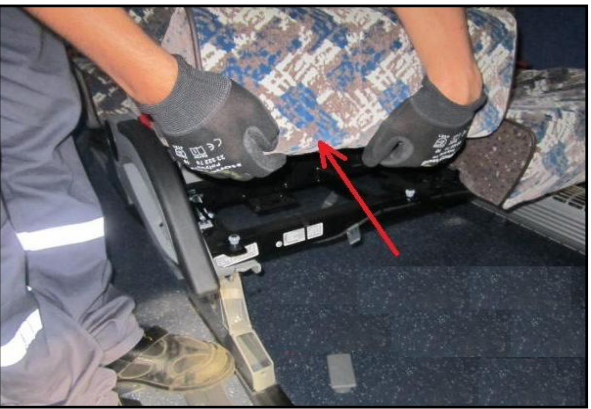
Photo 35

**20 .** The whole process is completed by inserting seat cushions back.
