AC Evaporator Bolt Replacement Instructions

Glaval Bus Recall Notice Number 13V-309

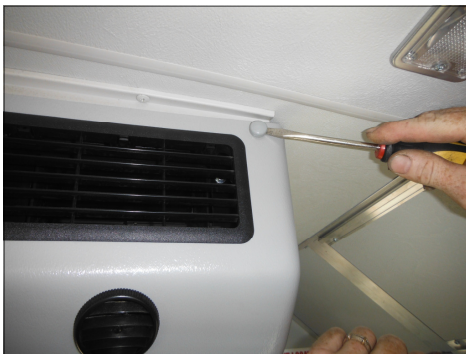
(Figure 1)

- Remove rear evaporator ABS A/C cover by removing the fasteners by popping off the caps and removing the screws . (See Figure 1)
- Locate the 4 5/16 bolts securing the unit to the structure. (See Figure 2)
- Check the torque on each of the four (4) bolts to ensure it is at 19 FT LBS.
- If a plus nut will not hold the torque or if the bolt spins, is loose or stripped see the steps below.
- Replace the ABS A/C cover
