RECALL CAMPAIGN BULLETIN

NTB13-073

VOLUNTARY SAFETY RECALL CAMPAIGN 2014 VERSA NOTE; LOWER BODY SILL BOLTS

APPLIED VEHICLES: 2014 Versa NOTE (E12)

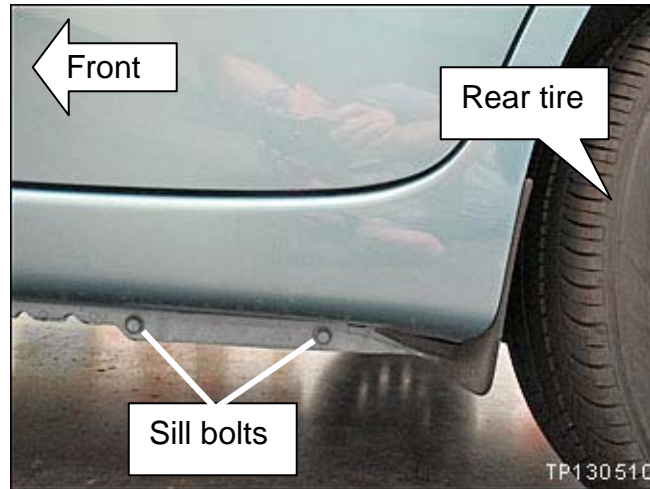
Figure 1

1. Locate the 2 lower body sill bolts on the left or right side (see Figure 1).

2. Perform the following checks and repairs:

If both sill bolts are present:

- Make sure both bolts are torqued to 30 N•m (3.0 kg-m, **22 ft-lb**).

If sill bolt(s) are missing:

- a. For missing bolts, clean the female threads with an 8 mm x 1.25 tap.
- b. Apply “thread locker” to the male threads of replacement bolts.
 - To obtain replacement bolts, see Replacement Lower Body Sill Bolts on the next page.
 - Use Loctite® 243™ medium strength thread locker or equivalent.
- c. Replace the missing bolts.
- d. Make sure both bolts are torqued to 30 N•m (3.0 kg-m, **22 ft-lb**).
- e. Apply body color touch up paint to the new bolts.
