Technical Service Bulletin

GROUP CAMPAIGN	NUMBER 13-01-039
DATE OCTOBER, 2013	MODEL(S) NF SONATA, TG AZERA

SUBJECT: REAR CROSSMEMBER CORROSION TREATMENT (RECALL 113)

Description: This bulletin describes the procedure to inspect and service the rear crossmember of certain NF Sonata and TG Azera vehicles. Additionally, a procedure is provided to apply cavity wax to the front crossmember as a preventative measure.

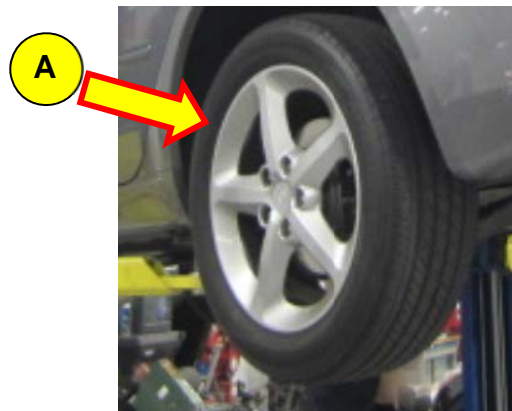
2. Remove the 4 rear crossmember rubber plugs (B). Discard the plugs; do not reinstall.

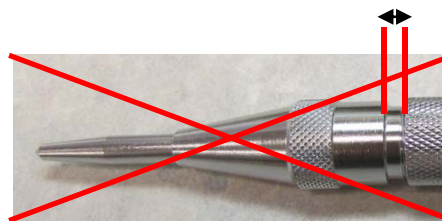
Set the punch adjustment to the fully tight position (highest spring pre-load).

There should be no gap, as shown to the right.

Incorrect Adjustment – Note the gap

Correct Adjustment – No gap

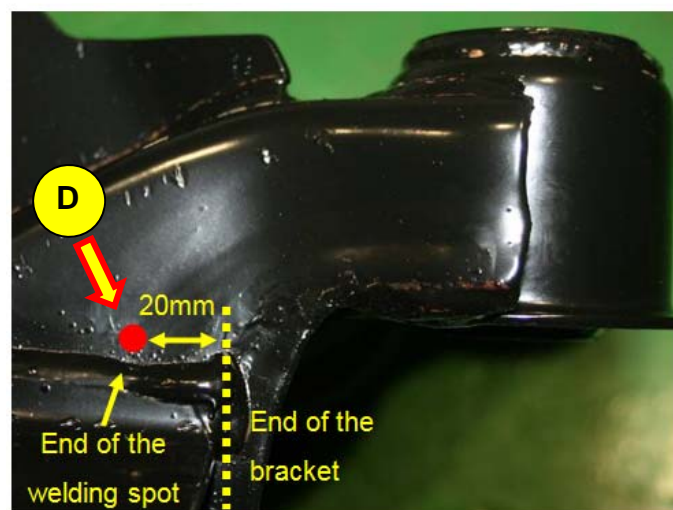
D: Punching location is right above the end of the weld line, 20mm inwards from the end of the bracket.

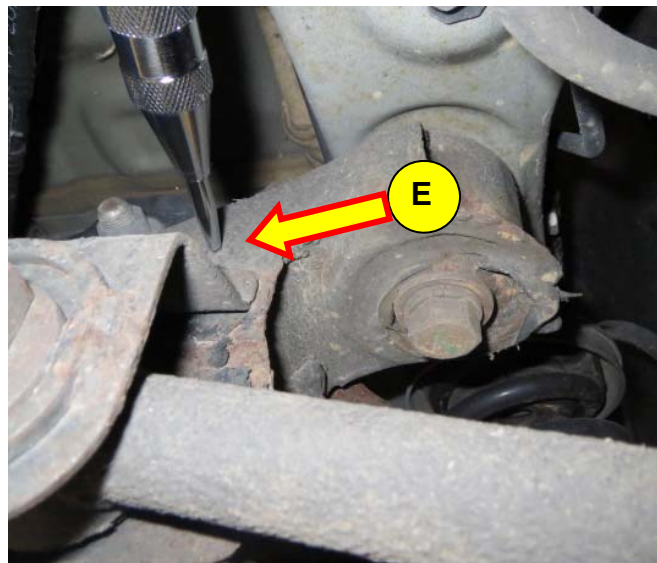
- 5c. Depress the automatic center punch by hand (**DO NOT USE A HAMMER**) to punch the rear crossmember (E) 10 times in the same location, as defined below. Repeat on the opposite side of the crossmember.

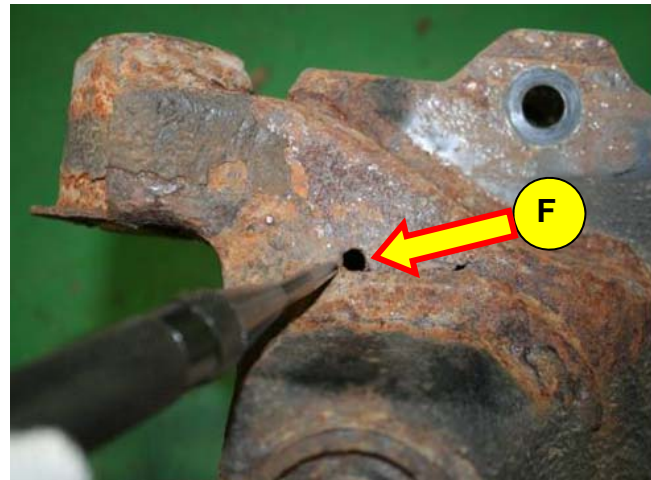
6. Check if there is a hole (F) on the crossmember after the punching.

If there is a hole, replace the rear crossmember with the new one following the '**REAR CROSSMEMBER ASSEMBLY REPLACEMENT**' procedure below.

If no hole exists, follow the '**REAR CROSSMEMBER AND CONTROL ARM CAVITY WAX / UNDERCOATING APPLICATION**' procedure.

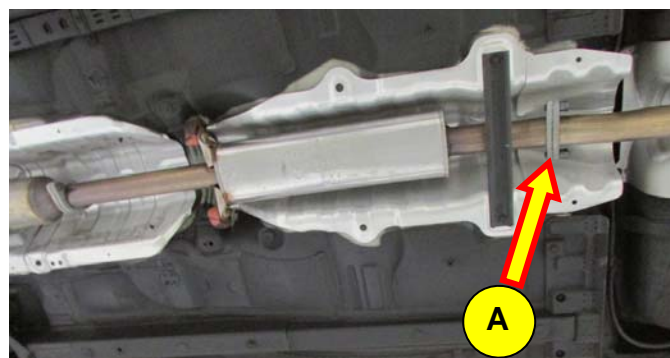
Disconnect the exhaust at the outlet flange of the center muffler (A).

Disengage the exhaust hangers to remove the rear muffler assembly following the procedures in the appropriate shop manual.

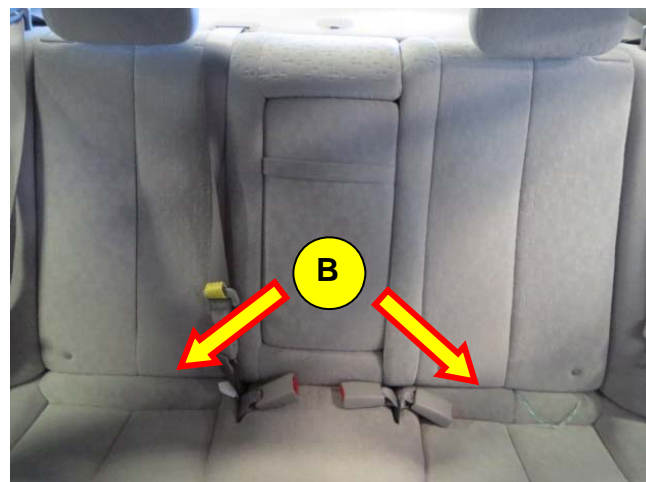
2. From the rear seat, remove the two 12mm seat bottom mounting bolts (B).

Tightening torque: 7.2~10.8 lb-ft
(9.8~14.7 Nm, 1.0~1.5 kgf.m)

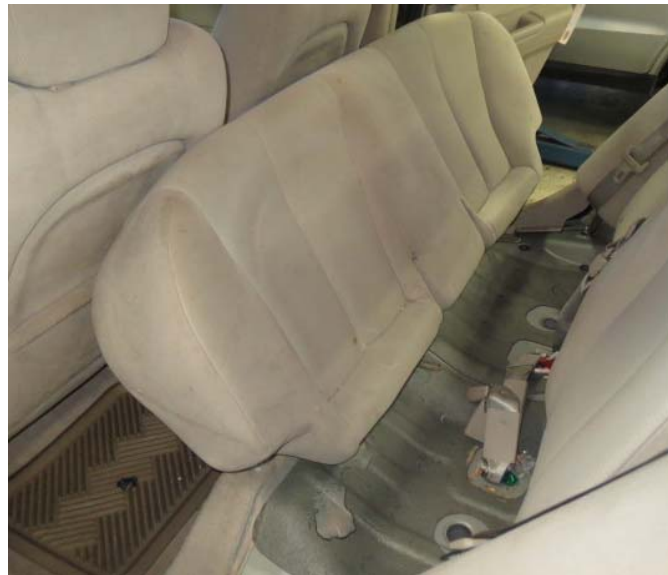
3. Remove the rear seat bottom cushion by pulling upward on the front edge.

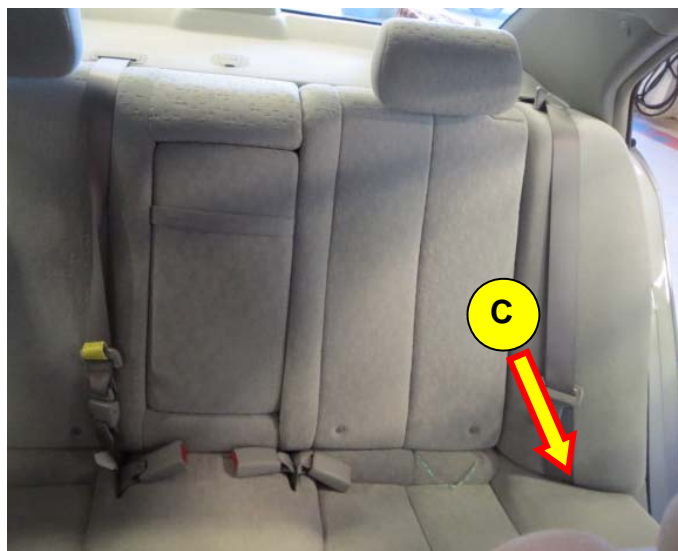
4. Remove the 12mm bolt (C) for the left side bolster cushion. Then lift the cushion upwards to remove. Repeat for the right side bolster.

Tightening torque: 7.2~10.8 lb-ft
(9.8~14.7 Nm, 1.0~1.5 kgf.m)

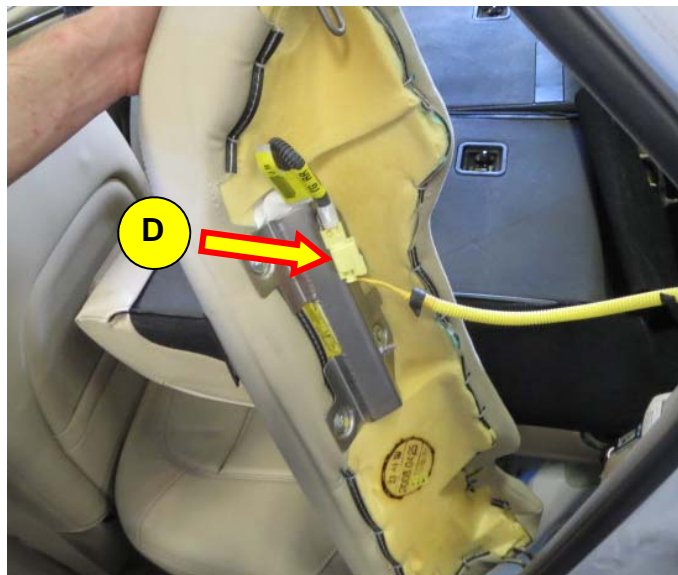
- 4a. If the vehicle is equipped with rear seat side air bags (Azera models only), disconnect the connector (D) before removing the side bolster cushions.

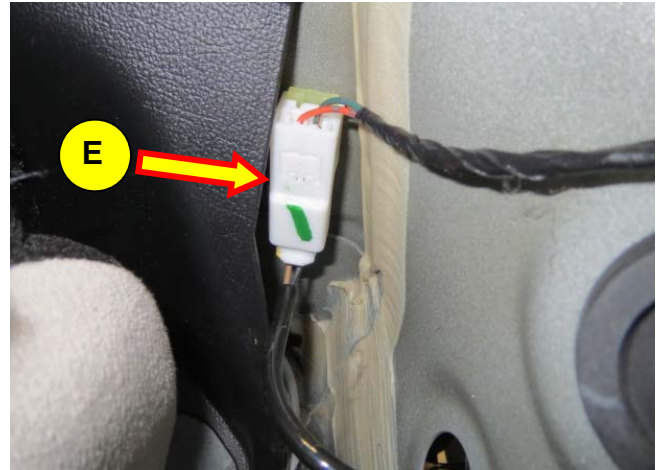
5. With the bolster cushions removed, locate the rear wheel speed sensor connectors (E), and disconnect them (both sides).

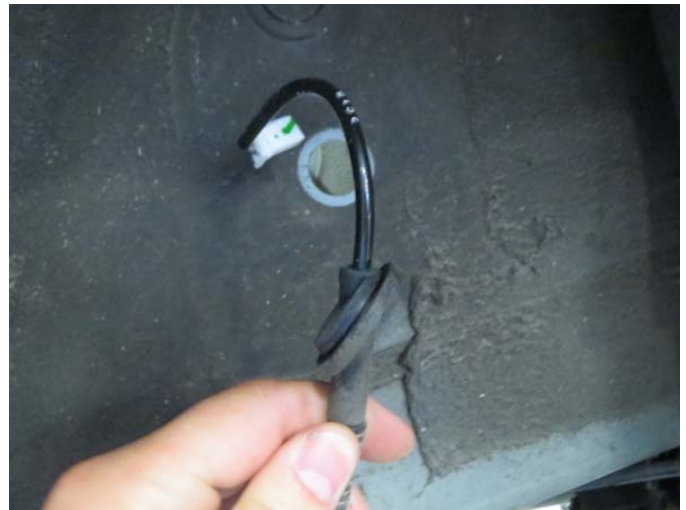
6. From the wheel housing side, disengage the grommet and pull the connector through.

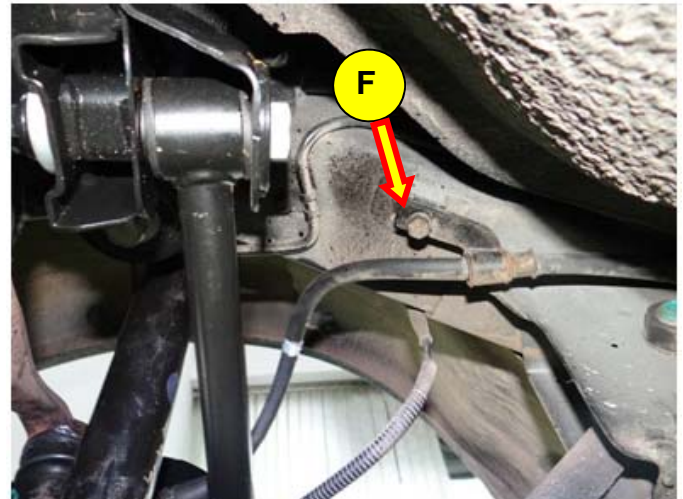
7. Remove the rear parking cable mounting bolt (F) on both sides (LH/RH).

Tightening torque: 14.5~21.7 lb-ft
(19.6~29.4 Nm, 2.0~3.0 kgf.m)

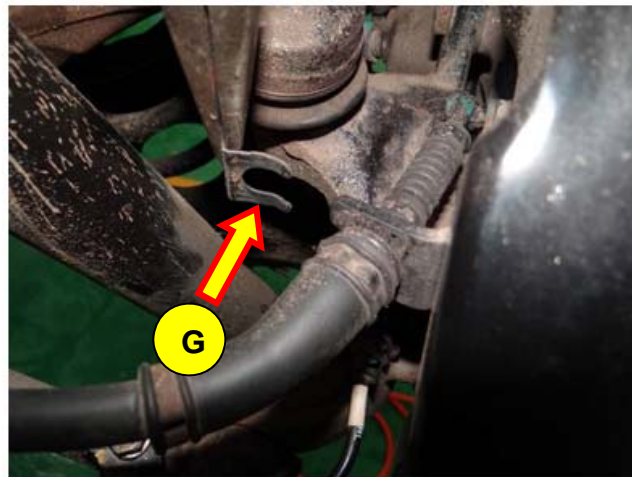
8. Remove the parking cable clip (G) on both sides (LH/RH) with a long nose plier and separate the parking cable from the rear axle.

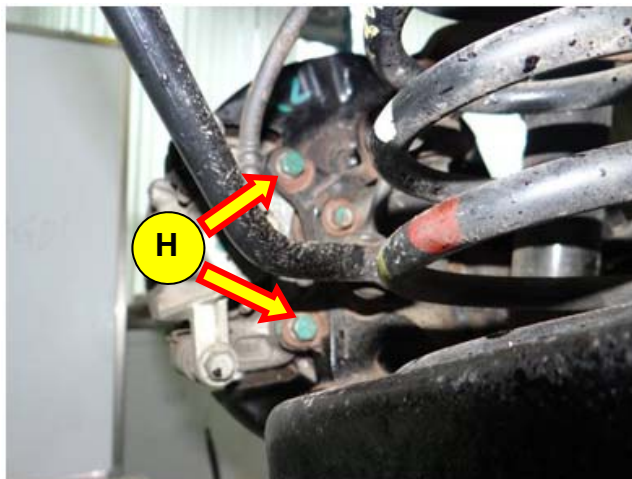
9. Remove the rear calipers from the knuckles by removing the bolts (H).

Tightening torque: 59.0~73.8 lb-ft
(78.4~98.1 Nm, 8.0~10.0 kgf.m)

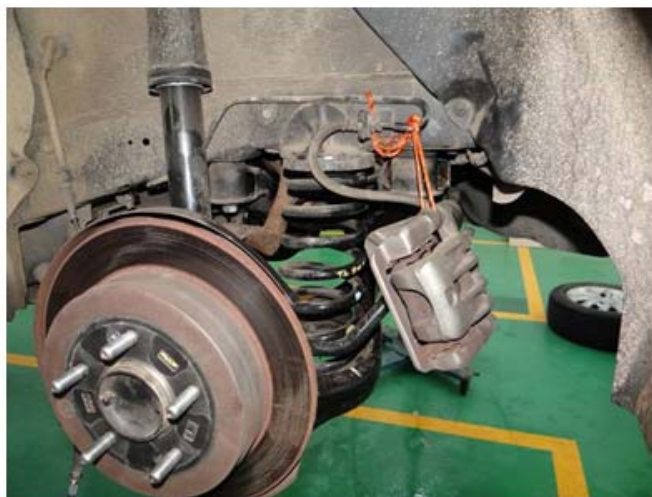
10. Secure the rear calipers so that the brake lines are not in tension, and that the calipers are out of the way when removing the rear crossmember.

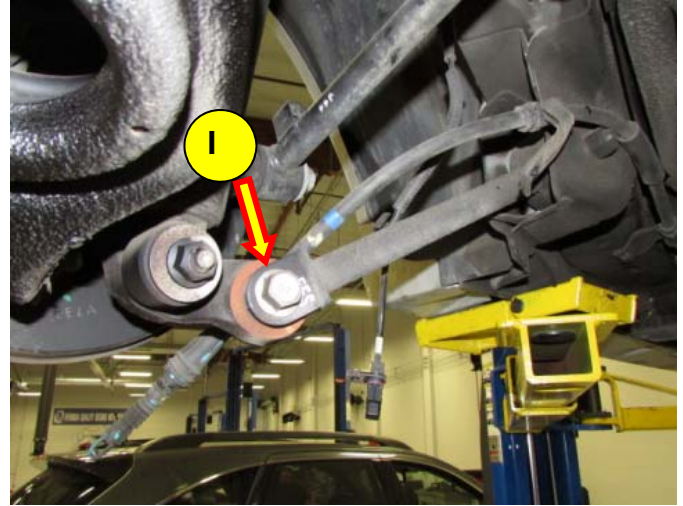
11. Remove the trailing arm mounting bolt (I).

Tightening torque: 101.2~115.7 lb-ft
(137.3~156.9 Nm, 14.0~16.0 kgf.m)

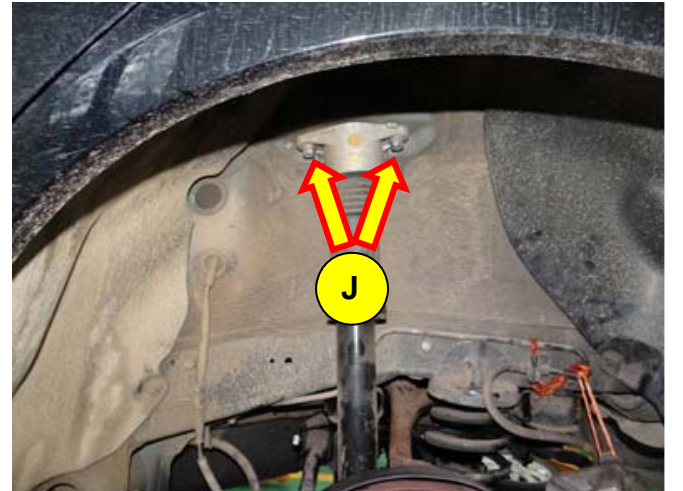
12. Remove the rear shock absorber upper mounting bolts (J).

Tightening torque: 36.2~43.4 lb-ft
(49.1~58.9 Nm, 5.0~6.0 kgf.m)

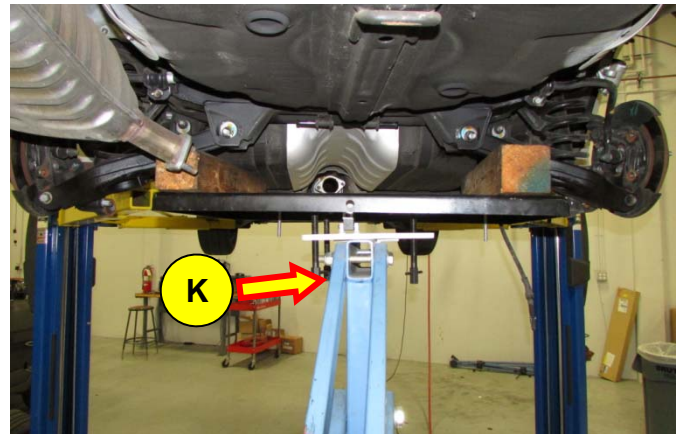
13. Support the crossmember using a hydraulic jack (K), or similar tool.

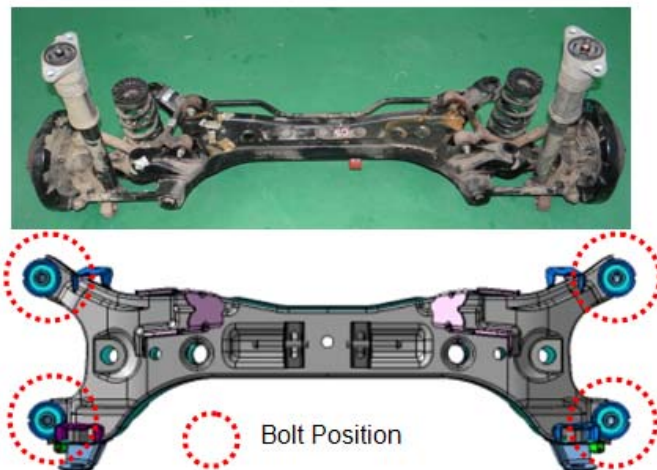
14. Remove 4 rear crossmember mounting bolts and lower the jack to remove the rear chassis module from the vehicle.

The crossmember-to-body mounting holes are 14MM X 1.5. If these threaded holes are damaged, use a tap to clean up the threads before attempting to install the new crossmember assembly.

Tightening torque: 101.2~115.7 lb-ft (137.3~156.9 Nm, 14.0~16.0 kgf.m)

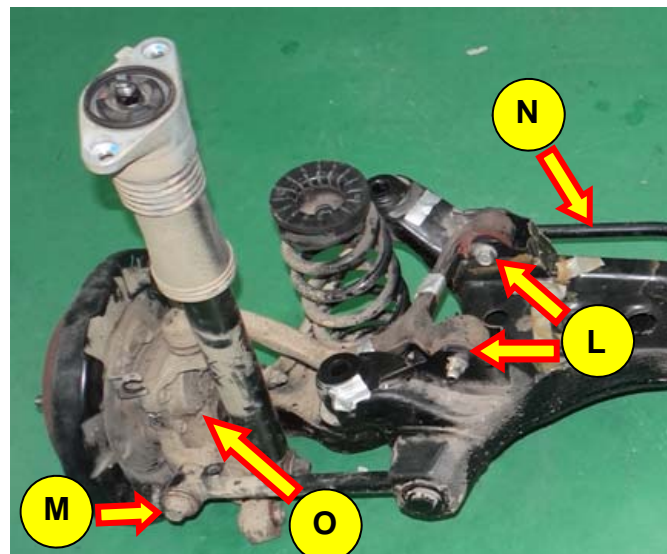
15. Remove the left and right knuckle assemblies from the rear chassis module:

- Unbolt the fasteners at the rear upper control arms (L).
- Unbolt the assist arms at the knuckles (M).
- Unbolt the sway bar (N) from the crossmember at the bushing brackets.
- Unbolt the lower control arms at the knuckles (O).

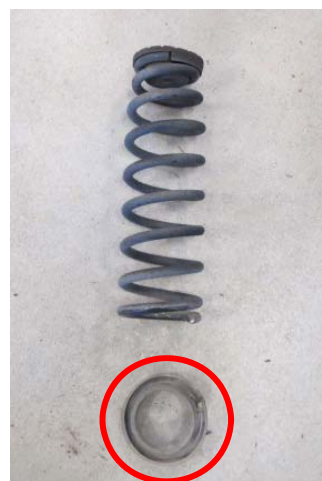
16. Remove the springs and set aside.

Make sure to transfer the lower spring isolators over to the new control arms.

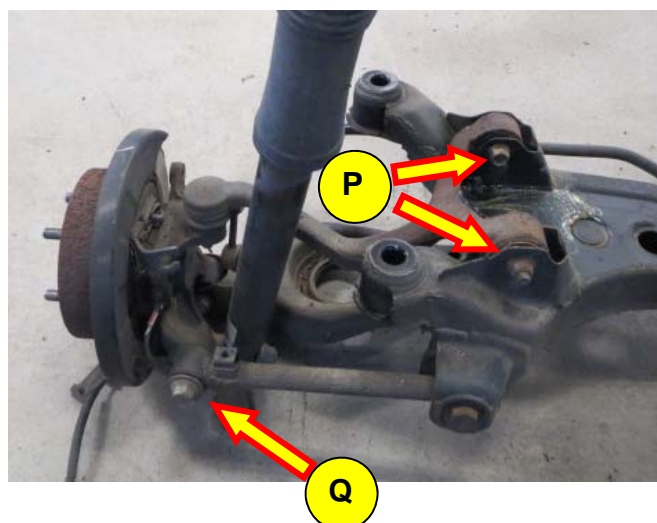
17. Install the removed knuckle assemblies onto the new crossmember using the provided fasteners:

- Fasten upper control arms to crossmember (P).
- Fasten assist arms to knuckle (Q).

Bolts for the assist arms are slightly shorter than the bolts for the lower control arms.

- Upper control arms: 72.3~86.8 lb-ft (100~120 Nm, 10.0~12.0 kgf.m)
- Assist arms: 101.2~115.7 lb-ft (137.3~156.9 Nm, 14.0~16.0 kgf.m)

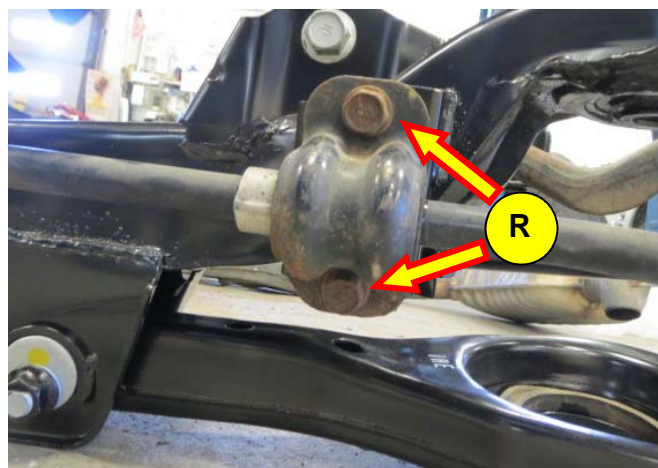
18. Install sway bar to crossmember at the bushing brackets (R).

- Bushing bracket: 32.5~39.8 lb-ft (45~55 Nm, 4.5~5.5 kgf.m)

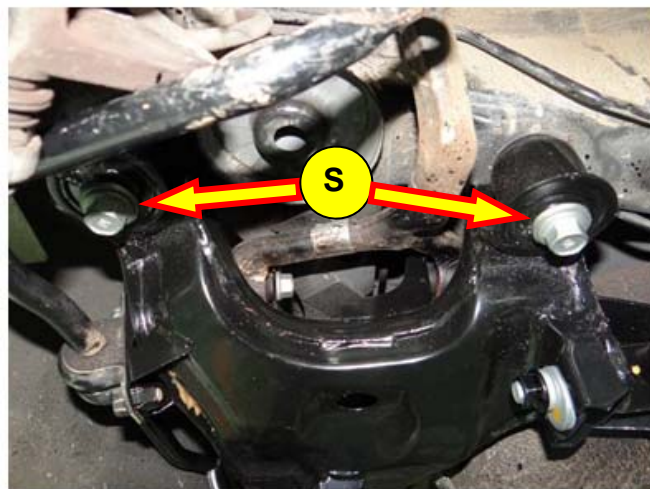
19. Install the rear chassis module using a hydraulic jack or similar tool by lifting it into place, and inserting and tightening the 4 rear crossmember mounting bolts (S).

Tightening torque: 101.2~115.7 lb-ft (137.3~156.9 Nm, 14.0~16.0 kgf.m)

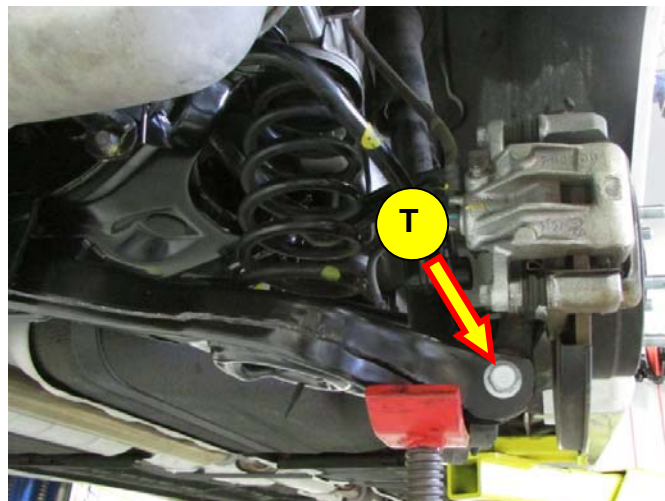
20. Place a spring into the spring seat on the lower control arm. Use a jack or similar tool on the lower control arm to compress the spring. Install the provided lower control arm bolt through the knuckle when lined up (T).

Bolts for the lower control arms are slightly longer than the bolts for the assist arms.

Tightening torque: 101.2~115.7 lb-ft
(137.3~156.9 Nm, 14.0~16.0 kgf.m)

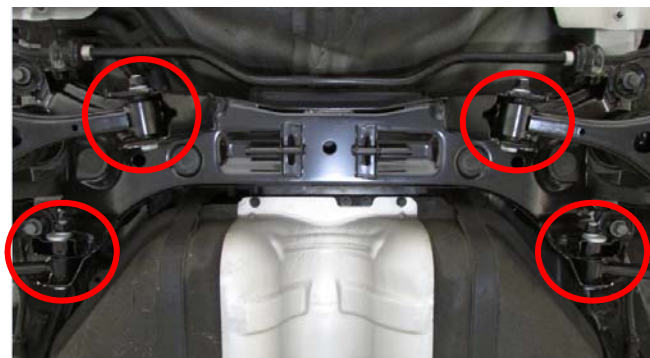
21. Torque the lower control arm, and assist arm fasteners at the crossmember to spec.

79.5~86.8 lb-ft (110~120 Nm,
11.0~12.0 kgf.m)

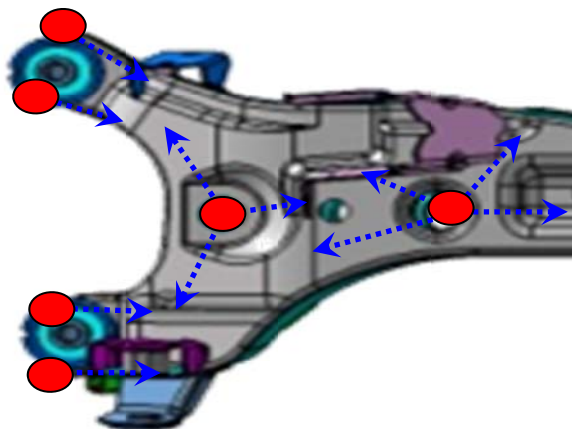
- 1b. **Inside the rear crossmember:**

Air gun position
-

Blowing direction

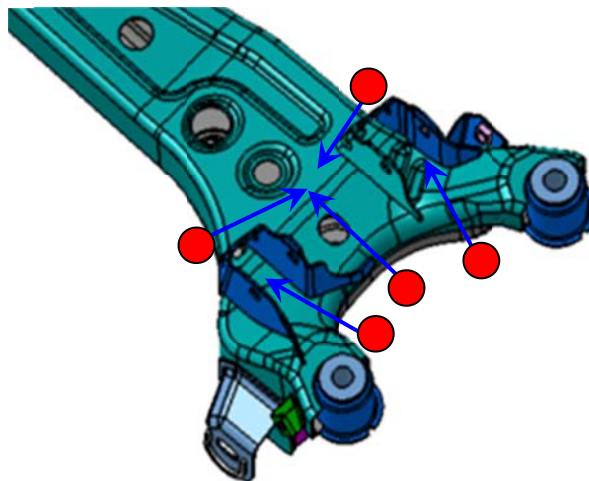
- 1c. **Outside the rear crossmember (on the top side):**

Air gun position
-

Blowing direction

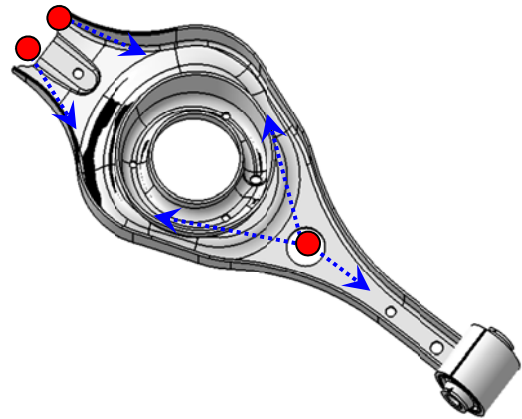
1d. Inside the lower control arms:

Air gun position
-

Blowing direction

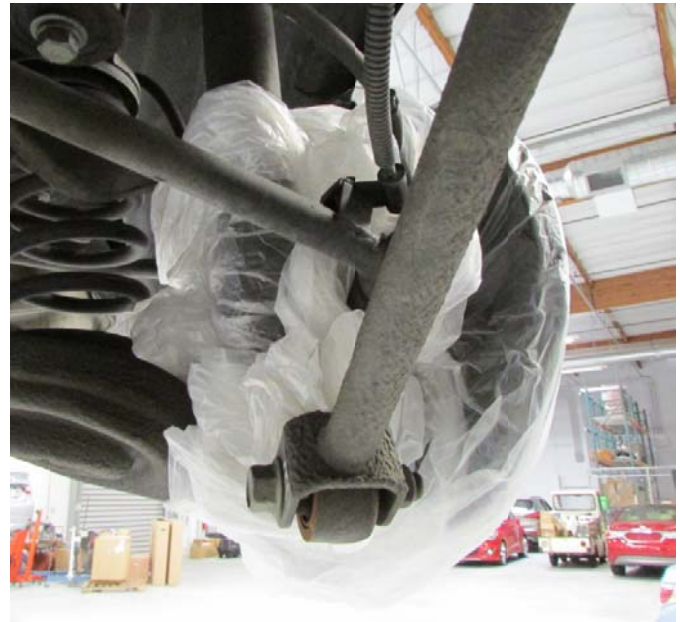
2. Protect the brake assemblies by wrapping a plastic bag around both rear brakes, as shown.

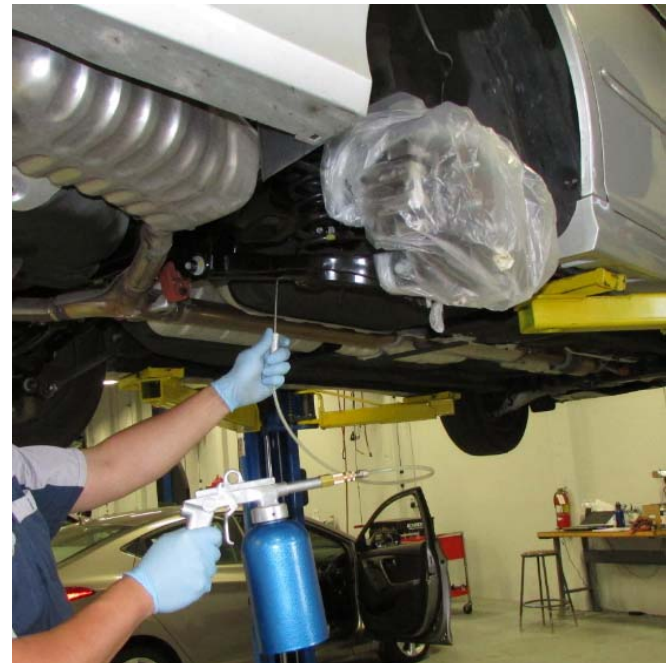
3a. Spray cavity wax inside and outside the rear crossmember, and inside the rear lower control arms.

Spray the wax in each location (each red dot, below) for 15 seconds, ensuring good wax flow during that time by seeing a visible light mist.

Some locations show multiple directions. For these locations, rotate the spray nozzle while spraying to ensure good coverage.

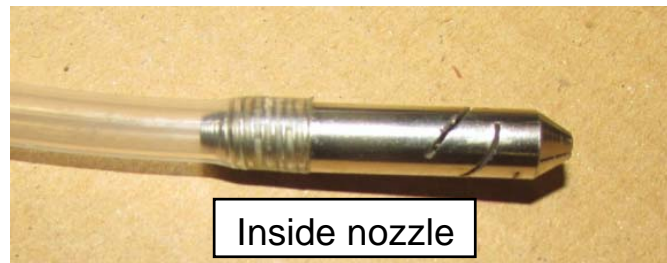
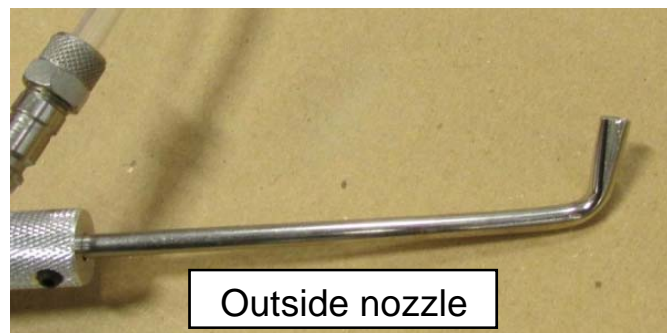
Use the “inside” nozzle to spray all interior surfaces.

Use the “outside” nozzle to spray all the exterior surfaces.

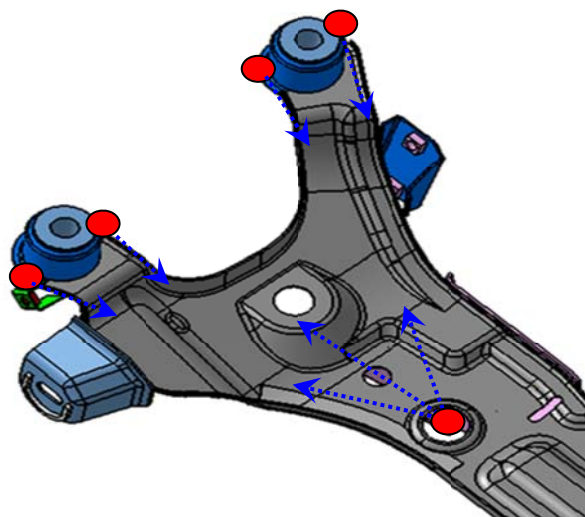
**3b. Inside the rear crossmember:**

Spray gun position

Spray direction

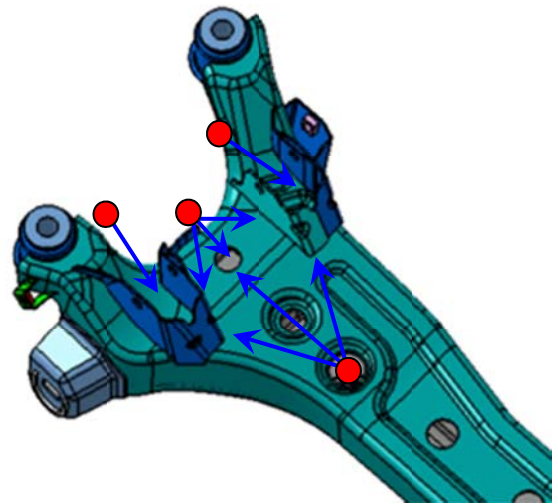
3c. **Outside the rear crossmember (on the top side):**

- Spray gun position
- ➔ Spray direction

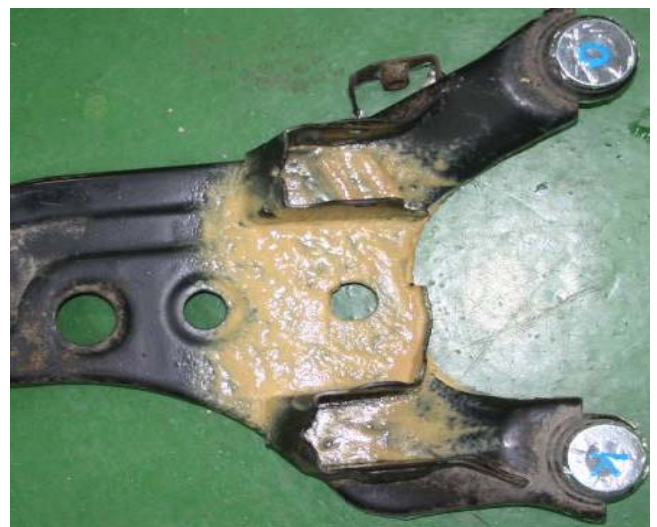
3d. After spraying the wax, the top side of the rear crossmember should look like the image to the right.

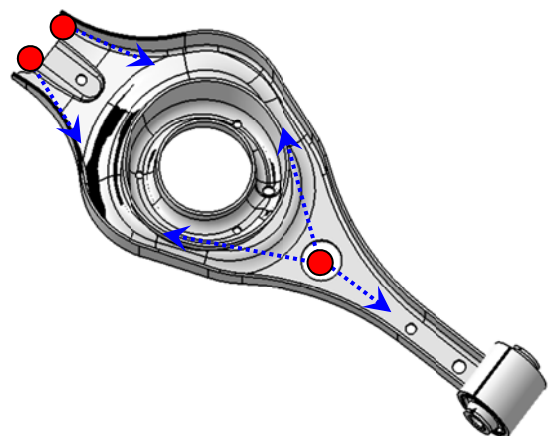
3e. **Inside the lower control arms:**

- Spray gun position
- ➔ Spray direction

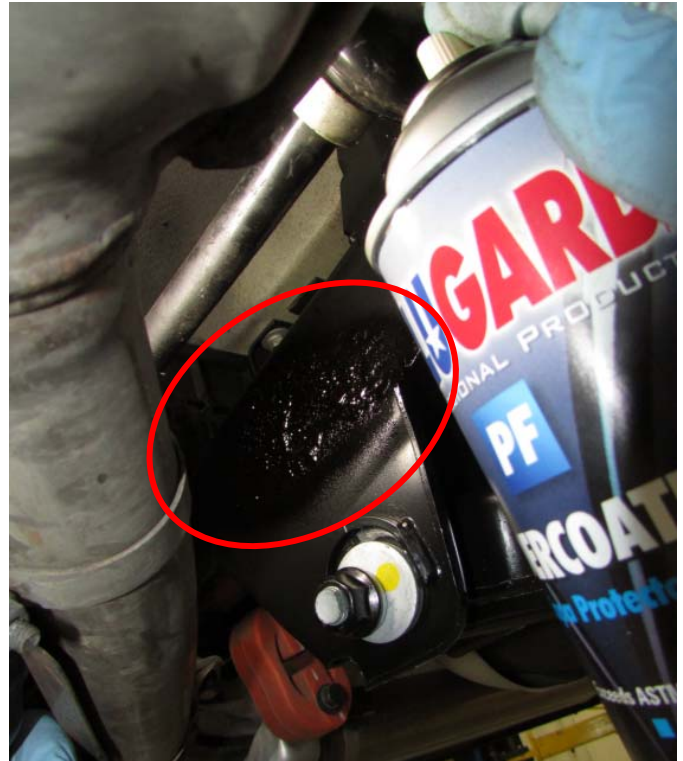
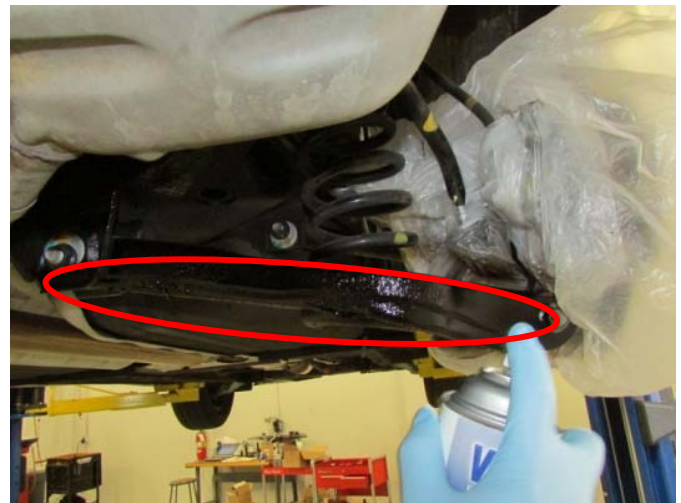
4. After applying the wax, spray the black undercoating on the surfaces of the rear crossmember and lower control arms, as shown.
- For the crossmember, spray the area above the lower control arm mounting bolt.
 - For the lower control arm, spray along the weld seam across the length of the arm.

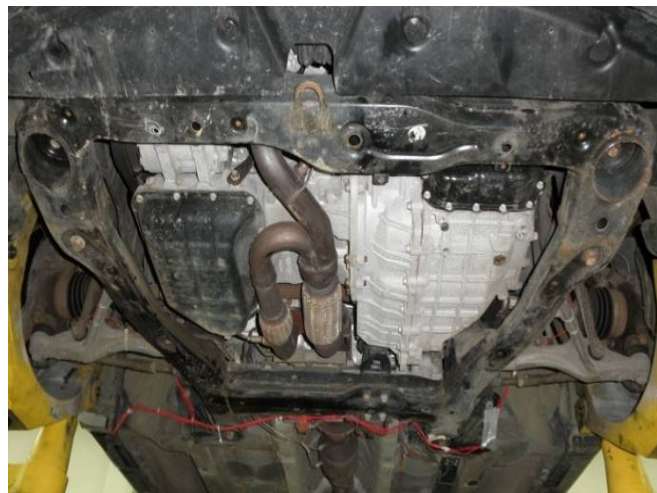
1. With the vehicle lifted on a hoist, remove the front wheel and tire assemblies, along with the engine under cover.

Tightening torque: 65.1~79.5 lb-ft
(88.3~107.9 Nm, 9.0~11.0 kgf.m)

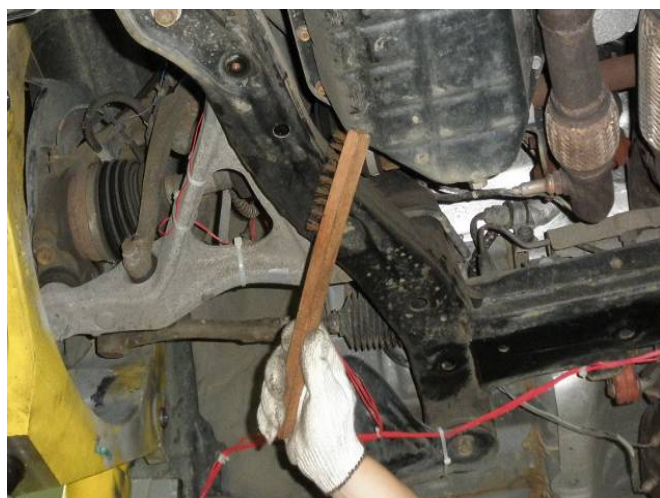
2. Use a wire brush to clean off any debris or other buildup on the front cross member.

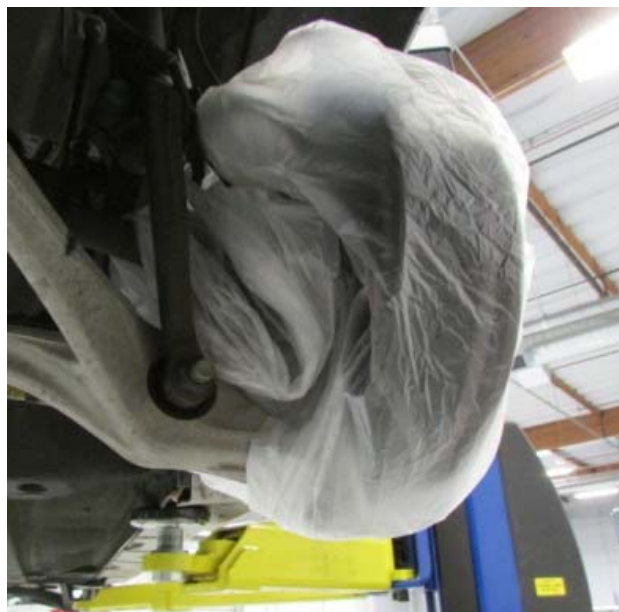
3. Protect the brake assemblies by wrapping a plastic bag around both front brakes, as shown.

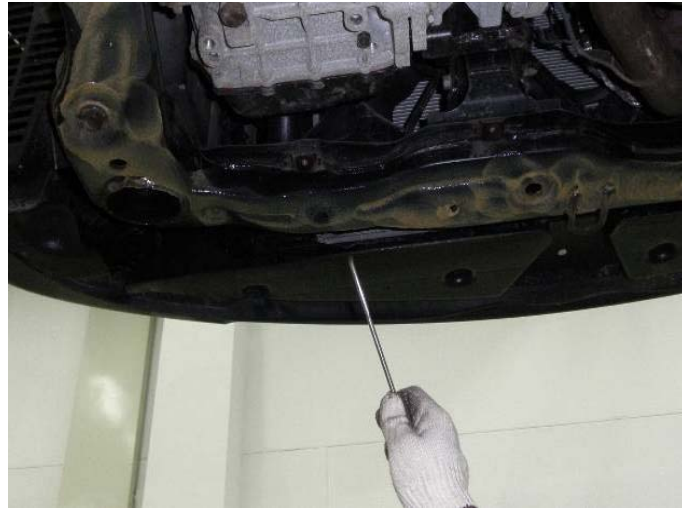
4. Spray cavity wax on the bottom surface of the front cross member using the wax spray gun. Make sure to cover the areas covered by the engine under cover, as shown.

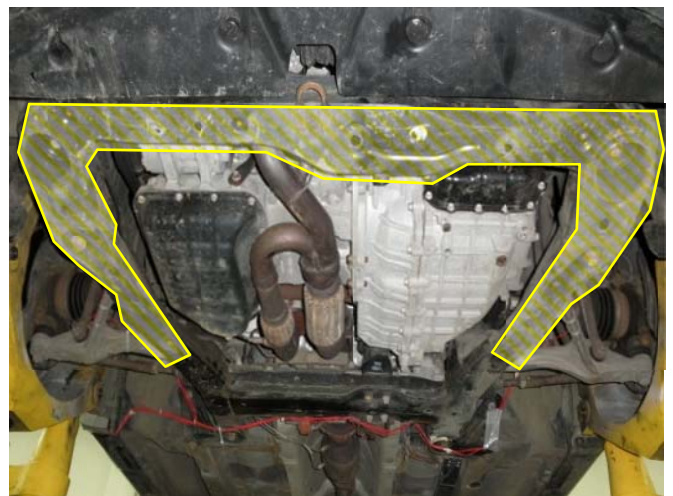
- 5a. For vehicles with a 1-piece under cover, spray the area highlighted on the image to the right.

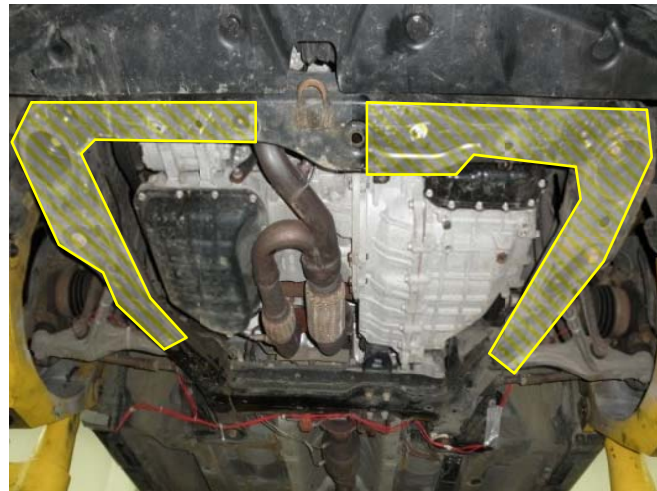
- 5b. For vehicles with a 2-piece under cover, spray the area highlighted on the image to the right.
