Technical Service Bulletin

GROUP	NUMBER	
CAMPAIGN	13-01-039	
DATE	MODEL(S)	
OCTOBER, 2013	NF SONATA, TG AZERA

SUBJECT: REAR CROSSMEMBER CORROSION TREATMENT (RECALL 113)

Description: This bulletin describes the procedure to inspect and service the rear crossmember of certain NF Sonata and TG Azera vehicles. Additionally, a procedure is provided to apply cavity wax to the front crossmember as a preventative measure.

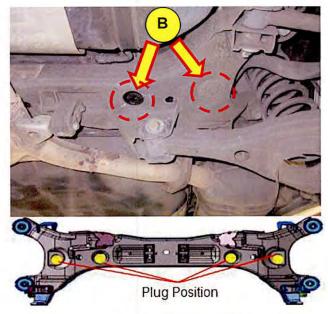
2. Remove the 4 rear crossmember rubber plugs (B). Discard the plugs; do not reinstall.

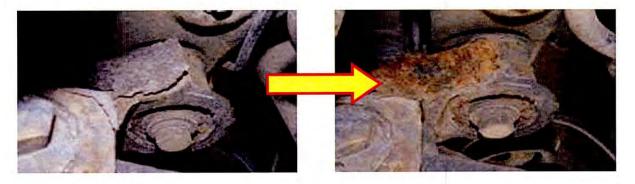
4. Peel away any residual PVC coating.

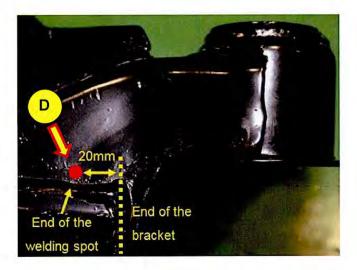
The punching location must be located precisely:

D: Punching location is right above the end of the weld line, 20mm inwards from the end of the bracket.

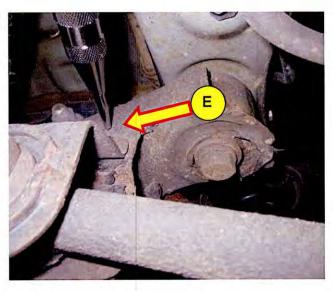
Depress the automatic center punch by hand (<u>DO NOT USE A HAMMER</u>) to punch the rear crossmember (E) 10 times in the same location, as defined below. Repeat on the opposite side of the crossmember.

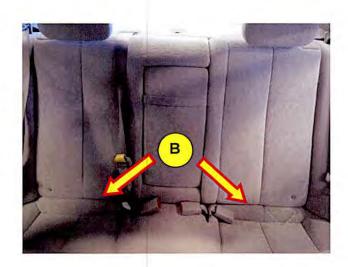
2. From the rear seat, remove the two 12mm seat bottom mounting bolts (B).

Tightening torque: 7.2~10.8 lb-ft (9.8~14.7 Nm, 1.0~1.5 kgf.m)

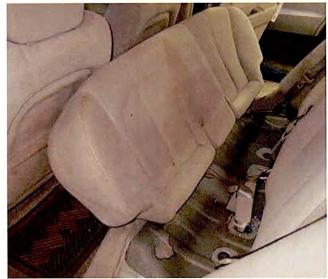
3. Remove the rear seat bottom cushion by pulling upward on the front edge.

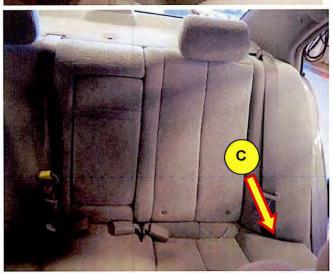
4. Remove the 12mm bolt (C) for the left side bolster cushion. Then lift the cushion upwards to remove. Repeat for the right side bolster.

Tightening torque: 7.2~10.8 lb-ft (9.8~14.7 Nm, 1.0~1.5 kgf.m)

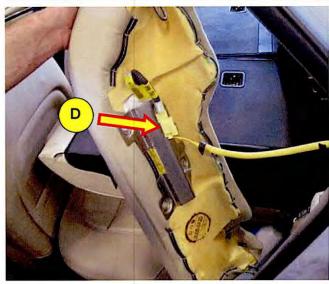
4a. If the vehicle is equipped with rear seat side air bags (Azera models only), disconnect the connector (D) before removing the side bolster cushions.

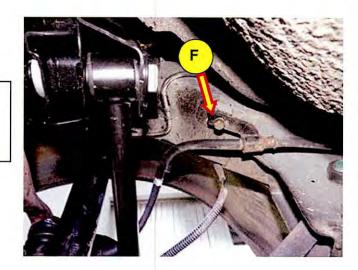
7. Remove the rear parking cable mounting bolt (F) on both sides (LH/RH).

Tightening torque: 14.5~21.7 lb-ft (19.6~29.4 Nm, 2.0~3.0 kgf.m)

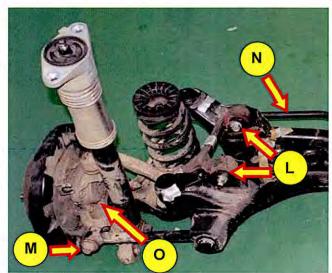
- 15. Remove the left and right knuckle assemblies from the rear chassis module:
 - Unbolt the fasteners at the rear upper control arms (L).
 - Unbolt the assist arms at the knuckles (M).
 - Unbolt the sway bar (N) from the crossmember at the bushing brackets.
 - Unbolt the lower control arms at the knuckles (O).

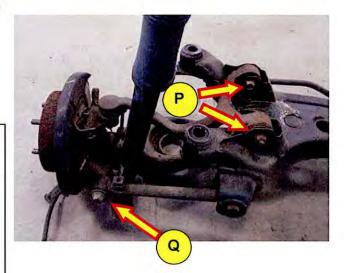
- 17. Install the removed knuckle assemblies onto the new crossmember using the provided fasteners:
 - Fasten upper control arms to crossmember (P).
 - Fasten assist arms to knuckle (Q).

Bolts for the assist arms are slightly shorter than the bolts for the lower control arms.

- Upper control arms: 72.3~86.8 lb-ft (100~120 Nm, 10.0~12.0 kgf.m)
- Assist arms: 101.2~115.7 lb-ft (137.3~156.9 Nm, 14.0~16.0 kgf.m)

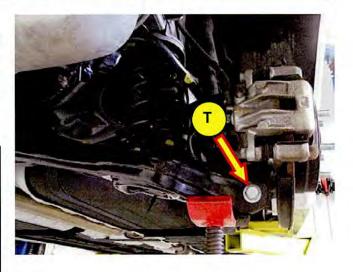
20. Place a spring into the spring seat on the lower control arm. Use a jack or similar tool on the lower control arm to compress the spring. Install the provided lower control arm bolt through the knuckle when lined up (T).

Bolts for the lower control arms are slightly longer than the bolts for the assist arms.

Tightening torque: 101.2~115.7 lb-ft (137.3~156.9 Nm, 14.0~16.0 kgf.m)

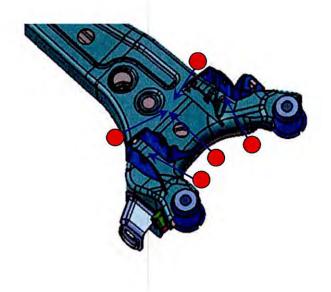
1c. Outside the rear crossmember (on the top side):

Air gun position

Blowing direction

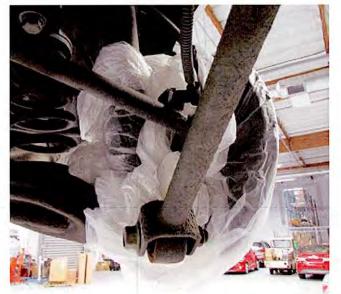
2. Protect the brake assemblies by wrapping a plastic bag around both rear brakes, as shown.

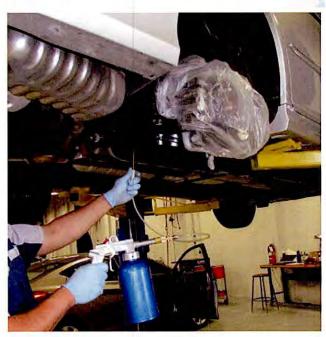
Spray cavity wax inside and outside the rear crossmember, and inside the rear lower control arms.

Spray the wax in each location (each red dot, below) for 15 seconds, ensuring good wax flow during that time by seeing a visible light mist.

Some locations show multiple directions. For these locations, rotate the spray nozzle while spraying to ensure good coverage.

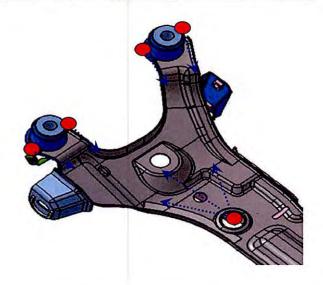
3b. Inside the rear crossmember:

Spray gun position

• ... Spray direction

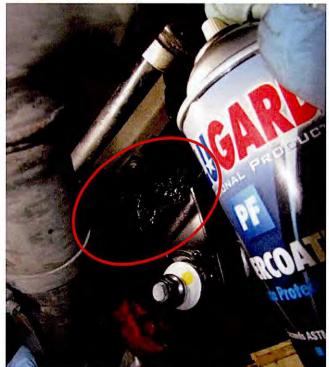
- After applying the wax, spray the black undercoating on the surfaces of the rear crossmember and lower control arms, as shown.
 - For the crossmember, spray the area above the lower control arm mounting bolt.

For the lower control arm, spray along the weld seam across the length of the arm.

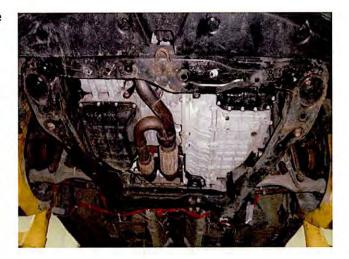
With the vehicle lifted on a hoist, remove the front wheel and tire assemblies, along with the engine under cover.

Tightening torque: 65.1~79.5 lb-ft (88.3~107.9 Nm, 9.0~11.0 kgf.m)

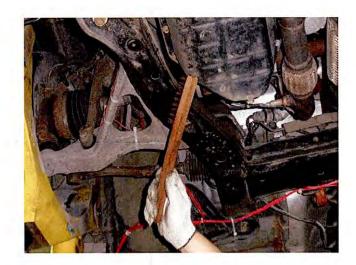
Use a wire brush to clean off any debris or other buildup on the front cross member.

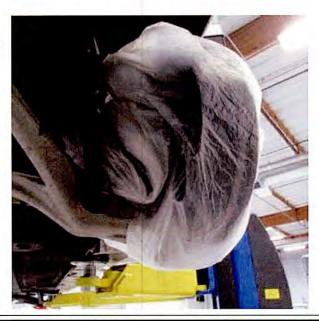
3. Protect the brake assemblies by wrapping a plastic bag around both front brakes, as shown.

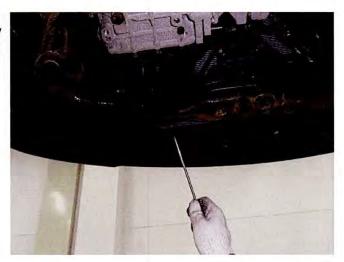
4. Spray cavity wax on the bottom surface of the front cross member using the wax spray gun. Make sure to cover the areas covered by the engine under cover, as shown.

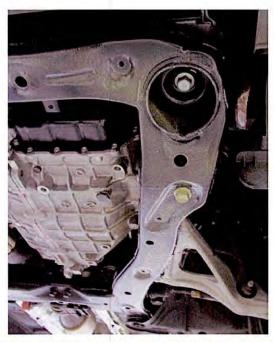
Spray enough cavity wax to provide a light coating. Wax coat should be thick enough to be visible, but not dripping.

5a. For vehicles with a 1-piece under cover, spray the area highlighted on the image to the right.

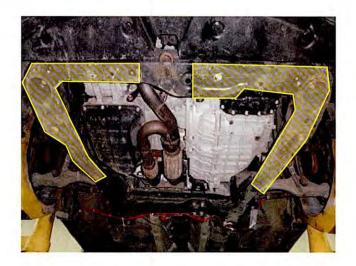
For vehicles with a 2-piece under cover, spray the area highlighted on the image to 5b. the right.
