13V-442
DEALER NOTICE
DATED 10/28/2013

**INTERIM INSPECTION INSTRUCTIONS
FOR
SAFETY RECALL D1T
HVAC ASSEMBLY
CERTAIN 2012 – 2013 MODEL YEAR AVALON
CERTAIN 2013 MODEL YEAR AVALON HYBRID**

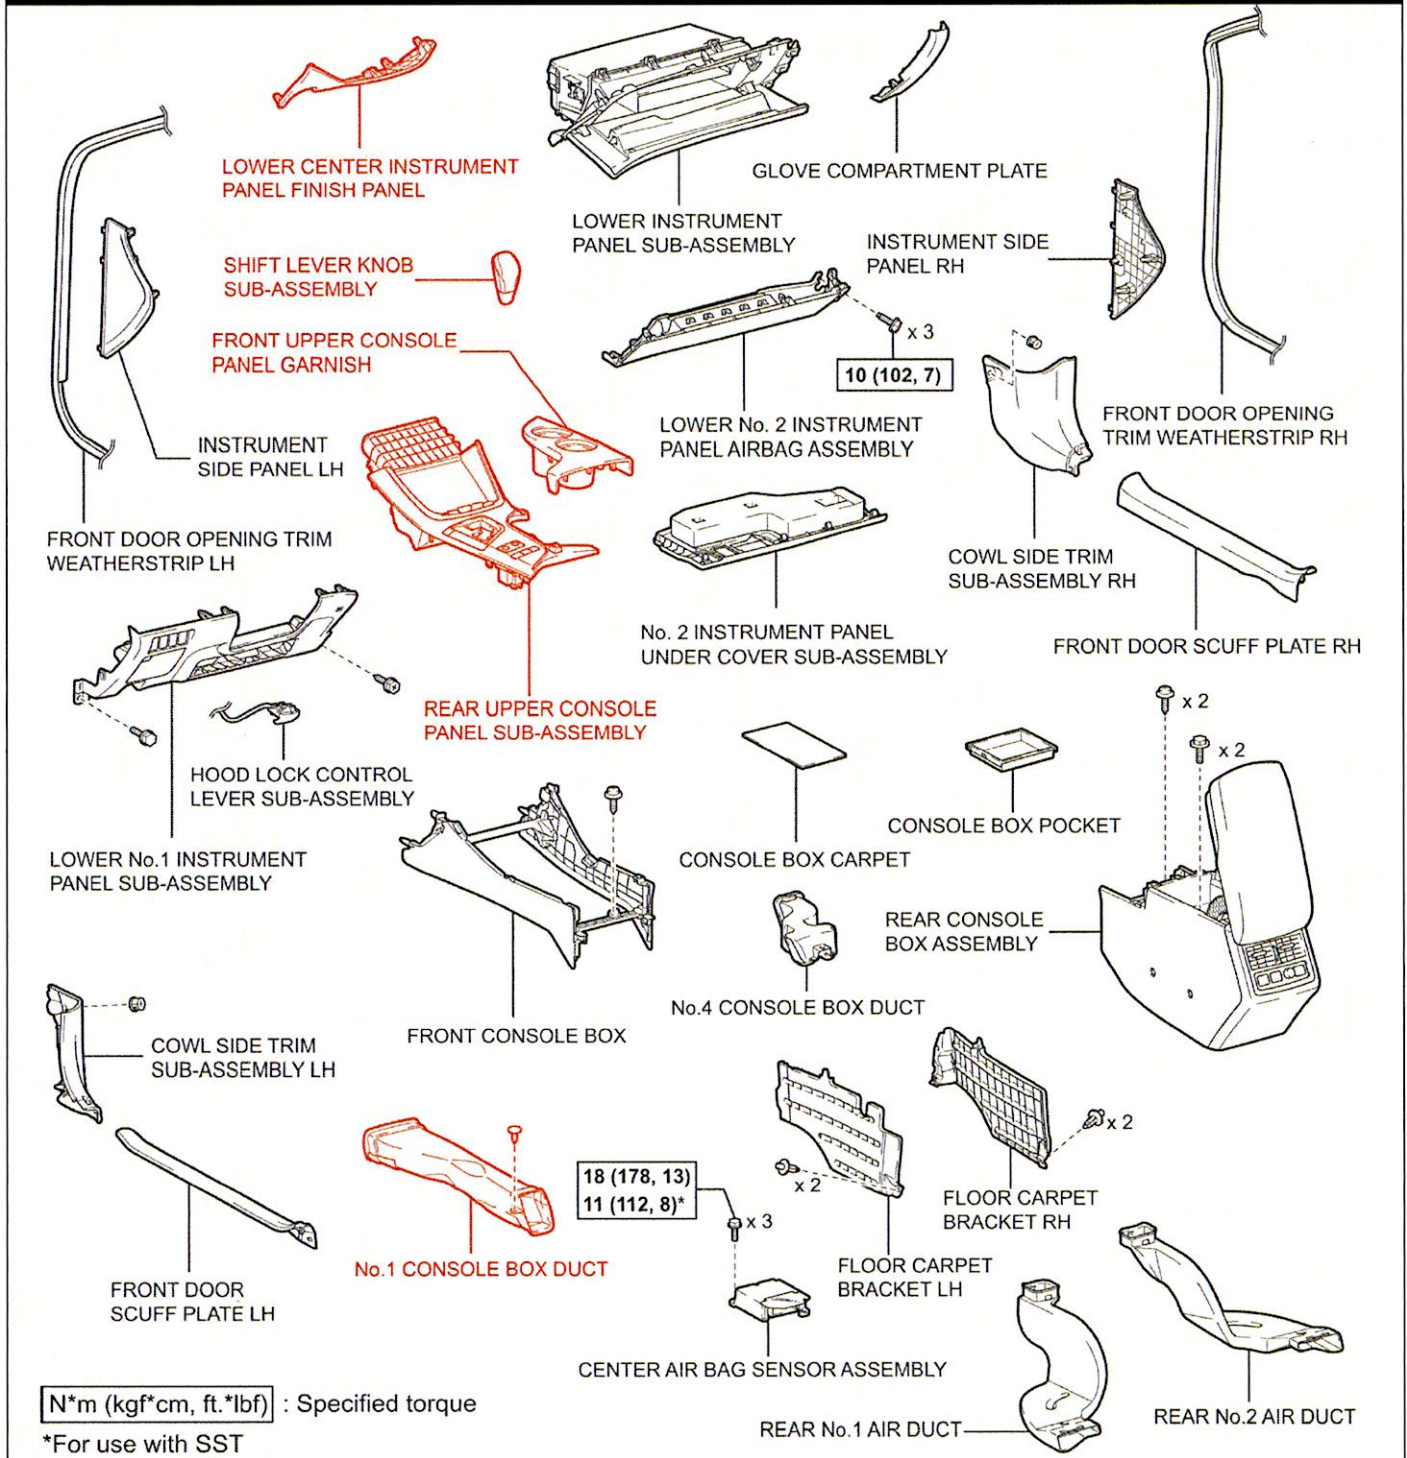
2013 MODEL YEAR

1. REMOVE ONLY THE COMPONENTS HIGHLIGHTED RED

NOTE: the No.1 Console Box Duct **DOES NOT** need to be completely removed, it only needs to be displaced.

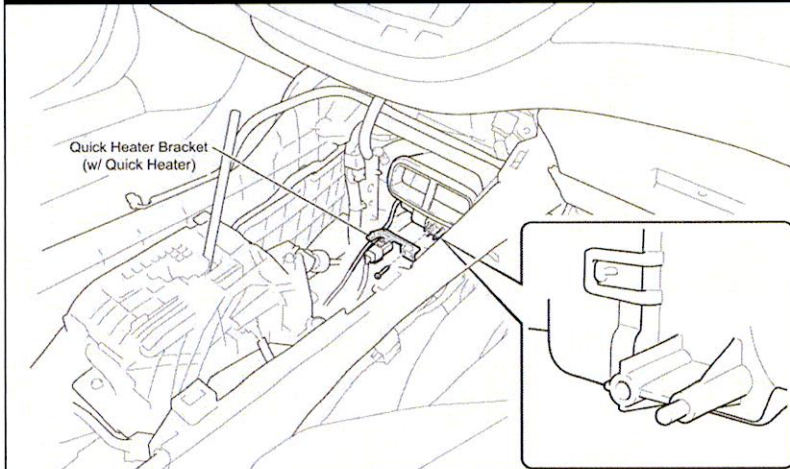
WITHOUT SCREW DESIGN

This is the **OLD** case design. **Additional inspection is required. Proceed to STEP 3.**

The old design case may develop a leak at the case seam if there is a buildup of condensed water. This inspection step is **CRITICAL** to determine which case design is installed in the vehicle.

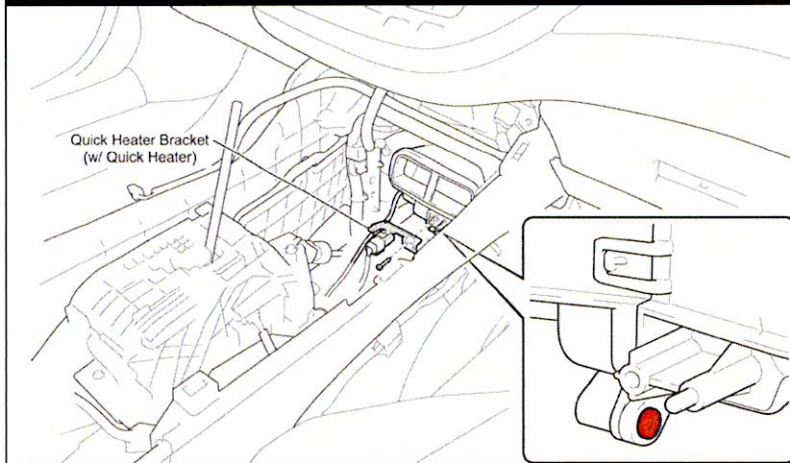
WITH SCREW DESIGN

This is the **NEW** case design. No further action required. Campaign Complete.

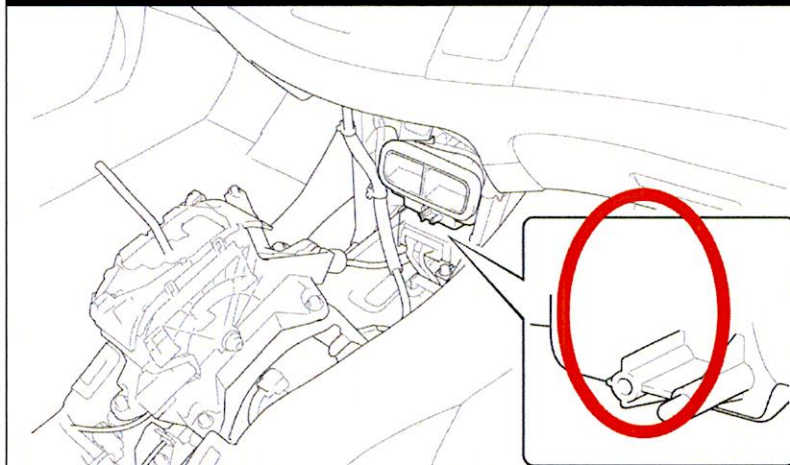
WITHOUT SEAM DESIGN – 2012MY ONLY

This case design will only be found on **SOME** 2012 model year Avalon vehicles. This case design **IS NOT** affected. No further action required. Campaign Complete.

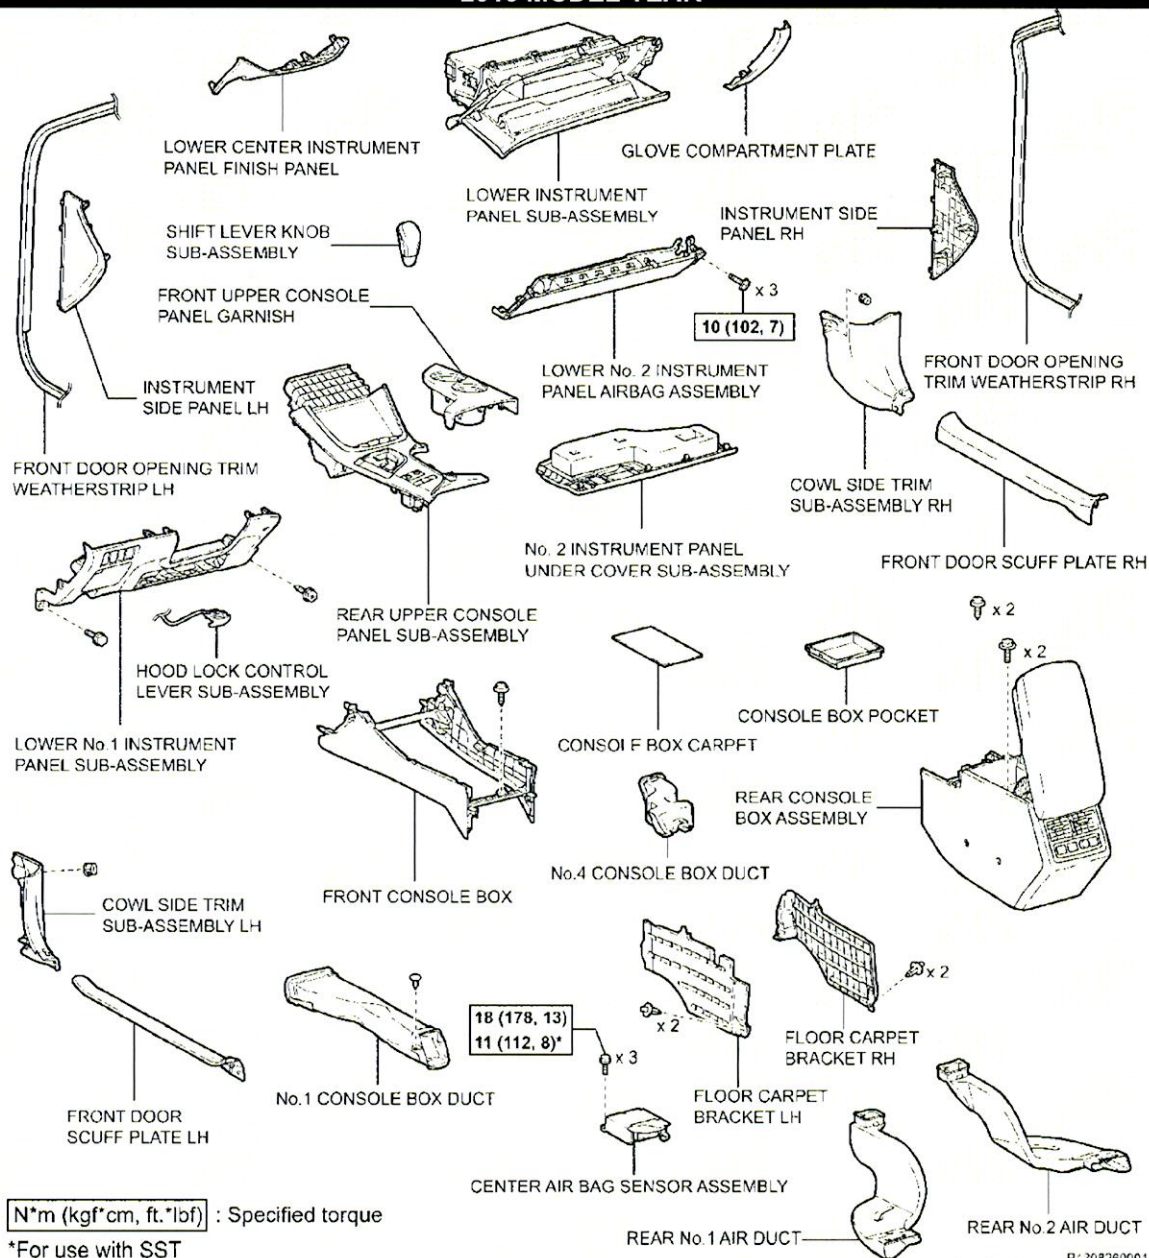
2013 MODEL YEAR

5. REMOVE ALL OF THE REMAINING COMPONENTS

- Refer to [TIS](#) for detailed instructions.

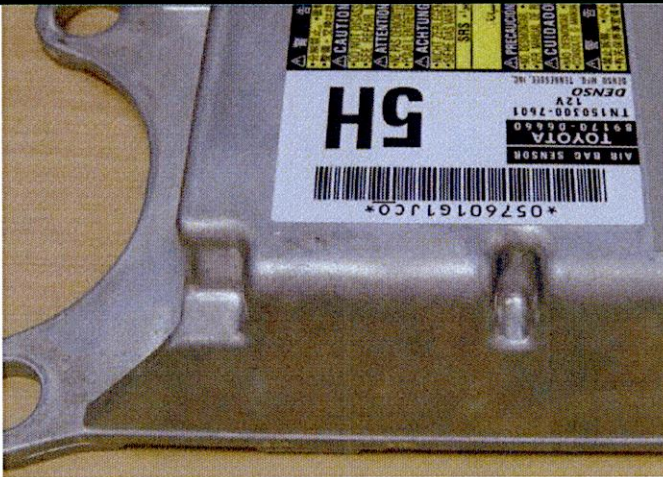
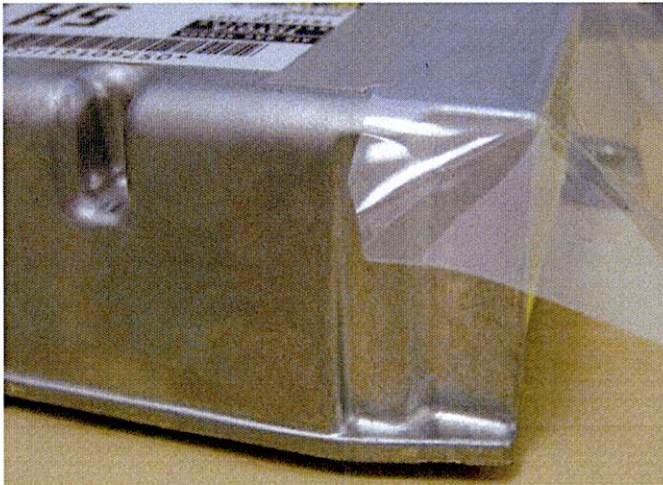
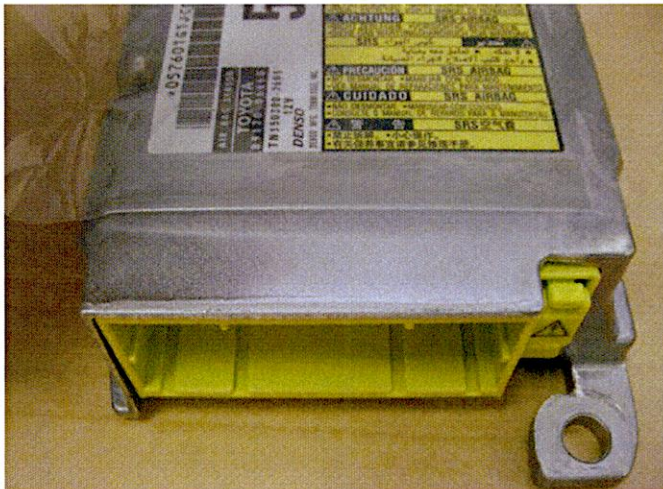
NO WETNESS FOUND

Additional inspection is required. Proceed to **STEP 7**.

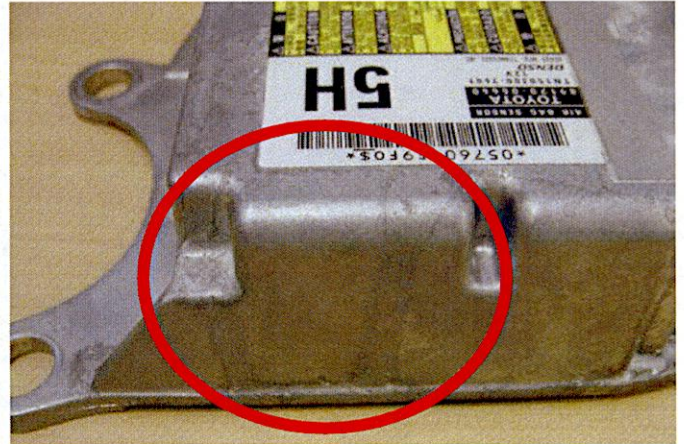
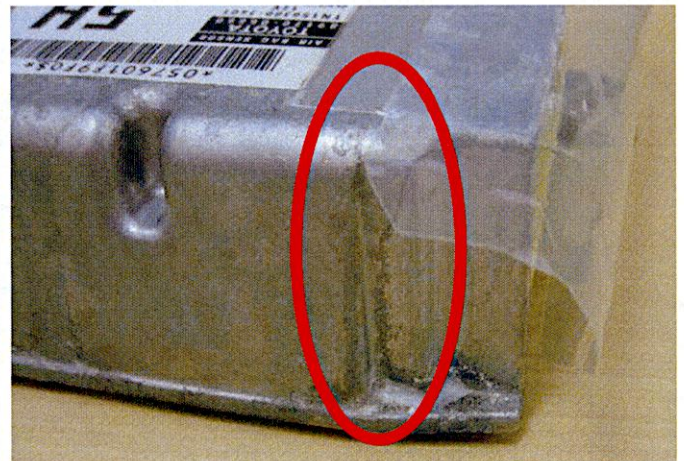
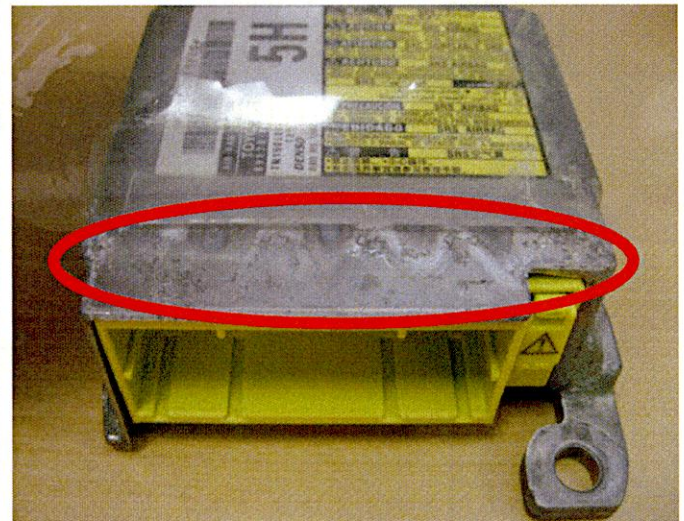
WETNESS FOUND

Wetness indicates that there may be additional component damage. Hold the vehicle until the remedy repair is available.

If wetness is found stop and report immediately.

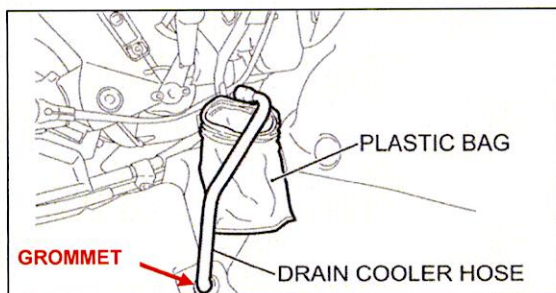
7. REMOVE THE DRAIN COOLER HOSE

- Place a bag or shop cloth under the hose to catch any water that may be remaining in the hose.

NOTE: Use caution to avoid displacing the floor pan grommet during hose removal and installation.

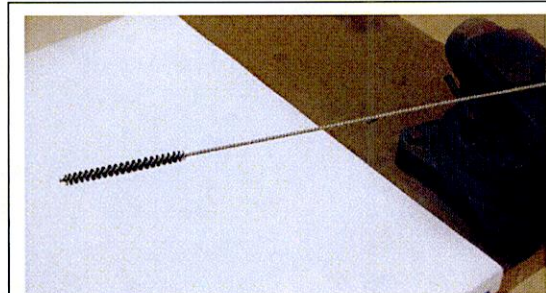
8. MOUNT THE WIRE BRUSH IN A VISE

- Mount the brush so that the bristles are above the bench, this will allow for any debris that is forced out of the hose to land on the bench for inspection.
- Place a clean sheet of paper on the bench directly below the brush.
- Verify the brush is clean and free of debris.

NOTE: If paper is not available, confirm the bench is clean to allow for an accurate debris inspection.

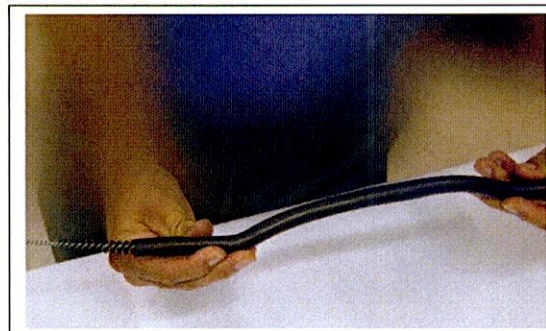
9. BRUSH THE HOSE

- Stretch the hose to straighten it and carefully work the hose onto the brush using a twisting motion, push the brush **COMPLETELY** through the hose.

The tip of the brush may catch on the tube, to help prevent damage keep the tube as straight as possible.

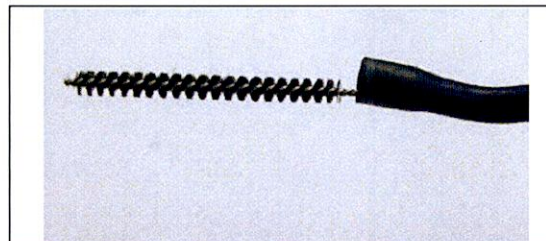
- Check the brush for any debris, **REMOVE DEBRIS FROM THE BRUSH IF FOUND.**

- Slowly pull the hose off of the brush.

After pushing the brush completely through the hose it is critical to remove any debris from the brush so that the debris does not get lodged in the hose.

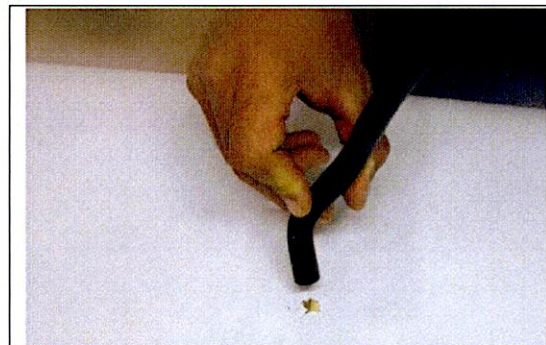
- Tap the hose on the bench to remove any debris that may remain in the hose.

- Check for debris on the brush **AND** on the bench.

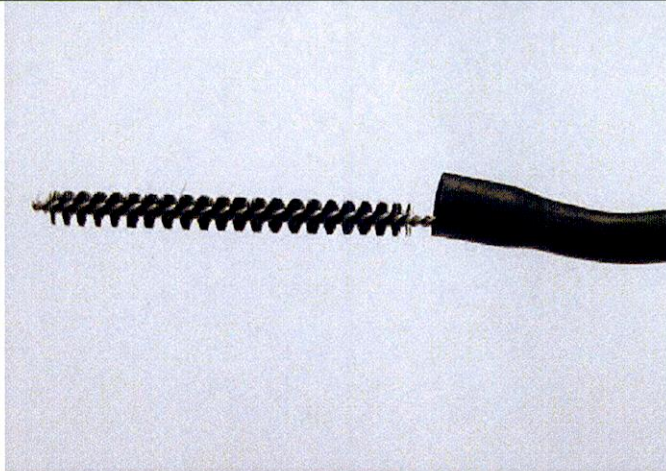
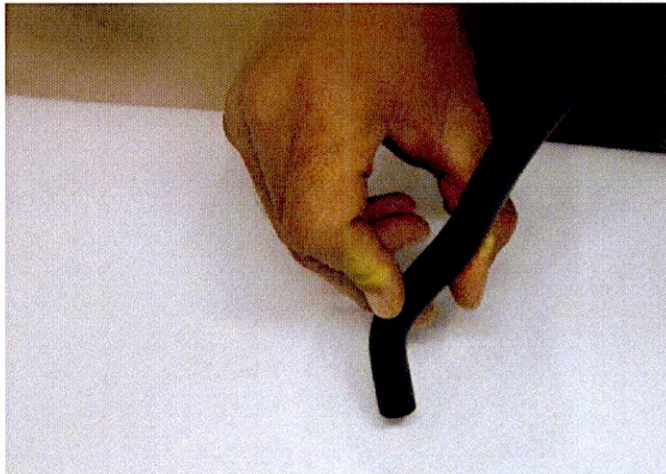
NO DEBRIS FOUND

Confirm the hose is clean by blowing compressed air through the hose. Reassemble the vehicle. Interim campaign complete. The vehicle **MUST** return when the remedy repair is available.

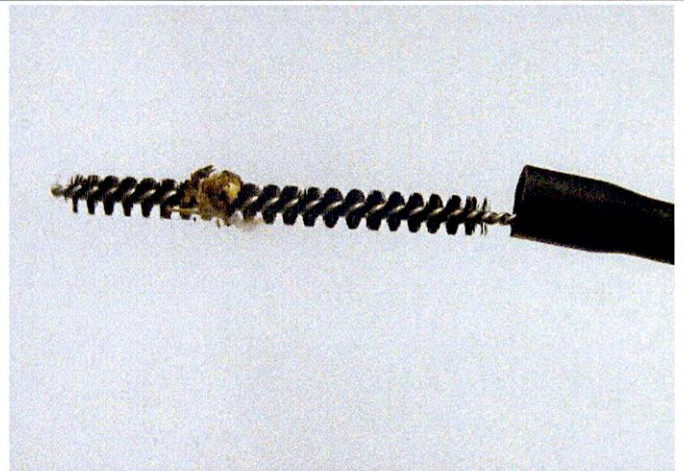
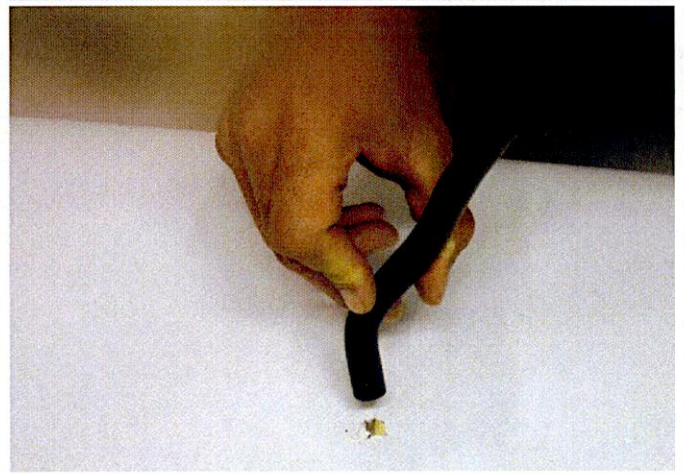
DEBRIS FOUND

Debris indicates that there may have been a blockage at some point in time that could have led to additional component damage. Hold the vehicle until the remedy repair is available.
