**TECHNICAL INSTRUCTIONS**

**SAFETY RECALL D0T**

**HVAC ASSEMBLY**

13V-442

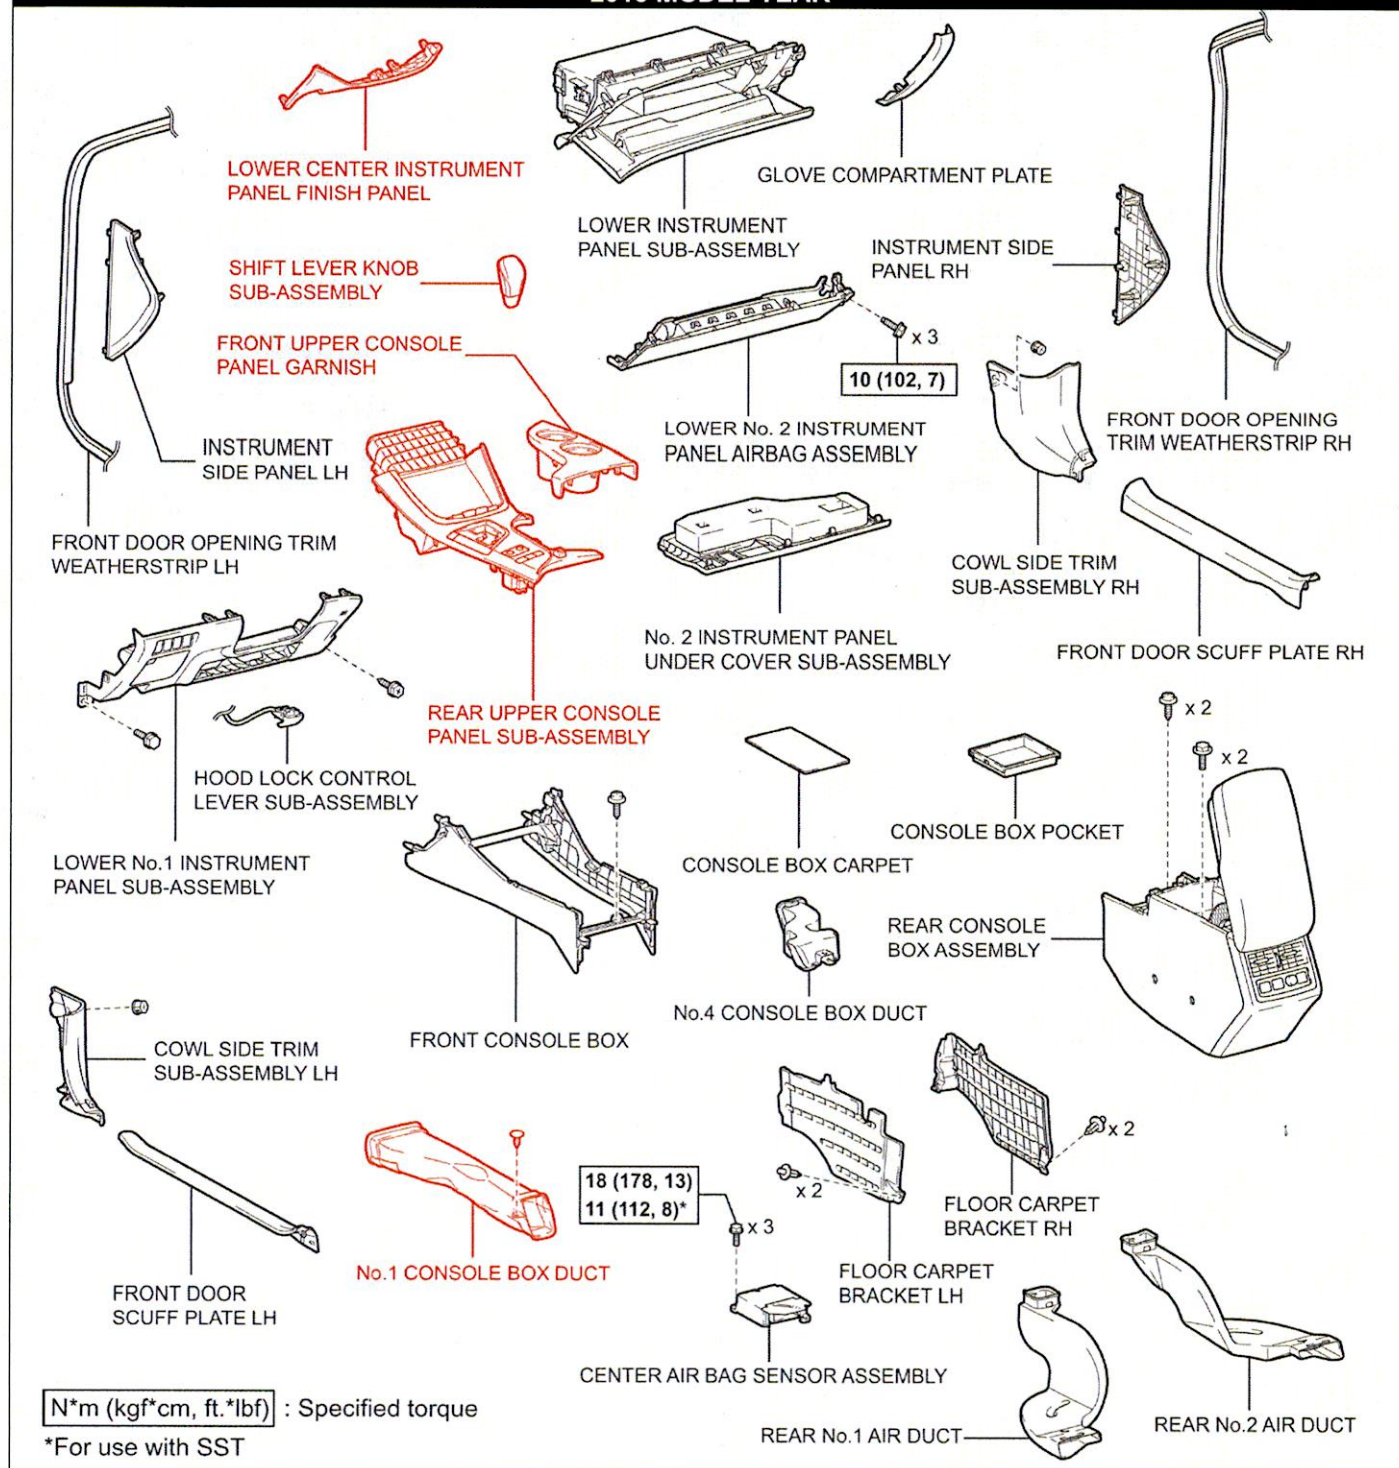
2013 MODEL YEAR

### 1. REMOVE ONLY THE COMPONENTS HIGHLIGHTED RED

**NOTE: The No.1 Console Box Duct DOES NOT need to be completely removed, it only needs to be displaced.**

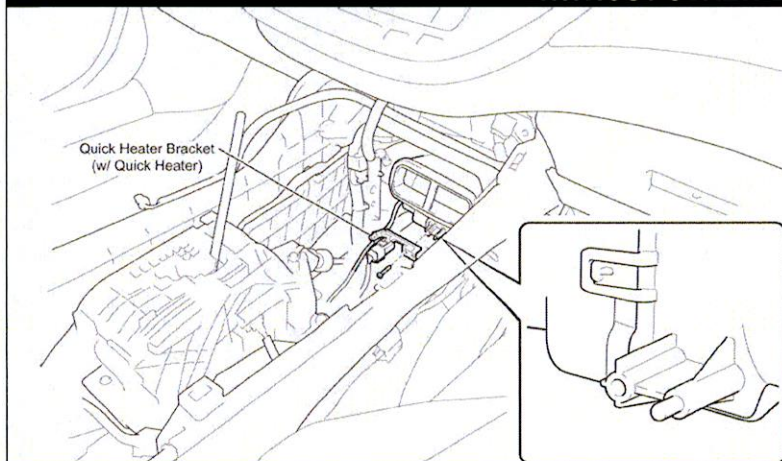
### WITHOUT SCREW DESIGN

This is the **OLD** case design. **Additional inspection is required. Proceed to STEP 3.**

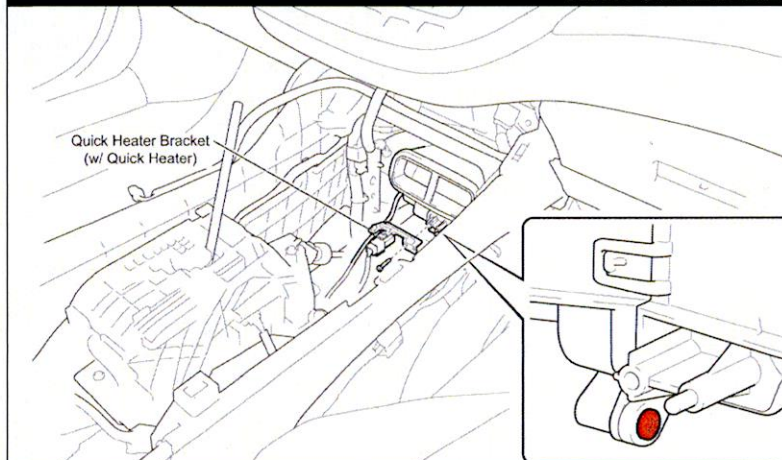
### WITH SCREW DESIGN

This is the **NEW** case design. No further action required. Campaign Complete.

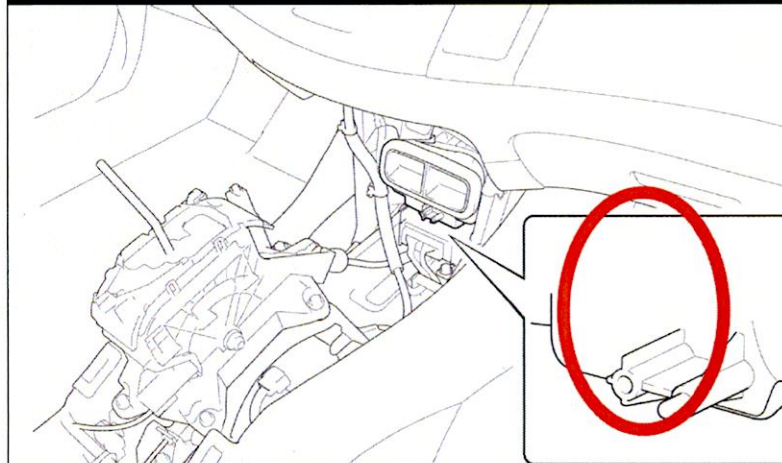
### WITHOUT SEAM DESIGN – 2012MY ONLY

This case design will only be found on **SOME** 2012 model year Avalon vehicles. This case design **IS NOT** affected. No further action required. Campaign Complete.

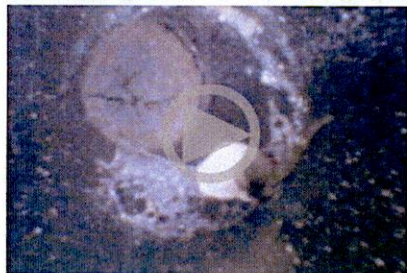
**HOSE WITH DEBRIS**

**DEBRIS FOUND**

The center airbag sensor assembly **MUST** be replaced. Proceed to **SECTION VI.** for instructions on seal tray installation.

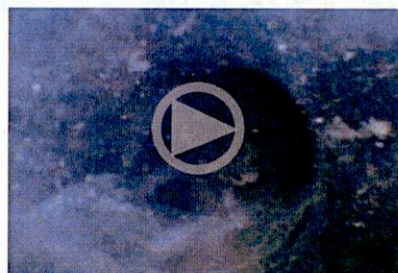
**HOSE WITH NO DEBRIS**

**NO DEBRIS FOUND**

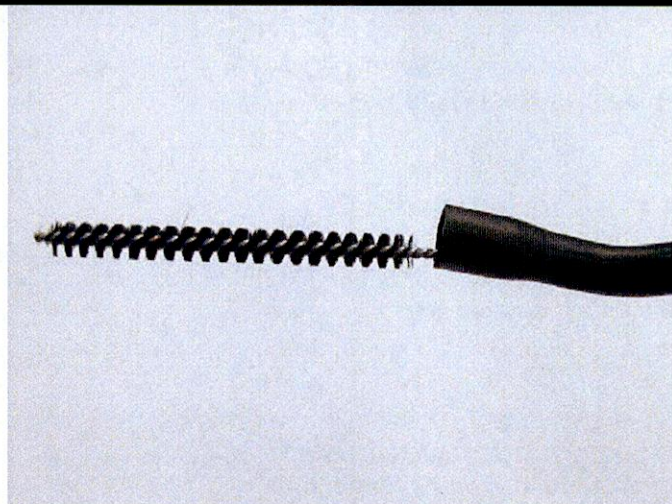
Additional inspection is required. Proceed to **STEP 9**.

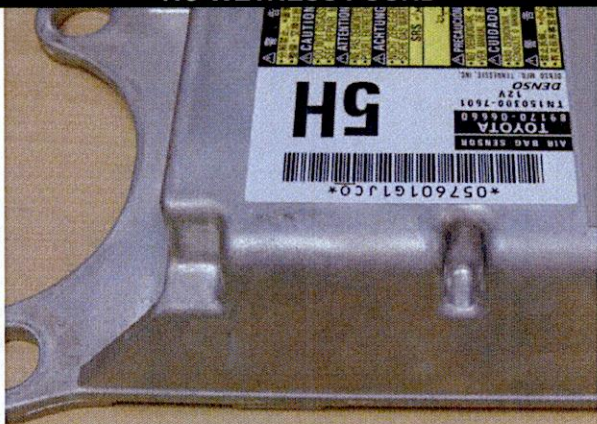
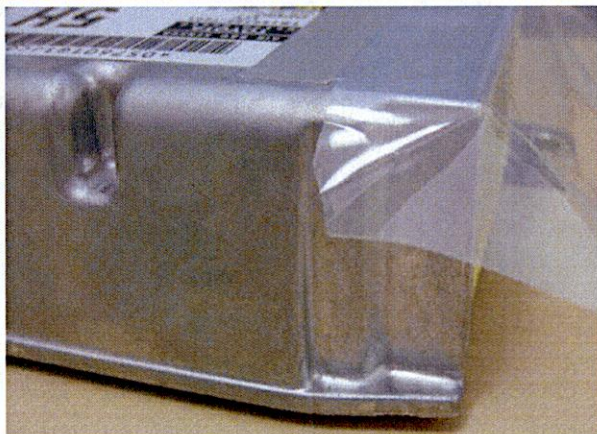
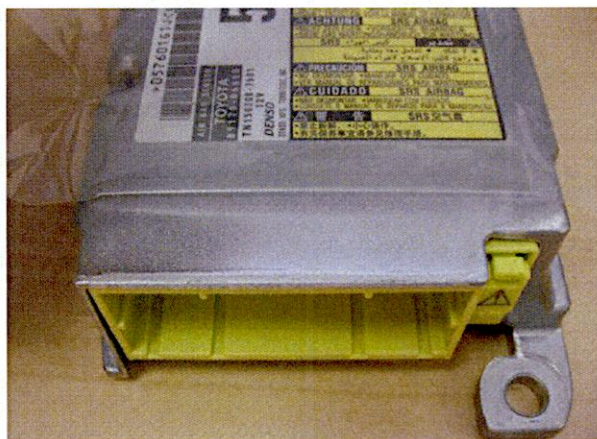
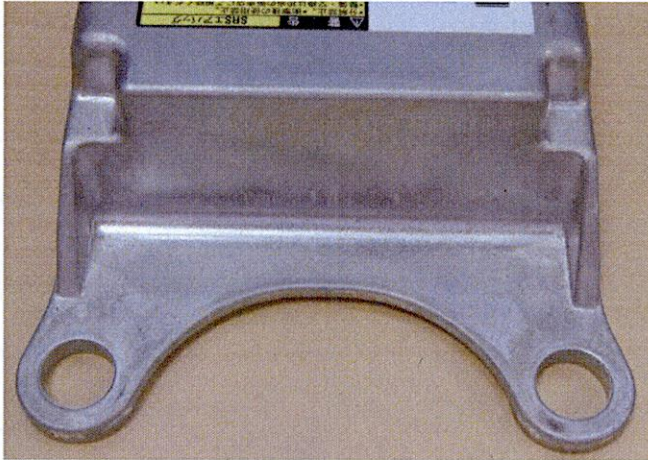
**NO WETNESS FOUND**

The center airbag sensor assembly **DOES NOT** require replacement. Proceed to **SECTION VI.** for instructions on seal tray installation.

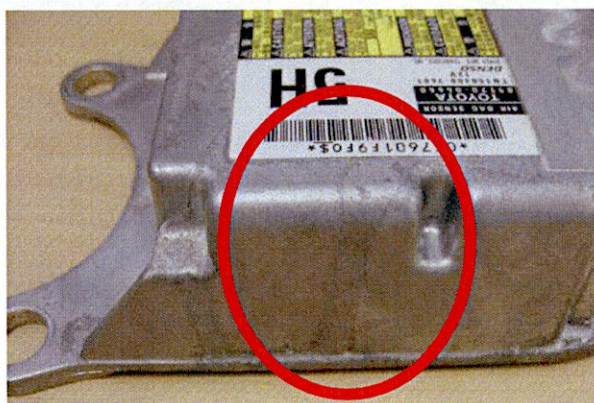
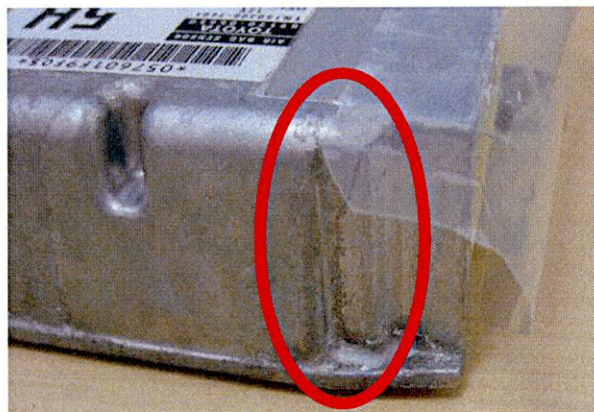
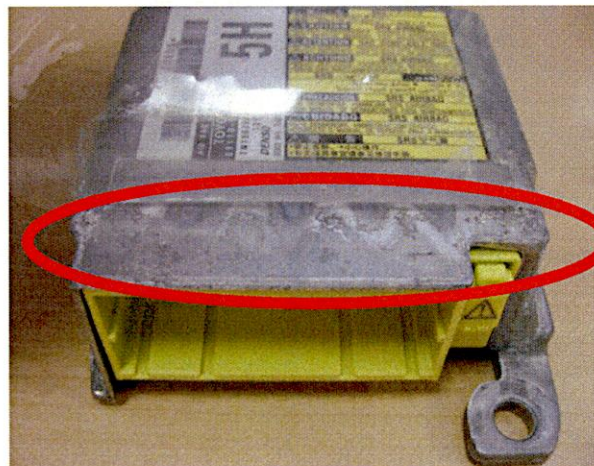
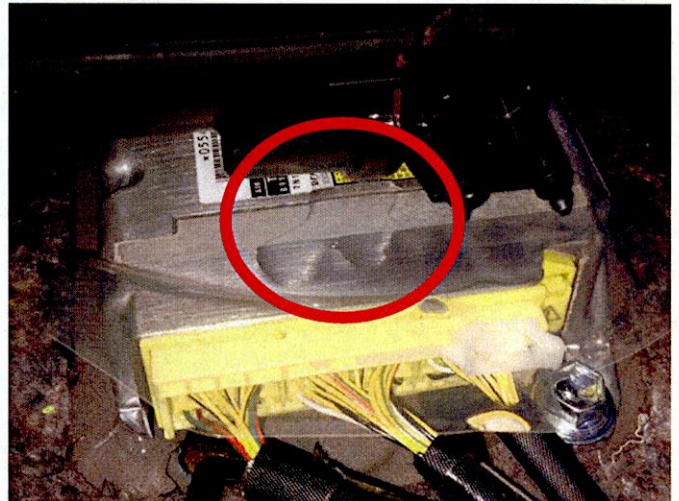
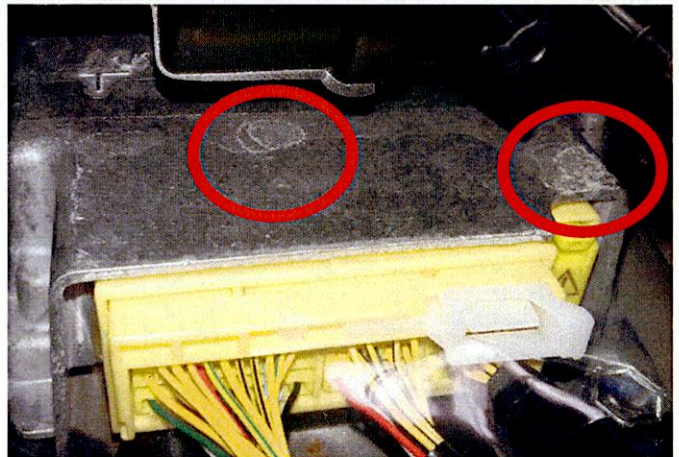
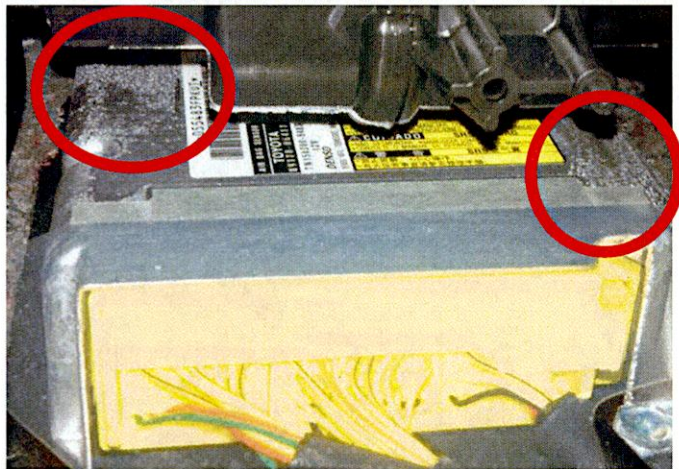
**WETNESS FOUND**

The center airbag sensor assembly **MUST** be replaced. Proceed to **SECTION VI.** for instructions on seal tray installation.

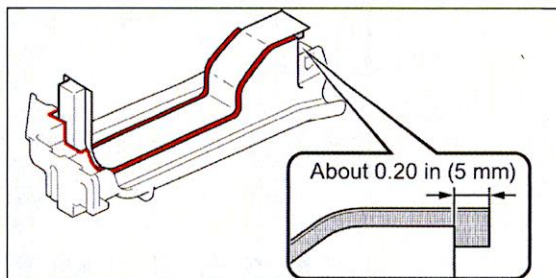
### 2. ATTACH THE BUTYL TAPE TO THE CENTER GROOVE OF THE SEAL TRAY

- Attach the tape so that it overhangs approximately ¼ inch at each end.

- Trim the ends of the tape if necessary.
- Press the tape firmly into the tray for good adhesion.

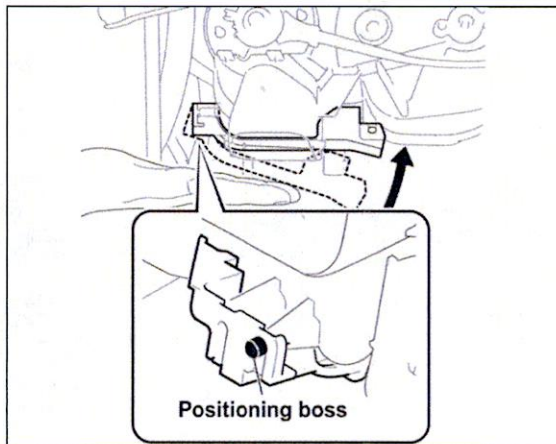
### 4. PUT THE SEAL TRAY IN PLACE

- Remove the paper backing from the tape.
- Align the front of the seal tray with positioning boss.
- Firmly press the seal tray up against the HVAC box.

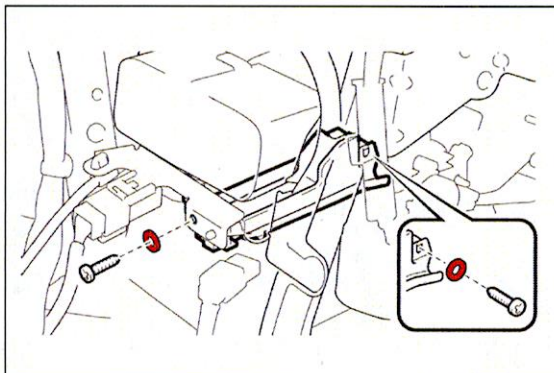
#### 5. INSTALL THE SEAL TRAY SCREWS

- If the vehicle is equipped with Quick Heater**, place the quick heater bracket into position on the front of the HVAC box.
- Install the 2 **NEW** long screws with washers.
- Confirm the screws are tightened completely.

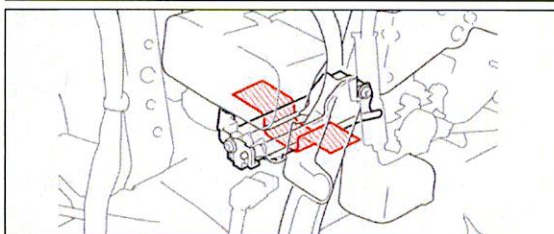
#### 6. ATTACH TAPE

- Attach duct tape or similar to the seal tray and HVAC box as shown.

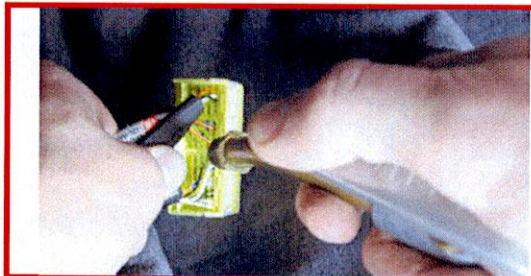
**ONLY PERFORM THIS STEP IF WETNESS WAS FOUND ON THE CONNECTOR DURING THE INSPECTION ON THE PREVIOUS PAGE**

### 1. USE COMPRESSED AIR TO DRY THE CONNECTOR

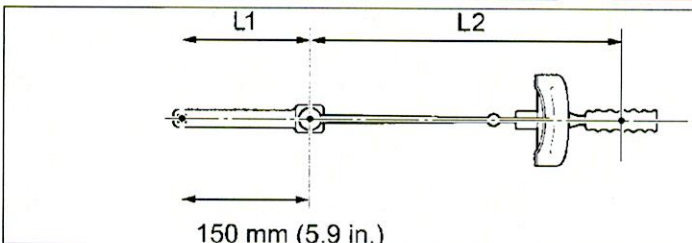
Formula  $T' = (L2 / (L1 + L2)) * T$

T'	Reading of torque wrench {N*m (kgf*cm, ft.*lbf)}
T	Torque {N*m (kgf*cm, ft.*lbf)}
L1	Length of SST or extension tool {mm(in.)}
L2	Length of torque wrench {mm(in.)}

**If a 10" torque wrench or the SST is not available, YOU MUST calculate the correct torque. Use the formula below with T = 13ft. lbf (18N·m).**

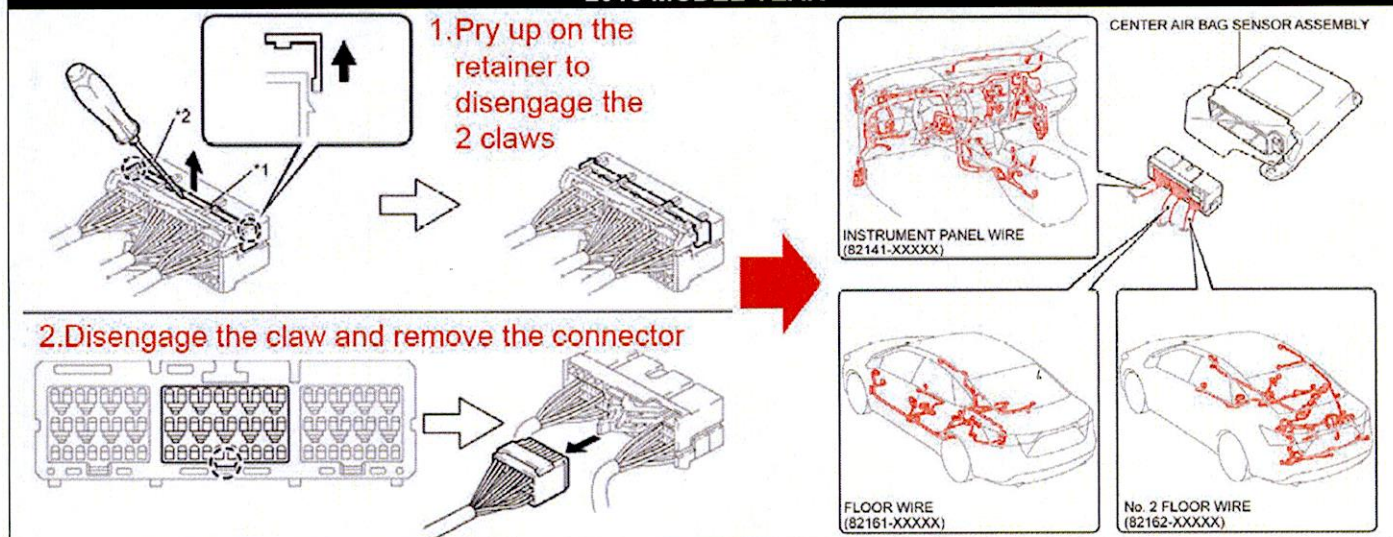
#### 2013 MODEL YEAR

### 1. REPLACE THE HARNESS(S) WITH RUSTED TERMINALS

a) Remove the affected harness(s) from the main center airbag sensor assembly connector.

b) Replace the harness, refer to TIS for additional details.
