Safety Recall

Code: 20U6

Subject: 2013-2014 MY Audi S6 and S7
Fuel Line

Problem Description

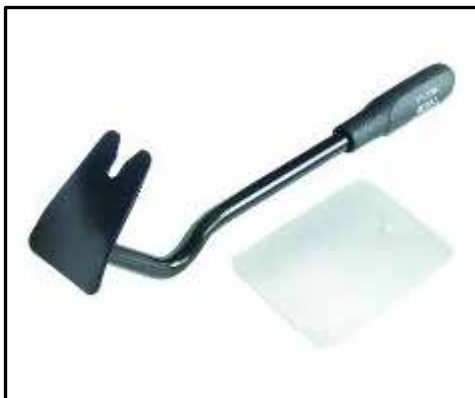
- Trim Release Lever, T10039
