# Safety Recall

Code: 20U6

Subject: 2013-2014 MY Audi S6 and S7  
Fuel Line

**REVISION**

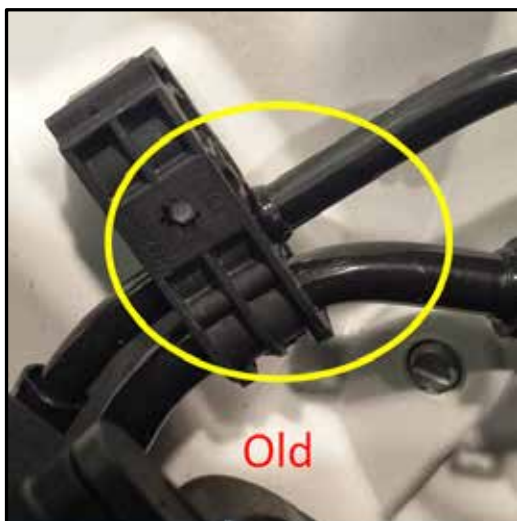
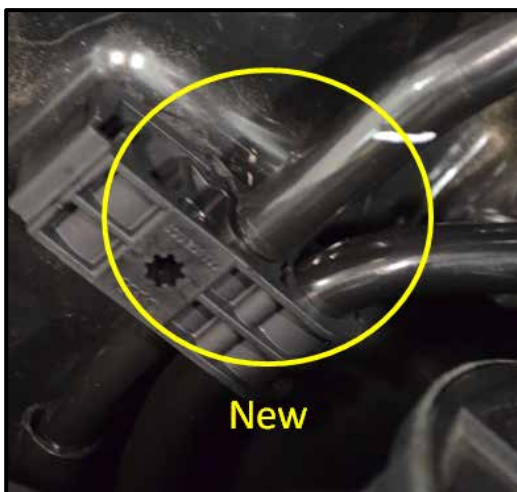
- Open the hood.
- Û Inspect the fuel line for flange <circle>
  - If the flange is present **continue to Section C**
  - If the flange is not present continue to next step.

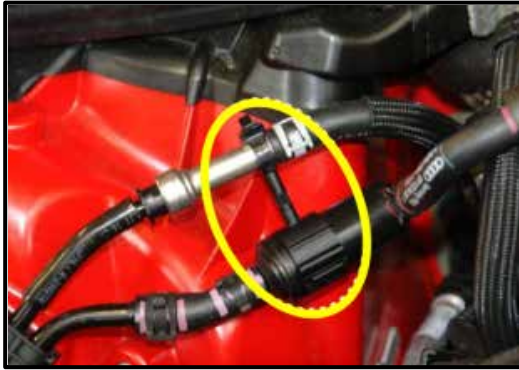
- Ü Inspect for the new clamp
  - If the clamp is not present **continue to Section C**
  - If the clamp is present no further work is required. **All work complete, continue to Section D**

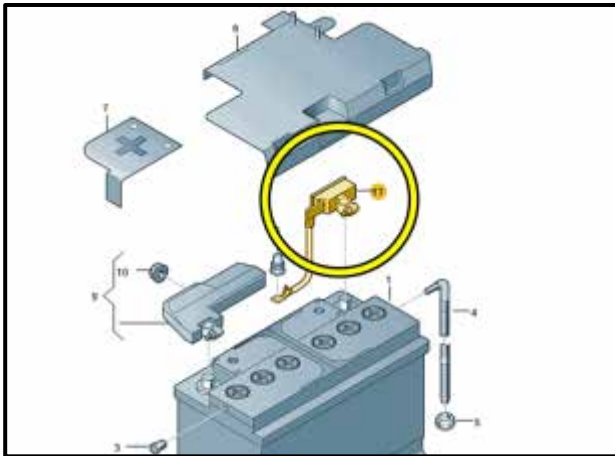
- Open the trunk.
- Open the spare tire cover.
- Ü Disconnect and isolate the negative battery cable <circle>.

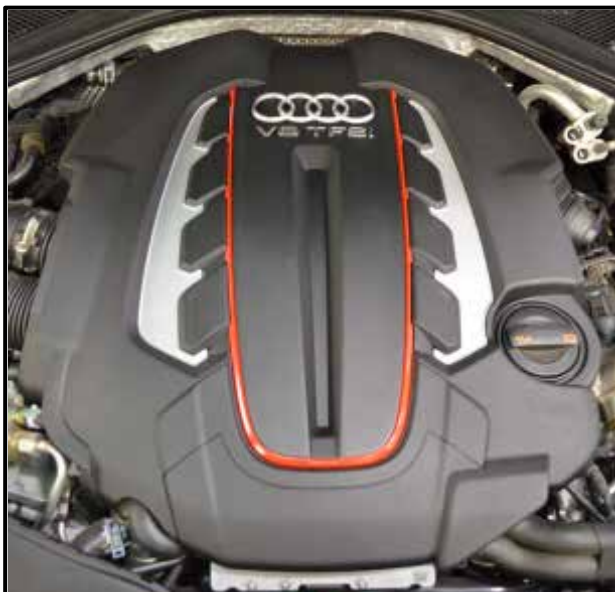
- Open the hood.
- Ü Remove the engine cover <left>.

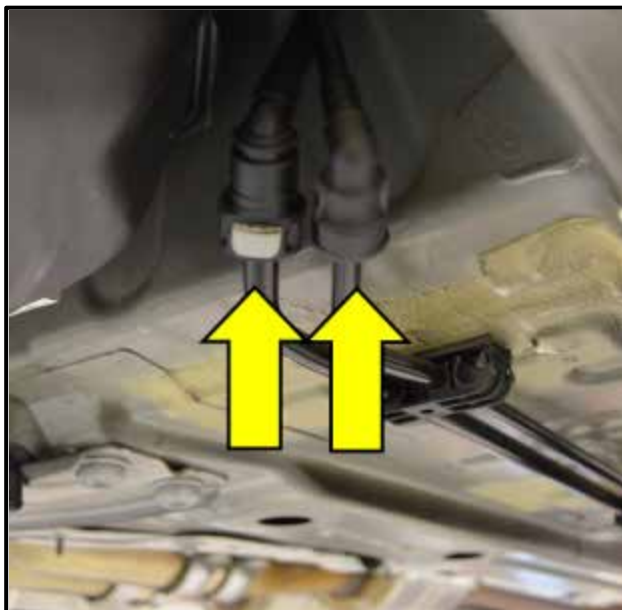
- Raise the vehicle on an appropriate hoist.
- Ü Disconnect the evaporative emissions line and the fuel supply line at the rear quick release connections <arrows>.

**WARNING:** The fuel lines must be disconnected at this location **FIRST**, prior to disconnecting the fittings under the hood. This will prevent potential damage the fuel system by fully releasing residual pressure.

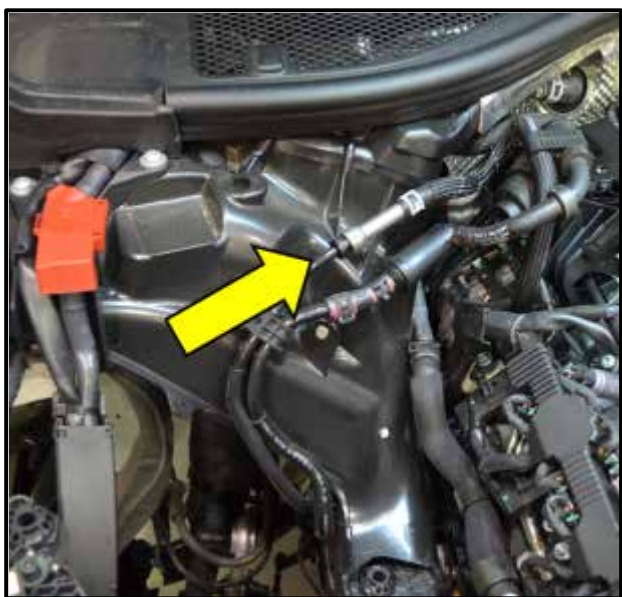
- Ü Disconnect the fuel supply line near the right front strut tower <arrow>.

**TIP:** Wrap a rag around the quick release connection on the fuel supply line to catch any residual fuel when the line is disconnected.

**TIP:** The fuel supply line is a smaller diameter than the evaporative emissions line.

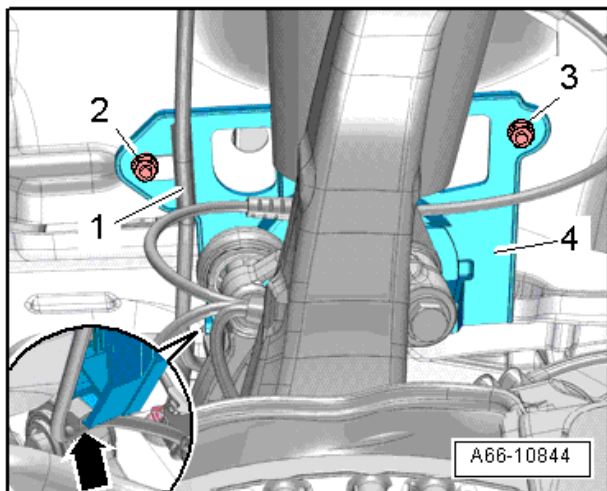
- Remove the right front wheel.
- Ü Remove the driveshaft cover mounting nuts <2, 3>.
- Ü Remove the driveshaft cover <4>.

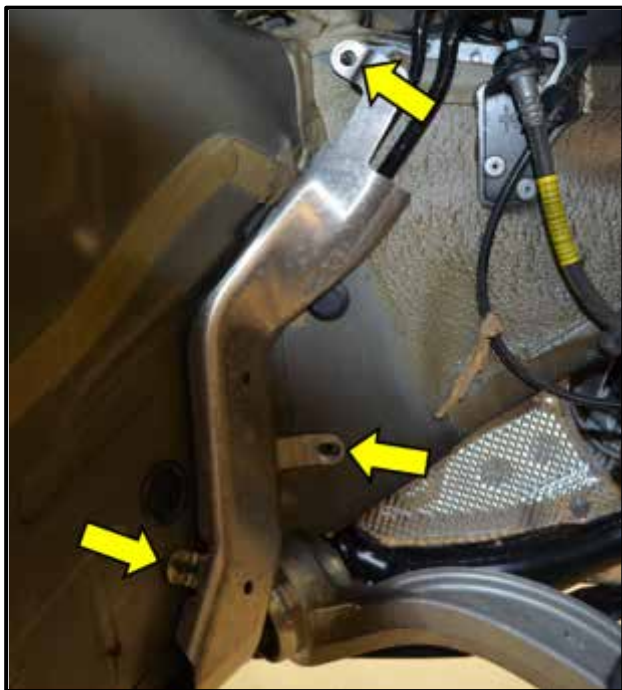
Ü Remove the three mounting nuts for the fuel line shield <arrows>.

- Remove the shield.

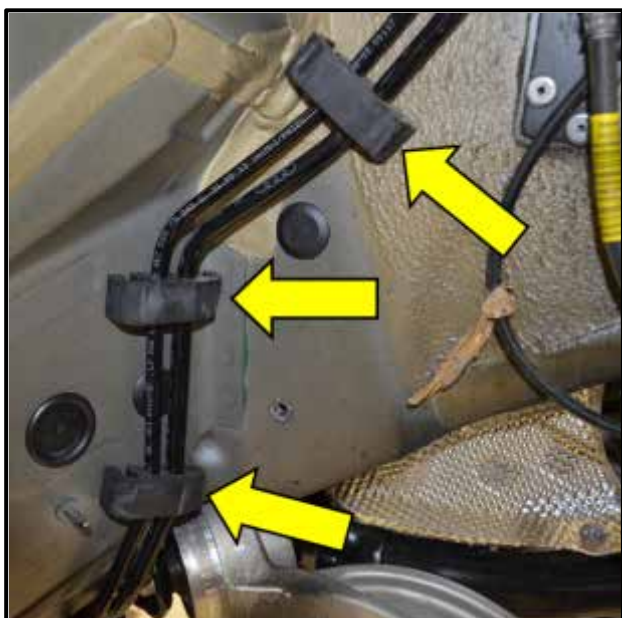
Ü Remove the three rubber insulators from the fuel line assembly <arrows>.

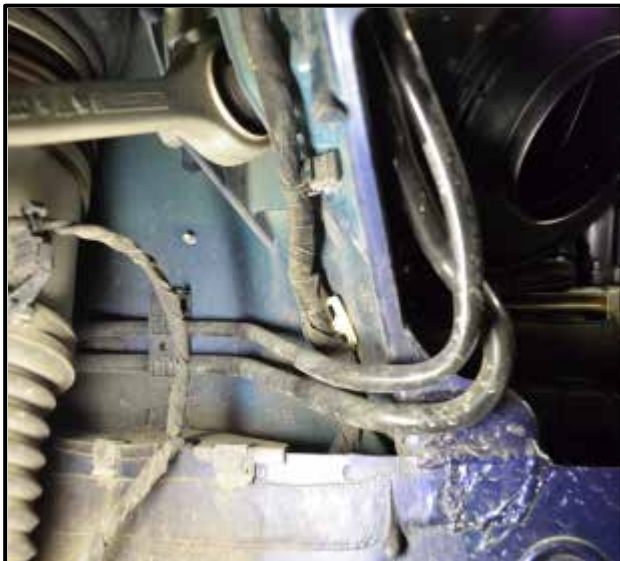
**TIP:** At this point in the repair process, note the routing of the fuel supply line and evaporative emissions line behind the front strut. Take photos if necessary. When the fuel line is reinstalled it must be routed in exactly the same location and orientation in order to fit properly.

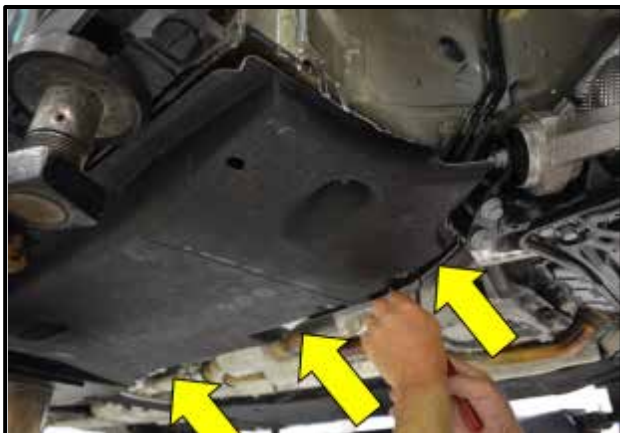
Ü Remove the right side underbody shields <arrows>.

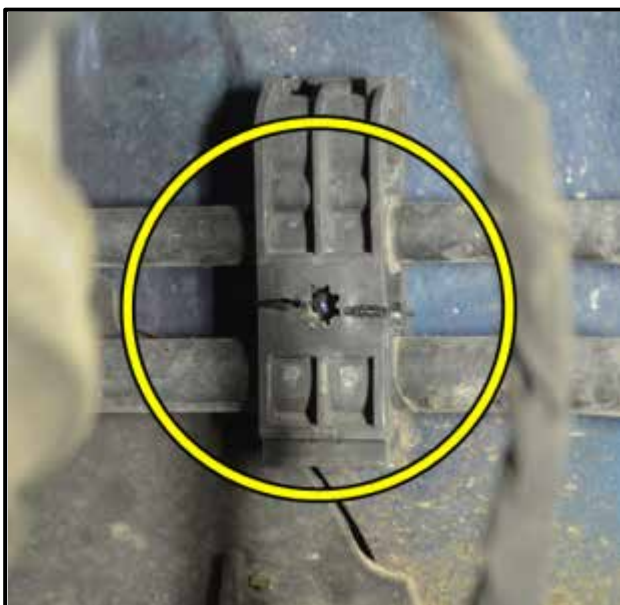
Ü Use a gasket scraper, small size chisel, or equivalent, to carefully split each fuel line mounting clip as shown <circle>.

- Starting in the rear of the vehicle, remove the clips from the mounting studs using Trim Release Lever T10039.

**WARNING:** The mounting studs may break if they are bent.

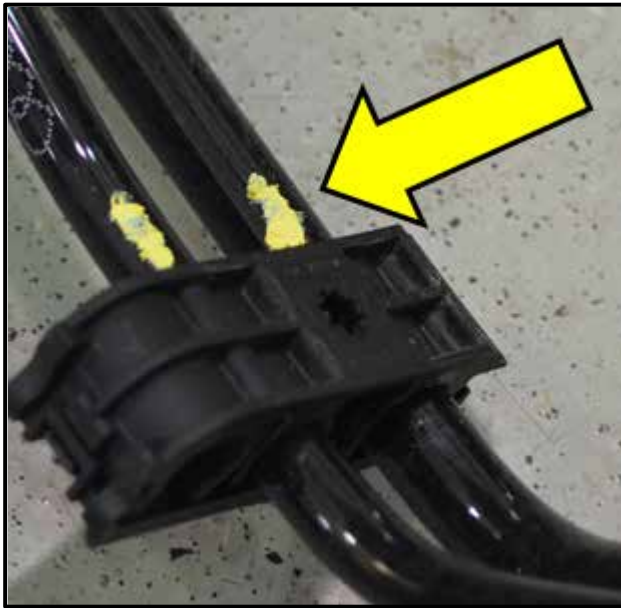
Ü Mark the location of each mounting clip on the evaporative emissions line <arrow>.

- Open and remove each plastic clip from the fuel line assembly.
- Remove the fuel supply line from the vehicle.
- Install the new fuel supply line, 4G0 201 545 BB, into position.

**TIP:** Note the routing of the line behind the front strut. It must fit between the strut and the body, above the right front brake line mounting bracket.

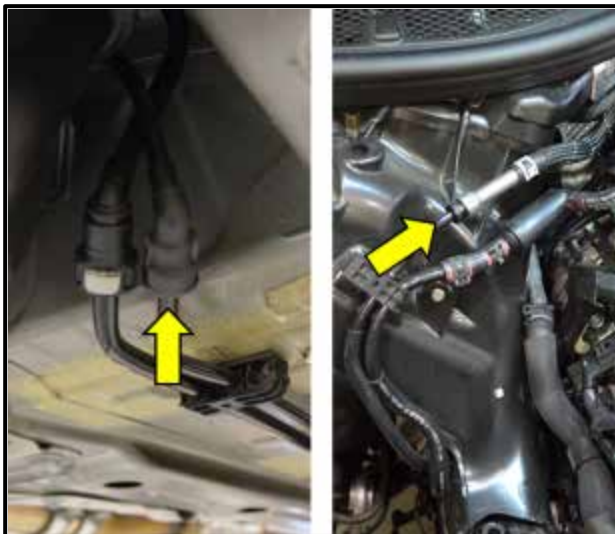
Ü Reconnect the quick release fittings at both the front and the rear of the fuel supply line <arrows>.

**WARNING:** Use caution during installation of the new fuel supply line. Do not bend or kink the line. Damage to the replacement fuel supply line or to the evaporative emissions line will not be covered under this action.

**TIP:** By reconnecting each end of the line first, it is positioned correctly to allow for reinstallation of the mounting clips.

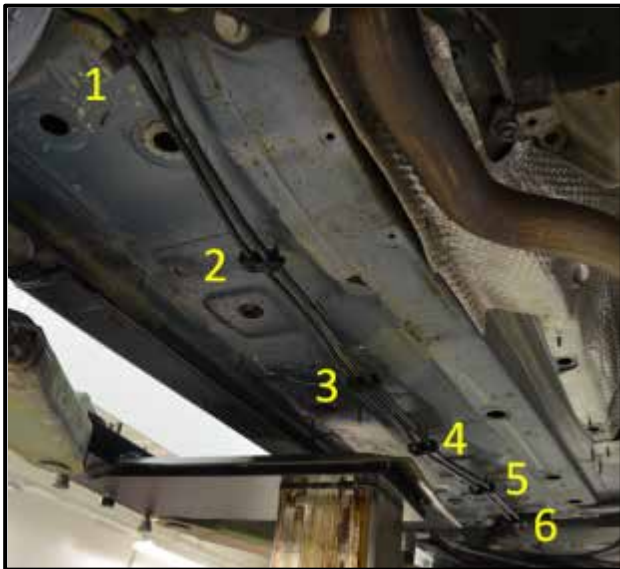
- Install the new mounting clips, 4G0 201 190, onto the evaporative emissions line and the fuel supply line.
  - Use the markings previously applied to the evaporative emissions line as a guide for clip placement.
- Ü Install each mounting clip onto the appropriate stud in the order shown <left>.

**TIP:** Once all the plastic clips are reinstalled inspect the fuel supply line and evaporative emission line routing. Verify both lines are secured to the body properly and that the lines are not able to rub against any components.

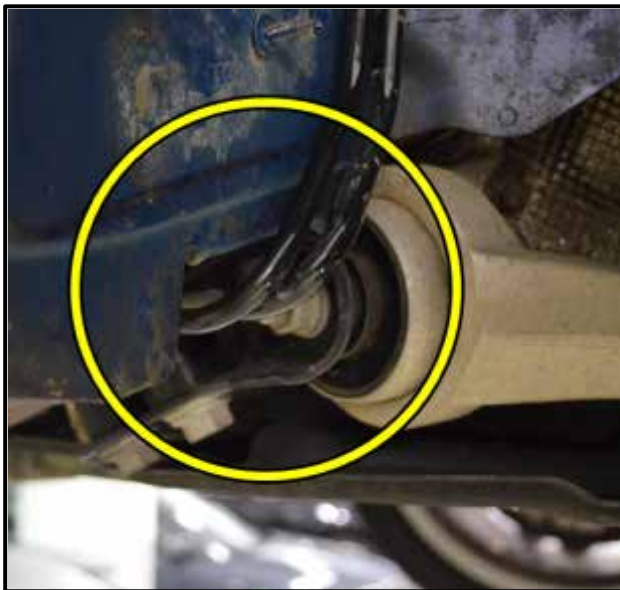
- Ü Inspect the fuel supply line and evaporative emissions line clearance where shown <circle>. Verify these lines do not contact the vehicle body.
- Reconnect the vehicle battery.
  - Start the engine
  - Verify the replacement fuel line is properly sealed and does not leak.

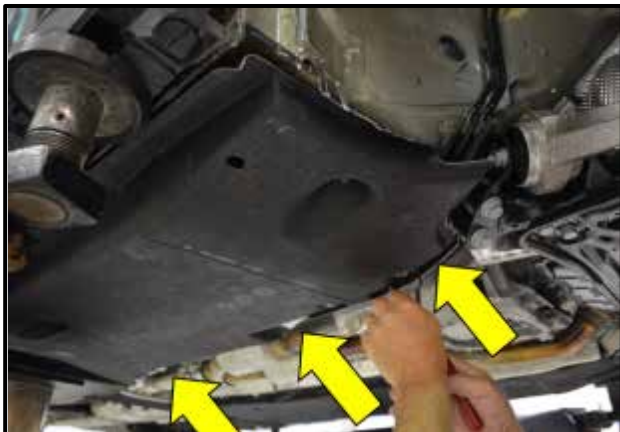
- Ü Reinstall the underbody shields <arrows>.

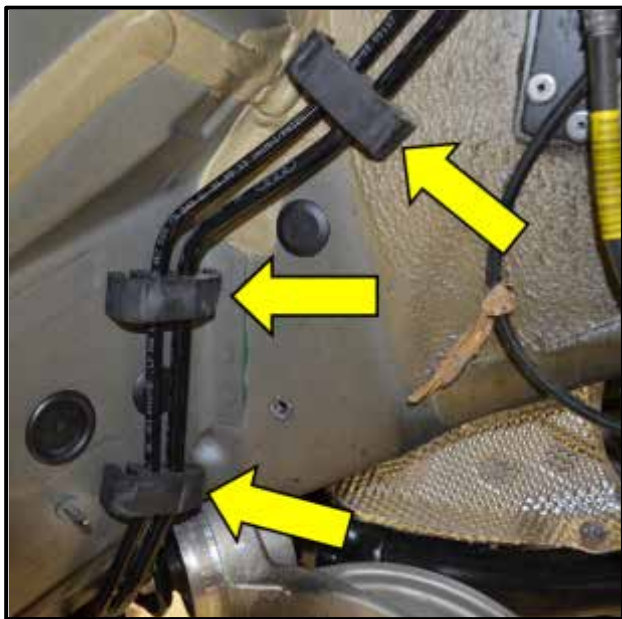
- Ü Install the three rubber insulators onto the fuel supply line and the evaporative emissions line <arrows>.

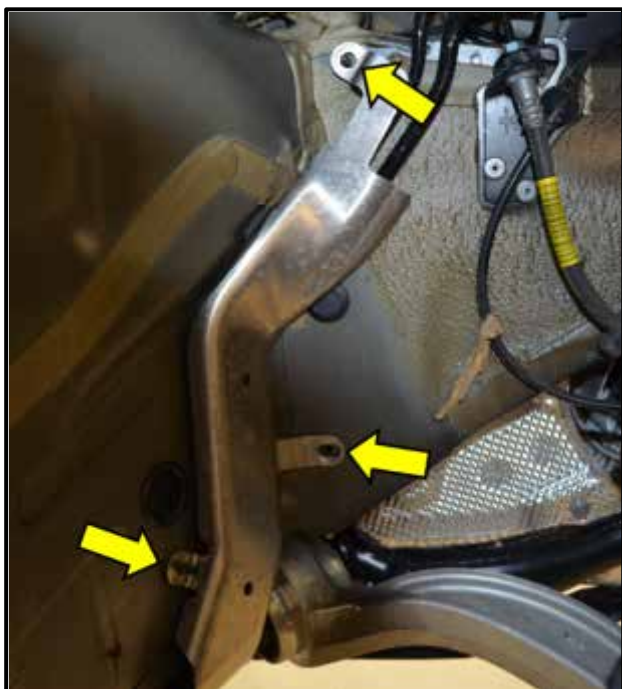
- Ü Reinstall the fuel line shield and mounting nuts <arrows>.

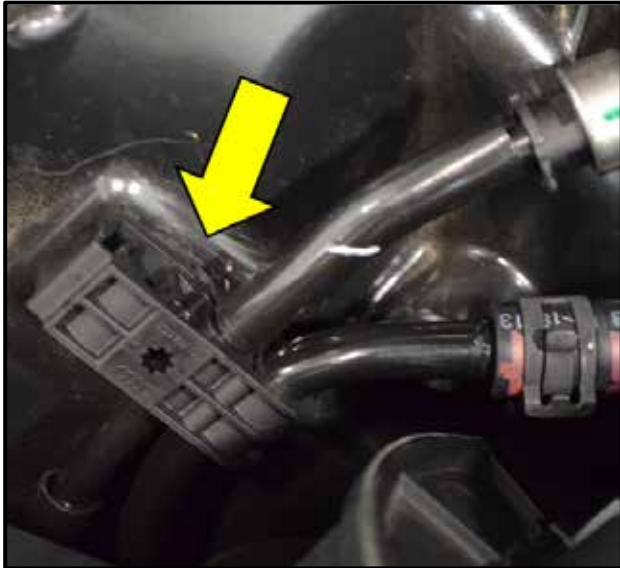
- Position and install the mounting clip at the top end of the fuel supply line and evaporative emissions line <arrow>.

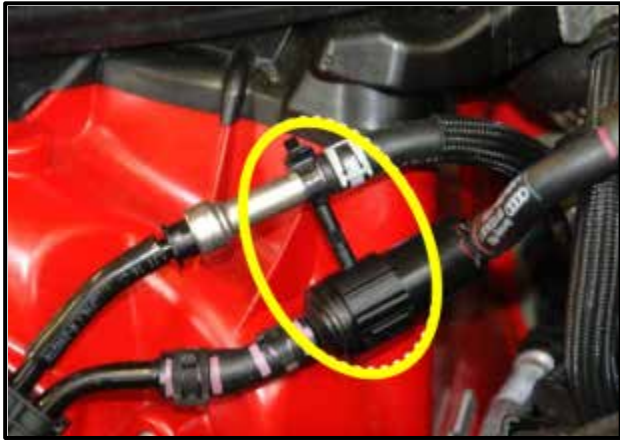
- Install new double clip, 4G0 201 449 AG, <circle>
