## REPLACEMENT OF PARK BRAKE VALVE

9700 (B13R)

On the vehicles affected by this bulletin, perform the replacement of the park brake control valve.

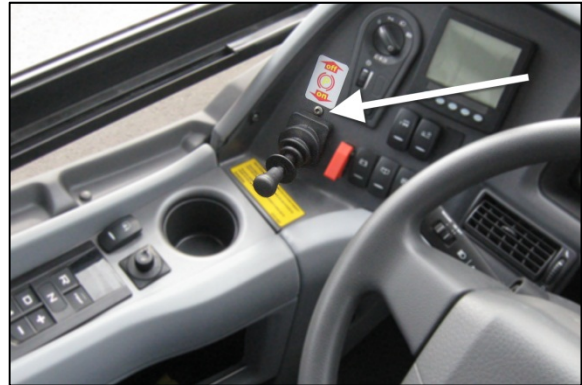
- 1) Park vehicle on level ground, choke the wheels.
- 2) Remove air in vehicle brake air system by depressing repeatedly the brake pedal until the gages indicate "0" air pressure.
- 3) Locate the park brake valve in the dashboard.

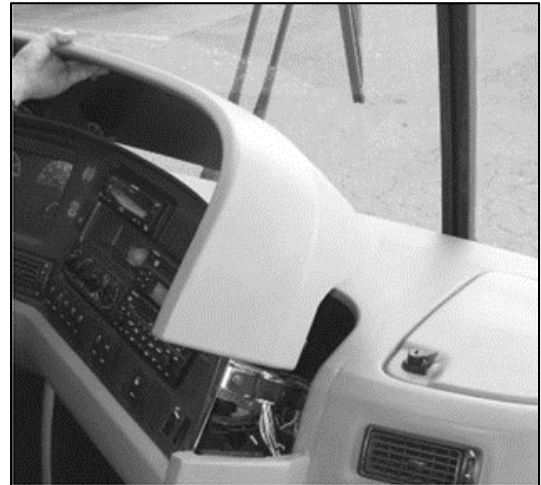
- 4) To replace the park brake valve, remove the upper dashboard cover (5 screws).

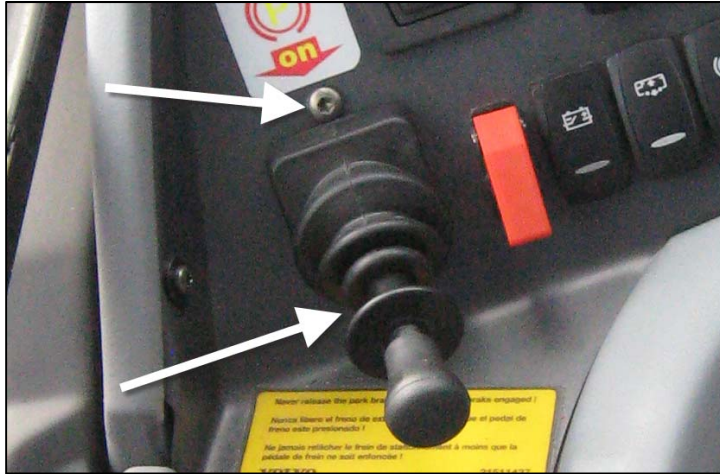
- 5) Dismount the park brake valve from the dash board. (2 screws)

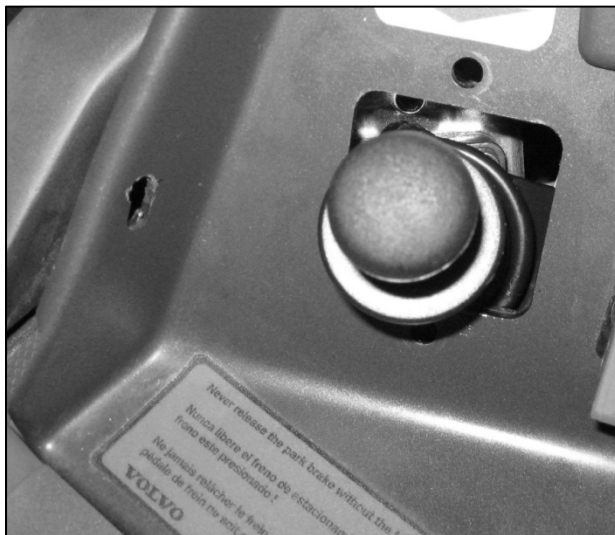
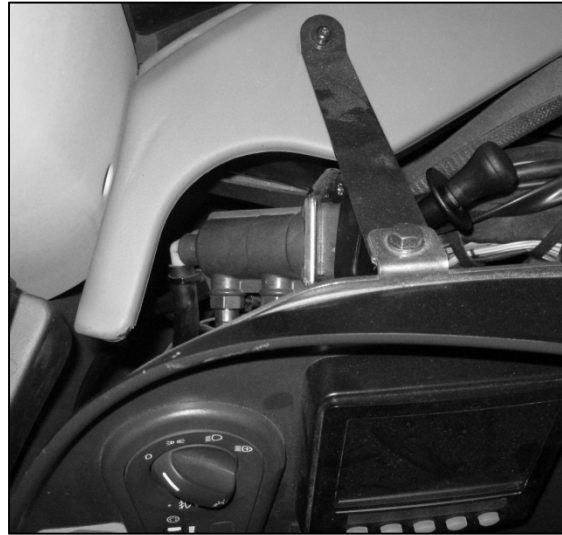
- 6) Slip the valve inside the dashboard, taking care not to stress the electrical harnesses. If required, identify and disconnect harnesses or cut cable ties to create some working space.
