Recall Bulletin

FMVSS NONCOMPLIANCE RECALL

SUBJECT: Fuel Label Compliance

MODELS: 2013-2014 Chevrolet Express, Silverado HD
2013 GMC Savana
2013-2014 GMC Sierra HD
Compressed Natural Gas Vehicles

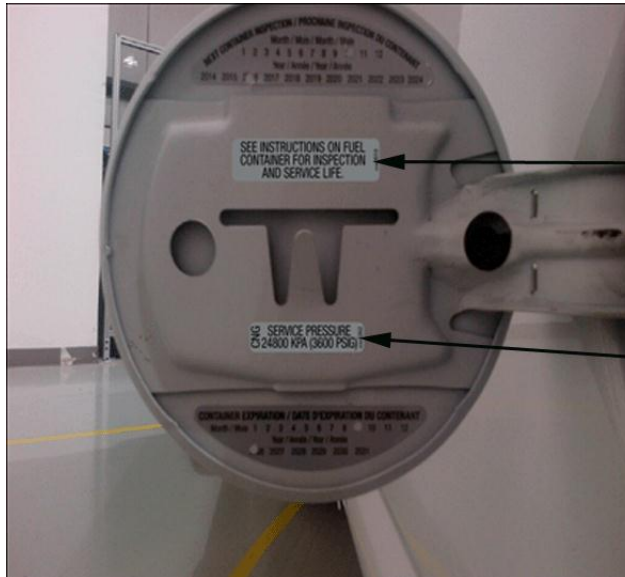
Chevrolet Express/GMC Savana Label Installation Instructions

PN 23463818

SEE INSTRUCTIONS ON FUEL CONTAINER FOR INSPECTION AND SERVICE LIFE.

PN 23465262

SERVICE PRESSURE 24800 KPA (3600 PSIG)

1. Remove existing label and any residue using isopropyl alcohol. Dry the label surface with clean, lint free cloth. The label surface must be clean, dry and free of any contaminants. Do NOT place new label over an existing label.
2. Firmly hold the new label and peel protective liner from the back side, being careful not to touch or contaminate the adhesive with dirt or foreign matter.
3. Carefully align new label to the surface press firmly and smooth out entire label ensuring corners are fully adhered.

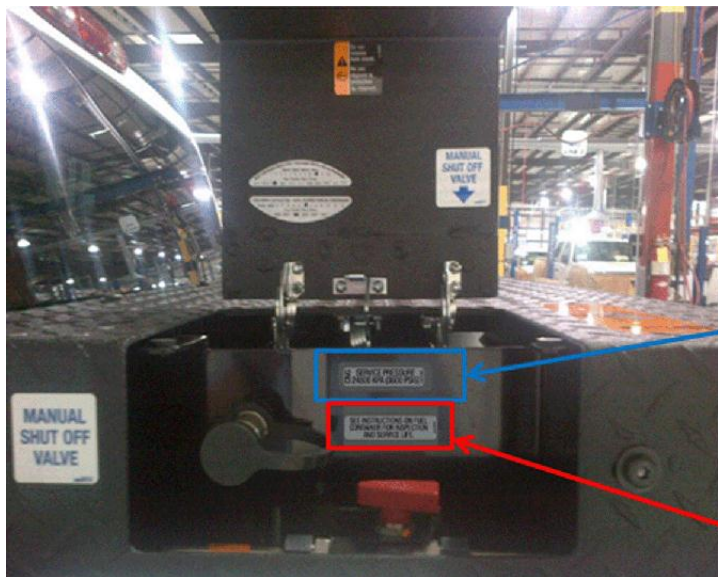
Chevrolet Silverado/GMC Sierra CNG Label Installation Instructions

PN 23465262

CNG SERVICE PRESSURE 24800 KPA (3600 PSIG)

PN 23463818

SEE INSTRUCTIONS ON FUEL CONTAINER FOR INSPECTION AND SERVICE LIFE.

1. Remove existing label and any residue using isopropyl alcohol. Dry the label surface with clean, lint free cloth. The label surface must be clean, dry and free of any contaminants. Do NOT place new label over an existing label.

2. Firmly hold the new label and peel protective liner from the back side, being careful not to touch or contaminate the adhesive with dirt or foreign matter.
3. Carefully align new label to the surface press firmly and smooth out entire label ensuring corners are fully adhered.
