## Campaign Service BULLETIN

BULLETIN NUMBER:  
SB13-11-S001A

### Regional Safety Recall 13V-547

## Corrosion Affecting the Forward Mounting Point for Rear Suspension Lower Link Brackets

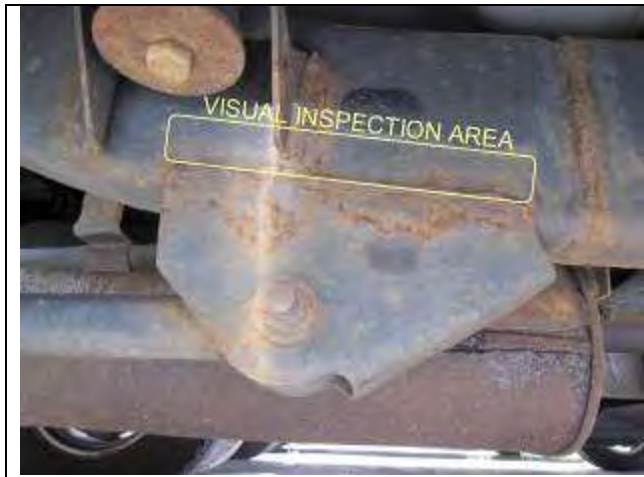
Figure 1 – Visual Inspection Area

1. Raise the vehicle. When placing the lift points, be sure to keep the rear lifting points at least 300mm (12 inches) ahead of the rear lower trailing link front mounting bracket. This spacing is necessary for inspection and repair accessibility.

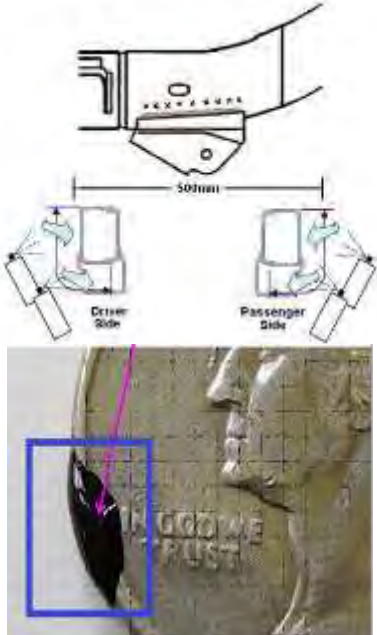
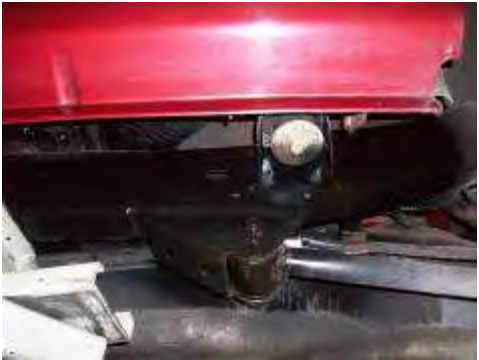
<p>Figure 4 – Noxudol 300 Application One coat is generally 50 microns which would cover the leading edge of a quarter.</p>	<p>Figure 5 – Noxudol 300 Applied</p>

1. Using a wire brush and scraper remove any loose coating material and rust from the outside frame and rear lower trailing link front mounting bracket area on both driver and passenger sides in the location shown in Figure 4.
2. Using a dry rag remove any remaining dust or debris. If the application area is wet, use a blow gun to remove any water.

3. Spray one coat of Noxudol 300 onto both driver and passenger side shown in Figures 4 and 5. Be careful not to overspray onto the exhaust system or body painted areas. See Figure 4.
4. Apply the campaign label (see "Applying the Campaign Label" in this bulletin).

2. Using a hammer, knock on the outside of the frame rail in the area indicated in Figure 4 to loosen any rust on the inside of the frame.
3. Using a blow gun, through the side frame hole, blow any rust debris to the front end and to the rear end of the frame away from the area indicated in Figure 4.

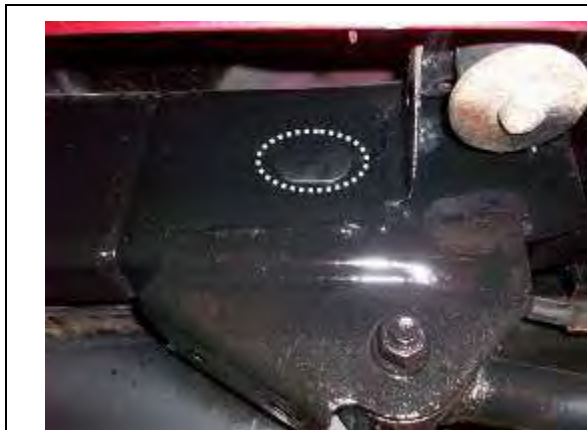
Figure 6 – Frame Hole Plug

5. Using a dry rag remove any remaining dust or debris. If the application area is wet, use a blow gun to remove any water.
6. Locate the long spray nozzle for Noxudol 700 and place a mark (tape or pen) 300 mm (12 inches) and 200 mm (7 inches) from the spray end of the nozzle. This mark indicates how far you will insert the long nozzle for some of the following steps. See Figure 7. Install the long spray nozzle onto a can of Noxudol 700.

15. Remove the frame hole plug from the driver and passenger side frame rails as shown in Figure 6. Discard the plug.
16. Using a hammer, knock on the outside of the frame rail to loosen any rust on the inside of the frame.
17. Using a wire brush and scraper remove any loose coating material and rust from the entire outside frame rail. Clean the area 10 inches forward and rearward the bracket location.
18. Using "C" clamps and the provided stud and nut (P/N 8-98174-543-0 and 8-97245-646-0), temporarily install both right and left brackets as shown in Figure 61.
  - a. Start by securing the bracket to the frame using the stud and nut at the upper link bracket.
  - b. Push the bracket up firmly against the frame and clamp into place with the "C" clamps. Be sure the clamps compress the bracket against the frame so there is not possibility of movement while marking the frame.

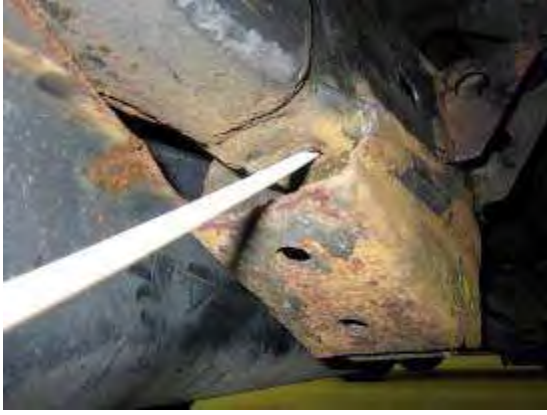
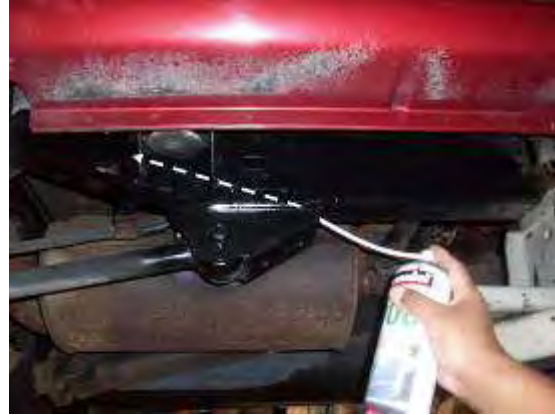
Figure 8 - Drain Hole

7. Insert the long spray nozzle with Noxudol 700 into the drain hole located on the bottom of frame up to the 300 mm (12 inches) mark. Then spray Noxudol 700 while drawing out the nozzle. Spray two times. See Figures 8 and 9.

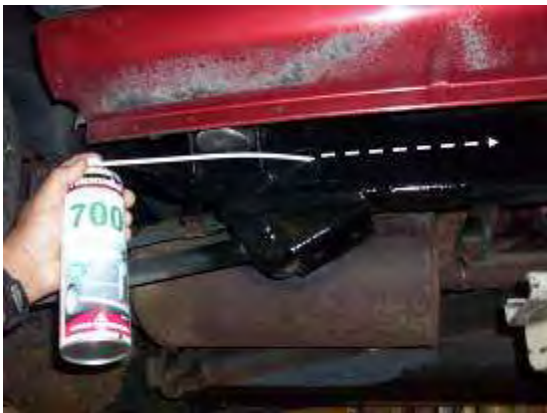
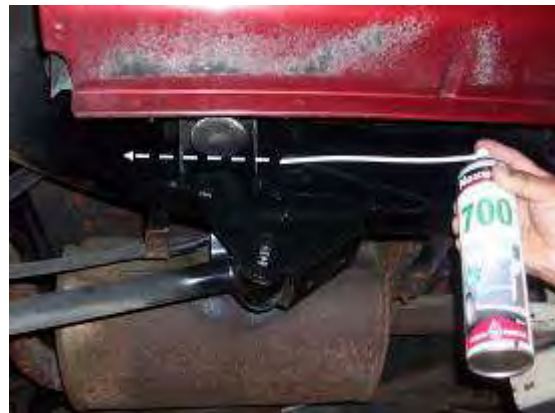
Figure 10 – Frame Hole Toward Front (300 mm)

8. Insert the long spray nozzle with Noxudol 700 into the side frame hole toward the front of the vehicle up to the 300 mm (12 inches) mark. Then spray Noxudol 700 while drawing out the nozzle. Spray four times. See Figure 10.
9. Insert long spray nozzle with Noxudol 700 into the side frame hole toward the rear of the vehicle up to the 200 mm (7 inches) mark. Then spray Noxudol 700 while drawing out the nozzle. Spray four times. See Figure 11.

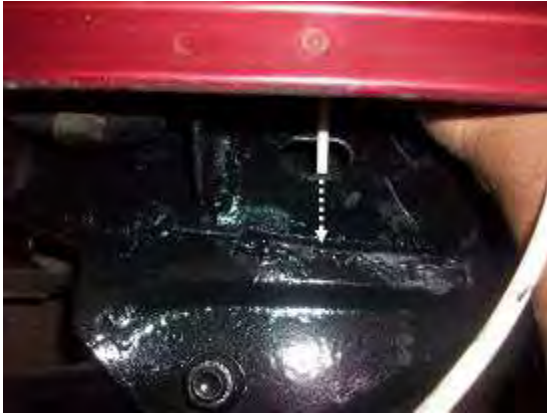
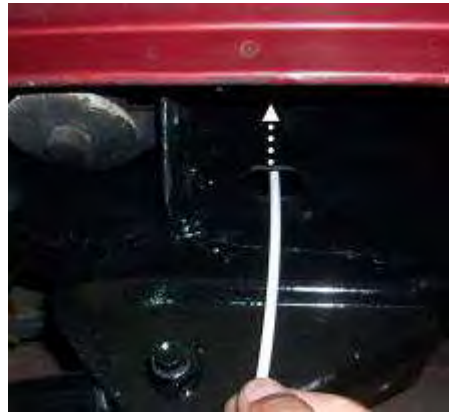
Figure 12 - Frame Hole Down

10. Insert long spray nozzle with Noxudol 700 through the side frame hole up and down. See Figures 12 and 13. Then spray Noxudol 700 with drawing out the nozzle. Spray two times in each direction.
11. Switch from the long spray nozzle to the short spray valve shown in Figure 7 and spray one coat of Noxudol 700 onto the outside of both driver and passenger side in the area indicated in Figure 4. Be careful not to overspray onto the exhaust system or body painted areas.

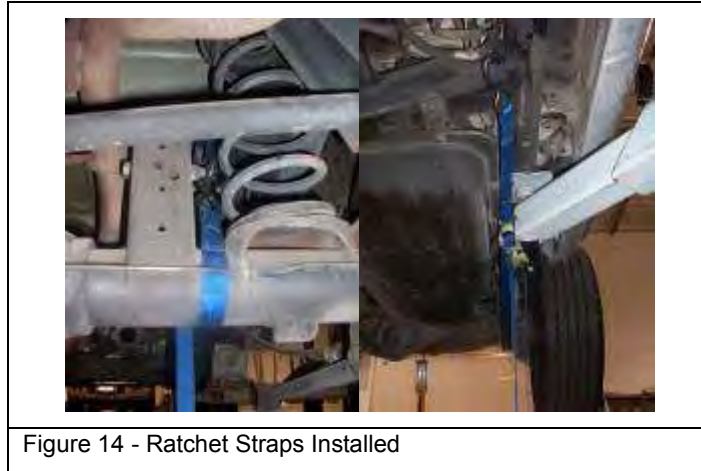
1. Remove the following components as per the service manual (see Figure 15):
  - a. Rear trailing link from mount mounting nut from driver and passenger sides.
  - b. Remove running boards or side steps (if equipped).
2. Remove lower half of body mount #4 from both driver and passenger side. See Figures 15 and 16.
3. Using a ratcheting strap, lash up the rear axle. Start by attaching one end of the strap to the upper link mount. Then route the strap around the rear axle, taking care not to cover any brake piping, and continue forward under the vehicle, attaching the other end of the strap to the transmission mount cross member. Apply enough forward tension on the rear axle to allow the lower link mounting bolt to be moved by hand (see Figure 14).

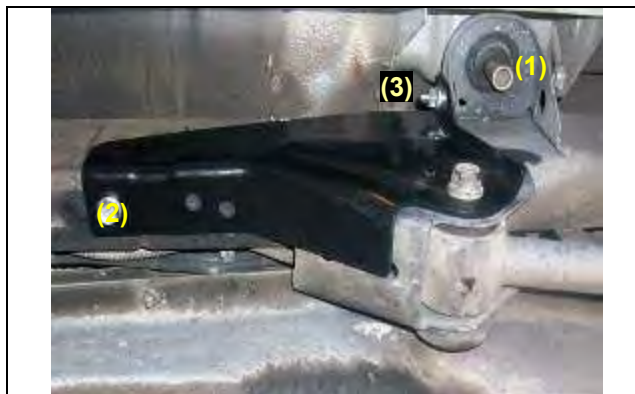
Figure 15 - Driver Side Temporary Installation

4. Using a hammer, knock on the outside of the frame rail to loosen any rust on the inside of the frame.
5. Using a wire brush and scraper remove any loose coating material, welding splatter and rust from the outside frame and rear lower trailing link front mounting bracket area on both driver and passenger sides.
6. Temporarily install both reinforcement brackets using the original lower link mounting nuts, "C" clamps and new studs and nuts. See Figures 15 and 16.

**NOTE:** It will be necessary to remove the fuel tank protector mounting bolt on the driver side for 2003 and 2004 model year vehicles. Save the bolt for reuse. It will be required for final installation of the reinforcement bracket on the driver side.

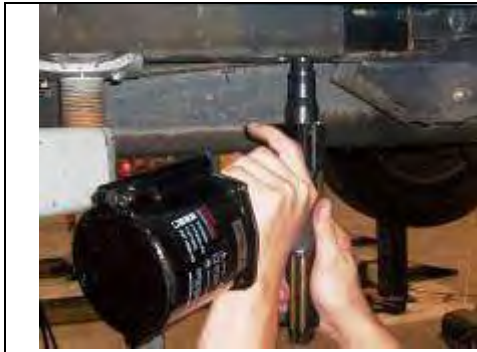
Figure 21 - Pop-nut Installer Ready for Use

**NOTE: Air pressure regulator adjustment is critical. Excessive air pressure will result in tool damage while low pressure may result in incorrect Pop-nut installation.**

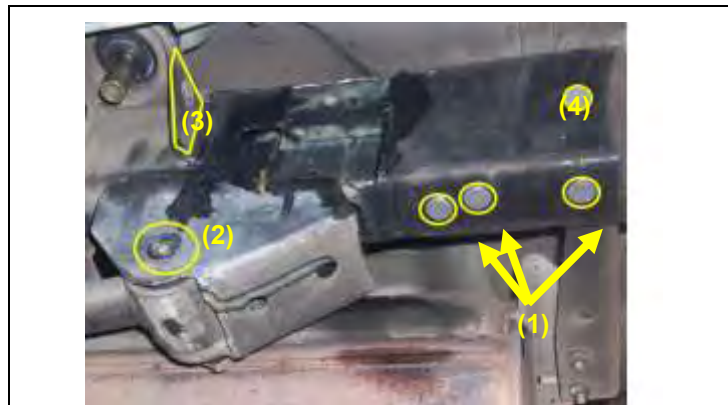
Figure 23 - Masking Locations for Bracket Type "A"

12. Using the  $\frac{3}{4}$ " round labels provided in the service kit, mask off the Pop-nuts. Use tape to mask off other related bracket mounting locations highlighted in Figure 23. This is required to inhibit Noxudol chemicals from coating the bracket mounting surfaces.

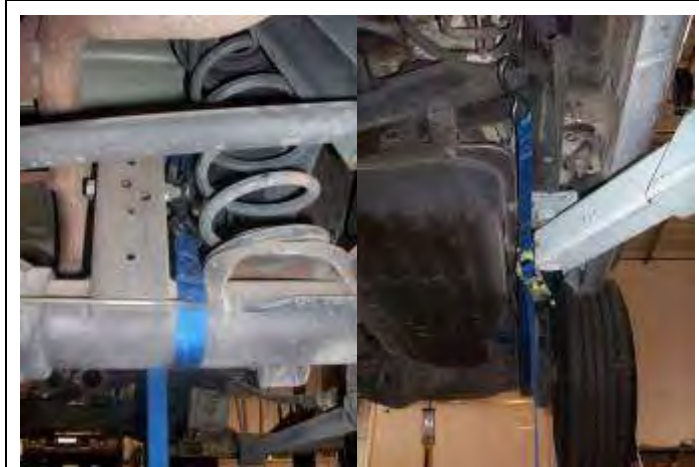
Figure 27 – Ratchet Straps Installed

1. Remove the following components as per the service manual (See Figure 28):
  - a. Rear trailing link front mount mounting nut from driver and passenger sides.
  - b. Remove running boards or side steps (if equipped).
2. Using a ratcheting strap, lash up the rear axle. Start by attaching one end of the strap to the upper link mount. Then route the strap around the rear axle, taking care not to cover any brake piping, and continue forward under the vehicle, attaching the other end of the strap to the transmission mount cross member. Apply enough forward tension on the rear axle to allow the lower link mounting bolt to be moved by hand. See Figure 27.

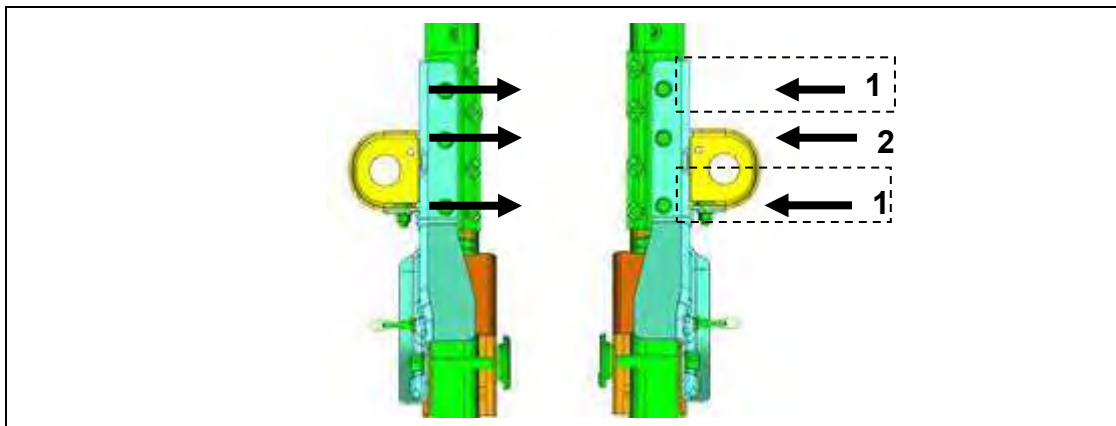
Figure 29 – Drilling Locations

**NOTE: There is a nut welded into the driver side frame at location 2 in Figure 29. This location is for the fuel tank protector. DO NOT DRILL THIS LOCATION.**

1. These locations may have weld nuts – DO NOT DRILL
2. This location is not used for 2003MY

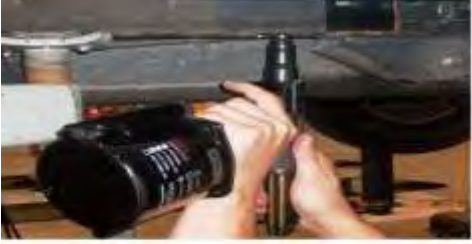
Figure 32 – Pop-nut Test Plate and Extra Pop-nuts (provided in kit)	Figure 33 – Pop-nut on Test Plate

- a. Before installing the Pop-nuts (P/N 8-98174-539-0), be sure the pressure regulator is adjusted between 72.5 and 87 psi (0.5-0.6MPa / 5-6bar) and using the provided test pieces, test install 1-3 Pop-nuts onto the test plate to be sure they are seating properly. See Figure 58.

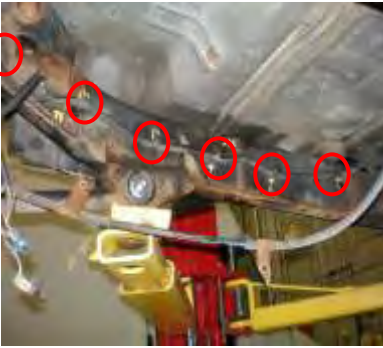
<p>Figure 48 - Parking Brake Cable Passenger Side</p>	<p>Figure 49 - Parking Brake Cable Driver Side</p>	<p>Figure 50 - Wire Harness</p>

- c. Wiring harness clips from frame driver side (6 points). See Figure 50.
  - d. Brake piping clips passenger side clips (4 clips). See Figure 51.
  - e. ABS speed sensor harness driver and passenger side (4 points). See Figure 52

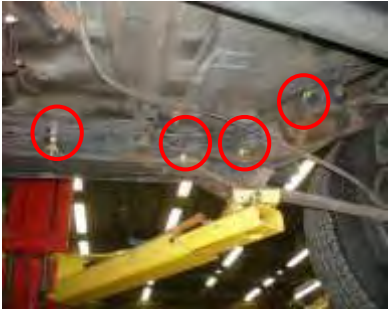
<p>Figure 51 - Brake Piping</p>	<p>Figure 52 - ABS Harness and Pipe</p>	<p>Figure 53 - Canister Pipe</p>

- g. Brake pipe retaining clip driver and passenger side. See Figure 51 (2 points)
  - h. Active suspension connector front right and left (if equipped).

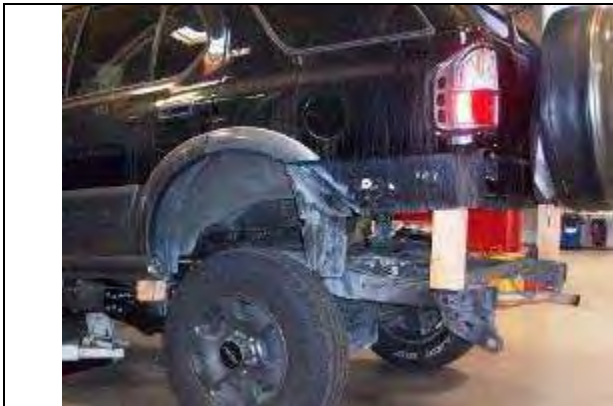
Figure 55 - Wood Block Installed at #5 Body Mount

**CAUTION: Failure to install the wooden blocks as directed below can create a dangerous situation in which the rear section of the frame rail may break off, collapse to the ground and cause serious personal injury to the technician during the repair as well as permanent frame damage, making the vehicle unreparable.**

11. Using wooden blocks, support the body off of the frame. See Figures 35 and 36.
  - a. Body mount #5 should be 10.25 inches (260 mm) above the frame and body mount #4 should be at least 7.0 inches (175 mm).

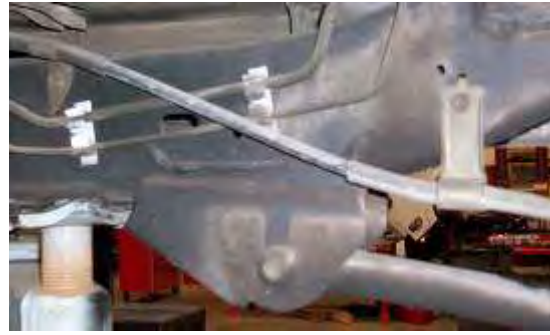
Figure 58 - Passenger Side Bracket Before Removal

12. Remove the rear lower link front mounting bolts, on driver and passenger side. Discard mounting bolts and nuts. New hardware is provided in the bracket kit.
13. Raise the vehicle into the air.
14. Remove the rear trailing link front mount. See Figure 57 for reference.
  - a. Using a cutting wheel cut just below or through the weld to remove the bracket.
  - b. Use a disk grinder to remove any excess material and smooth out the frame.

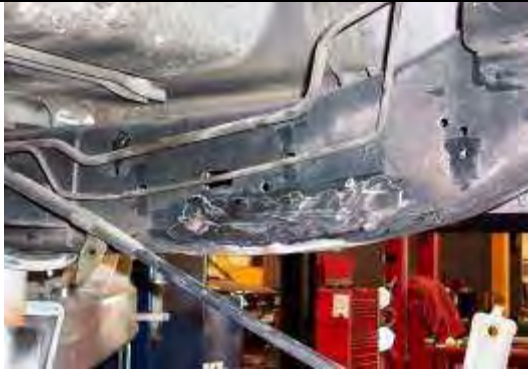
Figure 59 - Frame After Bracket Removal

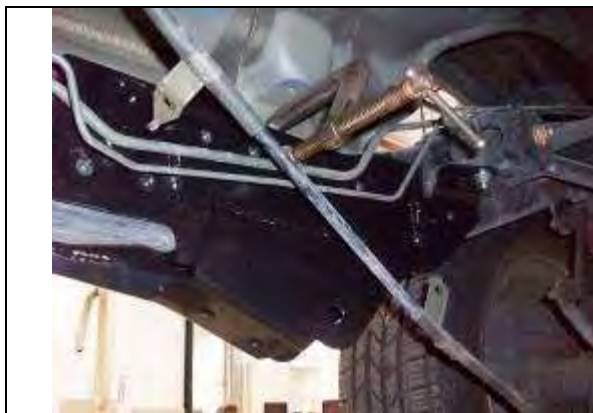
Figure 61 - Type "B" Bracket (temporary installation)

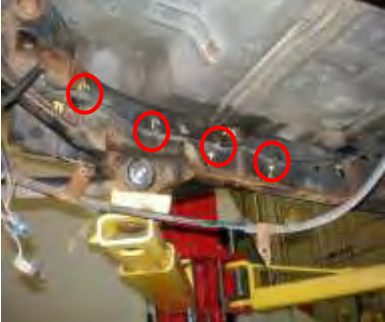
<p>Figure 73 – Parking Brake Cable Passenger Side</p>	<p>Figure 74 – Parking Brake Cable Driver Side</p>	<p>Figure 75 – Wire Harness Driver Side</p>

5. Remove/disconnect the following components per the service manual:
  - a. Parking brake cable passenger side mounting bolts. See Figure 73 (1 point).
  - b. Parking brake cable driver side mounting bolts. See Figure 74 (1 point).
  - c. Wiring harness clips from frame driver side). See Figure 75 (4 points).
  - d. Brake piping passenger side clips. See Figure 76 (3 clips).
  - e. ABS speed sensor harness driver and passenger side. See Figure 77 (4 points).
  - f. Brake pipe retaining clip driver and passenger side. See Figure 76 (2 points).
  - g. Canister pipe. See Figure 78 (3 points).
  - h. Active suspension connector front right and left (if equipped).
  - i. Seat belt tension rod. Save the mounting bolts for reuse. See Figure 79.
  - j. Fuel tank protector by removing the fixing bolts.

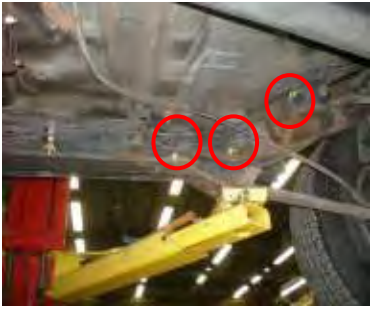
<p>Figure 76 – Brake Piping</p>	<p>Figure 77 – ABS Harness and Pipe</p>	<p>Figure 78 – Canister Pipe</p>

- e. ABS harness and piping right front fender well.
  - f. Brake pipe retaining clip driver and passenger side. See Figure 76 (2 points).
  - g. Canister pipe. See Figure 78 (3 points).

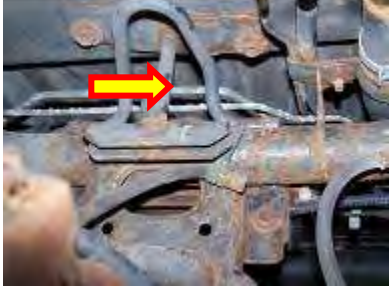
<p style="text-align: center;">Figure 79 - Seat Belt Tension Rod</p>

- h. Active suspension connector front right and left (if equipped).
  - i. Seat belt tension rod. See Figure 79
    - i. Reuse original bolts; Torque: 6.5 to 8.5 Nm (57 to 75 lb in).

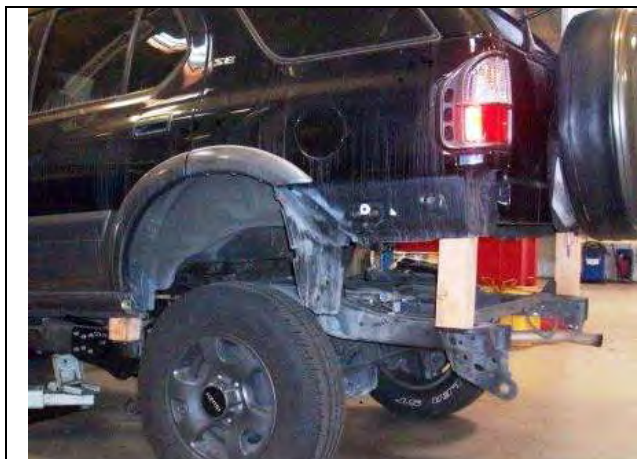
Figure 81 – Wood Blocks Installed at #5 Body Mount

**CAUTION: Failure to install the wooden blocks as directed below can create a dangerous situation in which the rear section of the frame rail may break off, collapse to the ground and cause serious personal injury to the technician during the repair as well as permanent frame damage, making the vehicle unreparable.**

11. Using wooden blocks, support the body off of the frame. See Figures 81 and 82.
  - a. Body mount #5 should be 7.85 inches (200 mm) above the frame and body mount #3 should be at least 4.75 inches (120 mm).

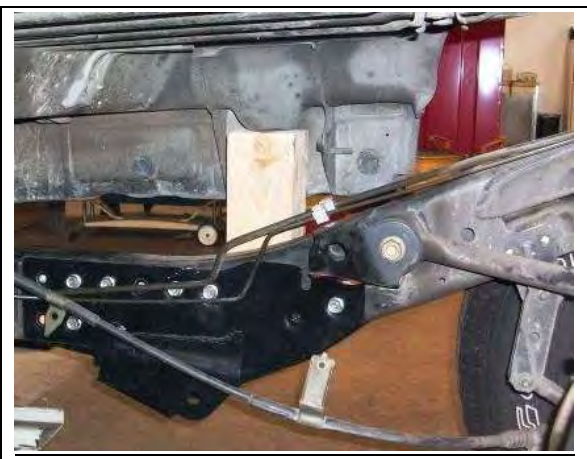
Figure 82 – Wood Block Installed at #3 Body Mount

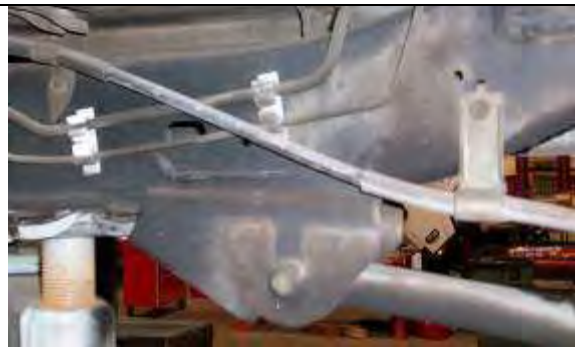
Figure 84 – Passenger Side Bracket Before Removal

12. Remove the rear lower link front mounting bolts, on both driver and passenger sides. Discard the mounting bolts and nuts. New hardware is provided in the reinforcement bracket kit.
13. Raise the vehicle into the air.
14. Remove the rear trailing link front mount. See Figure 83 for reference.
  - a. Using a cutting wheel, cut just below or through the weld to remove the bracket.
  - b. Use a disk grinder to remove any excess material and smooth out the frame.

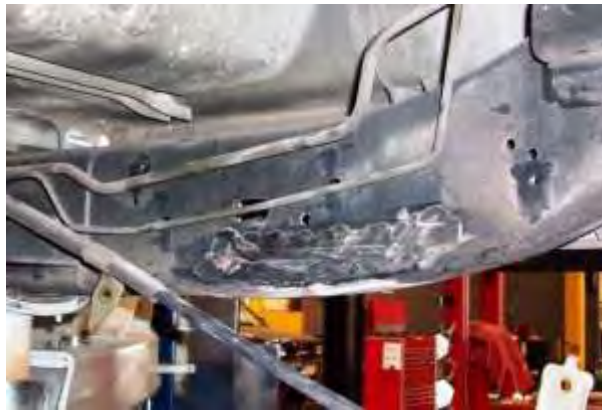
Figure 85 – Frame After Bracket Removal

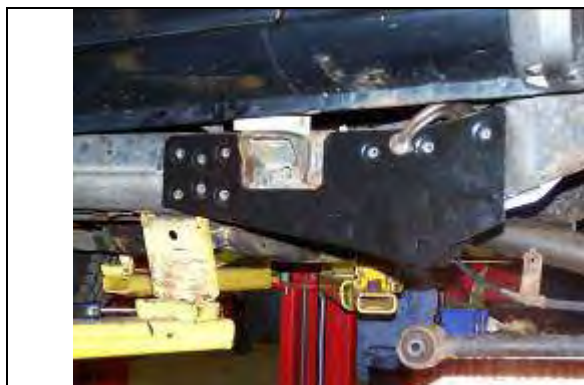
Figure 87 – Type “D” Bracket (temporary installation)

15. Remove the frame hole plug from the driver and passenger side frame rails as shown in Figure 6. Discard the plug.
16. Using a hammer, knock on the outside of the frame rail to loosen any rust on the inside of the frame.
17. Using a wire brush and scraper, remove any loose coating material and rust from the entire outside frame rail. Clean the area 10 inches forward and rearward the bracket location.
18. Using “C” clamps and the provided studs and nuts (P/N 8-98174-543-0 and 8-97245-646-0), temporarily install both right and left brackets as shown in Figure 87.
  - a. Start by securing the bracket to the frame using the stud and nut at the upper link bracket.
  - b. Push the bracket up firmly against the frame and clamp into place with the “C” clamps. Be sure the clamps compress the bracket against the frame so there is no possibility of movement while marking the frame.
