ISUZU

BULLETIN NUMBER:
SB13-11-S001

Regional Safety Recall 13V-547

Corrosion Affecting the Forward Mounting Point for Rear Suspension Lower Link Brackets

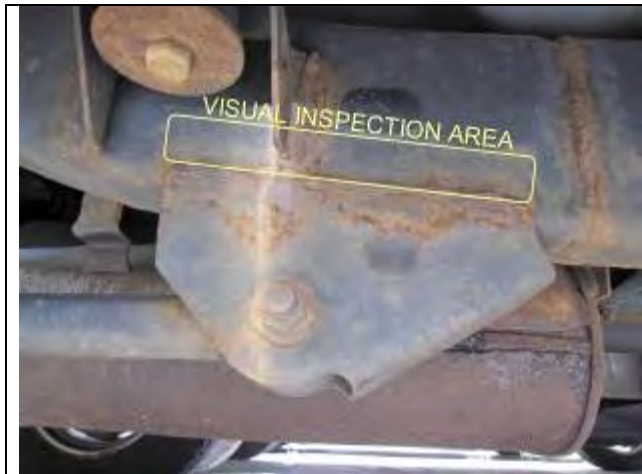
Figure 1 – Visual Inspection Area

1. Raise the vehicle. When placing the lift points, be sure to keep the rear lifting points at least 300mm (12 inches) ahead of the rear lower trailing link front mounting bracket. This spacing is necessary for inspection and repair accessibility.
2. Visually inspect the Rear Lower Trailing Link Front Mounting Bracket inspection area. Use the Visual Comparison Photo (P/N 2-90SVA-003-0) or Figure 1 for reference. If most of the frame coating is still in place and very little surface rust is present, apply Noxudol 300 (Go to “Condition One: Apply Noxudol 300” in this bulletin). If most frame coating is missing and excessive rust is present go to the next step.

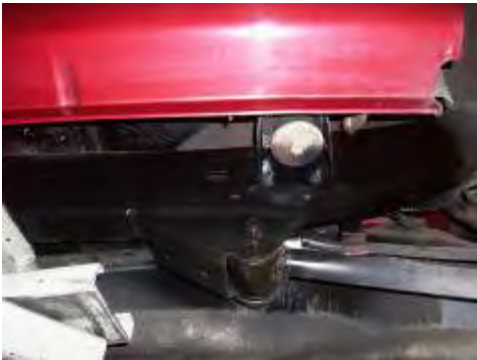
1. Using a wire brush and scraper remove any loose coating material and rust from the outside frame and rear lower trailing link front mounting bracket area on both driver and passenger sides in the location shown in Figure 4.
2. Using a dry rag remove any remaining dust or debris. If the application area is wet, use a blow gun to remove any water.

3. Spray one coat of Noxudol 300 onto both driver and passenger side shown in Figures 4 and 5. Be careful not to overspray onto the exhaust system or body painted areas. See Figure 4.
4. Apply the campaign label (see "Applying the Campaign Label" in this bulletin).

<p>Figure 4 – Noxudol 300 Application One coat is generally 50 microns which would cover the leading edge of a quarter.</p>	<p>Figure 5 – Noxudol 300 Applied</p>

2. Using a hammer, knock on the outside of the frame rail in the area indicated in Figure 4 to loosen any rust on the inside of the frame.
3. Using a blow gun, through the side frame hole, blow any rust debris to the front end and to the rear end of the frame away from the area indicated in Figure 4.

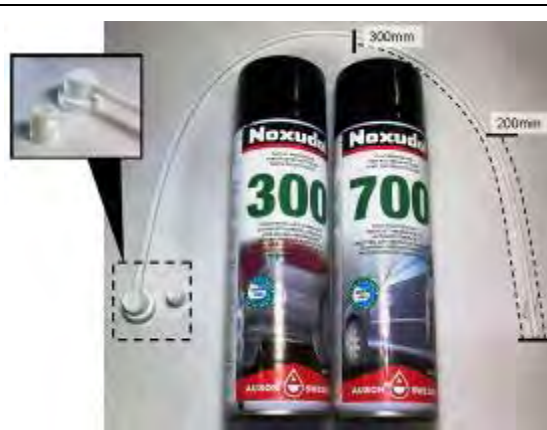
Figure 7 – Noxudol with Long and Short Spray Nozzles

5. Using a dry rag remove any remaining dust or debris. If the application area is wet, use a blow gun to remove any water.
6. Locate the long spray nozzle for Noxudol 700 and place a mark (tape or pen) 300 mm (12 inches) and 200 mm (7 inches) from the spray end of the nozzle. This mark indicates how far you will insert the long nozzle for some of the following steps. See Figure 7. Install the long spray nozzle onto a can of Noxudol 700.

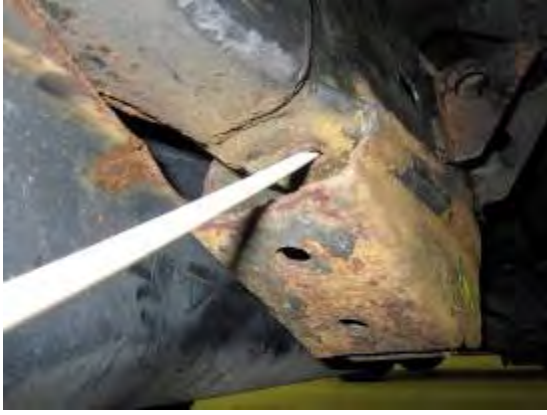
Figure 8 - Drain Hole

7. Insert the long spray nozzle with Noxudol 700 into the drain hole located on the bottom of frame up to the 300 mm (12 inches) mark. Then spray Noxudol 700 while drawing out the nozzle. Spray two times. See Figures 8 and 9.

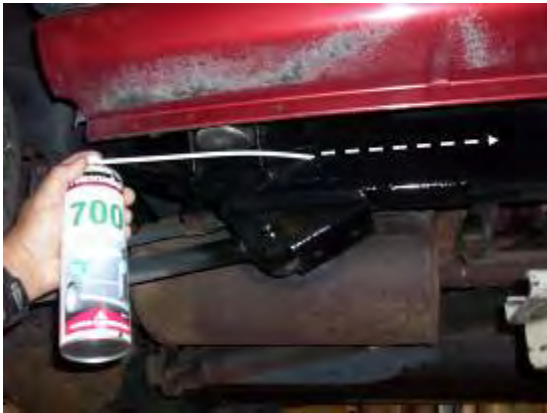
Figure 10 – Frame Hole Toward Front (300 mm)

8. Insert the long spray nozzle with Noxudol 700 into the side frame hole toward the front of the vehicle up to the 300 mm (12 inches) mark. Then spray Noxudol 700 while drawing out the nozzle. Spray four times. See Figure 10.
9. Insert long spray nozzle with Noxudol 700 into the side frame hole toward the rear of the vehicle up to the 200 mm (7 inches) mark. Then spray Noxudol 700 while drawing out the nozzle. Spray four times. See Figure 11.

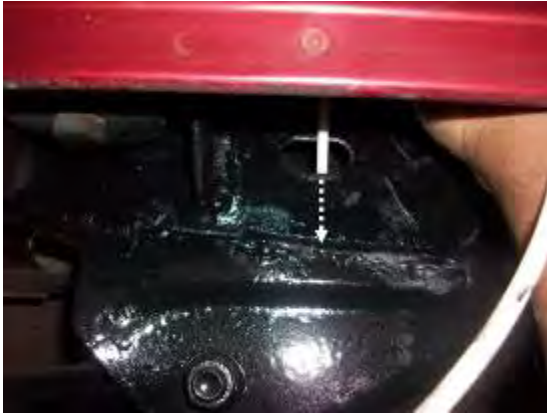
Figure 12 - Frame Hole Down

10. Insert long spray nozzle with Noxudol 700 through the side frame hole up and down. See Figures 12 and 13. Then spray Noxudol 700 with drawing out the nozzle. Spray two times in each direction.
11. Switch from the long spray nozzle to the short spray valve shown in Figure 7 and spray one coat of Noxudol 700 onto the outside of both driver and passenger side in the area indicated in Figure 4. Be careful not to overspray onto the exhaust system or body painted areas.

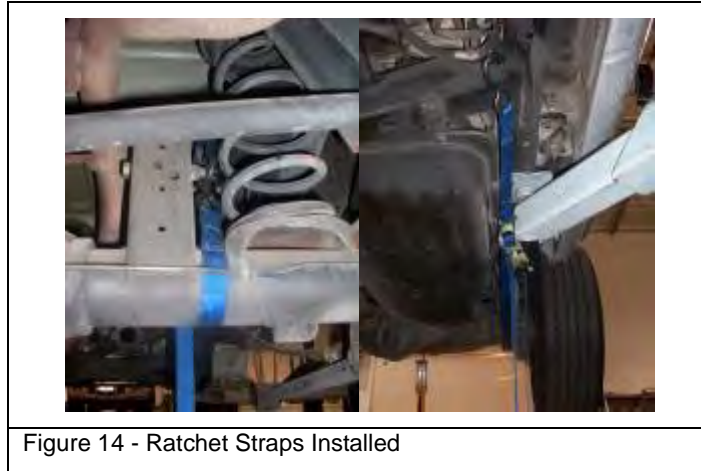
1. Remove the following components as per the service manual (see Figure 15):
 - a. Rear trailing link from mount mounting nut from driver and passenger sides.
 - b. Remove running boards or side steps (if equipped).
2. Remove lower half of body mount #4 from both driver and passenger side. See Figures 15 and 16.
3. Using a ratcheting strap, lash up the rear axle. Start by attaching one end of the strap to the upper link mount. Then route the strap around the rear axle, taking care not to cover any brake piping, and continue forward under the vehicle, attaching the other end of the strap to the transmission mount cross member. Apply enough forward tension on the rear axle to allow the lower link mounting bolt to be moved by hand (see Figure 14).

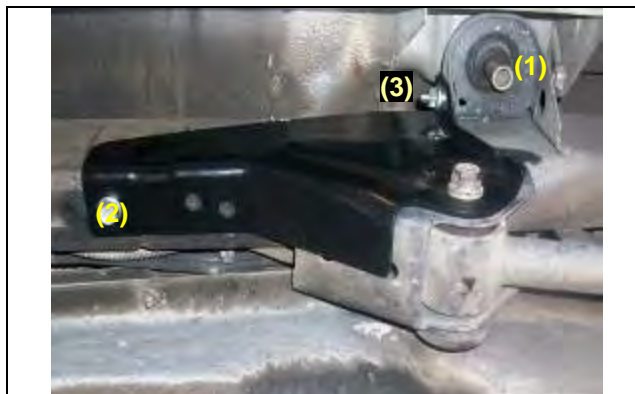
Figure 15 - Driver Side Temporary Installation

4. Using a hammer, knock on the outside of the frame rail to loosen any rust on the inside of the frame.
5. Using a wire brush and scraper remove any loose coating material, welding splatter and rust from the outside frame and rear lower trailing link front mounting bracket area on both driver and passenger sides.
6. Temporarily install both reinforcement brackets using the original lower link mounting nuts, "C" clamps and new studs and nuts. See Figures 15 and 16.

NOTE: It will be necessary to remove the fuel tank protector mounting bolt on the driver side for 2003 and 2004 model year vehicles. Save the bolt for reuse. It will be required for final installation of the reinforcement bracket on the driver side.

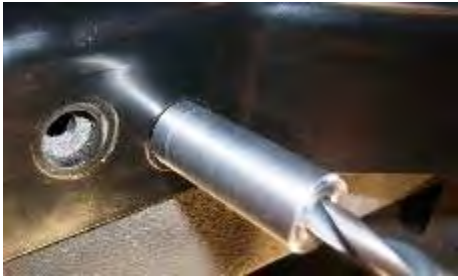
NOTE: There is a nut welded into the driver side frame at location 2 in Figure 16. This location is for the fuel tank protector. **DO NOT DRILL THIS LOCATION.**

<p>Figure 16 - Drilling Locations [2] This Location has a Welded Nut for the Fuel Tank Protector – DO NOT DRILL</p>	<p>Figure 17 - Drill Guide and Bracket</p>	<p>Figure 18 - 1/4" Holes</p>

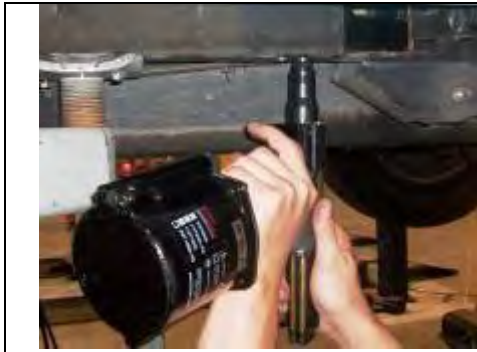
Figure 21 - Pop-nut Installer Ready for Use

NOTE: Air pressure regulator adjustment is critical. Excessive air pressure will result in tool damage while low pressure may result in incorrect Pop-nut installation.

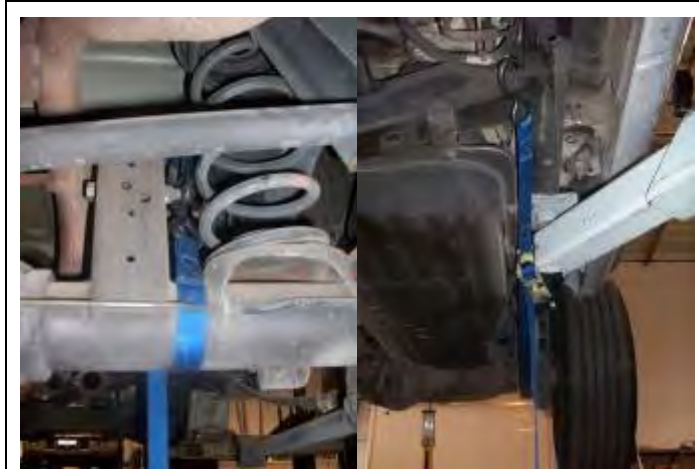
Figure 27 – Ratchet Straps Installed

1. Remove the following components as per the service manual (See Figure 28):
 - a. Rear trailing link front mount mounting nut from driver and passenger sides.
 - b. Remove running boards or side steps (if equipped).
2. Using a ratcheting strap, lash up the rear axle. Start by attaching one end of the strap to the upper link mount. Then route the strap around the rear axle, taking care not to cover any brake piping, and continue forward under the vehicle, attaching the other end of the strap to the transmission mount cross member. Apply enough forward tension on the rear axle to allow the lower link mounting bolt to be moved by hand. See Figure 27.

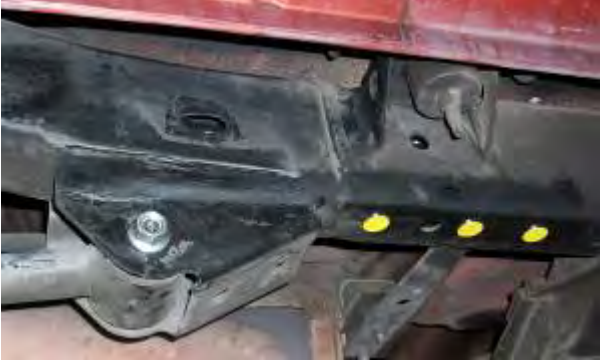
Figure 34 – Pop-nut Installer Ready for Use	Figure 35 – Passenger Side Pop-nuts Installed

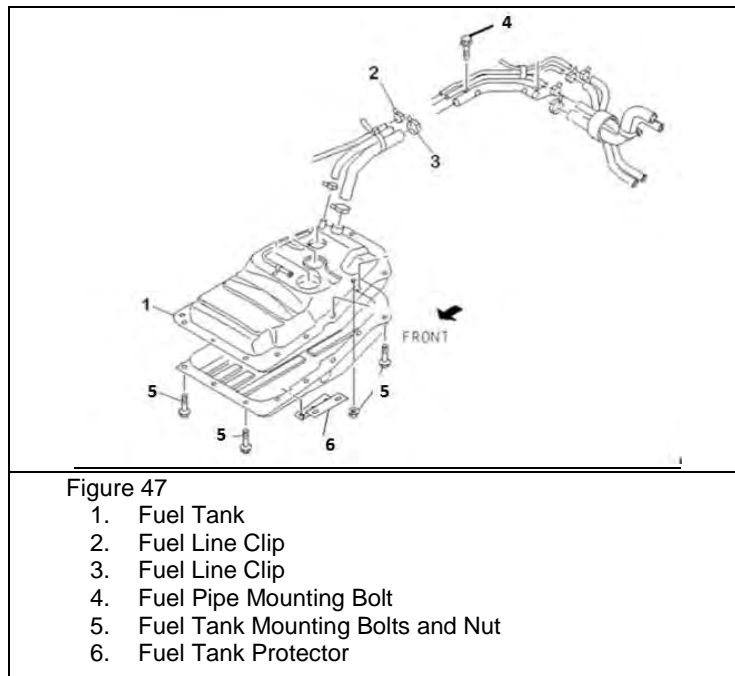
1. Remove the fuel tank assembly per the service manual. New clamps are provided in kit.
 - a. Disconnect fuel line at fuel filter supply and return hoses.
 - b. Disconnect fuel tank at locations 2 and 3 shown in Figure 47.

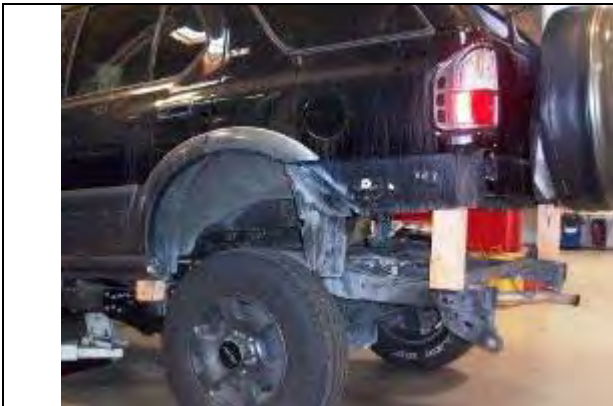
Figure 55 - Wood Block Installed at #5 Body Mount

11. Using wooden blocks, support the body off of the frame. See Figures 35 and 36.
 - a. Body mount #5 should be 10.25 inches (260 mm) above the frame and body mount #4 should be at least 7.0 inches (175 mm).

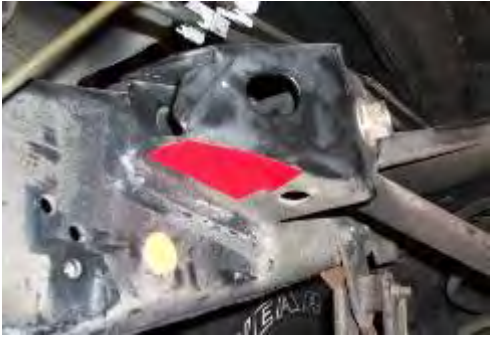
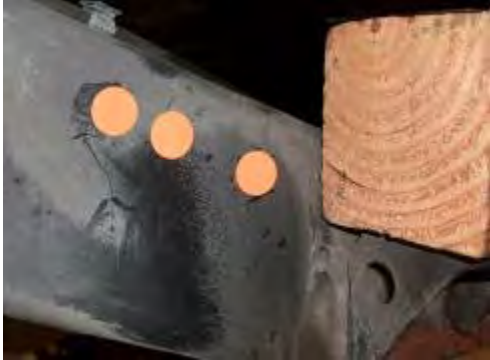
<p>Figure 66 - Upper Trailing Link Masking Point</p>	<p>Figure 67 - Pop-nuts Masked with 3/4' Round Label</p>

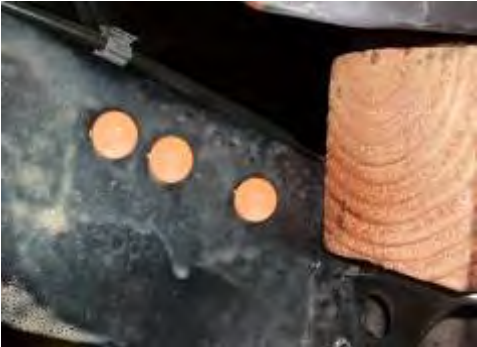
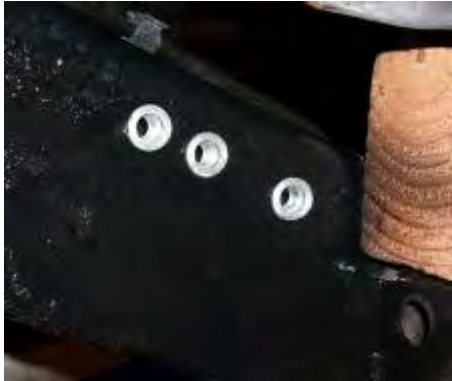
30. Follow Steps 6 through 12 in the section of this bulletin entitled "Condition Two: Apply Noxudol 700 and Noxudol 300."
31. Change to the spray valve and spray one light coat of Noxudol 700 onto inner and outer frame rail of both driver and passenger side. Wipe away any drips from the bottom of the frame rail. See Figure 68.

<p>Figure 68 - Pop-nuts Masked and Sprayed with Noxudol 700</p>	<p>Figure 69 - Noxudol Spray Completed and Pop-nuts</p>
