Federal Recall Information

14KWC

IMMI seatbelt buckles may hinder egress.

3/31/2014

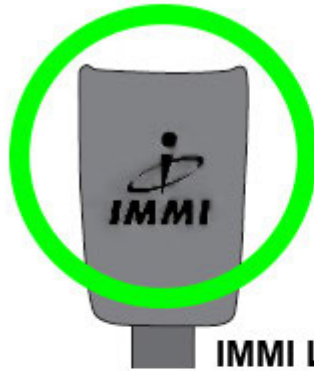
IMMI L9 Buckle

Verify that you have an IMMI buckle by looking for the IMMI logo on the back housing. If not, **DO NOT PROCEED**.

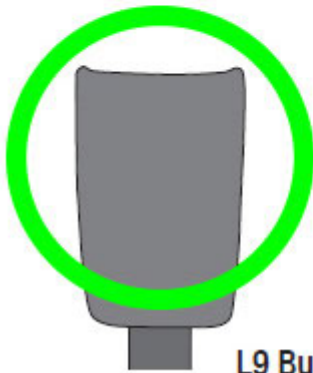
L9 Buckle

- 2) Verify you have an IMMI L9 buckle. If not, **DO NOT PROCEED**.

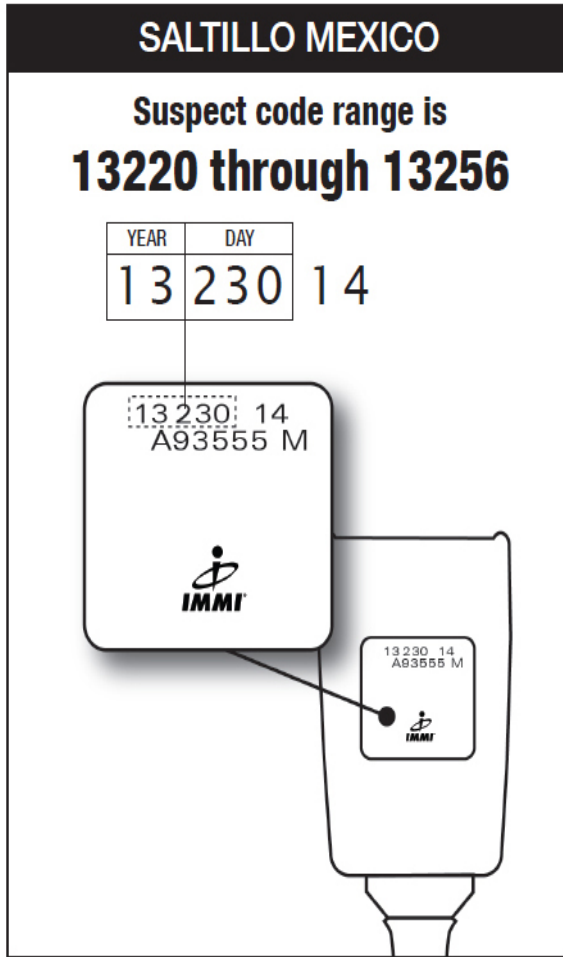
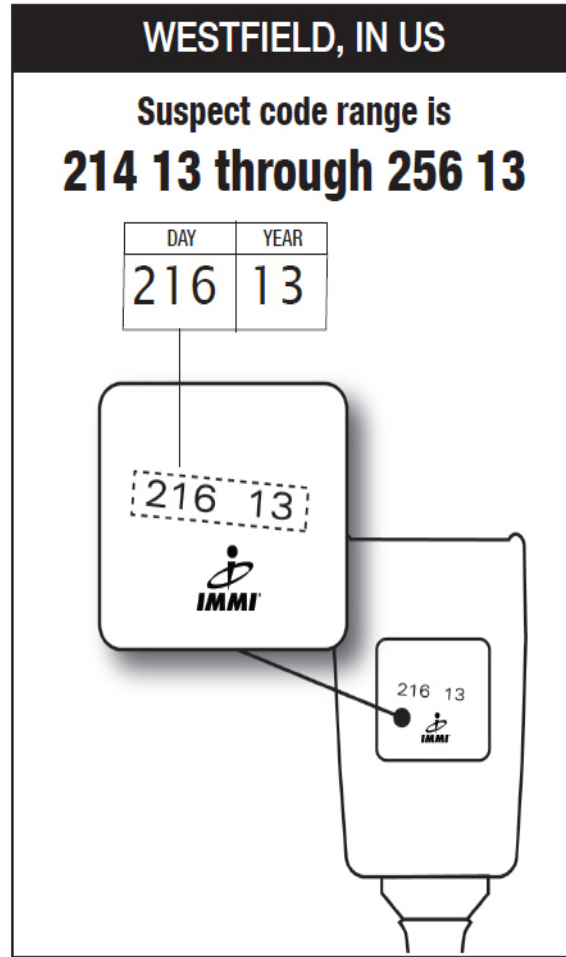
- 3) Verify date code is within suspect date code range. If not, **DO NOT PROCEED**.

- 4) If your buckle code is within either of the ranges above, replace your buckle with the substitute buckle. If you code does **NOT** fall within either range, you do **NOT** need to replace your buckle.
- 5) Reuse the existing bolt to install the replacement buckle. Do **NOT** apply thread locking compound when reinstalling the bolt. Torque the fastener to 35-50 lb-ft (47-68 Nm).
- 6) Destroy and dispose of all buckles verified to be within the specified suspect date code range.
