Re: Toyota Safety Recall 14V-051 – Remedy Dealer Notification

Subject: Safety (Noncompliance) Recall E0C – **Remedy Available**
Certain 2014 Model Year Highlander Vehicles
3rd Row Center Seat Belt

TECHNICAL INSTRUCTIONS
FOR
SAFETY (NONCOMPLIANCE) RECALL E0C
3rd ROW CENTER SEAT BELT
CERTAIN 2014 HIGHLANDER

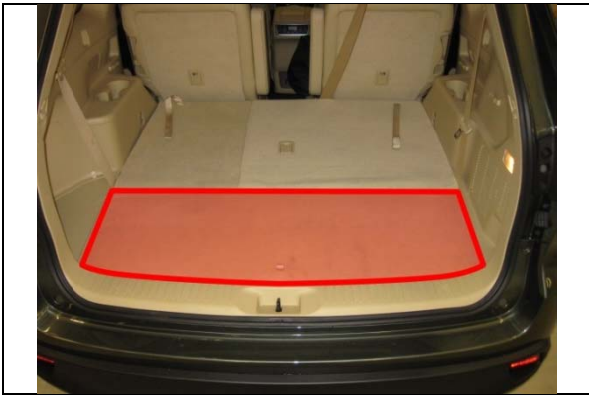
1. FOLD DOWN THE THIRD ROW SEATS
2. REMOVE THE DECK BOARD ASSEMBLY

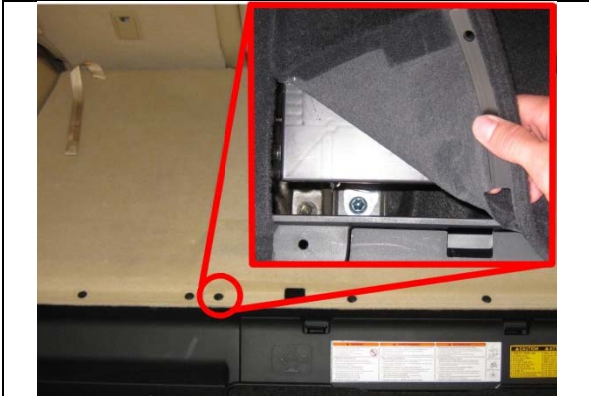
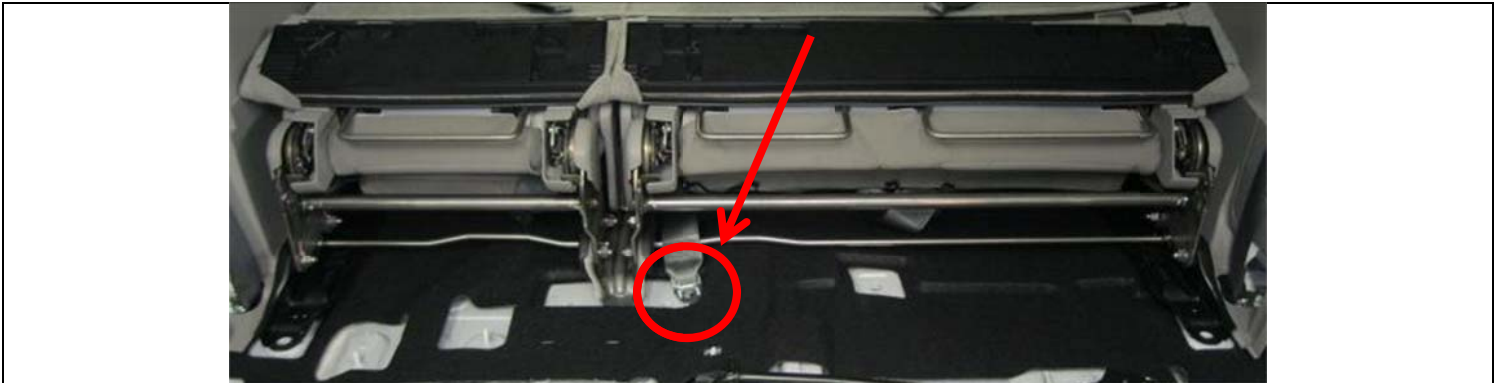
3. REMOVE THE CLIP TO GAIN ACCESS FOR INSPECTION
 - a) Remove the single highlighted clip.
 - b) Inspect the installation of the center seat inner belt assembly.

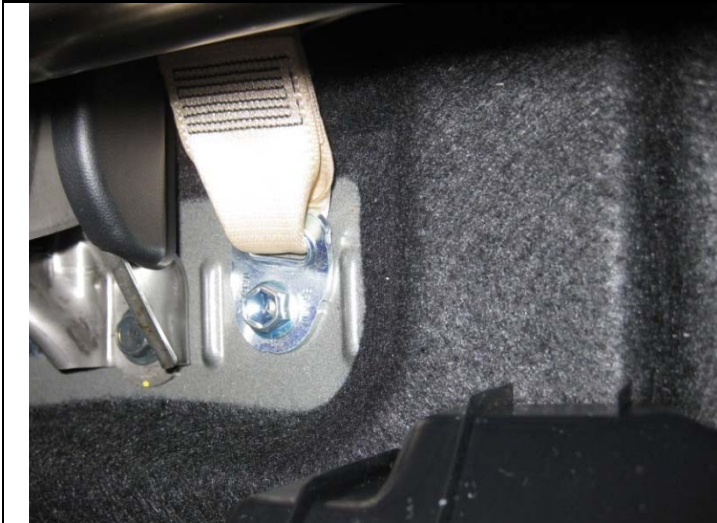
CORRECT INSTALLATION

The seat belt is installed **CORRECTLY**. Reassemble the vehicle. Campaign complete.

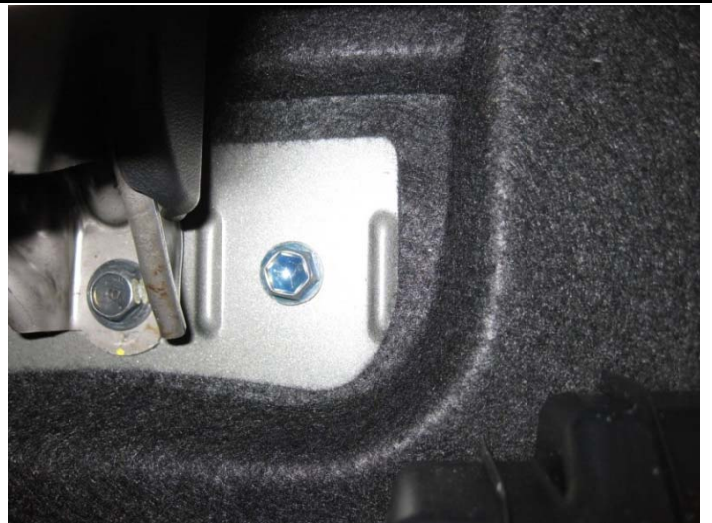
INCORRECT INSTALLATION

The seatbelt is installed **INCORRECTLY**. Proceed to **SECTION VII. SEAT BELT INSTALLATION**.

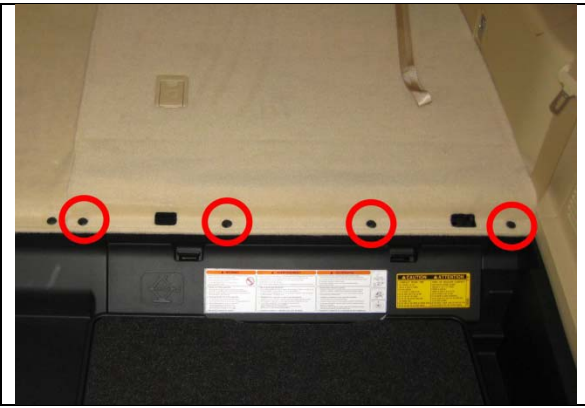
1. REMOVE THE CLIPS
 - a) Remove all 4 clips to gain full access to the seat belt.
2. REMOVE THE ANCHOR BOLT

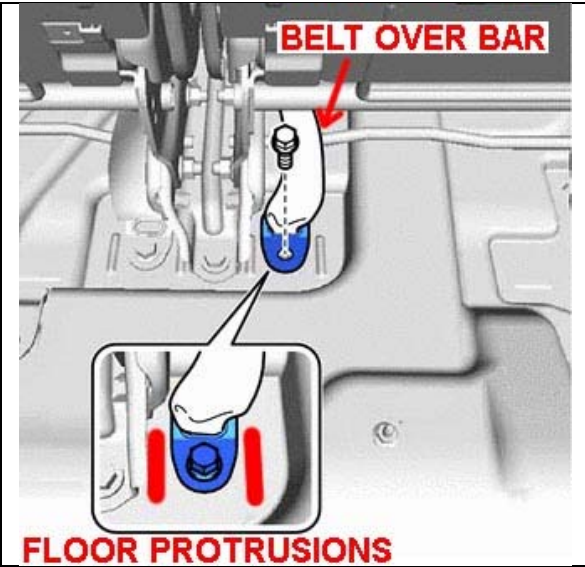
3. INSTALL THE SEAT BELT
 - a) Position the seat belt **OVER** the cross bar.
 - b) Align the anchor between the protrusions on the floor.
 - c) Torque the bolt.

Torque: 31ft. lbf (42N·m)

NOTE: Confirm the seat belt anchor is not positioned on top of the floor protrusions.

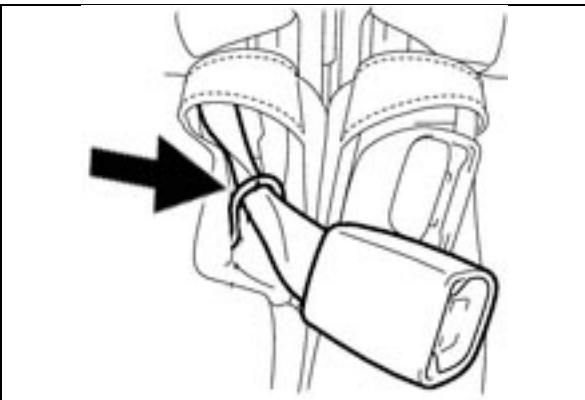
4. CONFIRM SEAT BELT ROUTING
 - a) Fold up the seats.
 - b) Confirm the seat belt is routed through the elastic strap.

- Use caution to prevent damage to the interior panels
- Confirm seat cleanliness
- Confirm belt routing and anchor bolt torque
