2013 Nissan Altima Secondary Hood Latch Voluntary Safety Recall Campaign

Reference: R1413
Date: October 10, 2014

R1413 – 2013 Altima Secondary Hood Latch Safety Recall Procedure

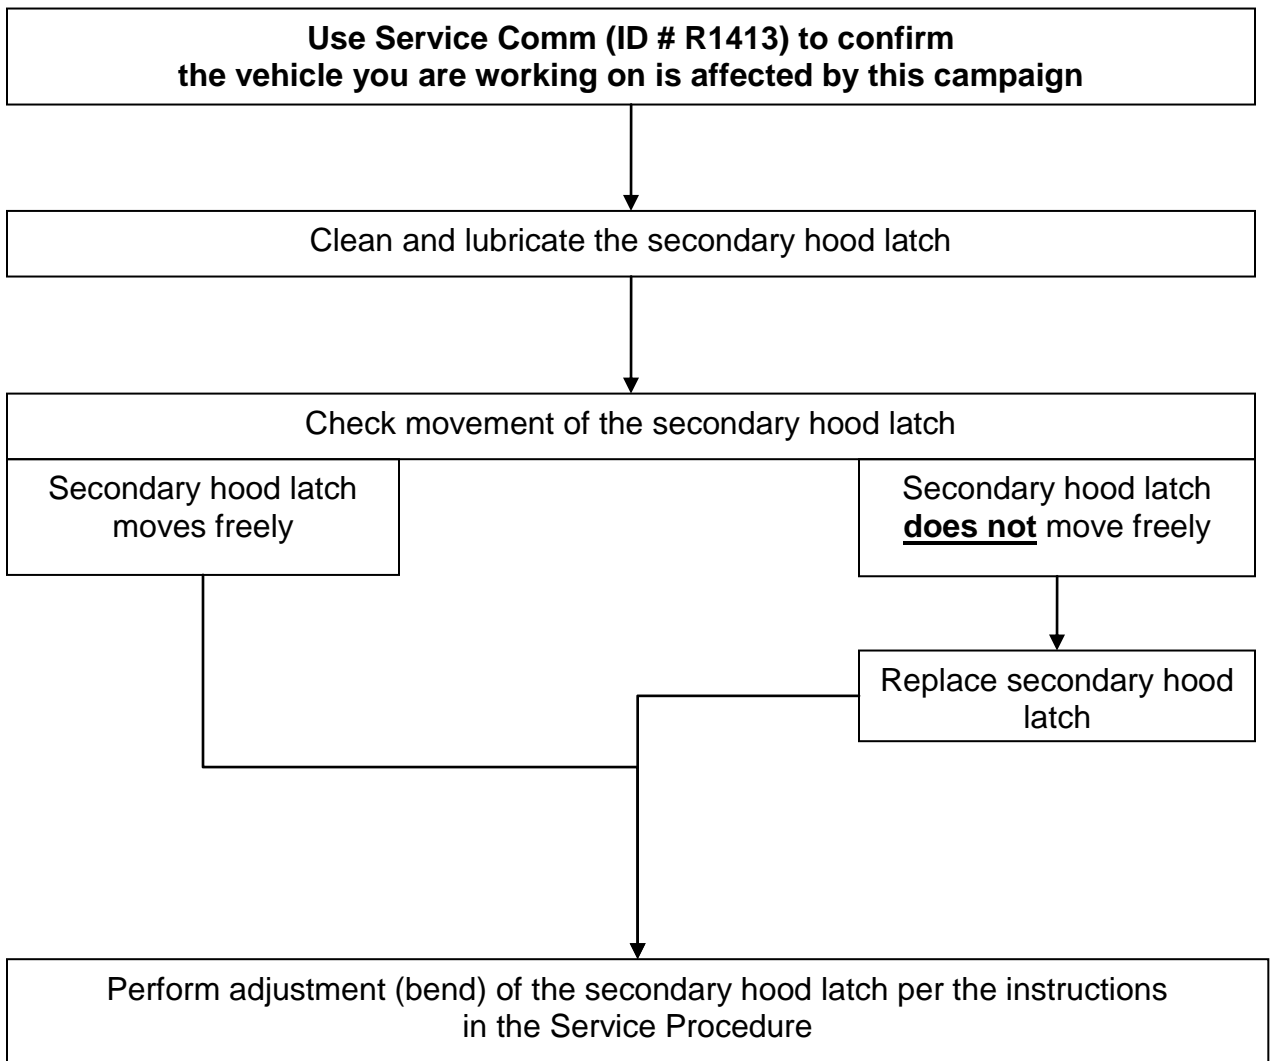
REPAIR OVERVIEW

Nissan is conducting a Voluntary Safety Recall on certain MY13 Altima vehicles to modify the bend angle, clean, and lubricate the hood actuation lever. If significant corrosion is identified, the latch assembly will be replaced. All parts and labor related to this action will be performed at no charge to the customer.

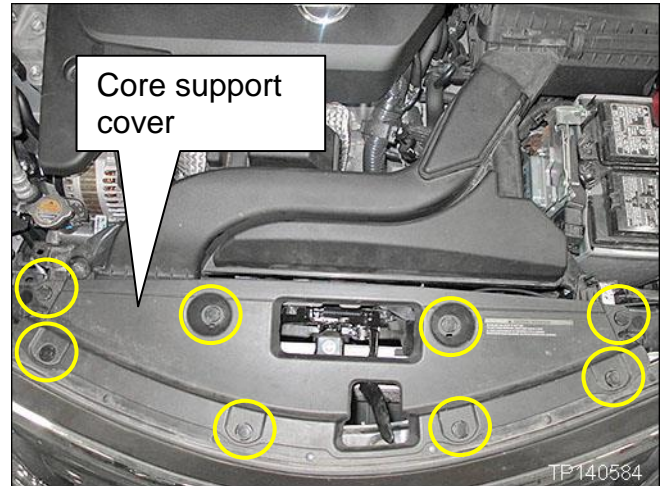
Figure 1

1. Open the engine hood.
2. Remove the core support cover.
 - Cover is held on with 8 clips shown in Figure 1.

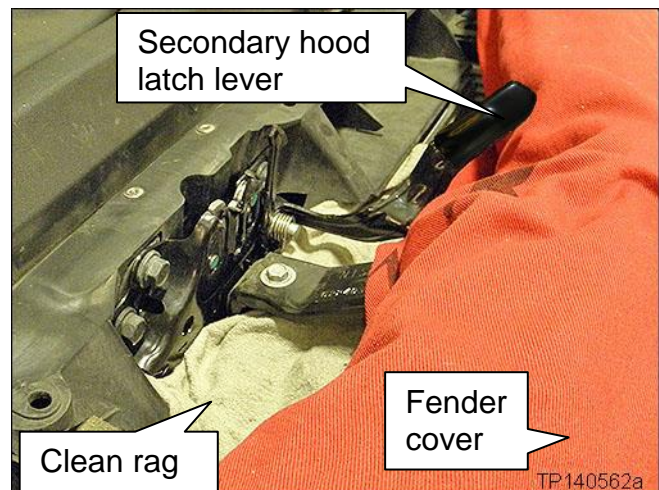
Figure 2

3. Place a clean rag under the hood latch as shown in Figure 2.
4. Place a clean fender cover to protect the front fascia as shown in Figure 2.
 - Allow the secondary hood latch lever to be above the fender cover as shown.

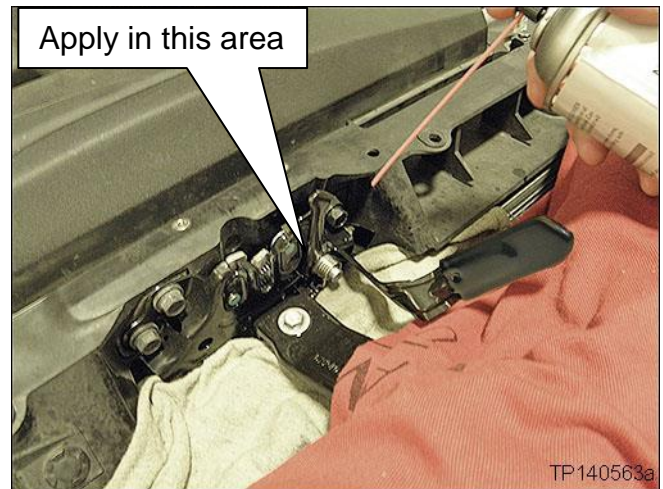
Figure 3

5. Apply aerosol rust penetrant to the secondary hood latch.
 - Use Nissan Rust Penetrant or equivalent.
 - Use a spray extension tube to help direct the application.
 - Apply to the pivot pin area and between latch lever and latch body.

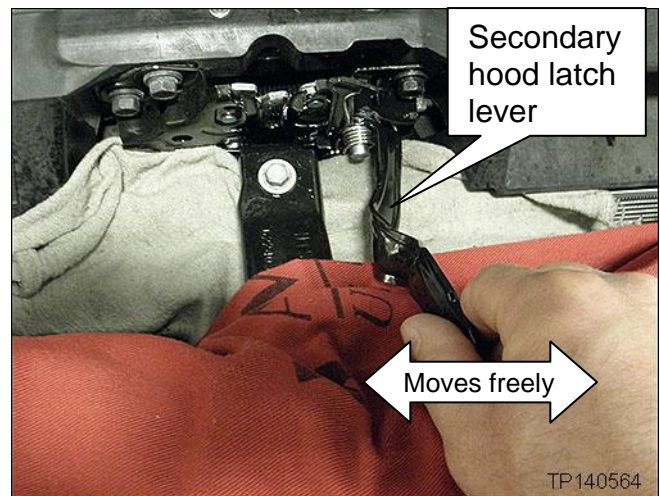
Figure 4

6. Move / cycle the secondary hood latch lever several times.
 - Move / cycle the lever 10-15 times or until it moves freely.

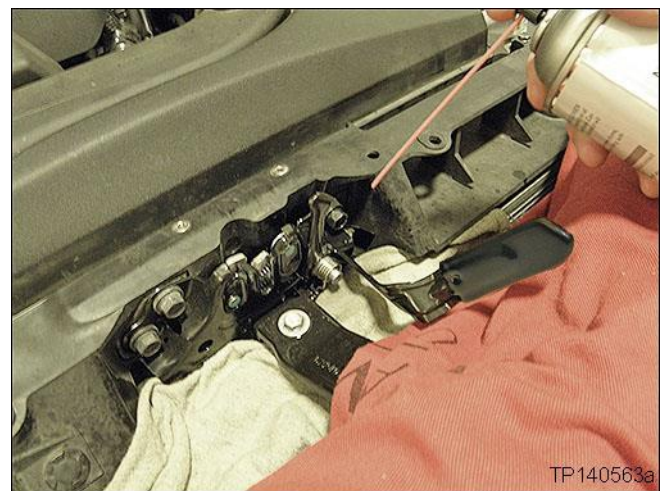
Figure 5

7. Remove / clean previous lubricants and debris from the secondary hood latch.
 - Use brake clean or equivalent type cleaner that complies with local regulations.
 - Use a spray extension tube to help direct the application.
 - Clean the pivot pin area and clean between latch lever and latch body.

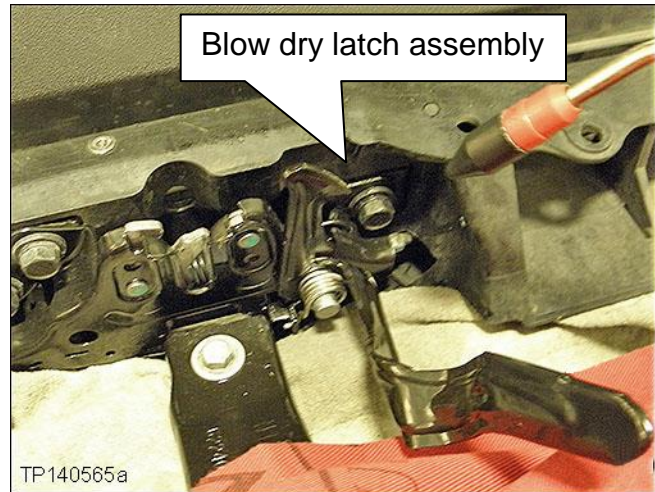
Figure 6

8. Use shop air to blow-dry the latch assembly before proceeding to the next step.

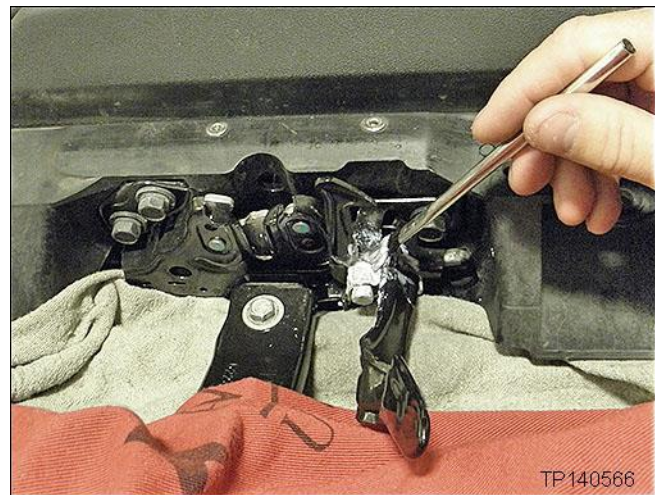
Figure 7

9. Apply non-aerosol white lithium grease to the secondary hood latch.
 - Do not use spray-on grease.
 - Apply the grease with a small brush
 - With the brush, work the grease onto the pivot pin area and between latch lever and latch body.

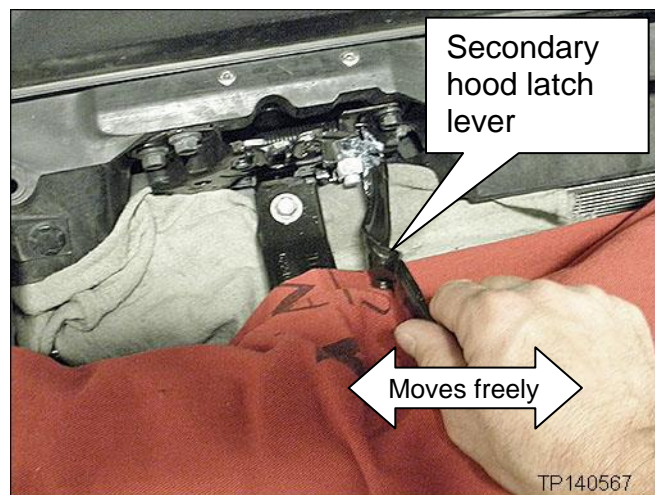
Figure 8

10. Make sure the secondary hood latch lever moves freely.

- If the secondary hood latch lever **does not** move freely, repeat steps 5 through 9.

NOTE: If you are unable to achieve smooth free movement of the secondary hood latch lever with cleaning and lubricating, replace the latch assembly.

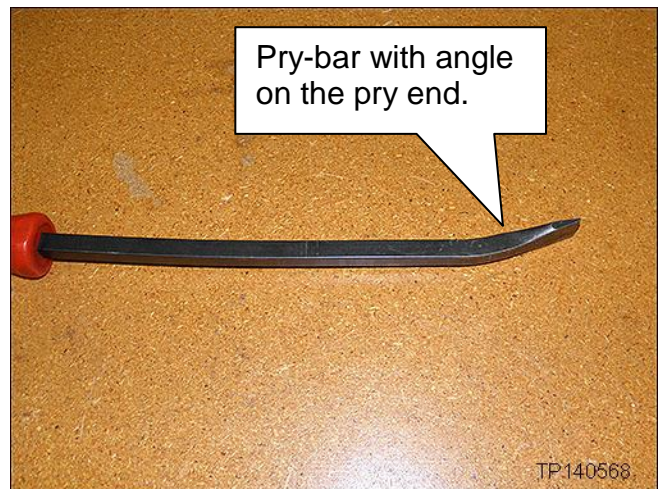
Figure 9

11. Obtain a pry-bar with an angle on the pry end.

- A straight end pry-bar will not work for the next step.

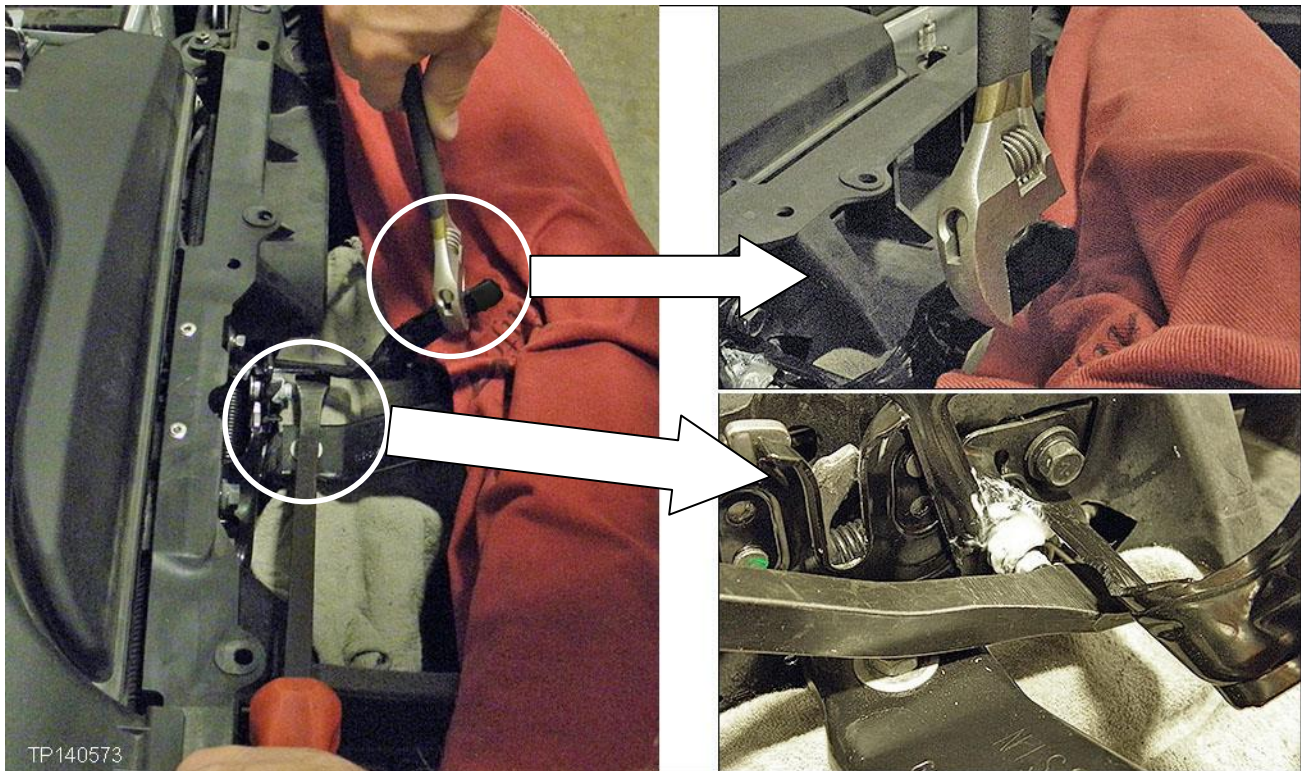
Figure 10

12. Position the angle end pry-bar and an 8-inch adjustable wrench on the secondary hood latch lever as shown in Figure 10.

- Position the pry end of the pry-bar under the lever and on top of the core support bolt as shown.
- Position the 8-inch adjustable wrench on the end of the lever.

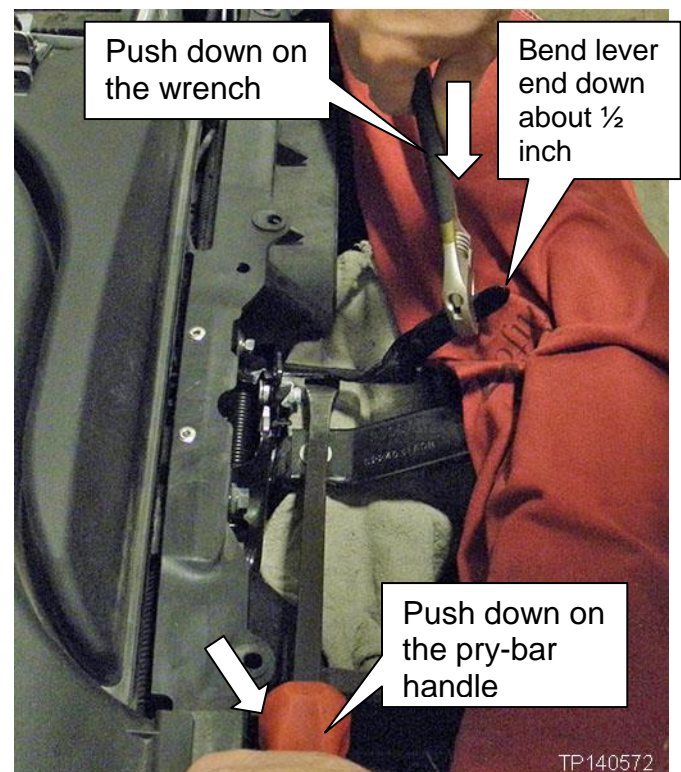
Figure 11

13. Push down on the pry-bar handle and hold in place to give upward pressure on the lever.

14. Push down on the adjustable wrench to bend the lever end down about 1/2 inch.

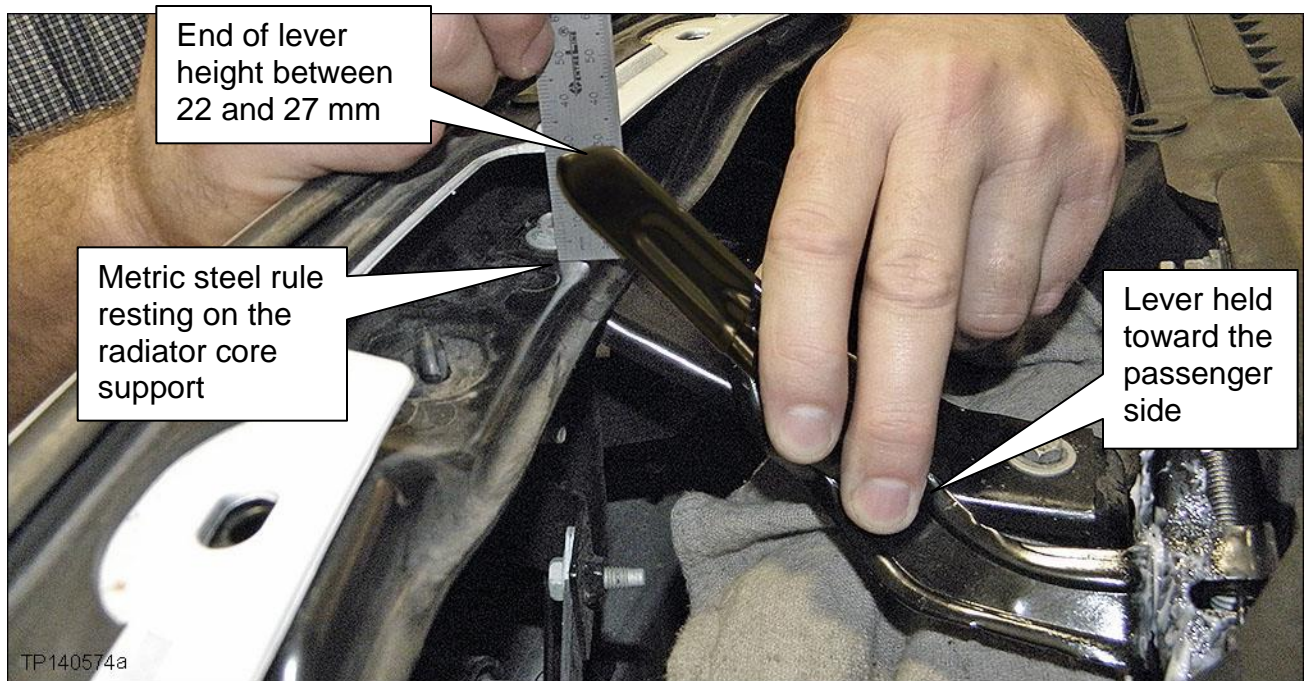
Figure 12

15. Measure the height of the secondary hood latch lever as follows (see Figure 12):

- Hold the lever toward the passenger side of the vehicle (unlatch position).
- Rest a metric steel rule on the radiator core support next to the lever end.
- Height of lever end should be between 22 and 27 mm.
- If lever height is out of the range (22-27 mm), adjust (bend) as necessary to achieve the correct height.

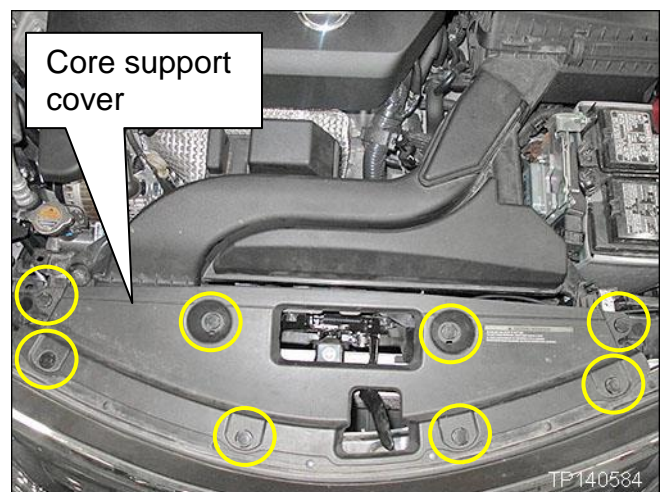
Figure 13

6. Reinstall the core support cover and the 8 clips.

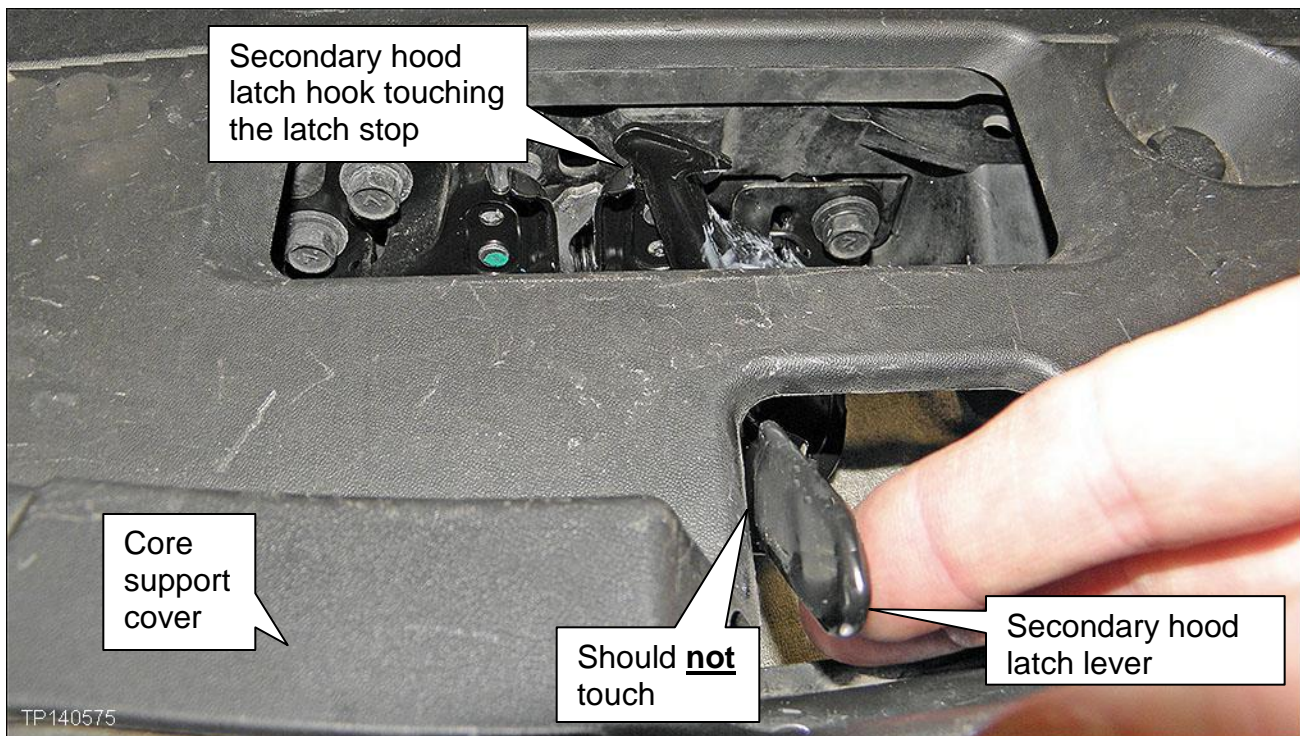
Figure 14

17. Make sure the secondary hood latch lever moves to the complete unlatched position without touching the core support cover as follows:

- a. Move the secondary hood latch lever all the way toward the passenger side (completely unlatched position) and hold it there (see Figure 14).
- b. Make sure the secondary hood latch hook is touching the latch stop.
- c. Make sure the secondary hood latch lever is **not** touching the core support cover.
 - It is OK for the secondary hood latch lever to be very close to the core support cover.
 - The latch hook must touch the latch stop.
 - When performing the above check, move the lever just far enough for the hook to touch the stop.
- d. If the secondary hood latch lever touches the core support cover and the hook does not touch the latch stop, perform adjustment (bend) as shown on the next page.

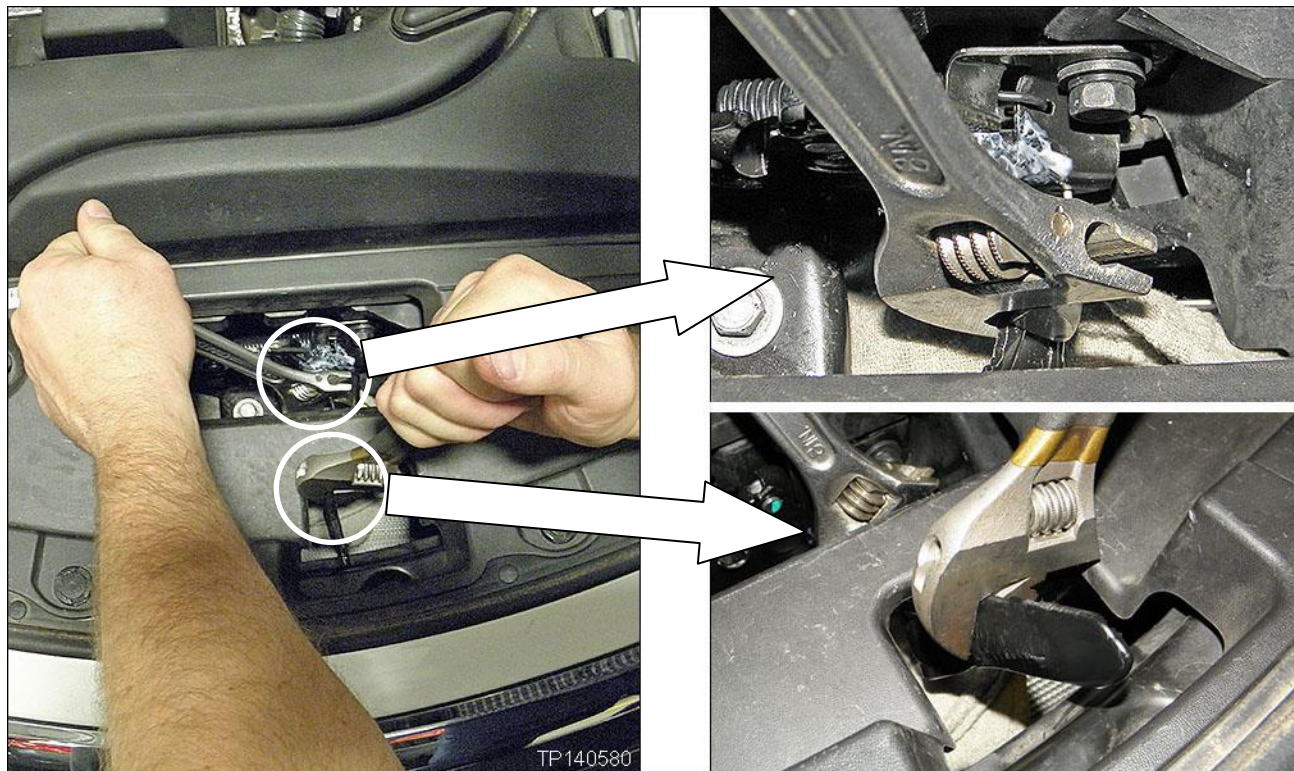
Figure 15

- a. Position two 8-inch adjustable wrenches on the secondary hood latch lever as shown in Figure 15.

- b. Hold wrench 1 all the way to the passenger side.
- c. Pull wrench 2 toward the driver side.
- d. Bend just enough to achieve the condition described in step 17 on the previous page.
