REFERENCE NHSTA RECALL # 14E015.

**VILLA INTERNATIONAL**

ISS LINK ASSEMBLY, RECALL FIX

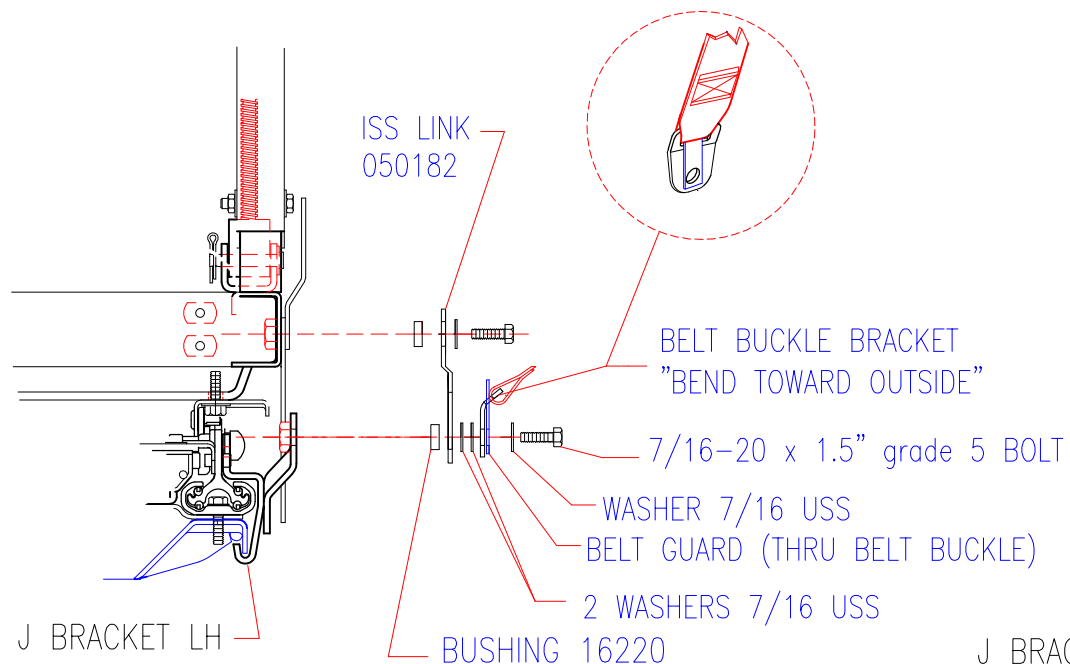
FRONT VIEW

NOTE:  
REMOVE TWIST IN SEAT BELT BEFORE FASTENING END.

LEFT SIDE OF DRIVERS SEAT SHOWN  
RIGHT SIDE PASSENGER SEAT THE SAME.
