SAFETY RECALL BULLETIN

SUBJECT:		No: SR-14-001	
2013 OUTLANDER SPORT DRIVER SIDE SEAT MOUNTED AIRBAG SAFETY RECALL		DATE: February, 2014	
		MODEL: 2013 Outlander Sport	
CIRCULATE TO:	<input checked="" type="checkbox"/> GENERAL MANAGER	<input checked="" type="checkbox"/> PARTS MANAGER	<input checked="" type="checkbox"/> TECHNICIAN
<input checked="" type="checkbox"/> SERVICE ADVISOR	<input checked="" type="checkbox"/> SERVICE MANAGER	<input checked="" type="checkbox"/> WARRANTY PROCESSOR	<input checked="" type="checkbox"/> SALES MANAGER

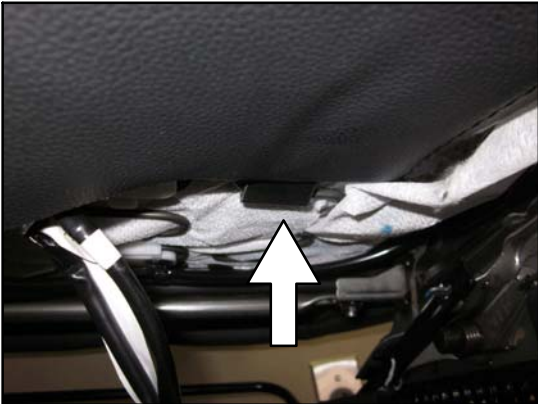
1. Open the driver door and move the driver seat forward to allow for enough workspace behind the driver seat.
2. Unfasten the lower rear leather flap by unhooking the (2) hooks located underneath the driver seat.

NOTE: Only the inner hook is shown below.

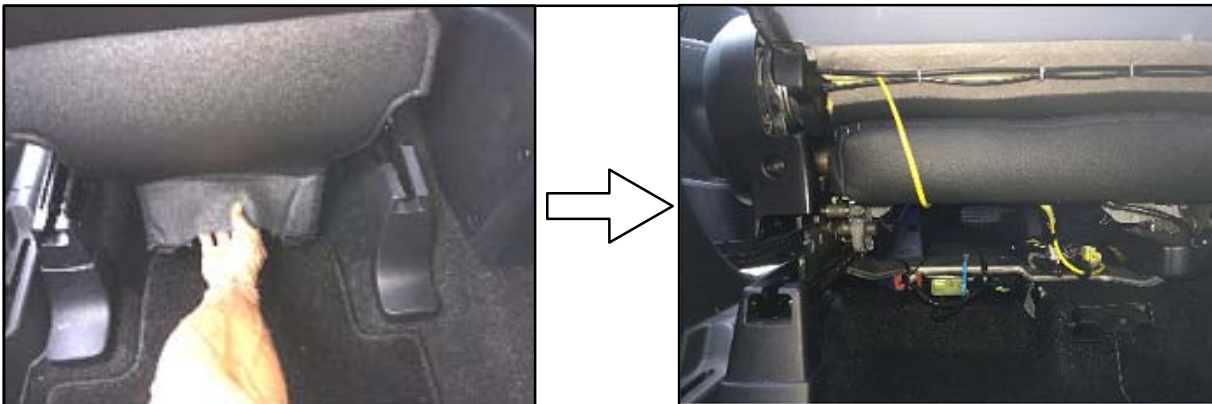
3. Lift the lower rear leather flap to expose the lower rear section of the driver seat.

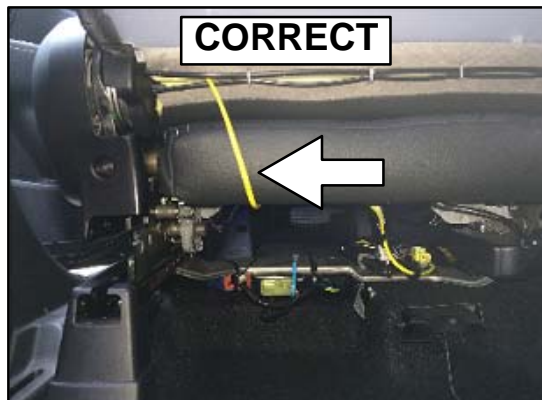
4. Inspect the driver side seat mounted airbag (SRS) wire and determine if it is correctly routed.
 - a. If the SRS wire is correctly routed, **no repairs are necessary**. Perform Steps 2–3 in reverse order, complete the campaign claim and enter campaign labor operation **C1401Z01**.

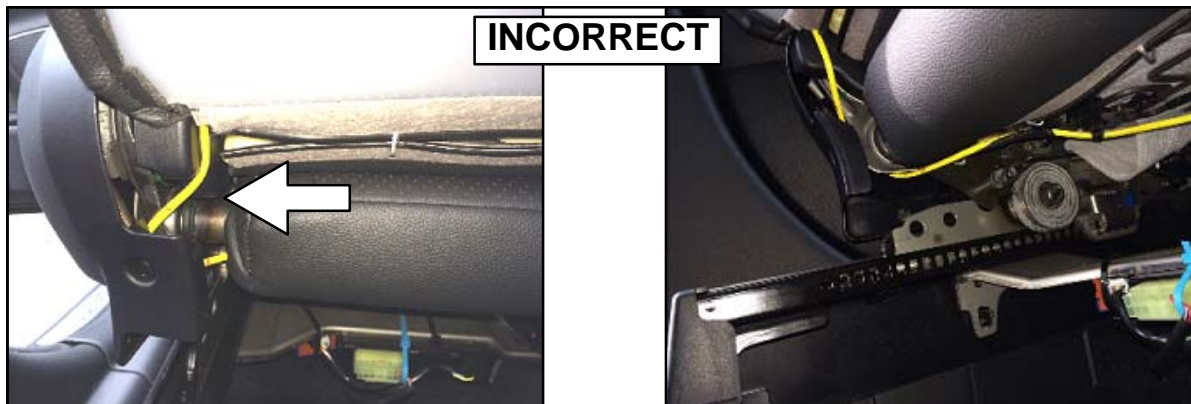
b. If the SRS wire is incorrectly routed, continue to Step 5.

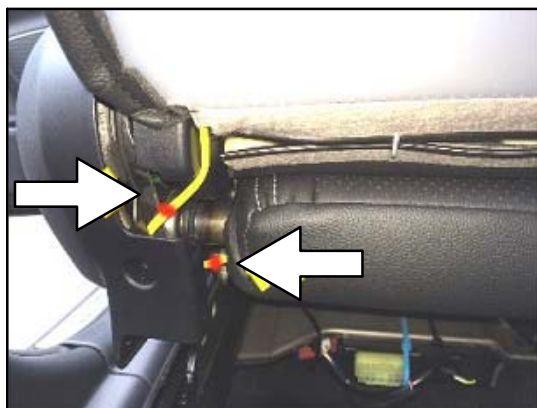
5. With a dark colored pen or marker, mark the SRS wire in the indicated areas (area to be inspected in Step 7).

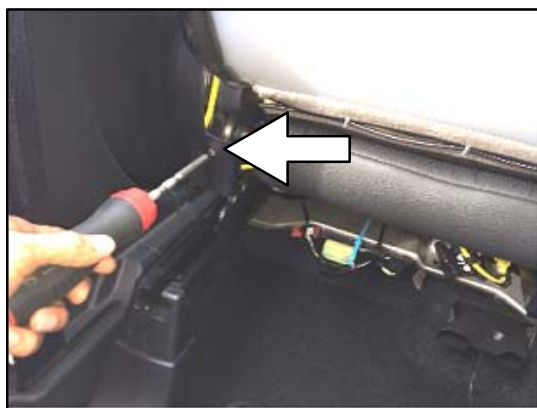
6. Unscrew the driver seat lower left rear cover. Do not remove the cover.

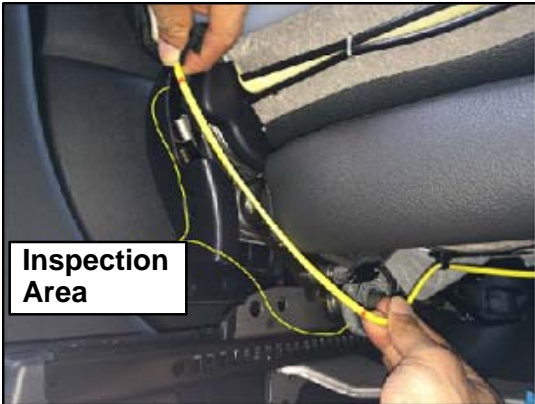
7. Pull the SRS wire out and inspect between the marked areas for damage.

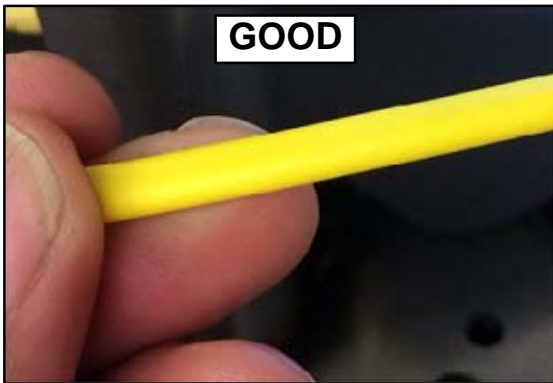
- a. If the SRS wire is not damaged (cuts, dents, etc.), proceed to the **Rerouting Procedure** section.

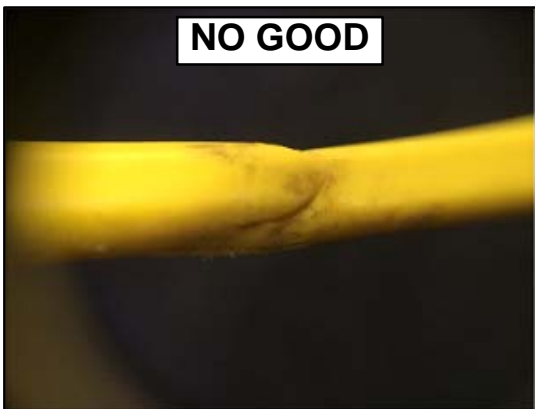
- b. If the SRS wire is damaged (cuts, dents, etc.), photograph the damaged area and check for related DTC's. Refer to the **Erase and Read DTC's from All ECUs** section below. Contact MMNA TechLine and provide photographs via email to MMNATechline@mmsa.com. If you receive TechLine's approval to replace the driver seatback assembly, an order will be placed for you. Proceed to the **Replacement Procedure** section. Otherwise, proceed to the **Rerouting Procedure** or follow TechLine's directions.

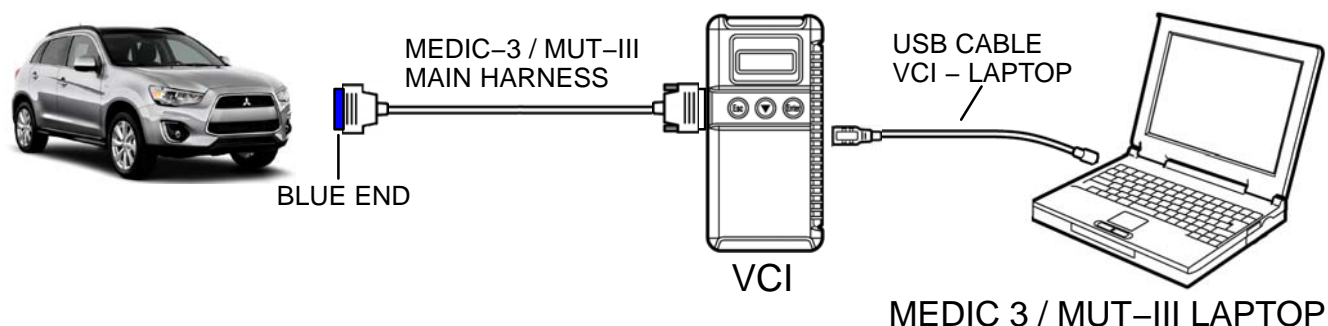
- Turn the laptop computer on.
- Connect the USB cable to the VCI.
- When the laptop displays the MUT-III main screen, connect the USB cable to the laptop.
- Connect the MUT-III main harness with the blue DLC connection to the VCI/VCI Lite.
- Connect the blue connector of the MUT-III main harness to the vehicle's data link connector.

NOTE: VCI shown for illustration purposes only.

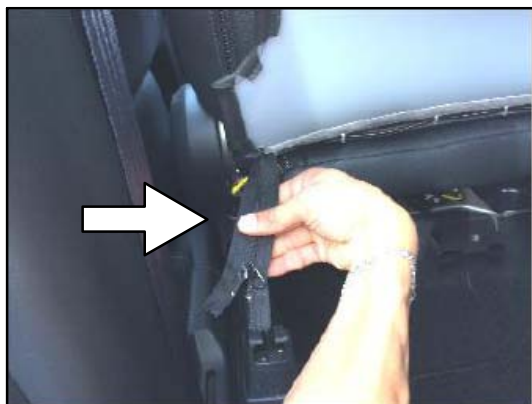
- a. Unzip the left side leather seat cover zipper to reveal the SRS wire. The zipper may be tucked into the seatback.

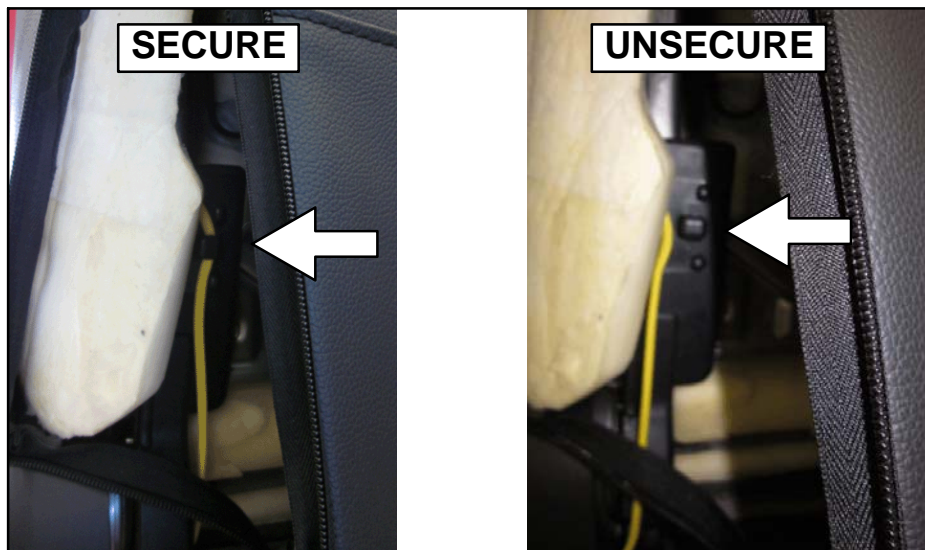
- b. Ensure the SRS wire is secured to the mounting clip inside the seatback. If unsecured, secure it.

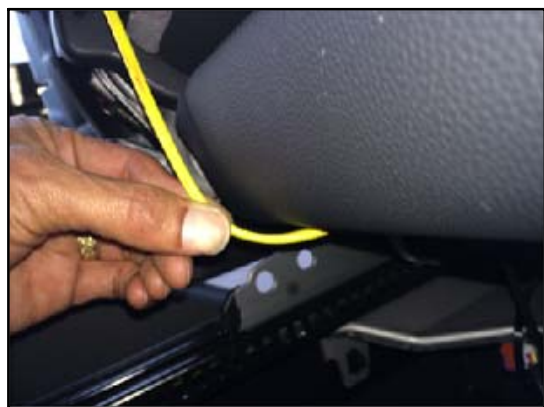
- 2. Reroute the SRS wire.
 - a. Position the seatback to its full upright position and ensure the SRS wire does not have any tension.

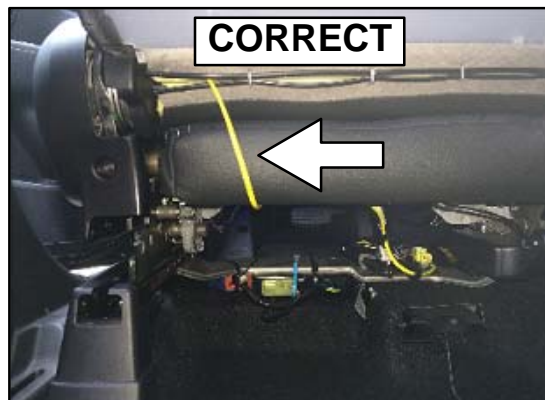
- b. A correctly routed SRS wire is shown below.

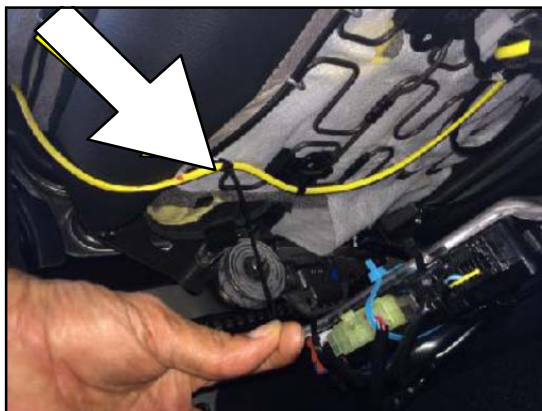
- c. Zip tie the SRS wire to the seat spring located underneath the seat.

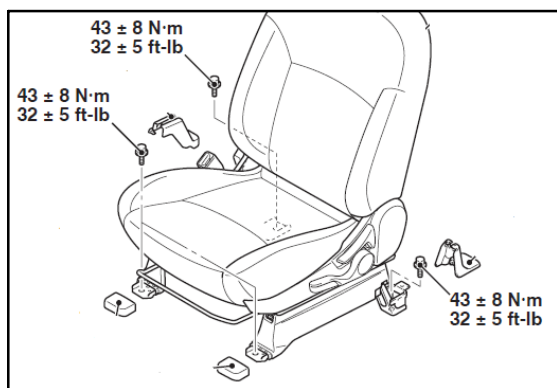
1. With the vehicle parked, engage the parking brake and turn OFF the vehicle. Adjust the steering wheel tilt to its upmost and forward position to ensure clearance for driver seat removal.
2. Remove the headrest from the driver seat.
3. Driver seat removal preparation.

- a. Slide the driver seat to its most forward position and carefully remove the (2) rear plastic seat anchor caps. Remove the (2) 14mm bolts
 - b. Slide the driver seat to its most rearward position and carefully remove the (2) front plastic seat anchor caps. Remove the (2) 14mm bolts.
4. If the vehicle is not equipped with the optional OEM navigation unit, please record all radio station presets and reprogram when repair is completed.

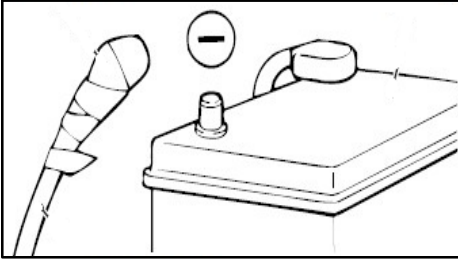
5. Open the hood. Disconnect the negative (-) cable from the battery and insulate it with electrical tape.

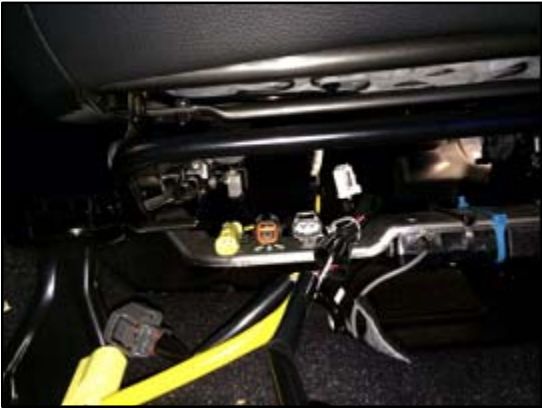
6. From the front side of the seat, reach under the seat and locate up to (5) wiring harnesses and the accessory remote start module (if installed). Carefully disconnect each connector.

- a. Side airbag module (Connector D-32, 2-pin yellow).

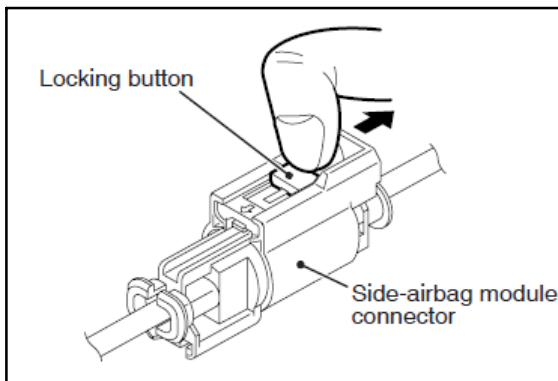
NOTE: When removing the side airbag module connector (yellow connector), unlock the connector by sliding the lock button to the direction shown in the arrow below.

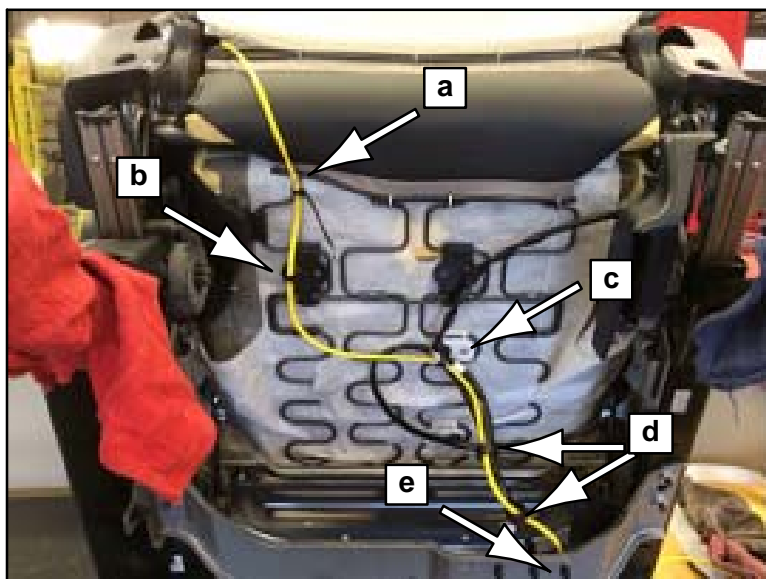
8. Place the driver seat assembly on a work bench. Disconnect and remove the SRS wire from underneath the seat.

- Discard – zip tie.
 - Reuse** – clip. Unfasten the clip and unzip the plastic connector from around the SRS wire.
 - Reuse** – clip. Unfasten the clip and unzip the plastic connector to release bundled wires. Use tape to hold bundled wires (other than the SRS wire) together.
 - Reuse** – clips (2). Unzip the (2) plastic connectors and use tape to hold bundled wires (other than the SRS wire) together.
 - Unfasten the (2) clips retaining the SRS wire to the seat frame.
9. Pull out the (2) leather seat zippers from both sides and unzip. The zippers may be tucked into the seatback.

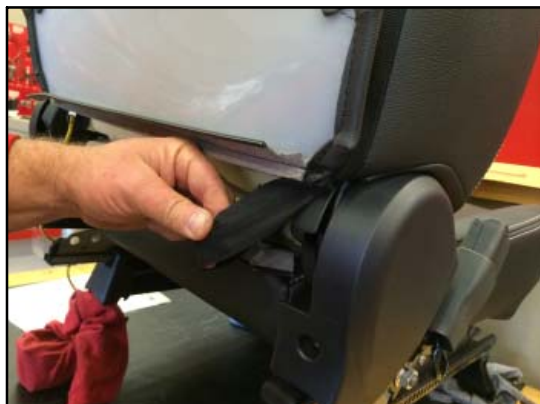
NOTE: Only inner zipper shown below.

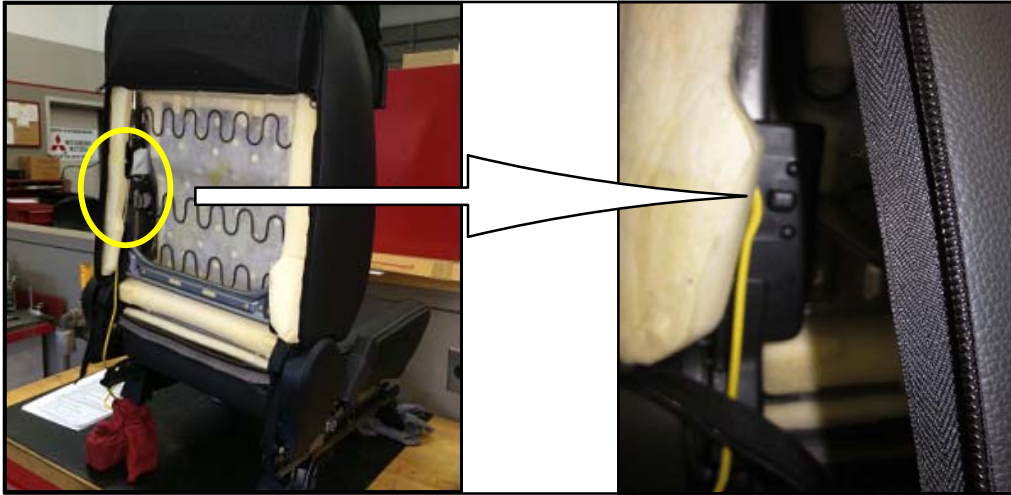
10. Flip seatback lower rear leather flap over to expose the rear seatback and unclip the SRS wire from the mounting clip.

20. Clip the SRS wire onto seatback frame (see Step 10 of this section for reference).

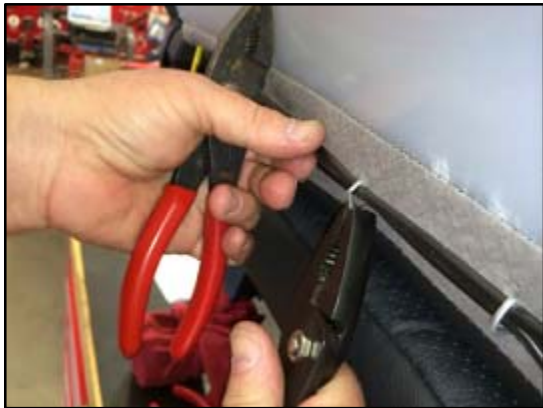
11. Remove (4) hog rings, which wraps the leather seatback from underneath the seatback frame. Use pliers to twist the hog rings or cutters for removal.

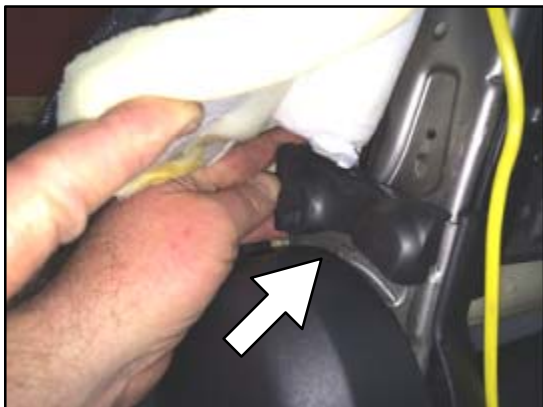
12. Remove the rubber cover on the left side, which conceals the left side seatback mounting bolts.

19. Reinstall the left rubber cover (see Step 12 of this section for reference).

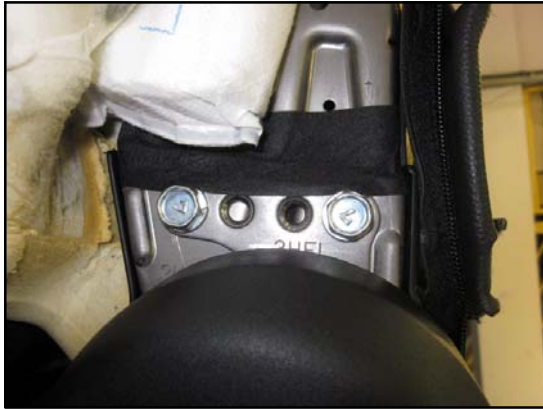
13. Remove the (4) 14mm bolts (two on each side), which hold the seatback to the seat frame.

NOTE: Left side shown below.

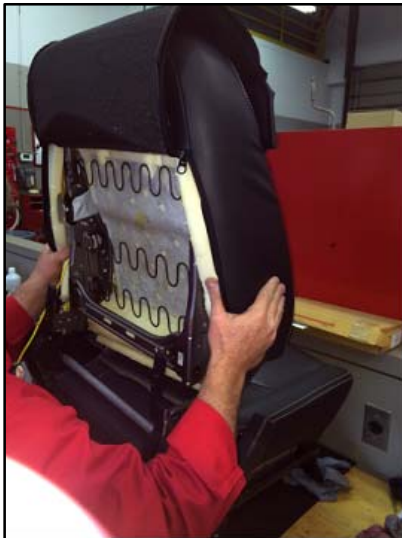
14. Remove seatback.

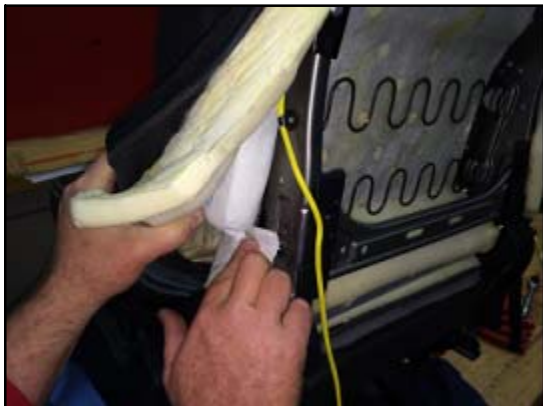
15. Install the new leather seatback assembly. Carefully align seatback frame to lower seat frame.
16. Reinstall the (4) 14mm bolts and torque to 22–37 ft-lb.
17. Clean the left side metal seam with alcohol (upper seatback and lower seat frame) to prep the area for felt tape attachment.

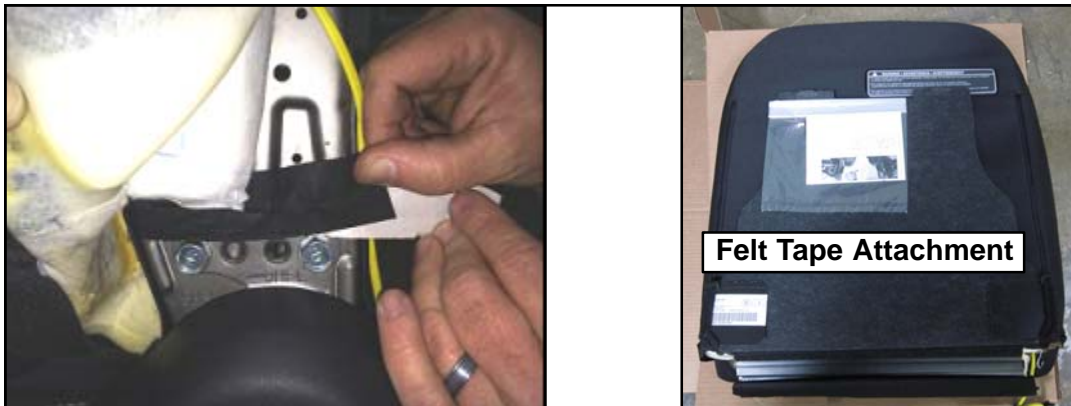
18. Apply provided felt tape over the left side metal seam.

IMPORTANT The felt tape is added to prevent abrasion to the SRS wire. It will be attached to the lower rear leather flap.

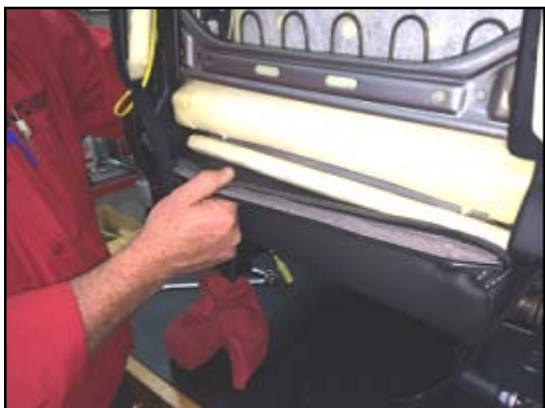
21. Properly fit the seatback foam and leather attachment material through the back side (pull the leather material through the section between the front side of the seatback and the top side of the seat cushion).

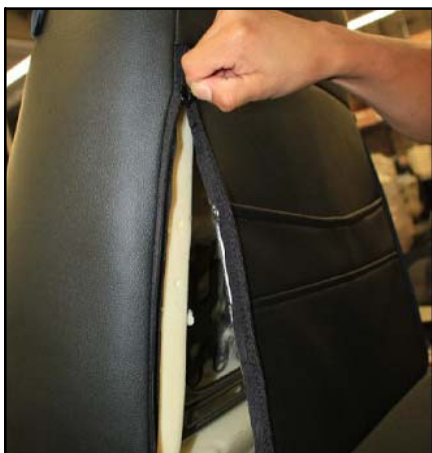
22. Gently pull the left and right zippers down and check for proper fit.

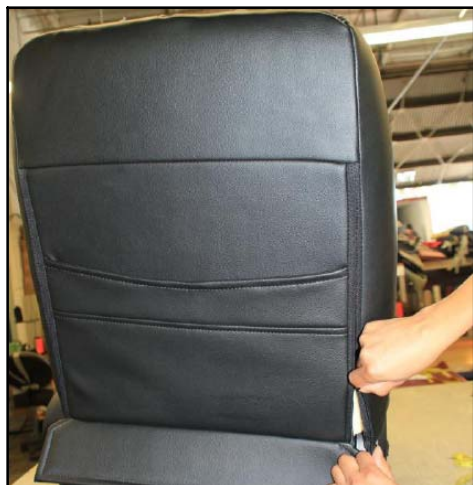
23. Bolsters should be straight and headrest holes should align.

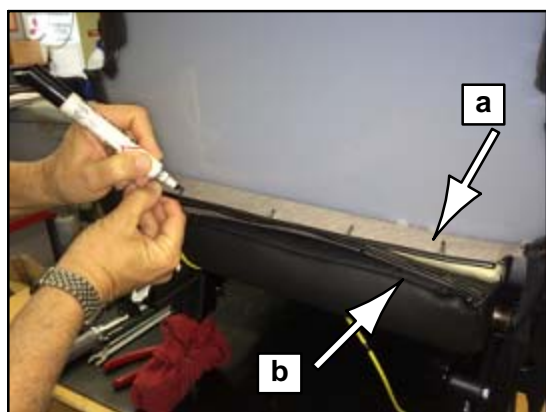
24. Mark upper and lower seatback material as shown to identify the zip tie installation points:

- a. Rear upper leather material
- b. Rear lower leather material

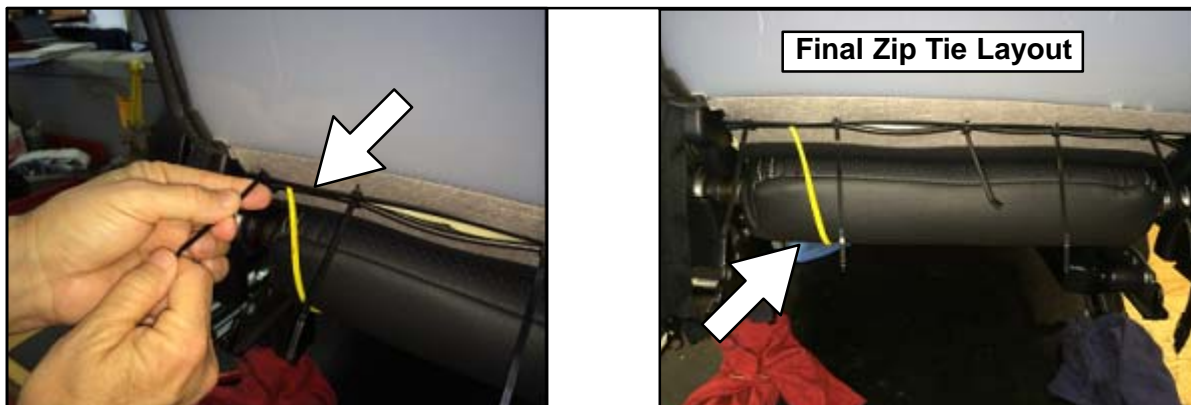
25. Gather seatback upper and lower leather material installation points together and secure using (5) zip ties. Place the SRS wire in between the zip ties as shown to prevent the SRS wire from moving towards the left side.

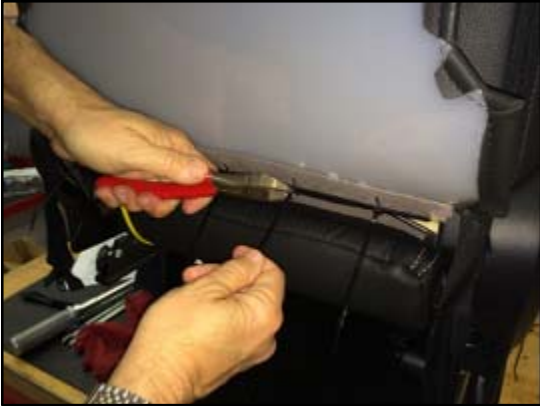
26. Cut the zip tie ends.

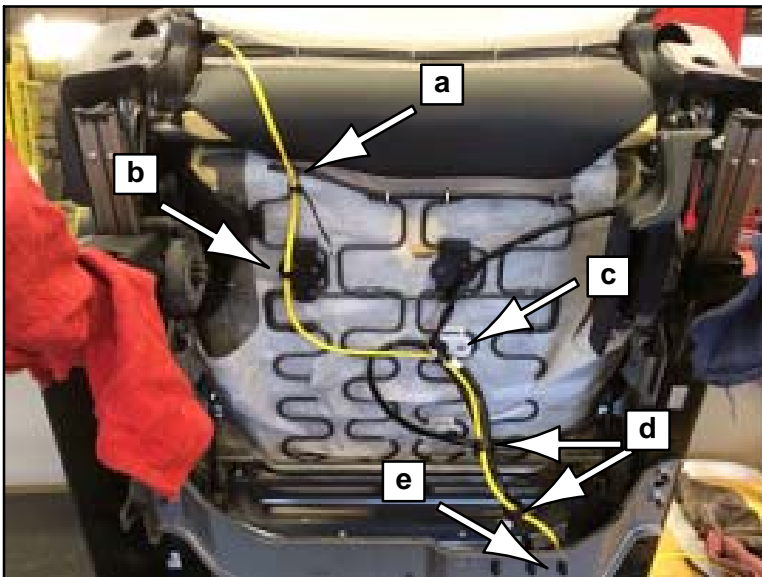
27. Flip seat over to route SRS wire and secure it in place.

- a. Add zip tie.
- b. Reuse the plastic connector clip to secure the SRS wire to the seat frame.
- c. Remove tape from the bundled wires. Reuse the plastic connector clip to secure the SRS wire to the seat frame and to the other bundled wires.
- d. Remove tape from the bundled wires. Reuse the (2) plastic connectors and secure the SRS wire to the other bundled wires.
- e. Secure the SRS wire to the seat frame with the (2) clips attached to the SRS wire.

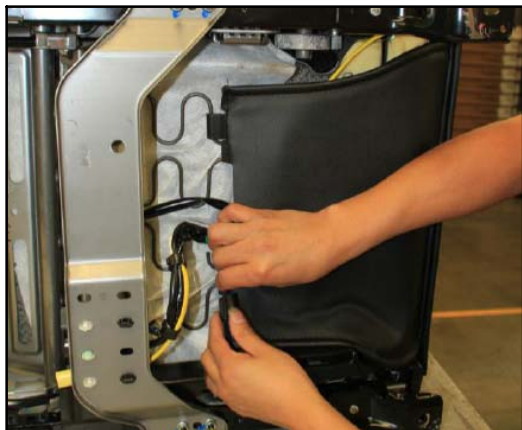
28. Attach the (2) hooks of the lower rear leather flap to the underside seat springs.
