## Recall Information Bulletin

**No:** C1006610 **Issued:** 2/13/2014

**Re:** DUONIC ATF Contamination

Safety Recall C1006610 – DUONIC ATF Contamination

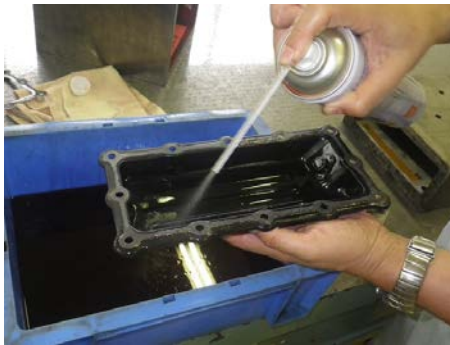
Remove ATF and contaminants from the oil pan using parts cleaner.

While the oil pan is removed, inspect the oil strainer for damage. If the strainer is damaged, contact your Product Support Manager, for authorization of strainer replacement through the regular Warranty Service Claim system.

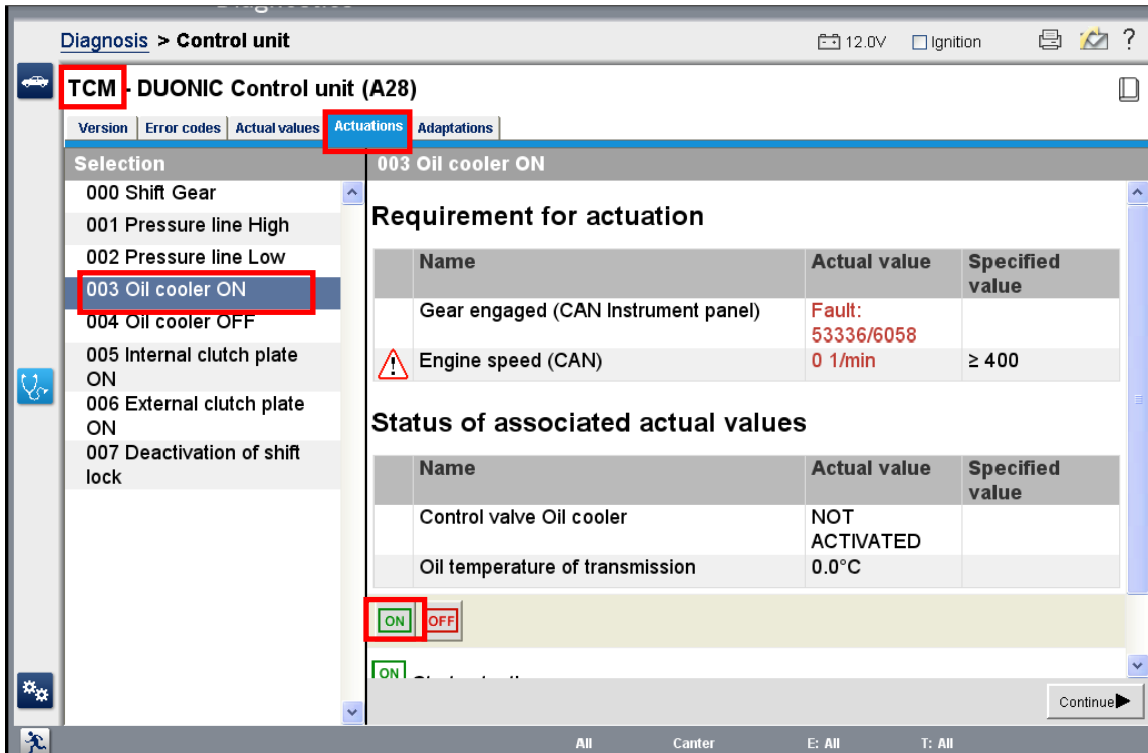
### Circulate the ATF through the valve body and oil cooler

- Move the shift lever from N to D, D to R(D→N→R), R to D(R→N→D) at 10 second intervals with the parking brake and service brake applied (To circulate the ATF through the oil cooler lines) – **Repeat 4 times.**
- Perform a DUONIC initialization. (Refer to Service Information Bulletin 11-008 or Groups 22 and 22E of the Service Manual) – **Repeat 4 times.**
- Turn off the engine.

- If the shift position does not change from to D or N on the indicator (due to shifting failure), please perform the operation using the 'Oil cooler ON' actuator test using Fuso Diagnostics. (It will automatically switch off after 30 seconds.)
- It is not required to adjust ATF temperature before this procedure. (Any ATF temperature is acceptable)
- If the system appears to be "sucking air", add additional ATF.

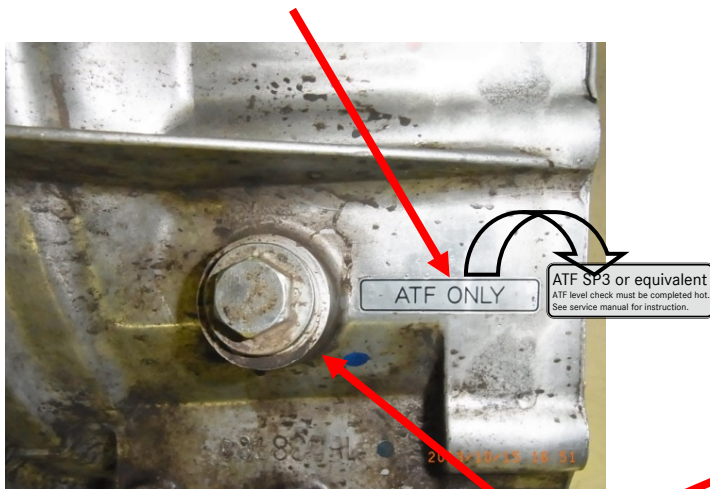
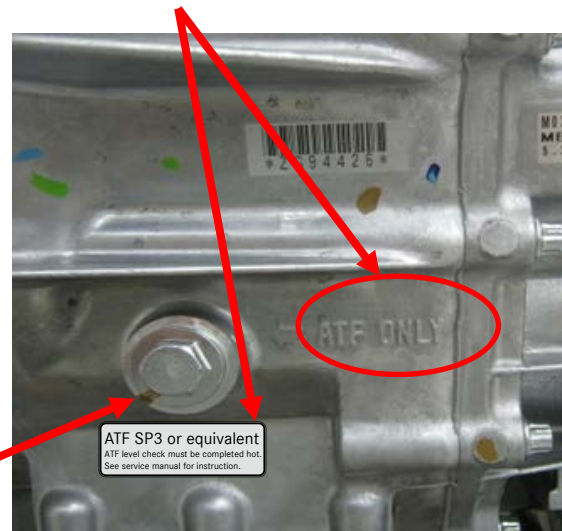
Level plug

Clean the left side of the clutch housing near the ATF level plug and affix the ATF label.

**ATF SP III or equivalent**  
ATF level check must be completed hot.  
See service manual for instruction.

If there is a character, please paste a new sticker on under the level plug.
