FL659A-C

### Subject: TBB Minotour Rear Floor Reinforcement

**Models Affected:** Specific Thomas Built Buses Minotour DRW school buses manufactured October 21, 2011, through January 16, 2014.

# Recall Campaign

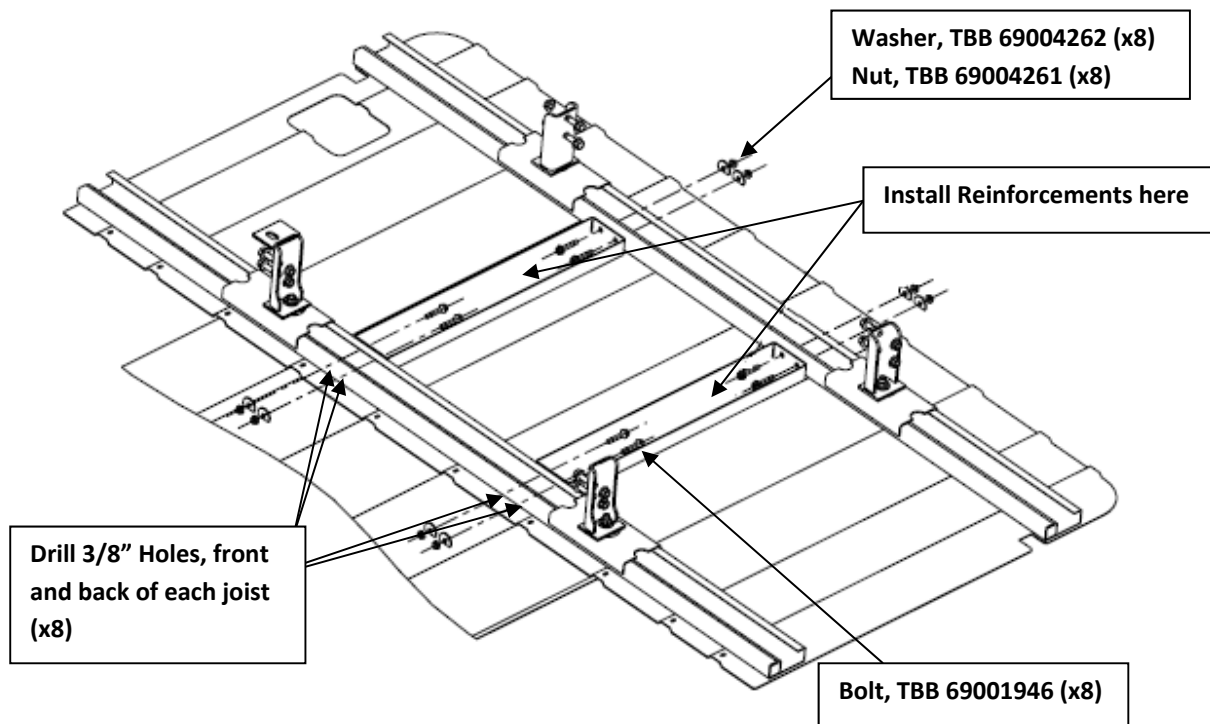
Figure 1

1. Chock wheels, shift into Neutral or Park. Set parking brake.
2. Remove any fasteners located at the area where reinforcements will be installed, such as seat bolts.
3. Position the reinforcement with the bend side down in the location shown in the installation diagram below that matches the bus. (See **Figure 1** below and diagrams at the end of these Work Instructions.)
4. Mark the location of each hole using a white grease pencil. Move the reinforcement to next the location and repeat.
5. Drill eight (8) 3/8" holes in the front side of the last joist and the back side of the second to last joist so that the reinforcements can be installed in the proper location. **Note: Each set of two holes must be drilled all the way through each joist. Figure 1**

6. Mount reinforcement TBB 185459 or TBB 186111 to the floor joists using bolt TBB 69001946, washer TBB 69004262, and nut TBB 69004261.
7. If any seat fasteners were located in this area, re-drill fastener holes from inside the bus through the reinforcement.
8. Reinstall seat fasteners through the reinforcement. Torque to 14 ft.-lbs.
9. Apply undercoating.
10. Unchock the wheels; place back into service.

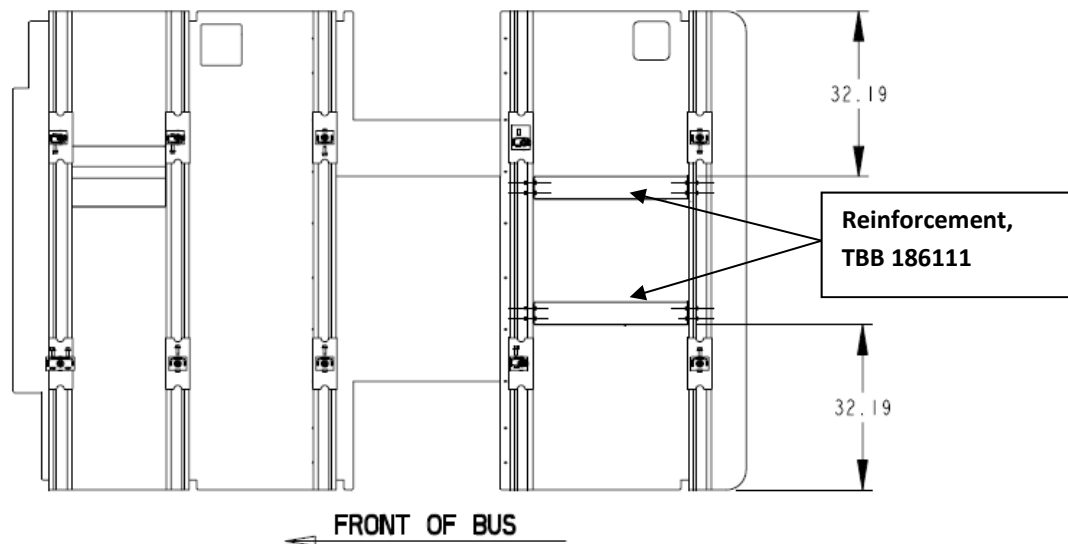
### Installation A: GM 041, IMMI/S3C Seats

To determine your seating configuration, review the plans below.
