# Safety Recall Trucks

Date	Group.	No.	Page
04.14	<b>SC0375</b>		1(17)

Electrical Power Distribution Module  
(EPDM)  
CHU, CXU, GU, TD

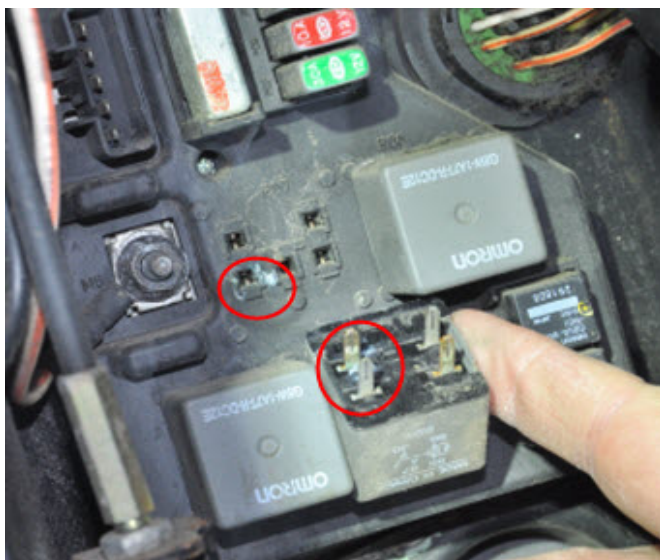
Mack Trucks Inc. has determined that the Electronic Power Distribution Module (EPDM) may become contaminated from water leaks in and around the windshield on certain CHU, CXU, GU and TD model vehicles. If exposed to water leaks, contaminants such as road salt may deposit on the power distribution module. If this occurs, circuits may be bridged creating a high resistance short that may result in damage.

**NOTE:** This photograph is an example only. Traces of water may be found at various locations on the EPDM, and to varying degrees of contamination.

10. Inspect the removed EPDM for signs of water damage. Pull each component from the EPDM and inspect both the component and the EPDM at that location for traces of water. Inspect both sides of the EPDM. If traces of water are found on the EPDM or any component go to step 11a and replace the EPDM and all components. If no signs of water are evident, go to step 11b.

11. A) If it is determined that a new EPDM is required, using new EPDM 85142790, install 2 x sealed relay 21595026 in positions R01 and R02. Install 3 x sealed relay 25110754 in positions R07, R08, and R09. Populate or remove any other fuses/circuit breakers/relays (using old EPDM as a guide), with new parts.

B) If it is determined that a new EPDM is not required, using the existing EPDM, install 2 x sealed relay 21595026 in positions R01 and R02. Install 3 x sealed relay 25110754 in positions R07, R08, and R09.

**NOTE:** Any old parts must not be reused if any one component shows sign of water damage. Any part not reused must destroyed.

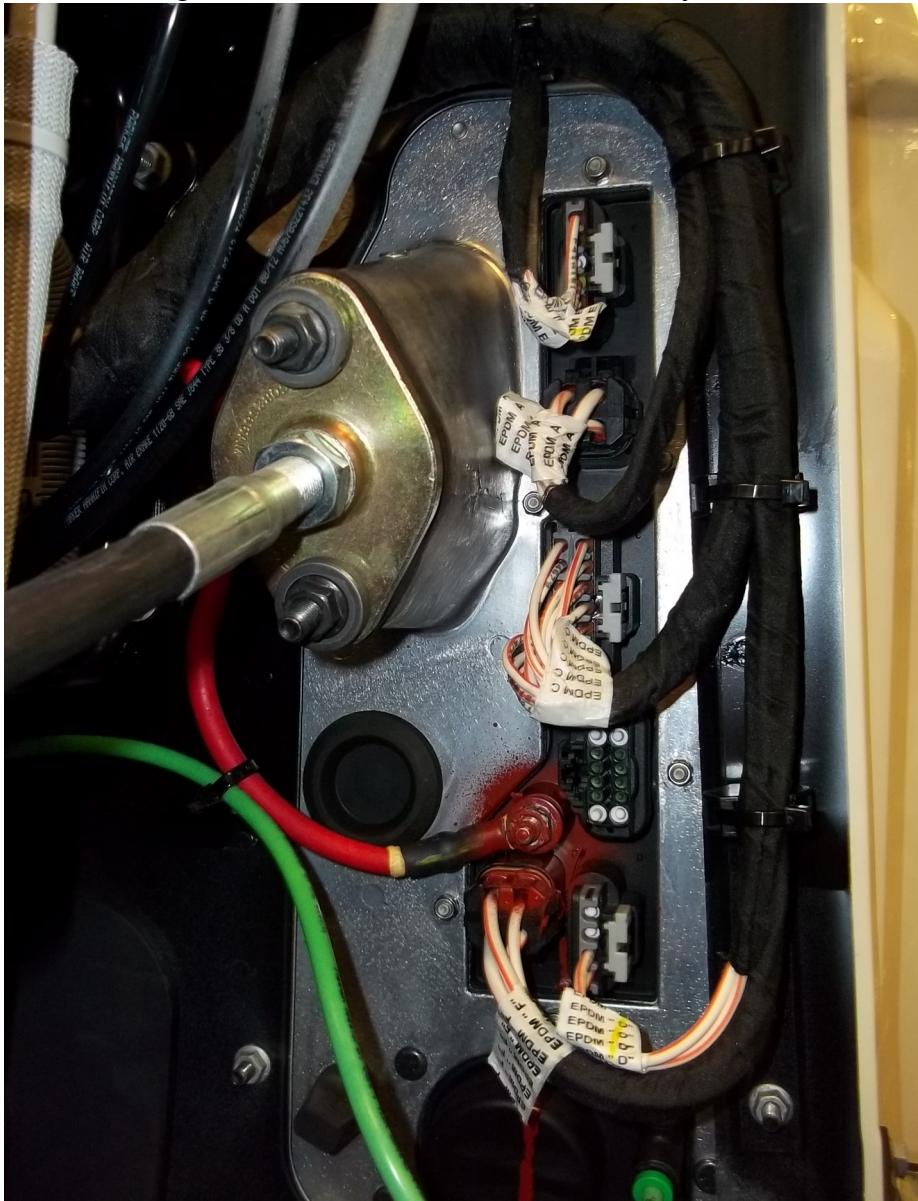
**NOTE:** Though seen in the illustration, the battery cable will not be connected at this point.

18. Under the hood install the EPDM connectors. Install the harness with sufficient drip loops

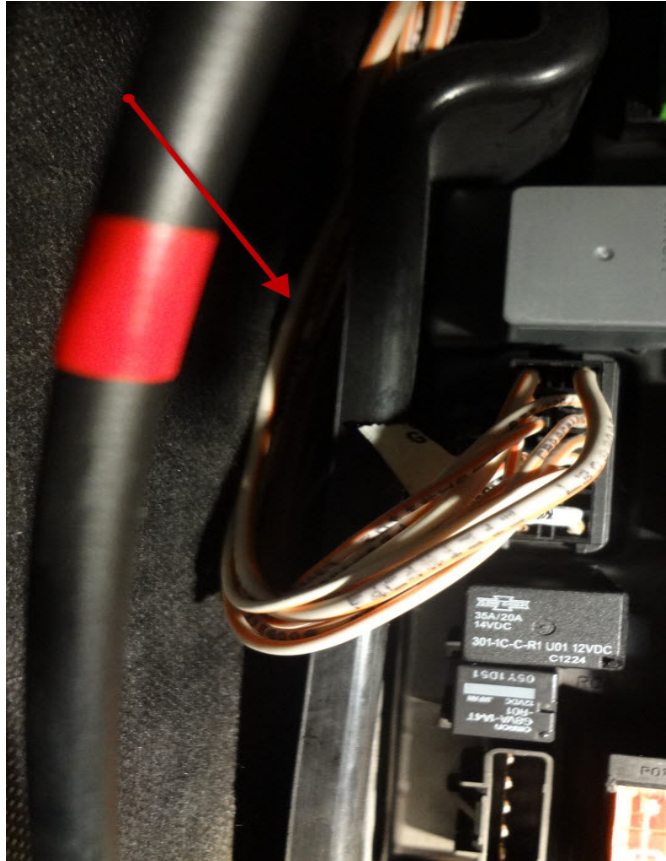
**NOTE:** The harness, if routed correctly, lays in behind the gasket

22. Route the upper portion of harness behind the gasket as shown.
