**SAFETY  
RECALL**

**SR14-10**

DATE :	APRIL 2014	SECTION :	06 - Electrical
SUBJECT:	12VI5 POWER CABLE CRIMPING [H Series]

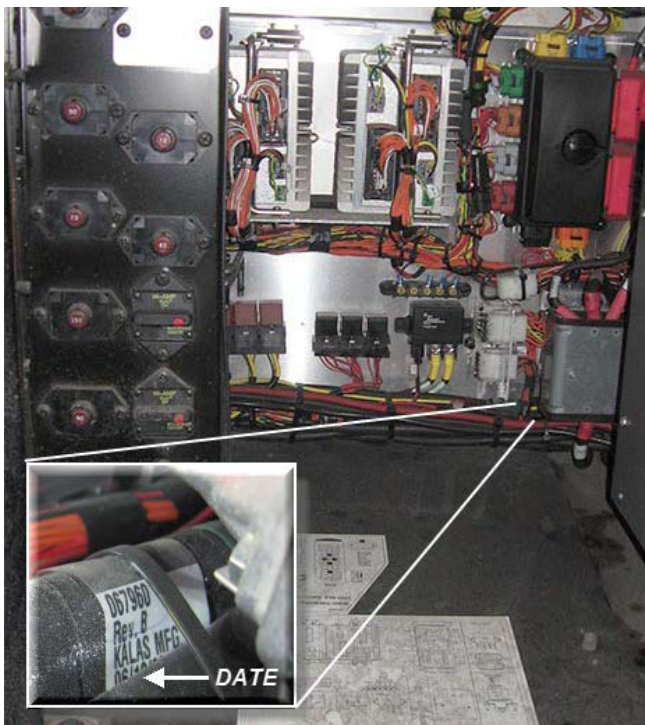
Figure 1 - Label

Locate the center section of harness **067960** that runs across the bottom of the electrical compartment. It is about one inch in diameter and is secured on the lower cable support.

Locate the harness label (Fig. 1): you may need to cut a few cable ties.

- If date code on harness is **03/21/2013**, proceed with the safety recall.
- If any other date code is present, vehicle is not subjected to recall. Do not carry out any further work.

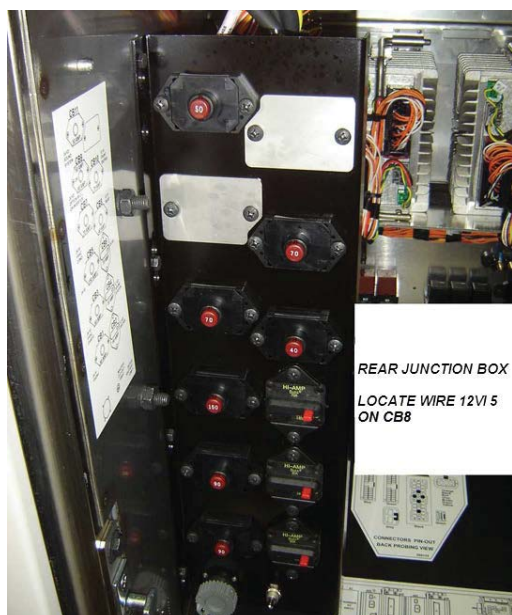
Figure 3 - CB8 end

2. Behind the circuit breaker junction panel (fig. 3), locate wire **12VI 5** connected to **CB8** (Fig. 2&6).

3. On circuit breaker end, cut cable 12VI5 just above the terminal.
4. Strip wire and install ring terminal #560086.

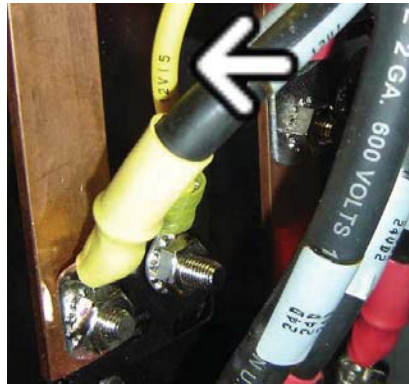
**Figure 4 - CB8 end**

Insulation at the crimped terminal ends may not have been stripped back on the power cable between a circuit breaker and the VECR (Vehicle Electrical Center Rear) power distribution box. As a result, the connection may be lost, which may cause the engine to shut down and increase the risk of a vehicle crash.
